# **NATIONAL TRANSPORTATION SAFETY BOARD**

## **AIRCRAFT ACCIDENT REPORT**

**HORIZON AIR, INC.  
DEHAVILLAND DHC-8  
SEATTLE-TACOMA INTERNATIONAL AIRPORT  
SEATTLE, WASHINGTON  
APRIL 15, 1988**

NTSB/AAR-89/02

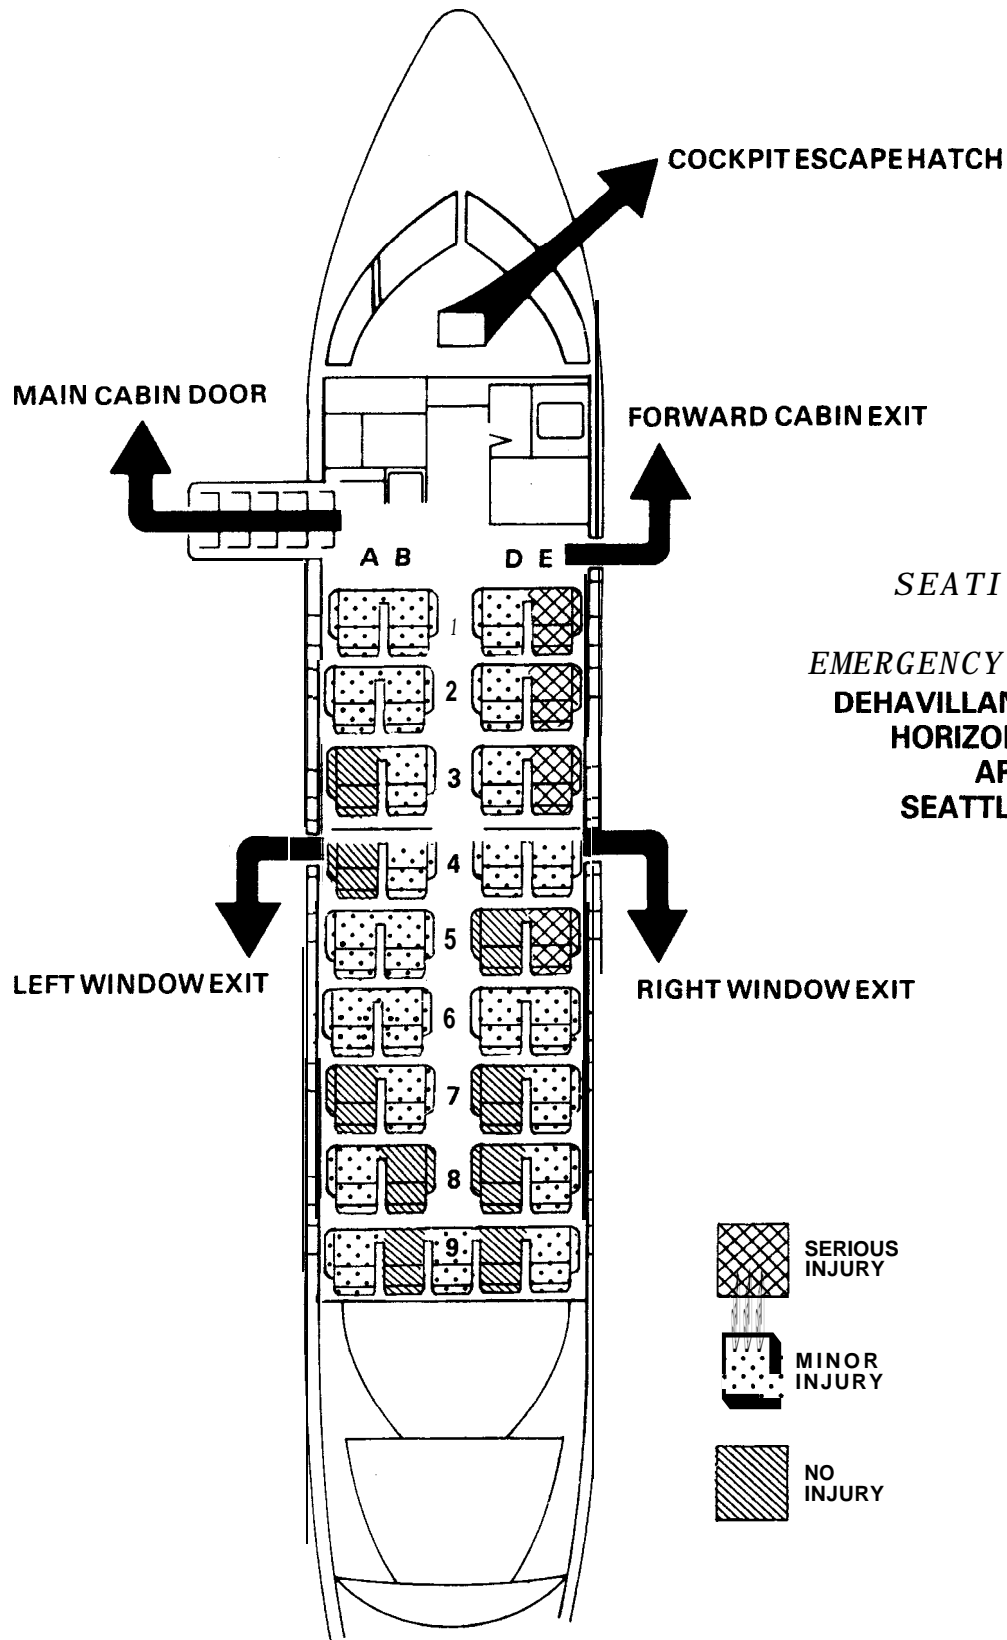
The cabin seating arrangement consisted of 37 coach seats. Seat rows 1-8 were double occupancy seats (four passengers per row with an aisle down the middle), and row 9 was a continuous row that seated five passengers. (See figure 5.) An aft facing single-occupancy flight attendant jumpseat was attached to the left rear side of the closet/wardrobe adjacent to the forward main cabin door.

A closet/wardrobe was installed on the left side of the cabin, forward of the main cabin door. A placard on the wardrobe read, in part, "100 lbs. floor load limit." Objects removed from this wardrobe following the accident included catering boxes, beer, wine and liquor containers, a suitcase and a small, portable mechanical carpet sweeper. The objects (not including the carpet

Figure 5. Injury distribution chart and seating arrangement

sweeper) weighed 146 pounds. DeHavilland Service Bulletin 8-25-35, dated February 19, 1988, called for a 1/4-turn latch that, at the operator's option, can be installed on the door of the wardrobe to prevent it from opening unexpectedly. This service bulletin also stated that until the latch had been installed, the wardrobe should be restricted to hanging items only. The 1/4-turn latch had not been installed on N819PH, and the closet/wardrobe door separated completely during the accident. Following the accident, on November 28, 1988, Transport Canada issued Airworthiness Directive (AD) CF-88-24. This document made the provision of Service Bulletin 8-25-35 mandatory for Canadian operators of DHC-8s. The FAA has not acted on this Canadian AD to make the service bulletin mandatory for U.S. operators.

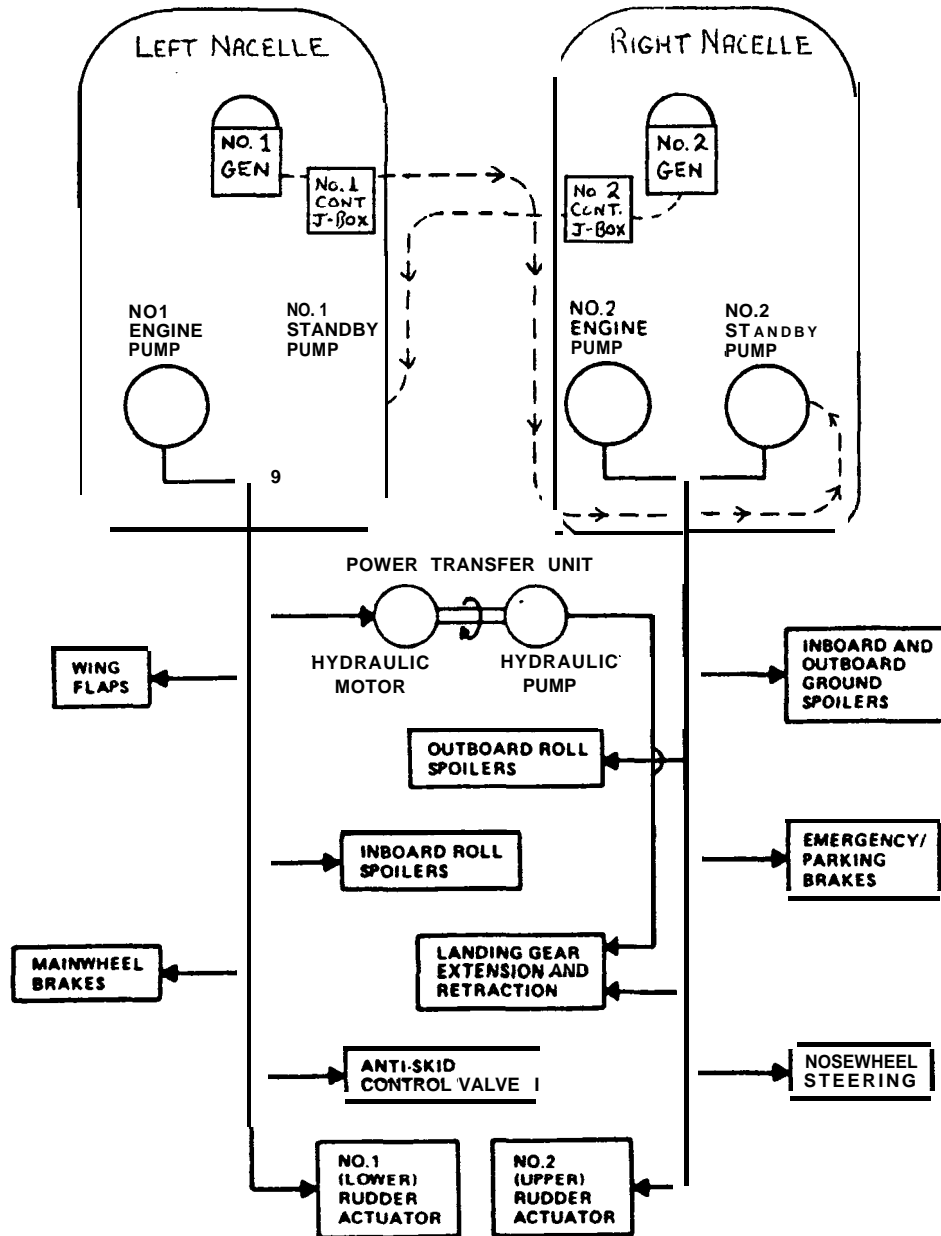
Figure 7. Schematic of the DHC-8 hydraulic system primary component

The N819PH was equipped with two independent constant pressure, variable flow hydraulic systems called the No. 1 (left) and the No. 2 (right) systems. By design, it was not possible to transfer control of hydraulic devices from one system to the other. The airplane was equipped with an emergency hydraulic system hand pump for use during emergency extension of the landing gear. Also, a power transfer unit (PTU) was installed to aid in the retraction of the landing gear in the event of a right engine failure on takeoff. The PTU consisted of a No. 1 (left) system hydraulic motor mechanically linked to a hydraulic pump that provided emergency pressure to the landing gear retract cylinders, a No. 2 (right) system component. No fluid transfer between hydraulic systems could occur normally in the PTU. The output pressure of the engine driven hydraulic pumps was rated at about 3,000 psi. Their flow rate was rated as 9.2 gallons per minute. The output pressure of the electric standby hydraulic pumps was rated as 2,750 psi under load. Their flow rate was rated as 1.56 gallons per minute. The No. 1 (left system) electric standby hydraulic pump received electrical power from the No. 2 (right) electrical supply contactor junction box, and vice versa. (See figure 7.)

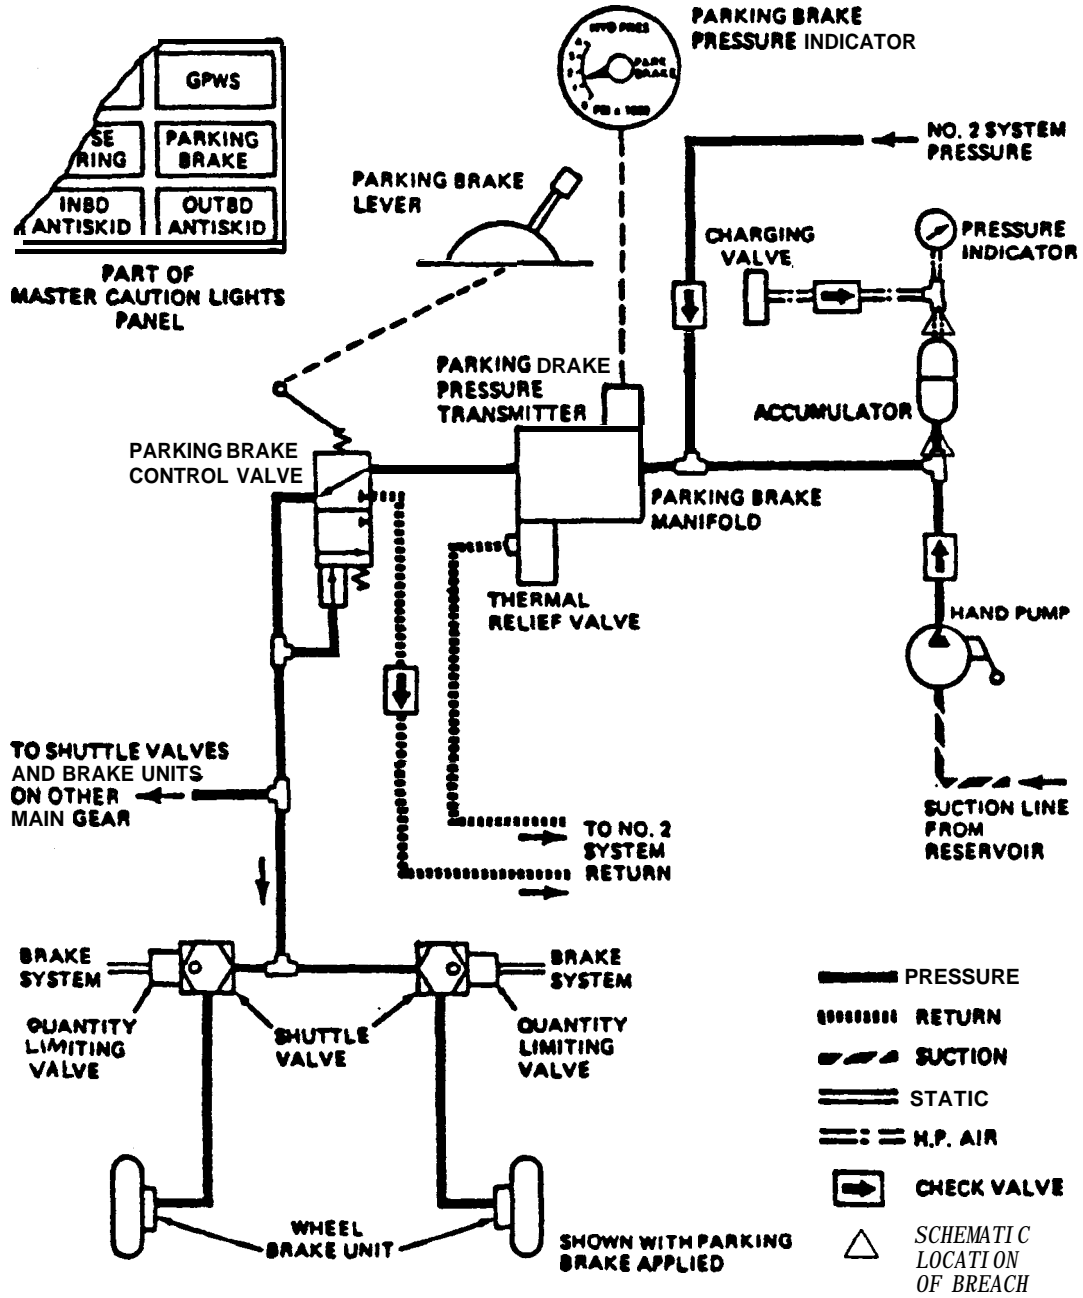
The DHC-8 emergency/parking brake system provides an independent source of braking to the main wheel brakes. During normal operations, the system receives hydraulic pressure from the No. 2 system engine-driven hydraulic pump. A check valve isolates the system from the No. 2 system pump in the event of an upstream line failure. An accumulator provides power for the system when engine-driven pump pressure is unavailable. The system is operated by a handle on the center console and serves as a parking brake system under normal operations. The crew may activate the lever and use a spring loaded button on the control lever to lock the lever in the on position. This provides hydraulic pressure to the main wheel brakes through the system powered by the accumulator. In an emergency, the lever is activated to provide braking to the main wheel brakes independent of No. 2 system hydraulic pressure. (See figure 9.)

Figure 9. Schematic of the emergency/parking brake system
