TECHNICAL REPORT

Accident which occurred to aircraft McDonnell Douglas DC-9
and Boeing B-727-200, Registration EC-CGS
and EC-CFJ, in Madrid-Barajas
Airport, Spain

Date and time: December 7th, 1983
at 0839.29 hours.

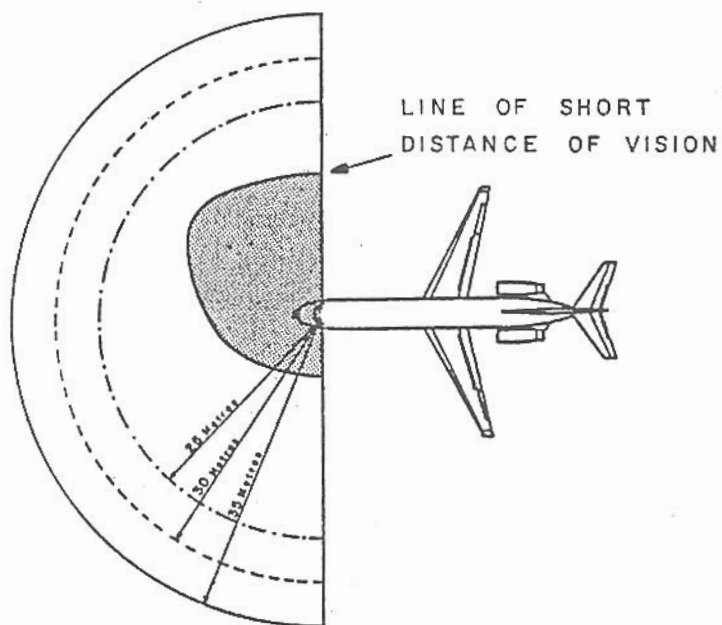
NOTE: For outer references, short distance vision is considered to be the one allowed by the geometry of the lower lines of the windshields and windows (according to the graph). Remote distance is considered to be the one defined by meteorology (50-38 meters maximum).

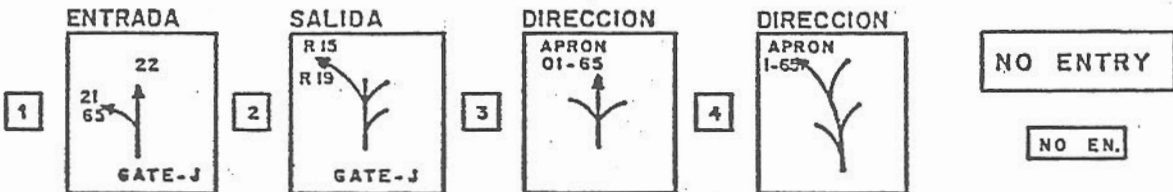
Indicadores:

The centerline sign from gate J joined the sign of taxiway O-8 centerline and the signs of exit taxiways J-1 and J-2 centerlines. To O-7 there was a discontinuity; also, close to O-7, this sign, old and discolored, did not leave J's centerline (its closest point was about 20 cm away), though it linked O-7 centerline. At the said "procedure for airplane movement at the Airport" an exit from J to O-7 had not been established, reason by which the taxiline of O-7 towards gate J was to be painted once the markers' position had been changed.
