**Aviation Safety Council
Taipei, Taiwan**

GE 791 Occurrence Investigation Report

**IN-FLIGHT ICING ENCOUNTER AND CRASH INTO THE SEA
TRANSASIA AIRWAYS FLIGHT 791
ATR72-200, B-22708
17 KILOMETERS SOUTHWEST OF MAKUNG CITY,
PENGHU ISLANDS, TAIWAN
DECEMBER 21, 2002**

ASC-AOR-05-04-001

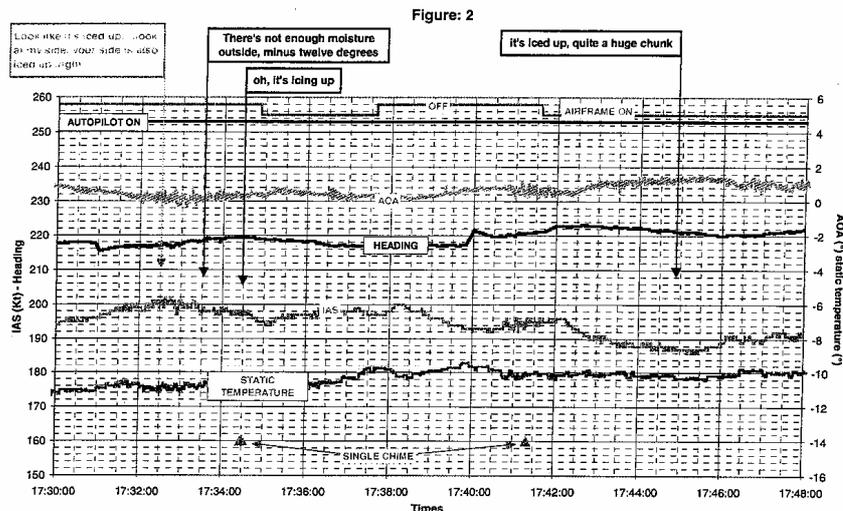
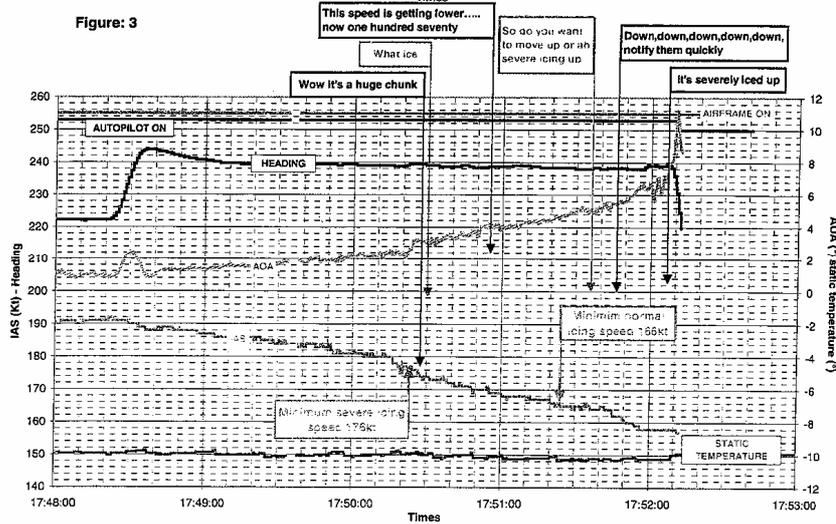
• **Audio alarms: (See figure 2)**

Note: Only the crew's conversation concerning icing events is reported on figure 2 and figure 3

The CVR transcription confirms that a single chime is the signal of ice detector because the first officer says just after the first single chime " Oh it's icing up". After both chime signals, crew action selected airframe de-icing system ON

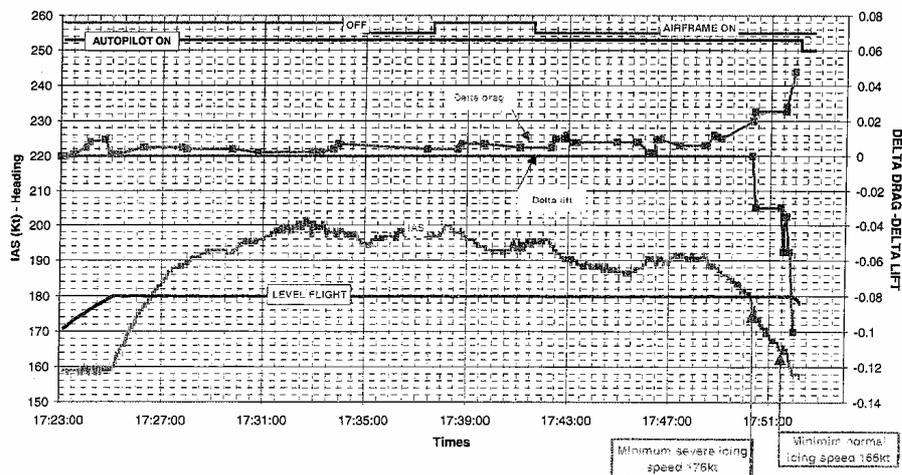
Figure: 4

The figure 4 shows that the aircraft staid exposed to icing conditions during 29mn. During the first 25 minutes the drag increased slowly (within 100 counts) inducing a speed diminishing about 10Kts. After that, the drag increased quickly and the speed dropped to 158 Kts in 4 minutes.

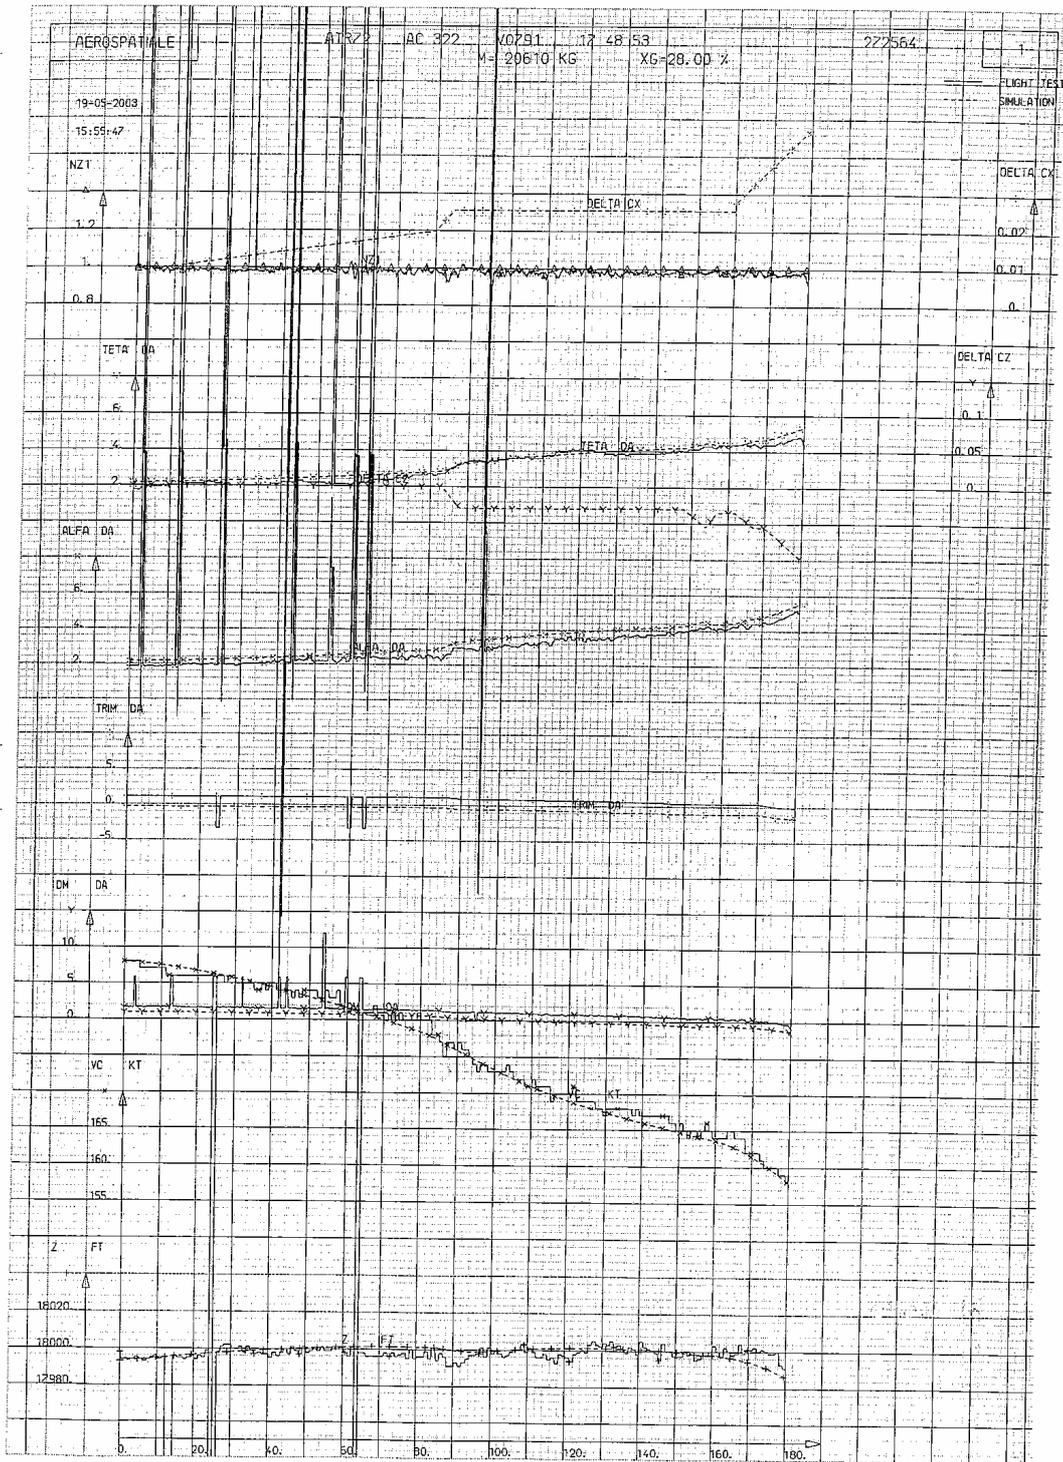
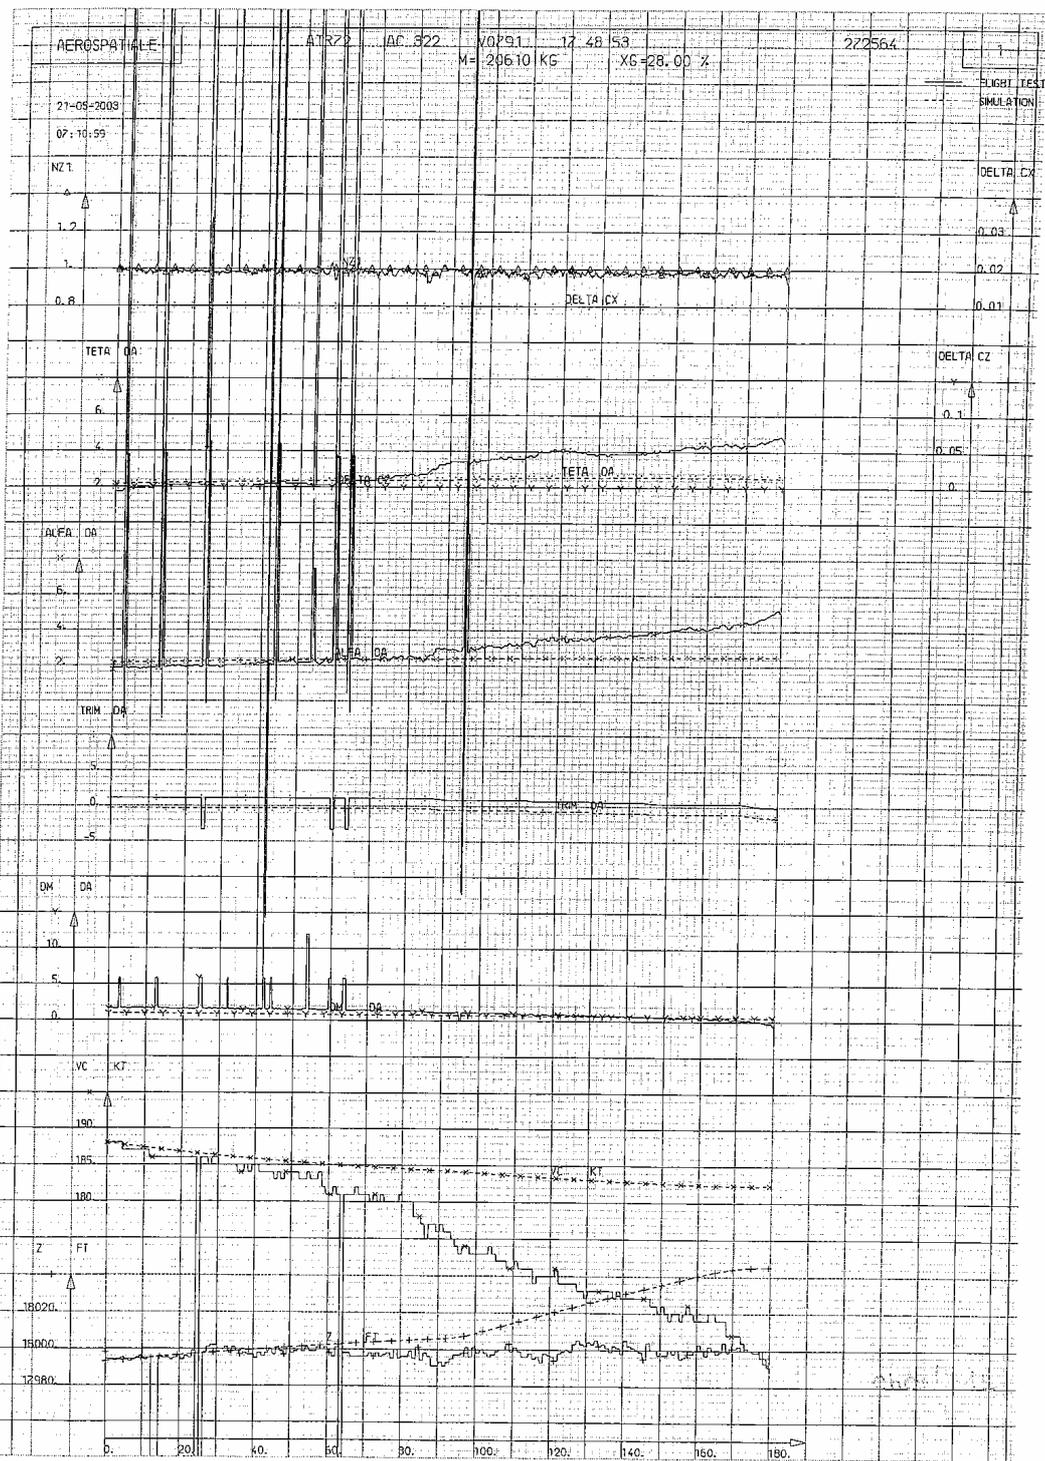
Figure 1 and 2

ANNEX 2 : DFDR

DFDR parameters

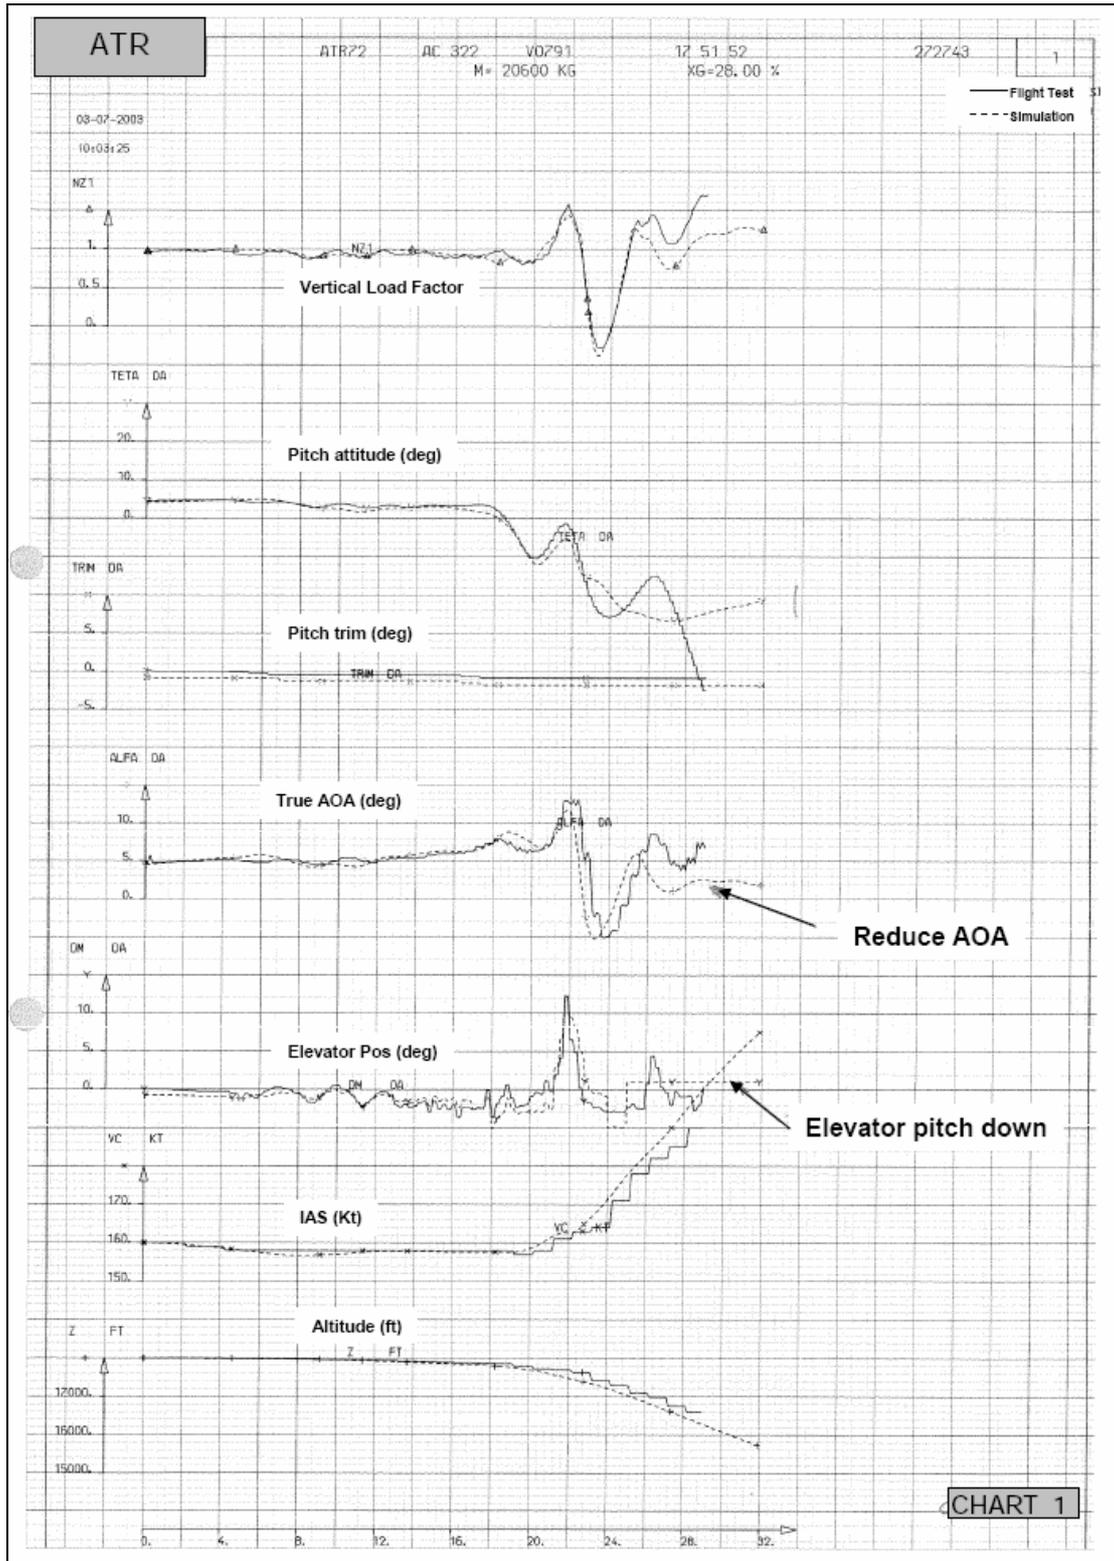
Fig. 1

The figures from 1 to 4 show that the simultaneous application of AFM procedure in the same accident flight conditions leads to the recovery of the correct flight attitude.

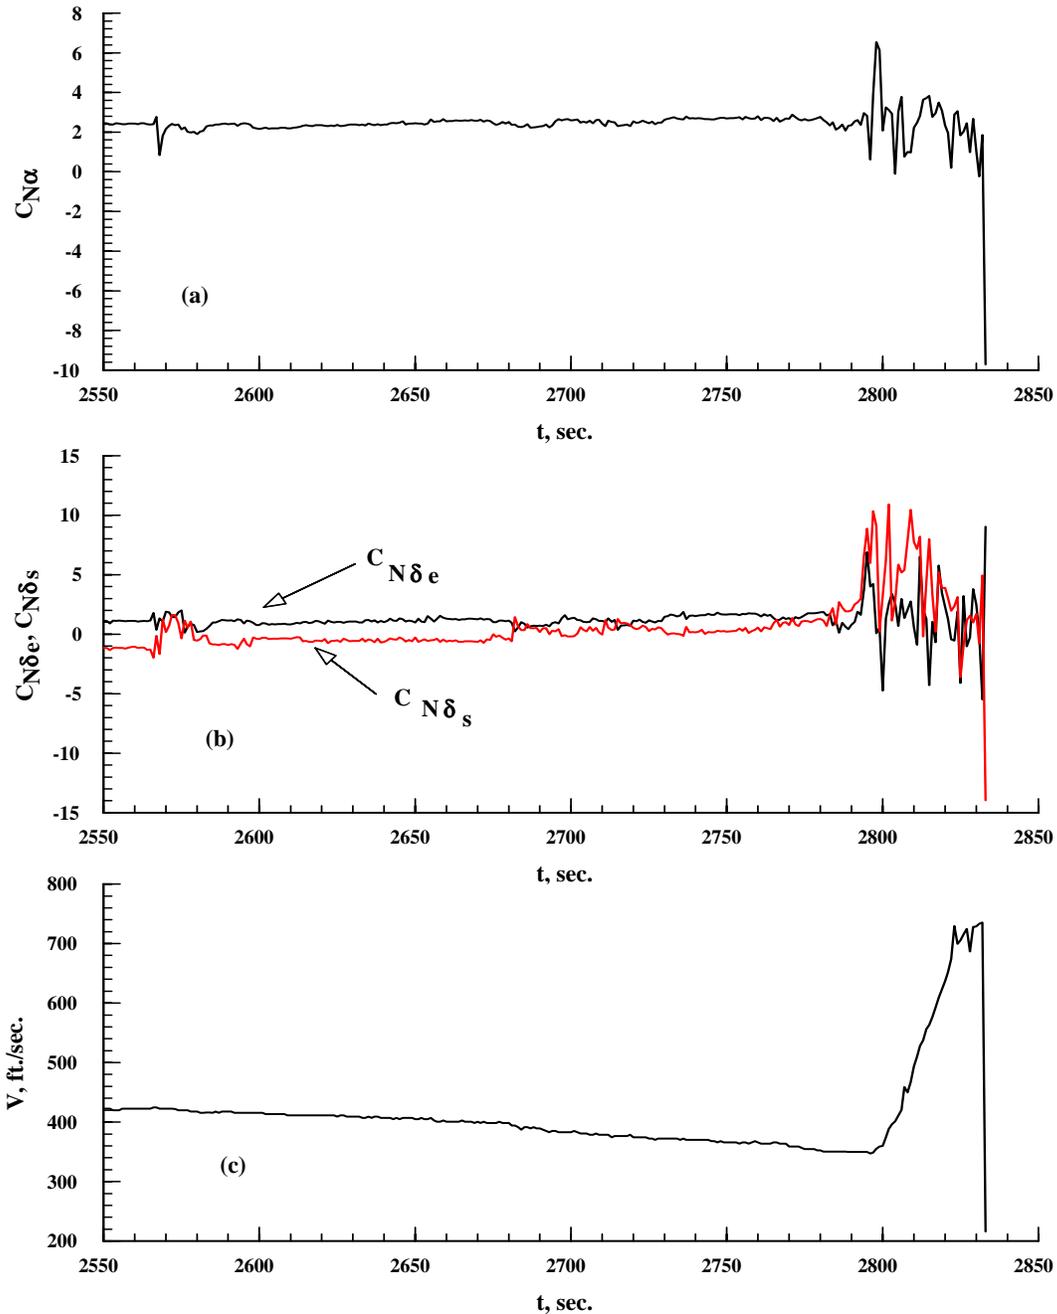
It is seen that large roll rates started at about $\alpha = 6$ deg. (fig. 6a), and the aileron was active (fig. 6b). In figure 6c, it is shown that roll rate is the primary angular rate affecting the motion. In figure 7, the normal force coefficient slope with α before roll excursion is estimated to be about 2.2 per radian. Since the effectiveness of both the elevator and stabilizer before the roll excursion appeared to be small (fig. 7b and fig. 8b), tail icing might have started before wing ice accretion.

Figure 7 Calculated derivatives for the normal force coefficient along the trajectory

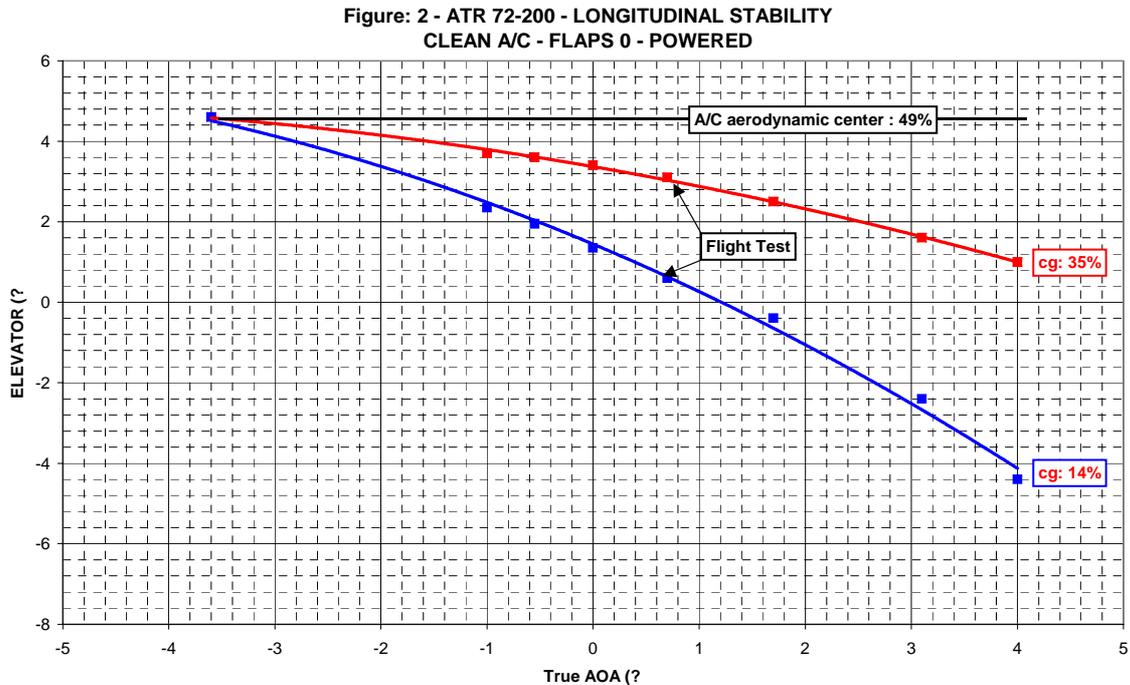
Flight test conducted on ATR 72 200 A/C 98 shows that the aerodynamic center with the same configuration is situated at 49% of the Mean Chord. The small differences in

Longitudinal stability of A/C 322 (flight 791) is nominal in this period

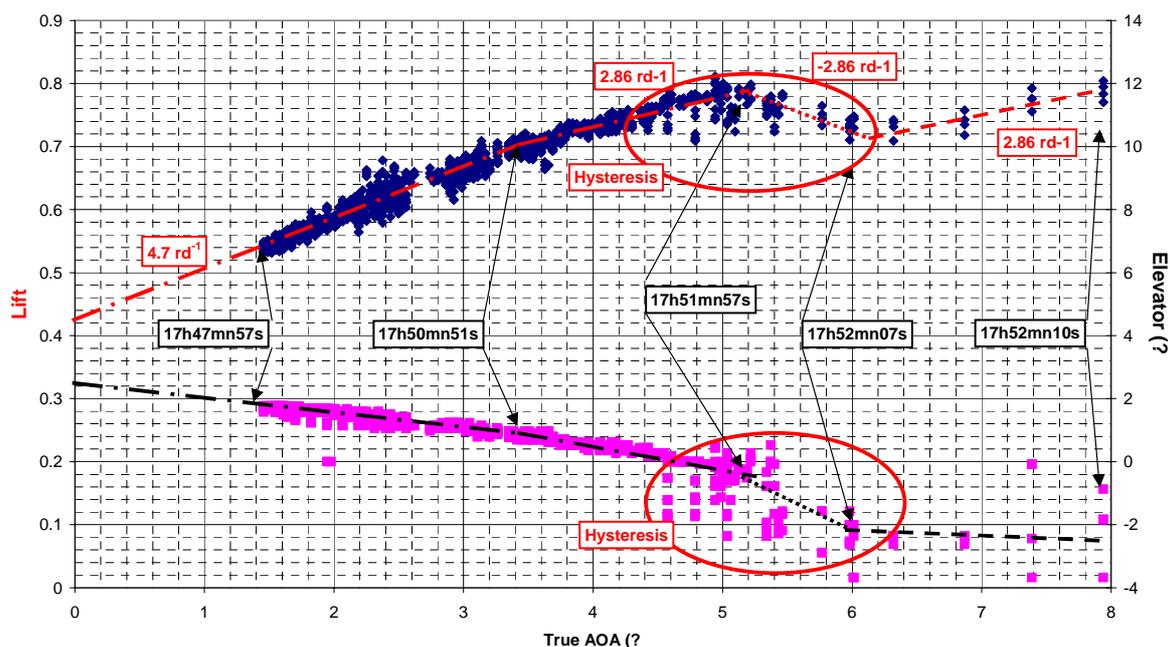
Figure: 3 - AC 322 LONGITUDINAL STABILITY

When the autopilot initiated the descent a flow separation occurs simultaneous on the two wings (no roll) up to $AOA=6^\circ$, then an asymmetrical left roll appears.

During this period it is difficult to check correctly the longitudinal stability due to the aerodynamic hysteresis phenomenon on the lift (See figure:3). However the elevator efficiency is not affected and after the roll departure (17h52mn07s). The longitudinal

According to the figure:1 $Cz_{\alpha} = 4.7^{rd-1}$ then $Cz_{\alpha} = 2.86^{rd-1}$ and according to the figure:3 $Cz_{\alpha} = -2.86$ few seconds before the roll departure and $Cz_{\alpha} = 2.86$ between roll departure and stall warning.

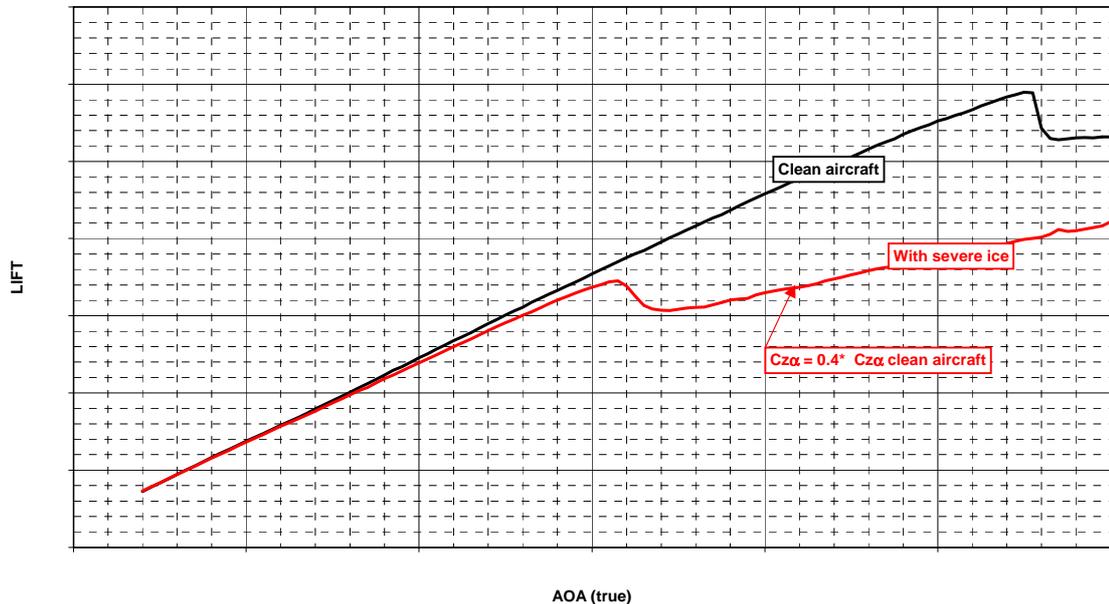
Figure 4 : ATR 72 - WIND TUNNEL TEST

Wind tunnel tests conducted on a mockup (1/2 span; Scale: 1/8) with and without Severe Ice on the airframe show a same result on lift coefficient (See Figure 4)

When a flow separation occurs, the figures 3 et 4 show that a significant reduction of angle of attack (about 3°) during few seconds, leads the aircraft in a situation where all aerodynamic parameters are nominal.
