**AERONAUTICAL ACCIDENT INVESTIGATION
AND PREVENTION CENTER**

**FINAL REPORT
A-00X/CENIPA/2008**

ACFT REGISTRATION: PR-GTD and N600XL

MODELS: B-737 8EH and EMB-135 BJ LEGACY

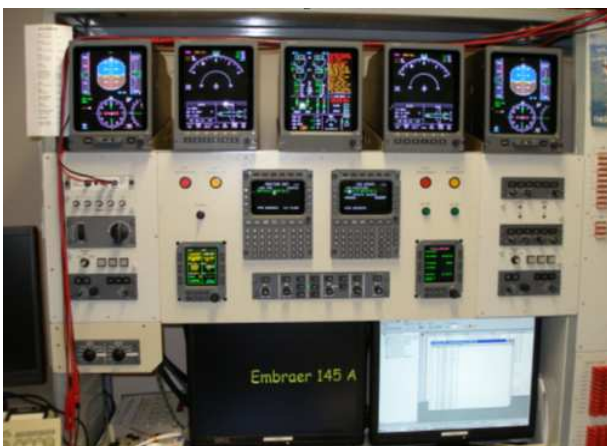
Figure 5. Integration bench for the Primus 1000

The second phase consisted in the execution of the procedure already validated, this time using the TCAS, RCZ and RMU units removed from the N600XL. This phase was successfully conducted, and the results did not indicate any unexpected behavior, or in discordance with the technical specifications, which could affect the adequate transmission of the Transponder signals. No change of the Transponder mode of operation was identified.

In addition, it was confirmed that the system being tested did not present the problem associated to the subject addressed by the AD 2005-0021 issued by EASA “*Transponder Reversion to Stand-By Mode*”, and by the AD 2006-19-04 issued by the FAA “*To prevent transponder of the Honeywell COM unit from going into standby mode*”. The members of the CIAA and other participants had the opportunity to randomly apply successive commands in the control panels, mainly in the RMUs, trying to create an unexpected abnormal behavior. Nothing abnormal in the functioning of the equipment was observed.

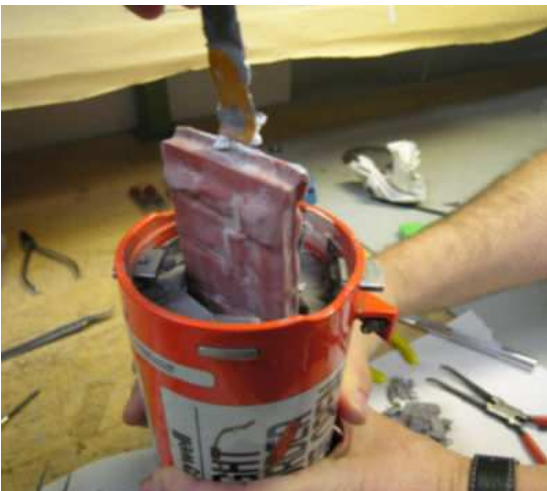
Figure 21: Removal of the memory, PR-GTD SSCVR

For the retrieval of the PR-GTD SSCVR cylinder data, the electronic board containing the memory chips was carefully removed from the cylinder (Figure 21), and the respective flat cable was recovered (Figures 22 and 23).

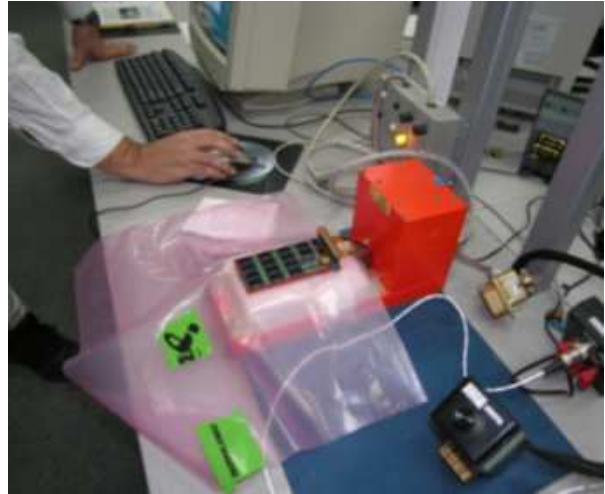
Figure 24: Memory board reading, PR-GTD SSCVR

The electronic board was then installed in a complete SSCVR unit (Figure 24). Similarly, the protected cylinder of the PR-GTD SSFDR was removed and subsequently installed in a complete SSFDR unit.

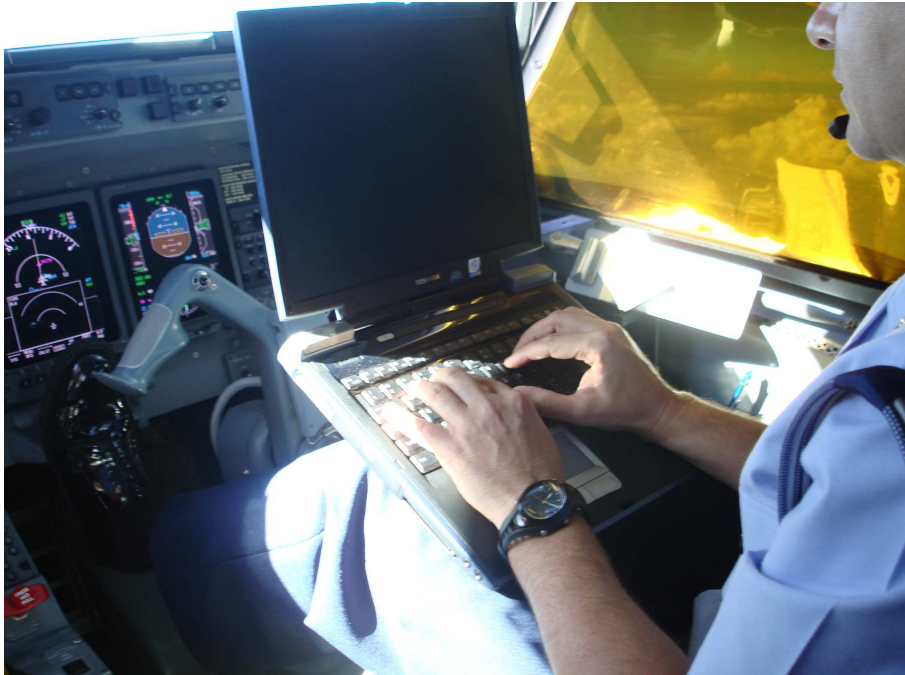
Figure 33

a) Use of the *laptop* by the SIC during cruise flight, leveled at FL370 and FL380. (Figure 33 shows the TCAS Box open, as should be expected):

- Likewise, it was observed that the control column is an obstacle for the contact of the *laptop* with the aircraft panel, preventing any type of inadvertent activation of the various systems;
- The *laptop screen* prevents the PIC from sighting the panel ahead and, thus, He cannot see the indications of the Transponder on the RMU and MFD;

- When the *laptop* is handled by the PIC, it is possible for the SIC to maintain normal visual contact with the panel ahead of him, sighting all the visual indications of the Transponder, as well as the indications of the panel ahead of the PIC, even considering the parallax.

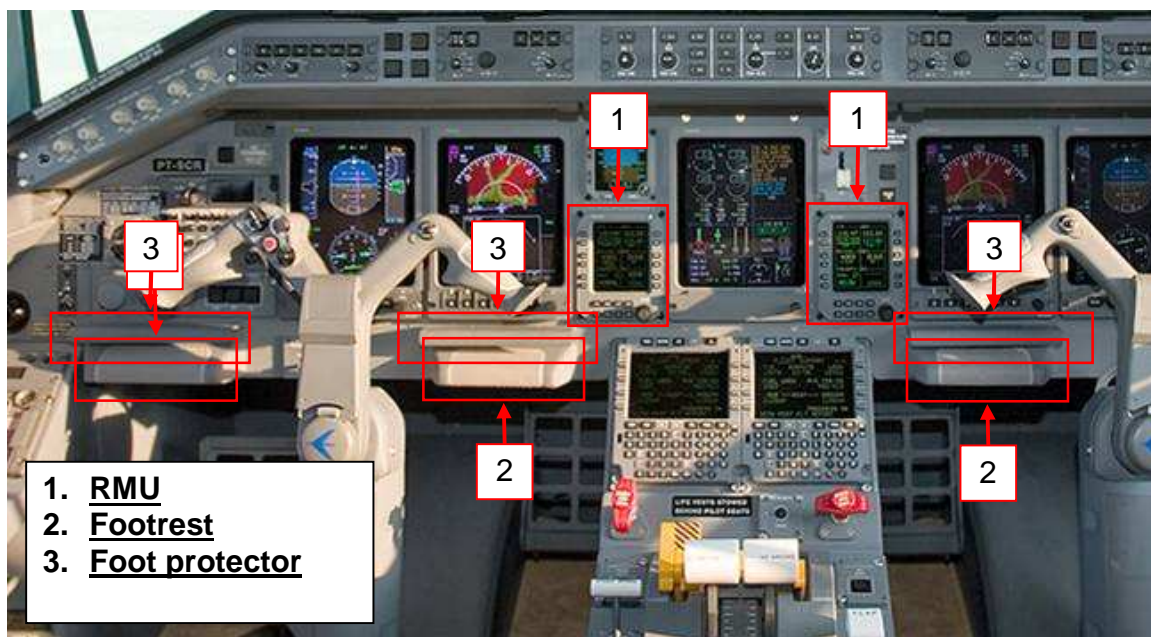
Figure 37

e) Ergonomic Aspects – Considering the positioning of the RMU1 and RMU2 in the instrument panel of the EMB-135BJ as in the picture above:

- With relation to “position”, the location of the RMU in the frontal panel of the aircraft is considered excellent when one verifies the angle of sight from both the PIC and SIC’s perspective.
- With relation to “luminosity”, the perception and understanding of the information of the RMU in the frontal panel of the aircraft were considered of easy interpretation, due to the size of the letters and distribution of colors, even with the intense luminosity present during the flight.

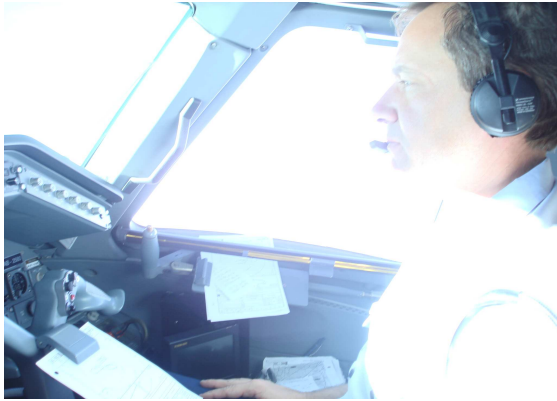
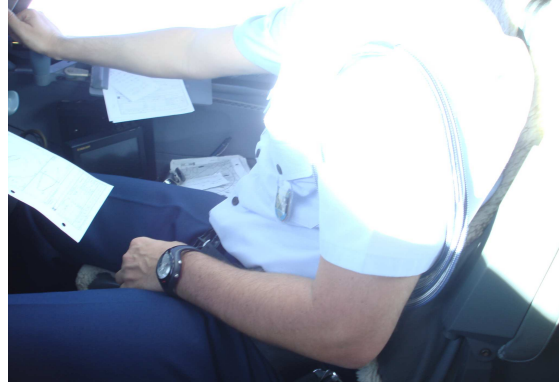
- It is possible to observe that the sunshine touches the SIC on the chest, in a area that is tangent to the chin is above the abdomen (Figures 41 and 42);
- The SIC reported a sensation of discomfort due to the intense heat on his chest;
- As the sunshine touches the SIC below his chin, his eyes end up being protected by the overhead panel, allowing a perfect visualization of the instruments, as they are not directly hit by the sunlight (Figures 38 and 39);
- Since the frontal panel of the PIC is also protected from the sunshine, it is possible for the SIC to visualize it normally (despite the parallax), in the same way he visualizes his own panel;
- For the PIC the conditions were similar, and, even with the sunlight coming from the left, the visualization of the instrument panel was not hindered (Figure 44). There is evidence of the use of the sunshade by the crew.

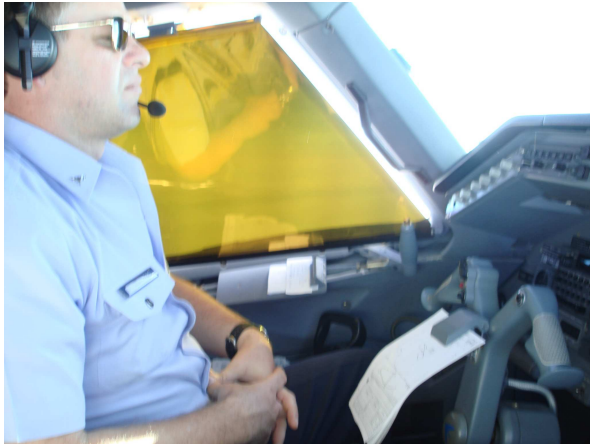
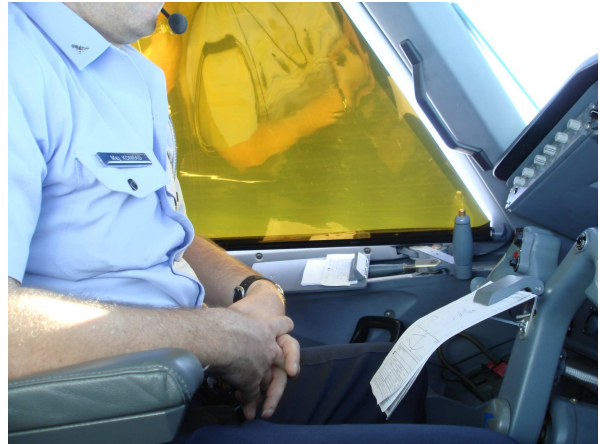
- i) Aspects related to the influence of the sunshine on the visualization of the aircraft panels and their respective instruments (with the use of the sunshade, lateral view of the PIC, same magnetic headings and same time of the accident flight):
- The aircraft possesses an amber color sunshade which proved efficient for preventing the incidence of the sunshine directly on the pilot or on the aircraft panels (Figures 45 and 46);
 - With the sunshade lowered, probably in the same position of the Day of the accident, the comfort of the pilot was rather improved, as the sunshine did not touch his chest directly (Figure 45);
 - The visualization of the instruments improved on account of the lower intensity of the sunlight in the cockpit (Figures 45 and 46).

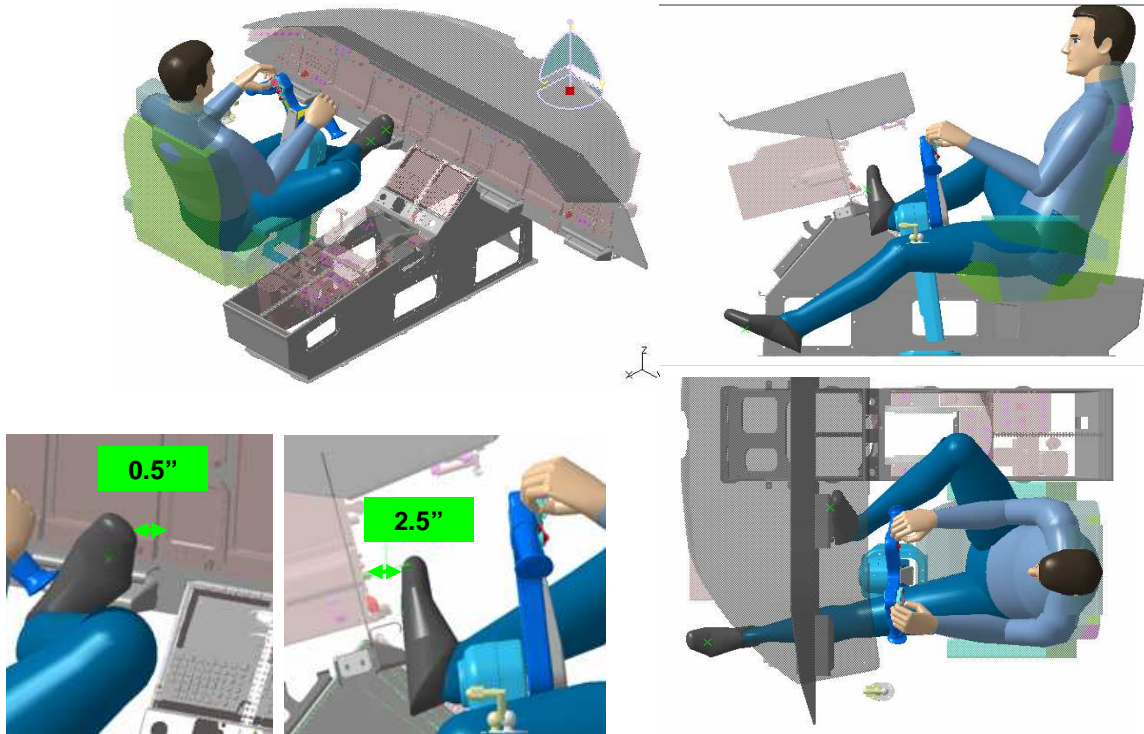
Situation (a): Figure 49 represents the position of the virtual human model, equivalent to the PIC, in the normal flight condition (DEP), using the *footrest* with the seat reclined 10°.

measurements eliminate the possibility of an inadvertent command from the foot on the RMU.

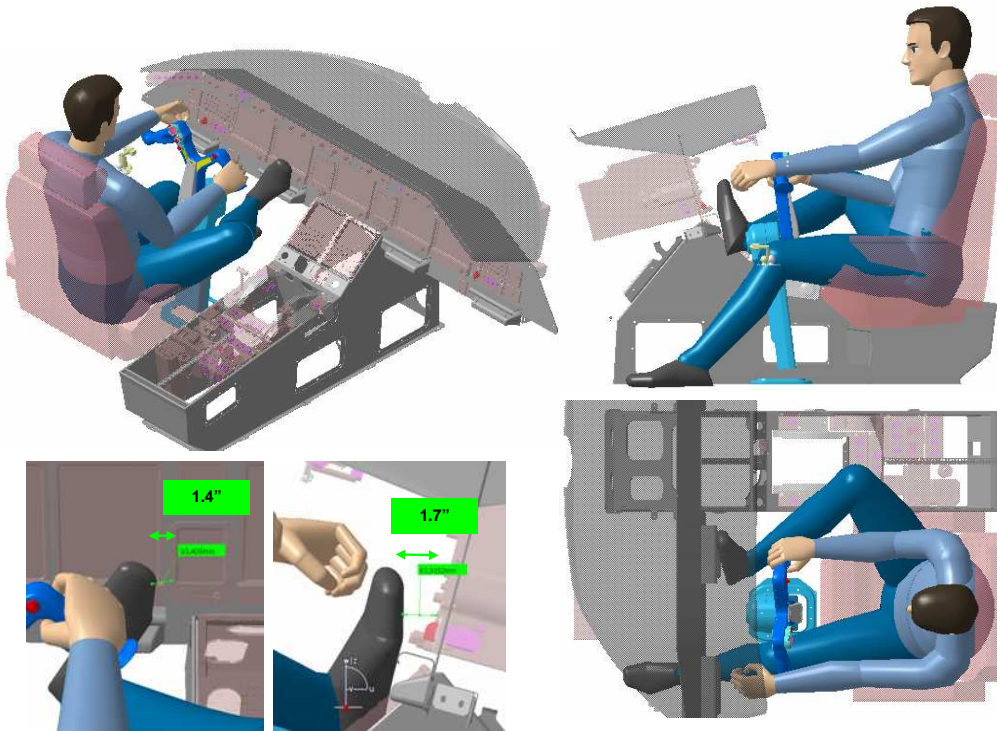
Situation (b): Figure 50 represents the position of the virtual human model, similar to the PIC, trying to utilize the *footrest* with the seat moved 2" back from DEP without reclining the seat and still having access to the primary flight controls (control wheel and pedals):

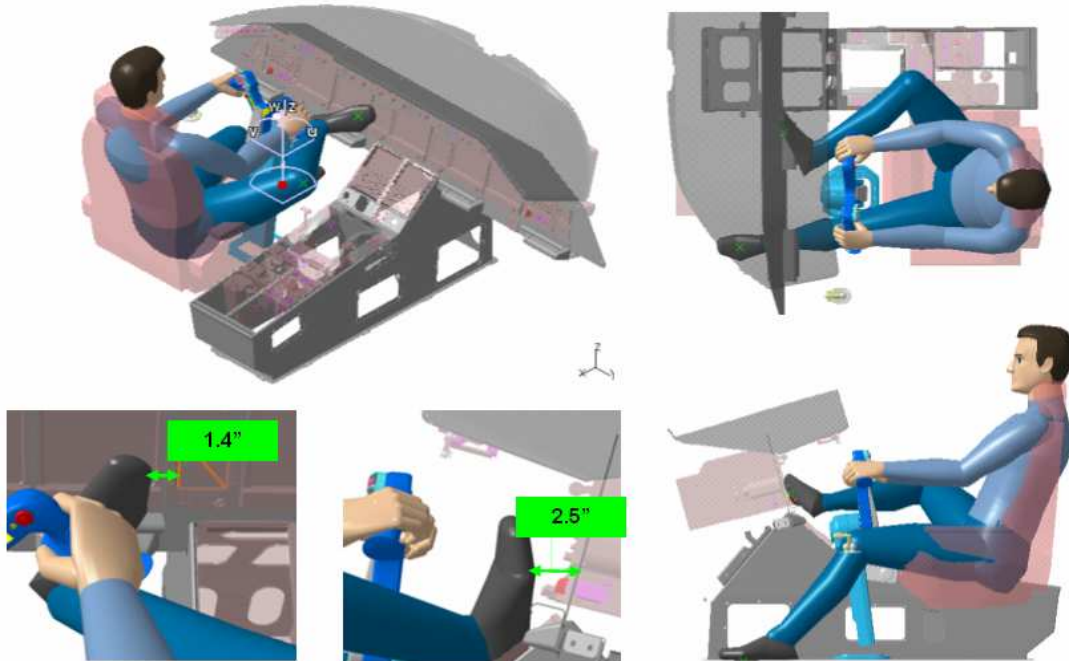
Situation (c): Figure 51 represents the position of the virtual human model, similar to the PIC, trying to utilize the *footrest* with the seat moved 2" back from DEP (i.e., without reclining the seat) and keeping access to the primary flight controls (control wheel and pedals), and now with the seat reclined 10°.

From this table, the posture of the pilot in this position remains unnatural and uncomfortable, which also eliminates the possibility of an inadvertent command from the foot on the RMU.

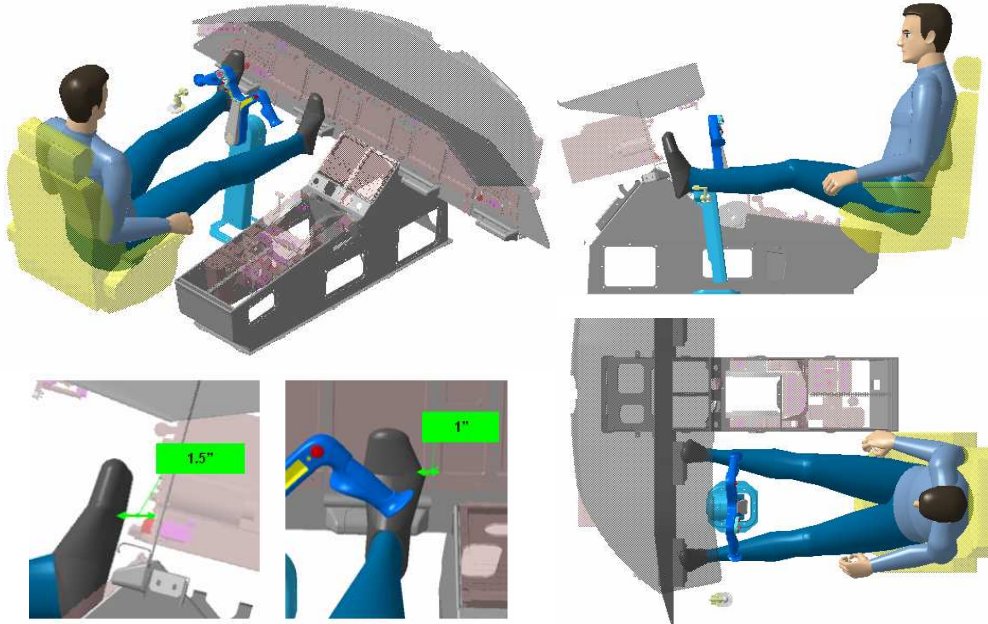
Situation (d): Figure 52 represents the position of the virtual human model, equivalent to the PIC, trying to utilize the footrest with the seat all the way to the back and without reclining the seat:

The utilization of the footrest with the seat in the flying position for the evaluated conditions, from the ergonomic point of view is extremely uncomfortable and therefore not usual or practical if we consider that the PIC would be looking for comfort while resting his right foot on the *footrest*.

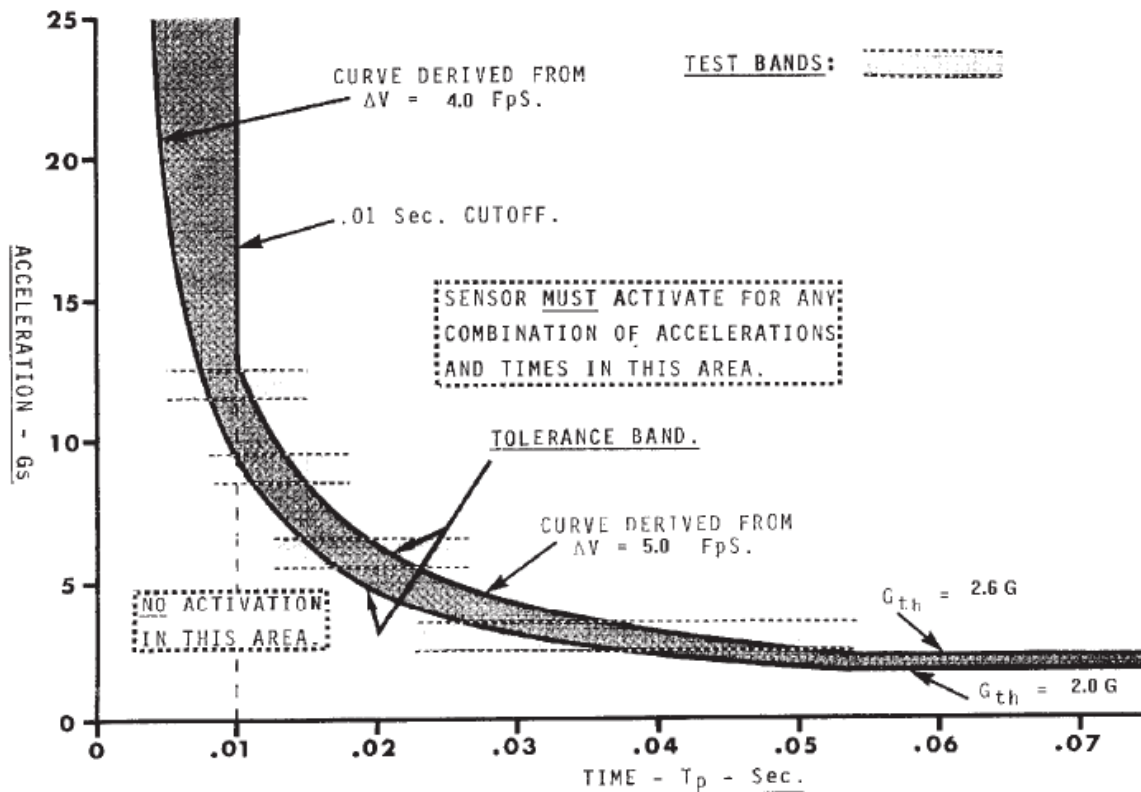
Figure 53

The crash force activation sensor or G-Switch is designed to activate according to the plot time versus longitudinal G force as shown by the Figure 1. For short impact the G force to activate the ELT is much higher than a relatively long impact.

After the N600XL and PR-GTD collision, no signal from the PR-GTD ELT was received by COSPAS/SARSAT system to help the search and rescue effort. While the PR-GTD was already in a spiral dive and before it suffered the in-flight breakup, the recorded FDR information revealed that the longitudinal acceleration did not exceed 0.5 G. This value was not sufficient to activate the ELT, according to figure 1.

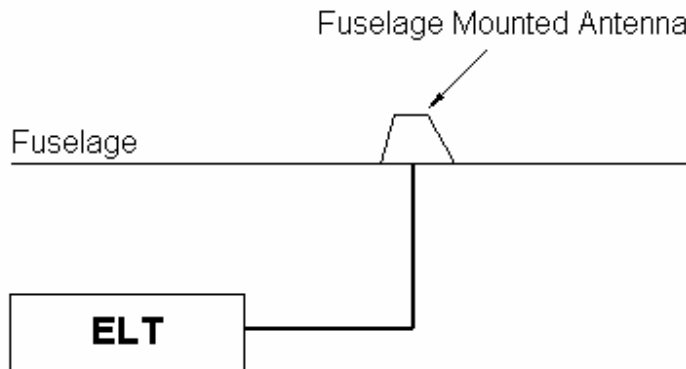
Figure 54

The ELT installation includes a fuselage mounted antenna (Figure 2). If the cable between ELT unit and respective antenna is damaged, the transmission of the signal will not occur.

After the in-flight breakup of 737, probably the connection between the ELT unit and respective antenna was damaged or the tail crashed vertically, preventing any possible signal transmission.

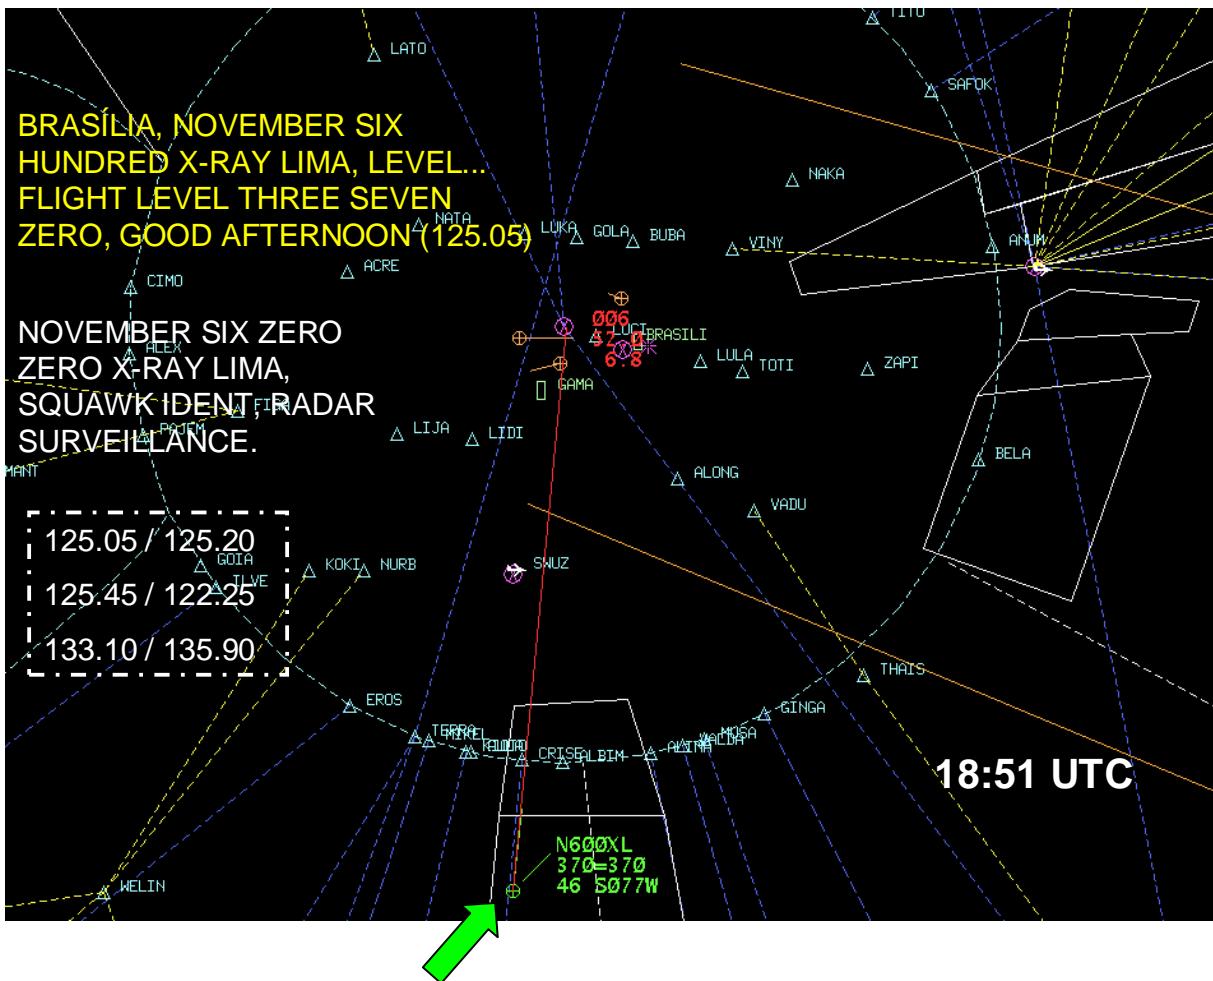
Figure 55 above depicts a view of the data block at the moment of the last two-way radio contact with Brasilia Center, sector 5, on the frequency 125.05 MHz.

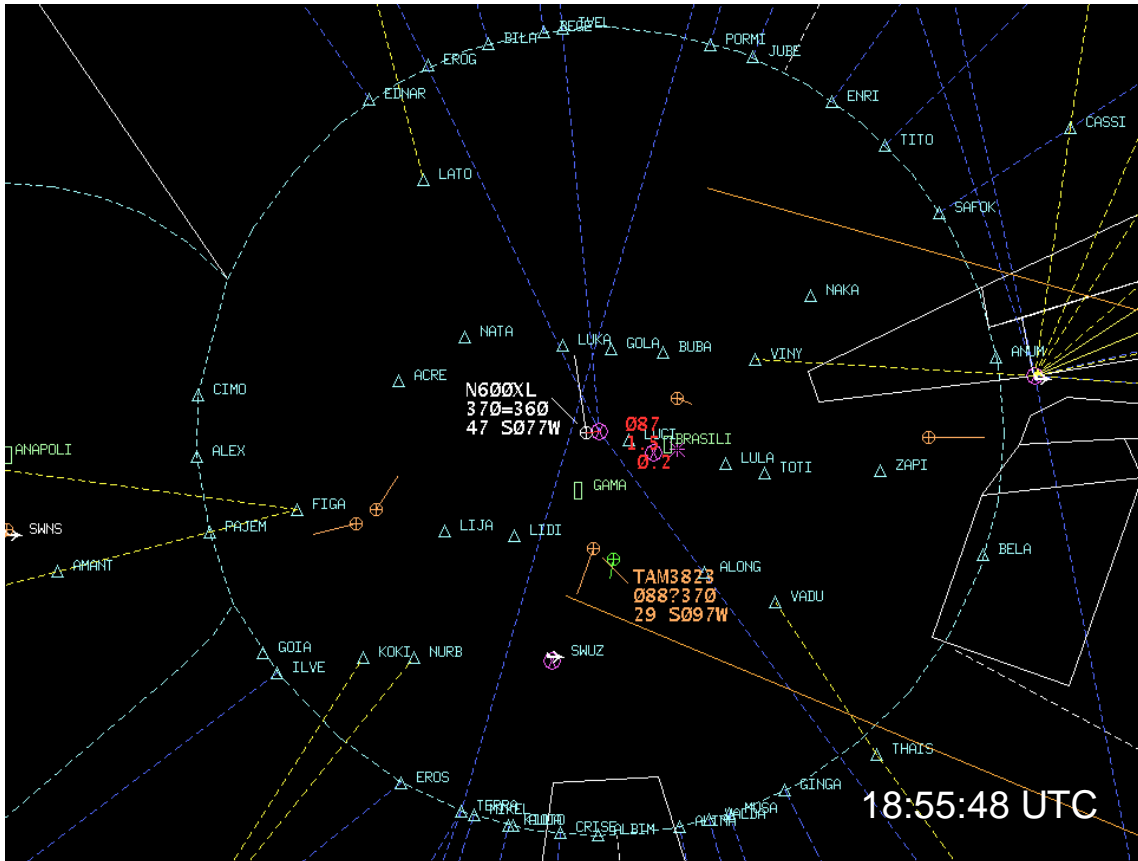
The information of the data block was that the aircraft, from that point on, **was flying at a flight level that was different from the flight level requested in the active flight plan**, as shown in Figure 56 below.

The failing to act, on the part of the controller, leads us, then, to the possibility of an inadequate situational awareness to react correctly to the pieces of information presented by the equipment, something that contributed to the N600XL maintaining of the FL370 after passing BRS VOR.

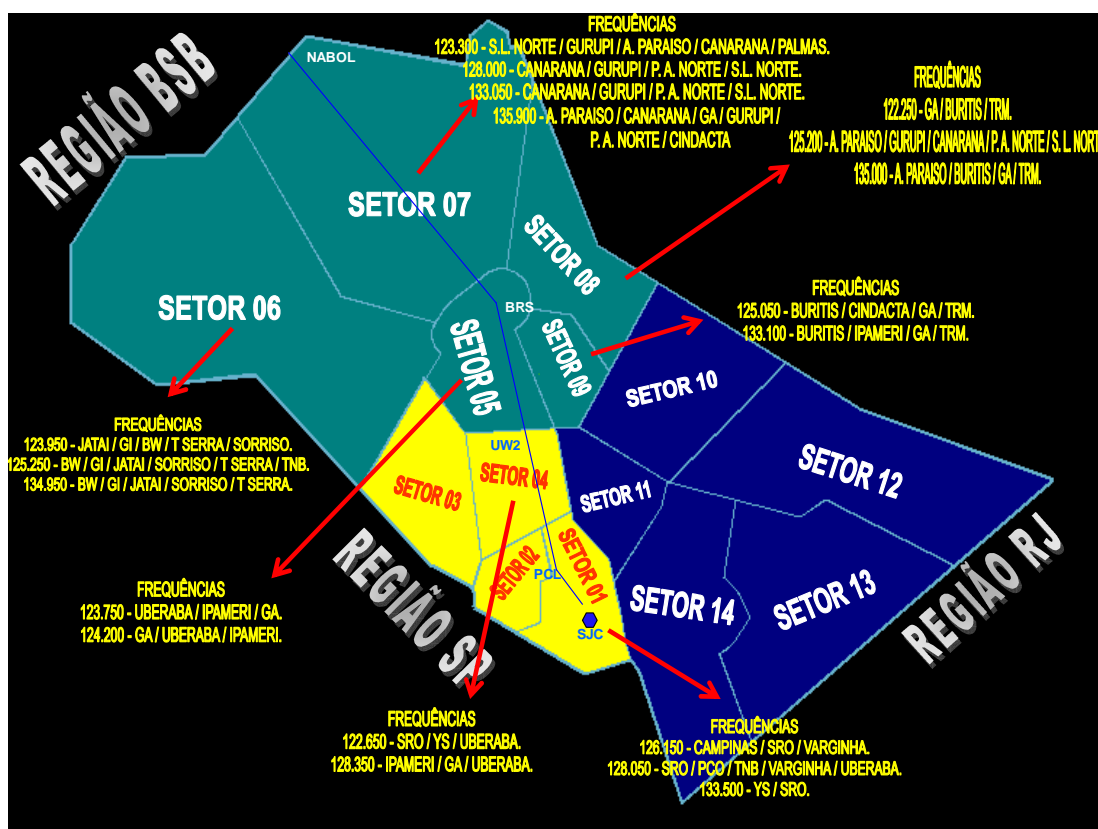
Figure 57

When the controller verified the aircraft entering sector 7, to the north of Brasilia, he had to have instructed the aircraft to change frequency to 135.9 MHz, in accordance with the sector frequency table (Figure 57), besides analyzing and deciding about the adequate instruction regarding the change to FL360 authorized by the active flight plan.

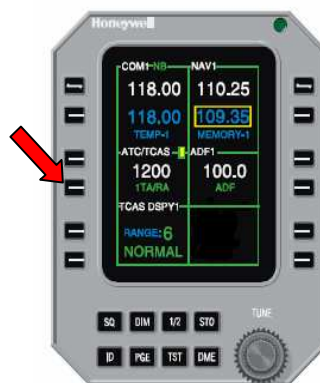
Figure 58

For the Standby mode to be selected, it is necessary to press the fourth top to bottom left button, in one of the RMUs (it has to be pressed twice in a 20-second interval).

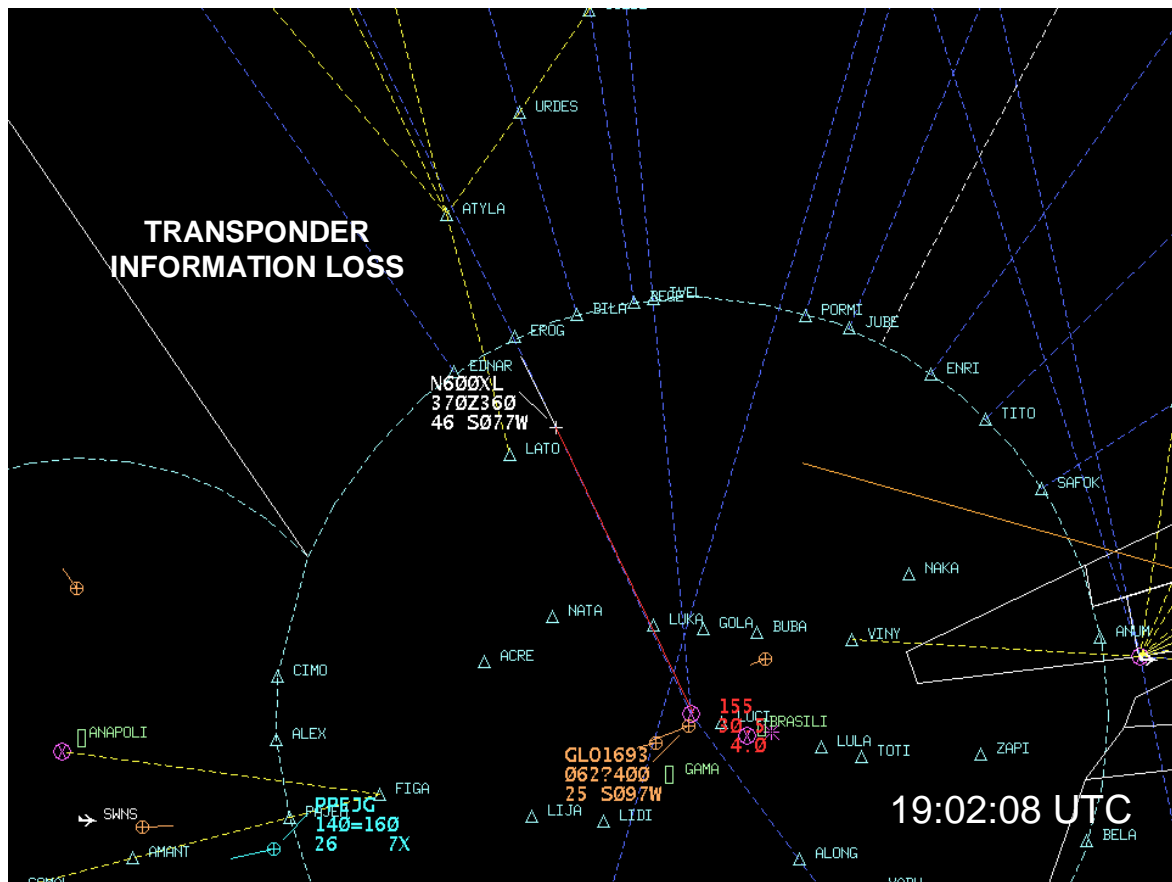
Figure 59

As seen in figure 59, the white data block pertaining to N600XL displays a letter Z between the two levels earlier identified as NIV and CFL, according to the ATECH Controller's Manual already mentioned, meaning **aircraft with a valid 3D altitude**. This meant that, from that moment on, the altitude information relative to that aircraft **was being obtained by 3D primary radar equipment and not from the transponder mode C** any longer.

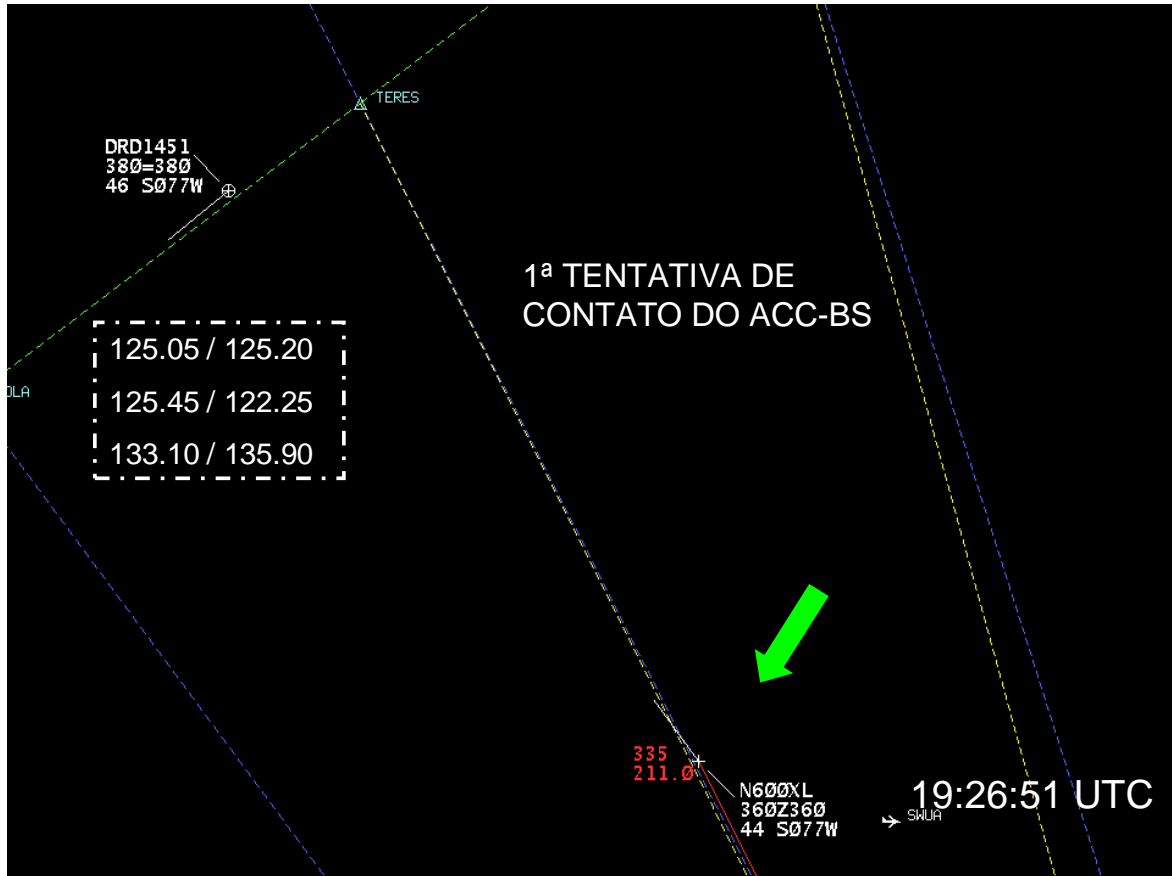
Figure 60

Despite being transmitting on 125.05 MHz, the first call was only made when the aircraft was already at **211 NM away from BRS VOR.**

The effective range of the frequency 125.05 MHz at FL 300 is 300 NM. Although the aircraft was within the frequency theoretical maximum range, the positioning of the aerials is for sector 09.

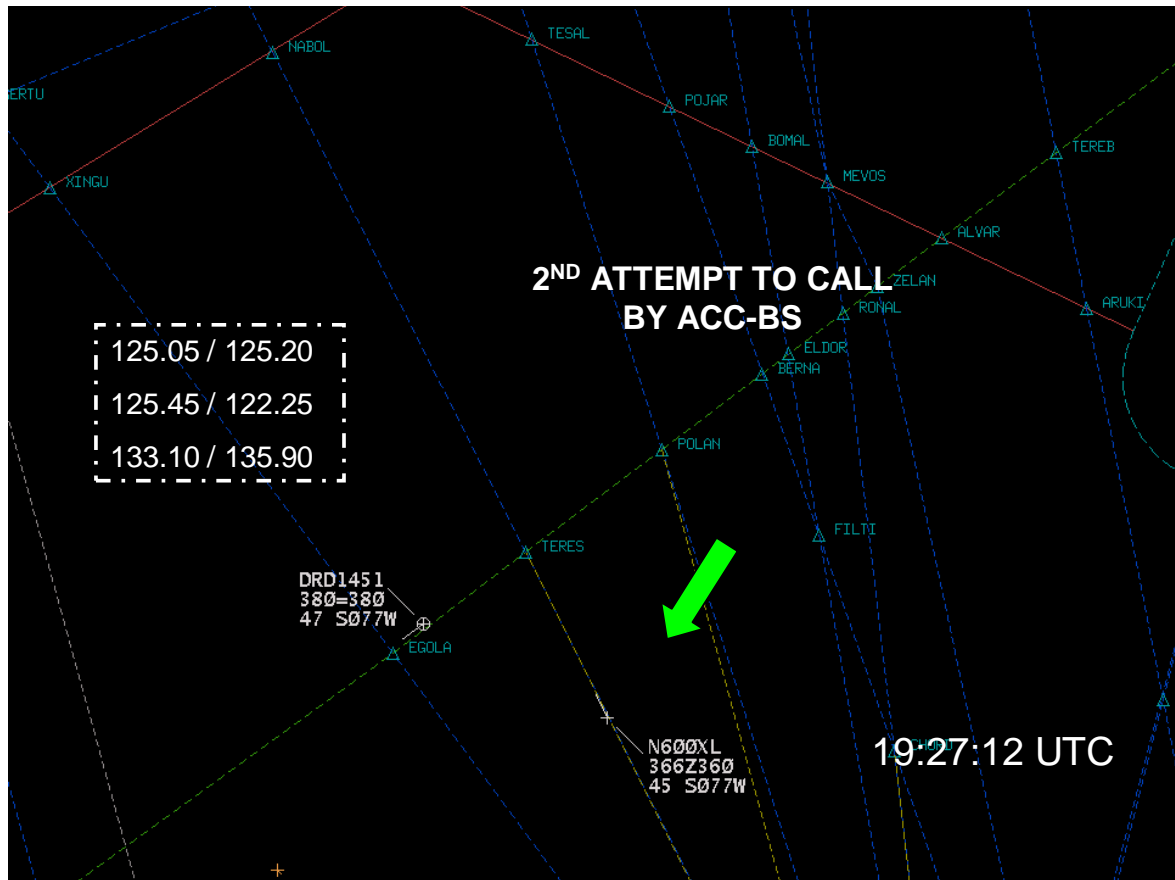
Figure 61

At the **second attempt, at 19:27:12 UTC**, for the **first time** a frequency change to **135.9 MHz** was commanded. Such a command should have been given, at least, 30 minutes earlier.

The aircraft was already at **218.5 NM from BRS VOR**, still with primary radar contact and correlation.

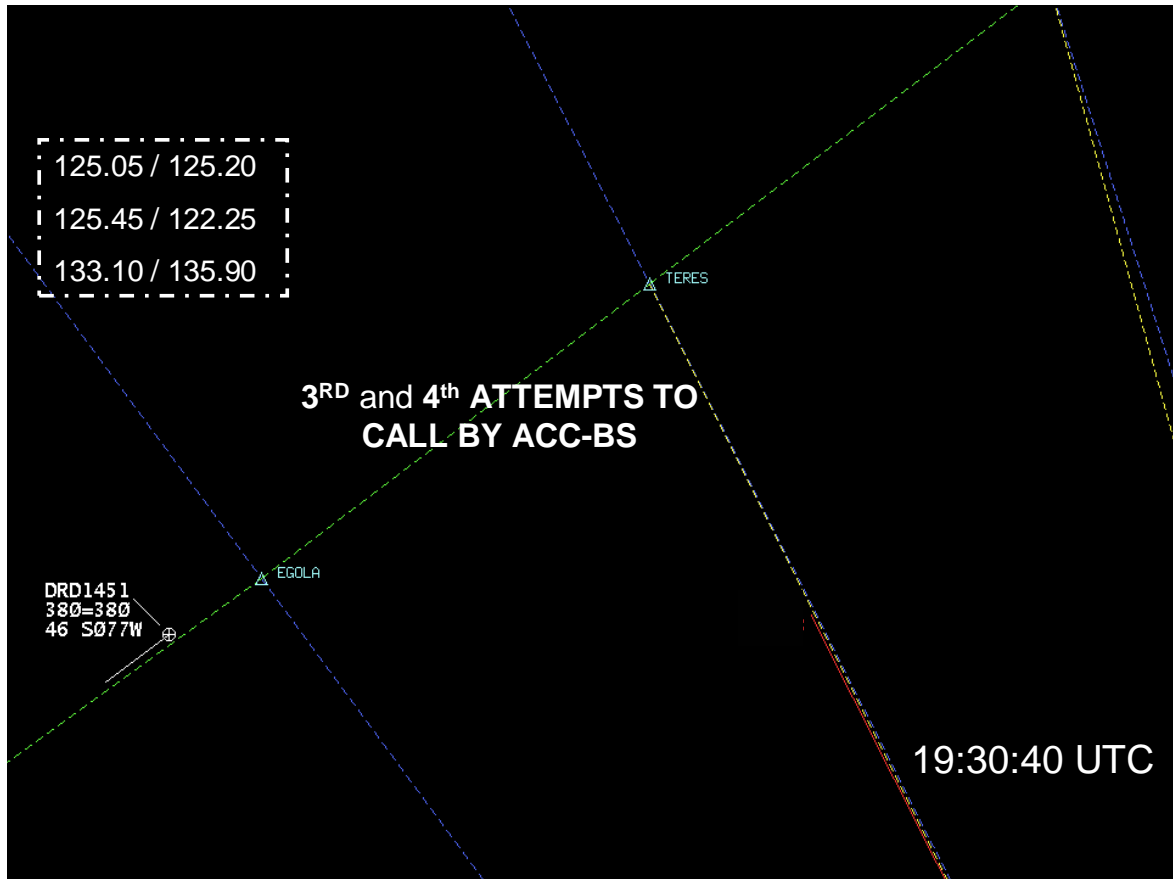
Figure 62

The ACC lost primary radar contact with the aircraft for two minutes. A **third attempt of radio contact** was made, at **19:30:40 UTC**, when the aircraft was already at **248 NM** from BRS VOR.

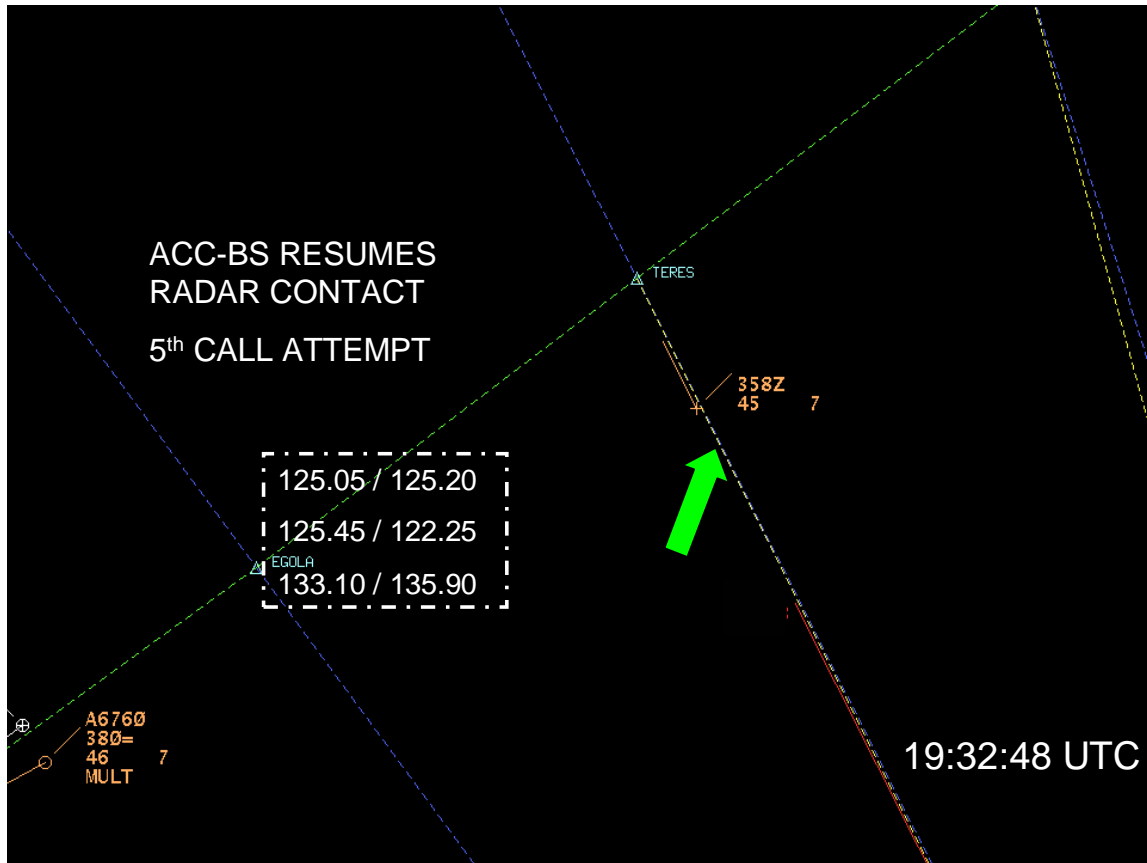
Figure 63

At **19:32:48 UTC**, the aircraft reappeared as a primary radar contact, at **265 NM**, but now without its correlation symbol. Instead of the earlier data block, it had only speed and 3D radar altitude information. This type of altitude information can not be used for vertical spacing under RVSM. The controller then made the **fifth** unsuccessful **attempt** to contact.

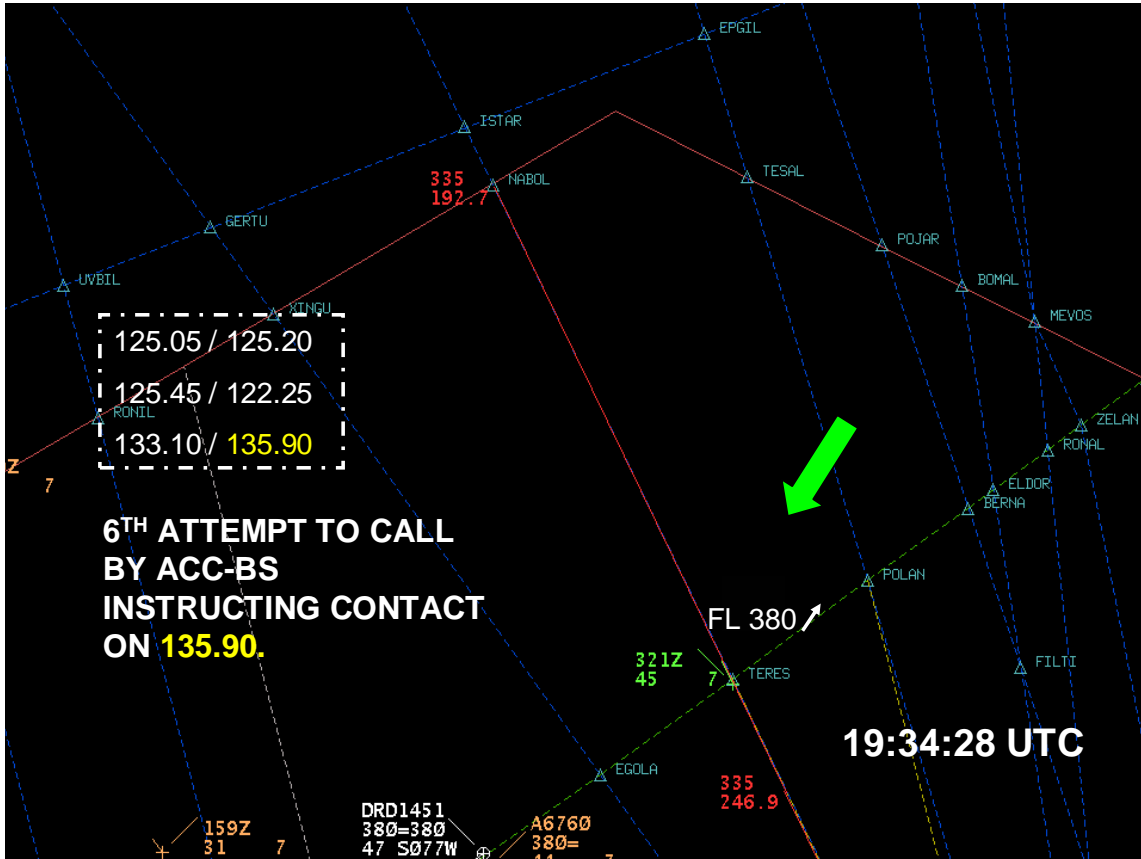
Figure 64

At **19:34:08 UTC**, the controller made the **sixth attempt**, and for the **second time** he added an instruction of frequency change to **135.9 MHz**, when the aircraft was already at **280 NM**.

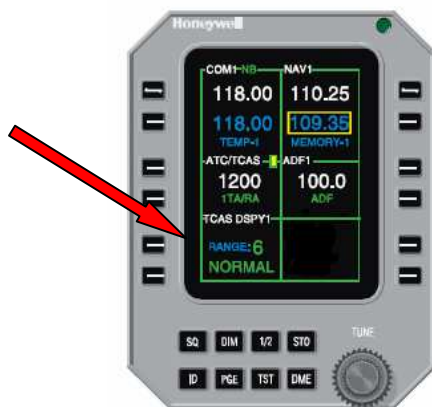
Figure 66

in the RMU, mainly due to the fact that the field that indicates the operation mode of the transponder in the RMU is located just below the field "COM".

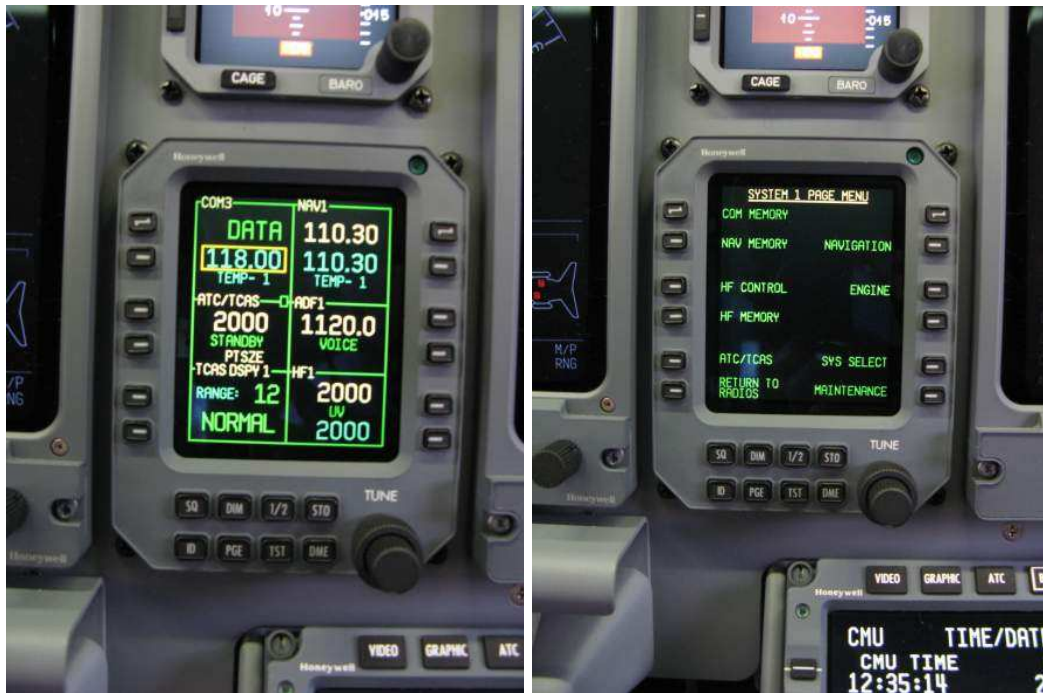
Fig. 67 and 68 (Adjustment of communication and navigation frequencies)

The RMU is used primarily for adjusting the navigation and communication frequencies. It also functions as a backup for the EICAS; therefore, pages of the RMU can be accessed to check the fuel status, engine parameters, flap position, TCAS, etc., as shown in the Figures below.

Therefore, it is possible that, while handling the pages of the RMU, the captain unintentionally set the Transponder to STANDBY, by pressing the RMU button twice in less than 20 seconds, without being aware of his action.

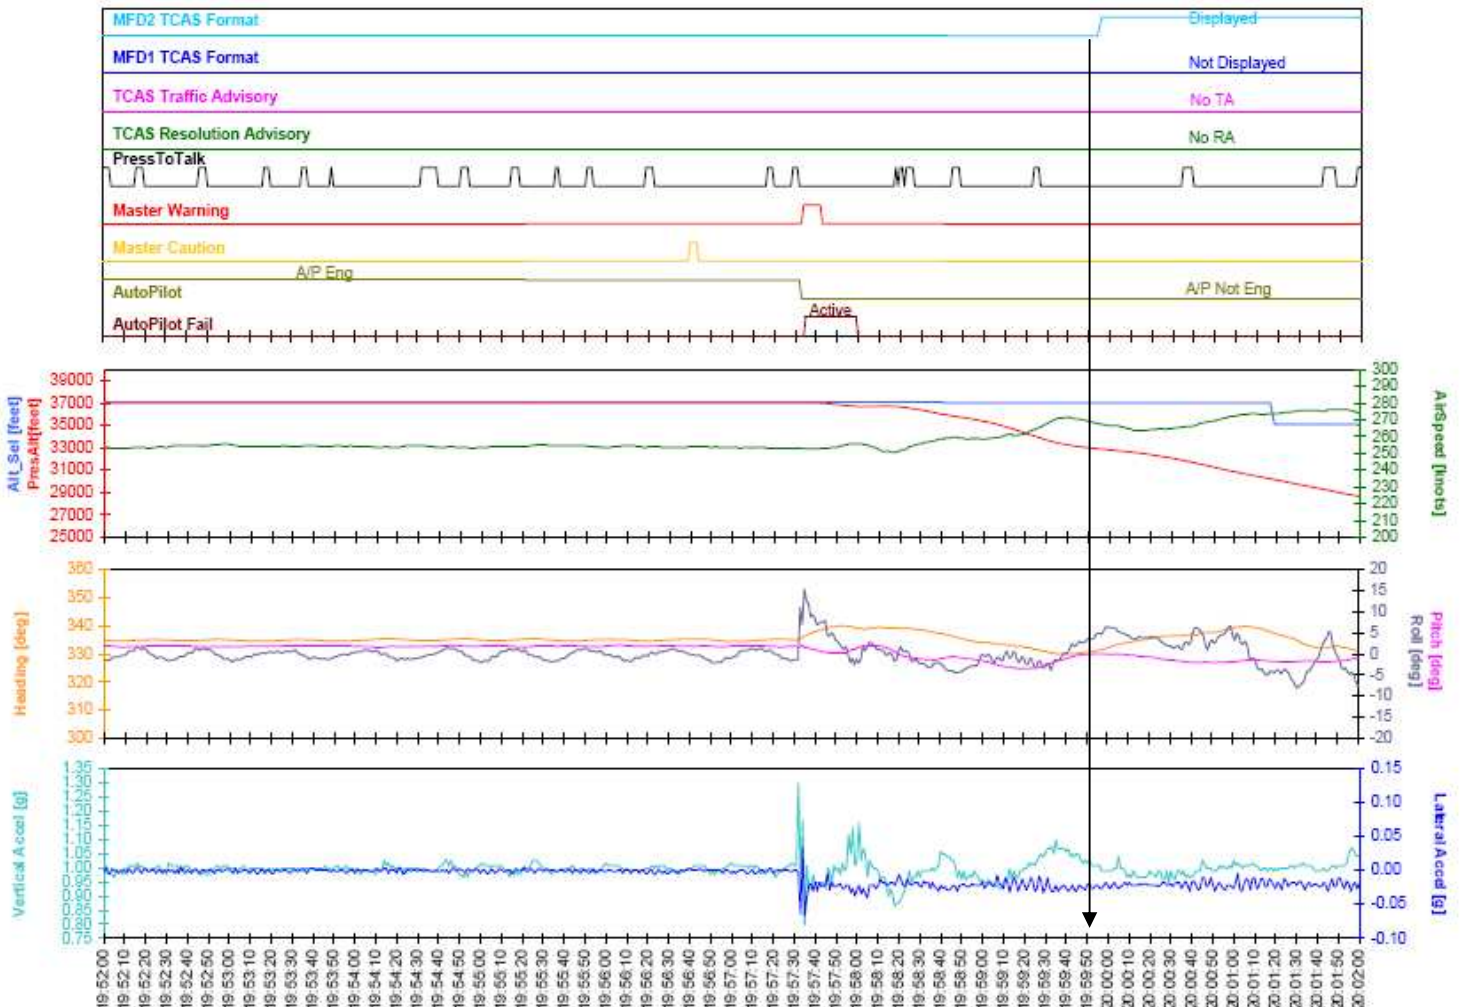
Fig. 71

The Figure 71 (above) shows the data from the DFDR of N600XL, with the opening of the TCAS screen on the MFD2 display (co-pilot side), precisely at 19:59:50 UTC.
