**AERONAUTICAL ACCIDENT INVESTIGATION
AND PREVENTION CENTER**

**FINAL REPORT
A-00X/CENIPA/2008**

ACFT REGISTRATION: PR-GTD and N600XL

MODELS: B-737 8EH and EMB-135 BJ LEGACY

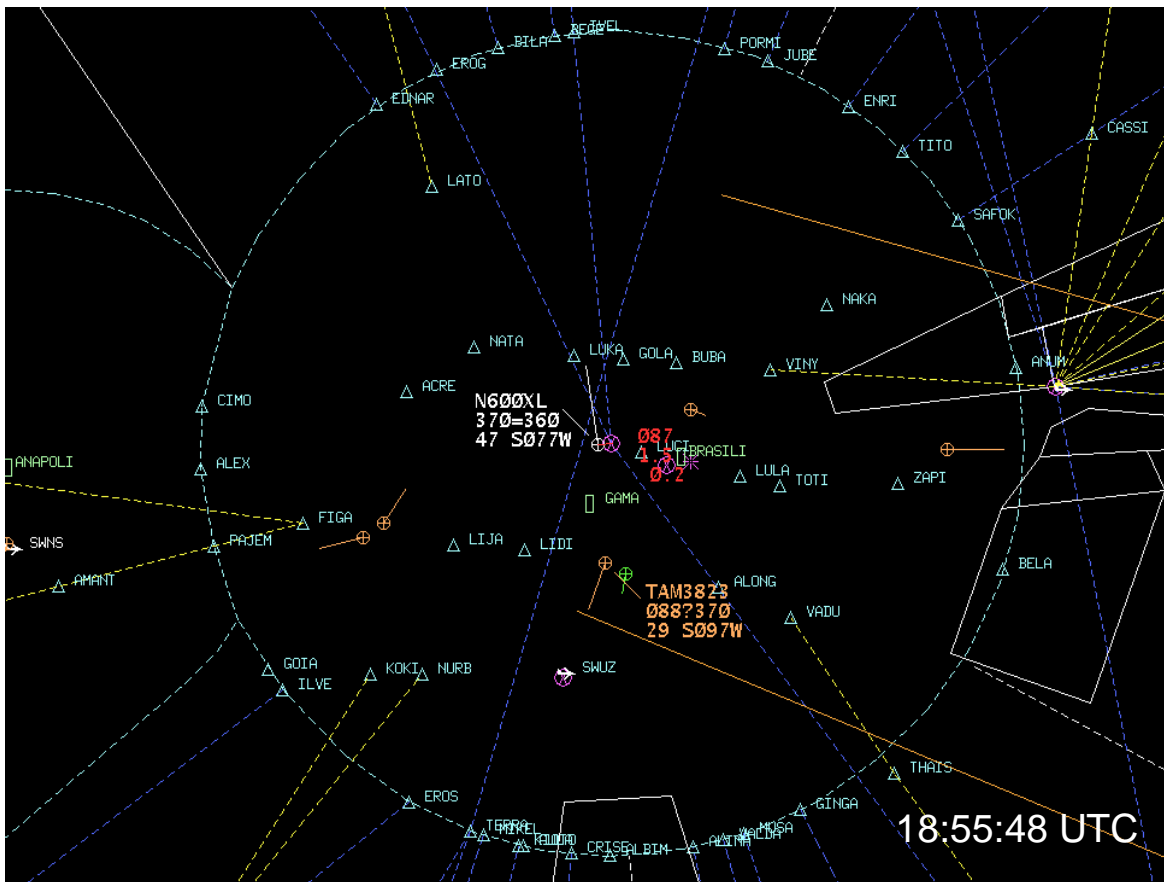
Figure 72 – RADAR presentation of the STVD at CINDACTA I

After the vertical of BRS VOR, the data block pertaining to N600XL started to show, as specified, the information 370=360, warning the controller that the aircraft was at flight level 370, while the level authorized for that segment was FL 360 (See Figure 70).
