*Accident
on 24 March 2001
at Saint-Barthélemy (971)
to the DHC-6-300
registered F-OGES
operated by Caraïbes Air Transport*

REPORT
f-es010324a

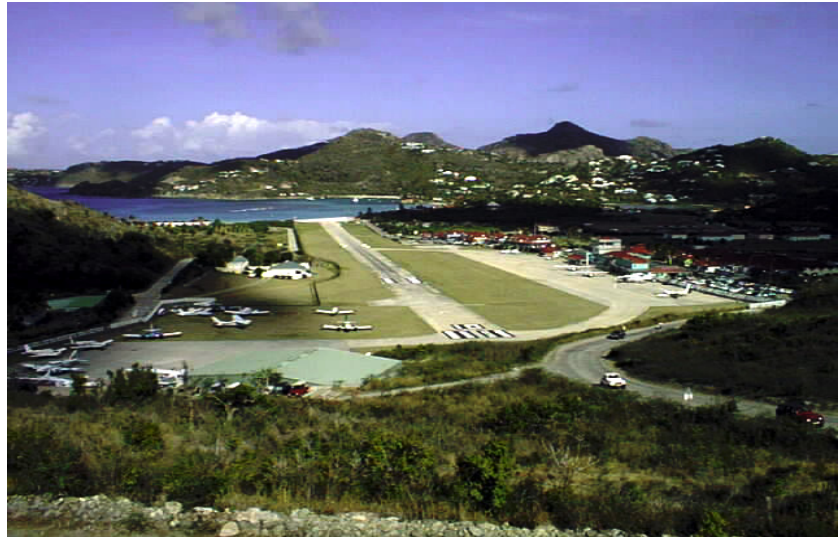
Aircraft landing on runway 10 fly over the La Tourmente pass at a very low height (less than ten metres). This area is subject to strong turbulence. A wind-sock, installed on the north side of the pass, indicates the direction and the strength of the wind going over the pass. These indications are not relayed to the tower.

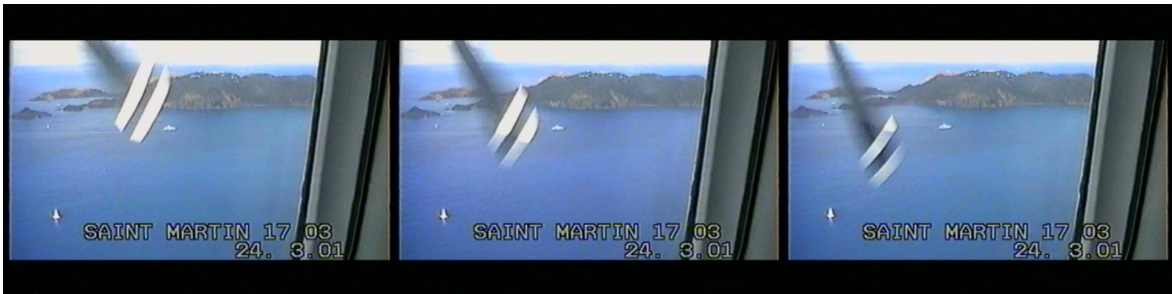
Analysis of the video tape where the left propeller is visible enabled the green curve to be drawn: there are twenty-five images per second; it is possible to determine on each the position of the blades and thus the number of passages per second. Three photos taken from the film are presented below to illustrate the calculation.

Overlaying the green and blue curves shows that the latter corresponds to the left propeller.

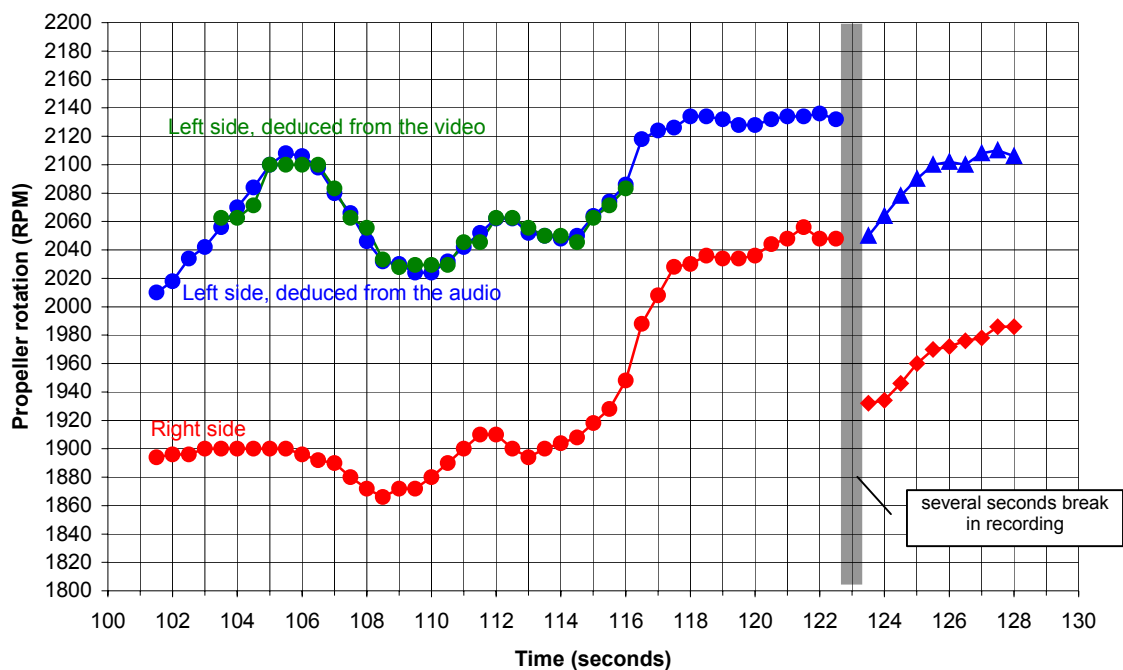
The asymmetry between the two propellers during the approach phase was around 9%, which is consistent with normal use (see following). An increase in RPM of the order of 6% to 8% was also noted.

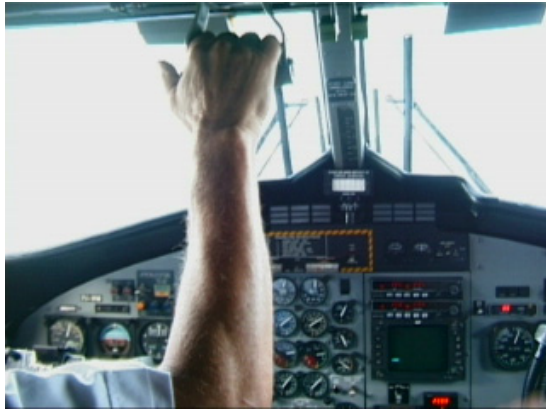
When the PF is seated in the left position, his right forearm is located in the extended vertical axis of the levers, a position which is favorable to symmetric handling.

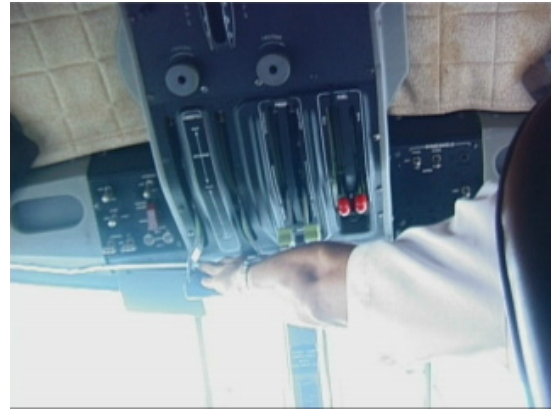
When the PF is seated in the right position, his left forearm is not vertical; he stretches slightly to the left and is thus not aligned with the axis of the levers, this “angle” being compensated by wrist movement.

During approaches to Saint-Martin Juliana, it was noted that certain pilots in the right position used short successive and separate movements on the engine n°1 lever, then on the engine n°2 lever, with the hand always remaining in contact with both levers.
