REPORT ON
ADC'S FLT. No. O86 CRASH
NOVEMBER 7, 1996

ADC FLIGHT 086 BOEING 727

5N-BBG WHICH CRASHED AT EJIRIN,

VOLUME 1

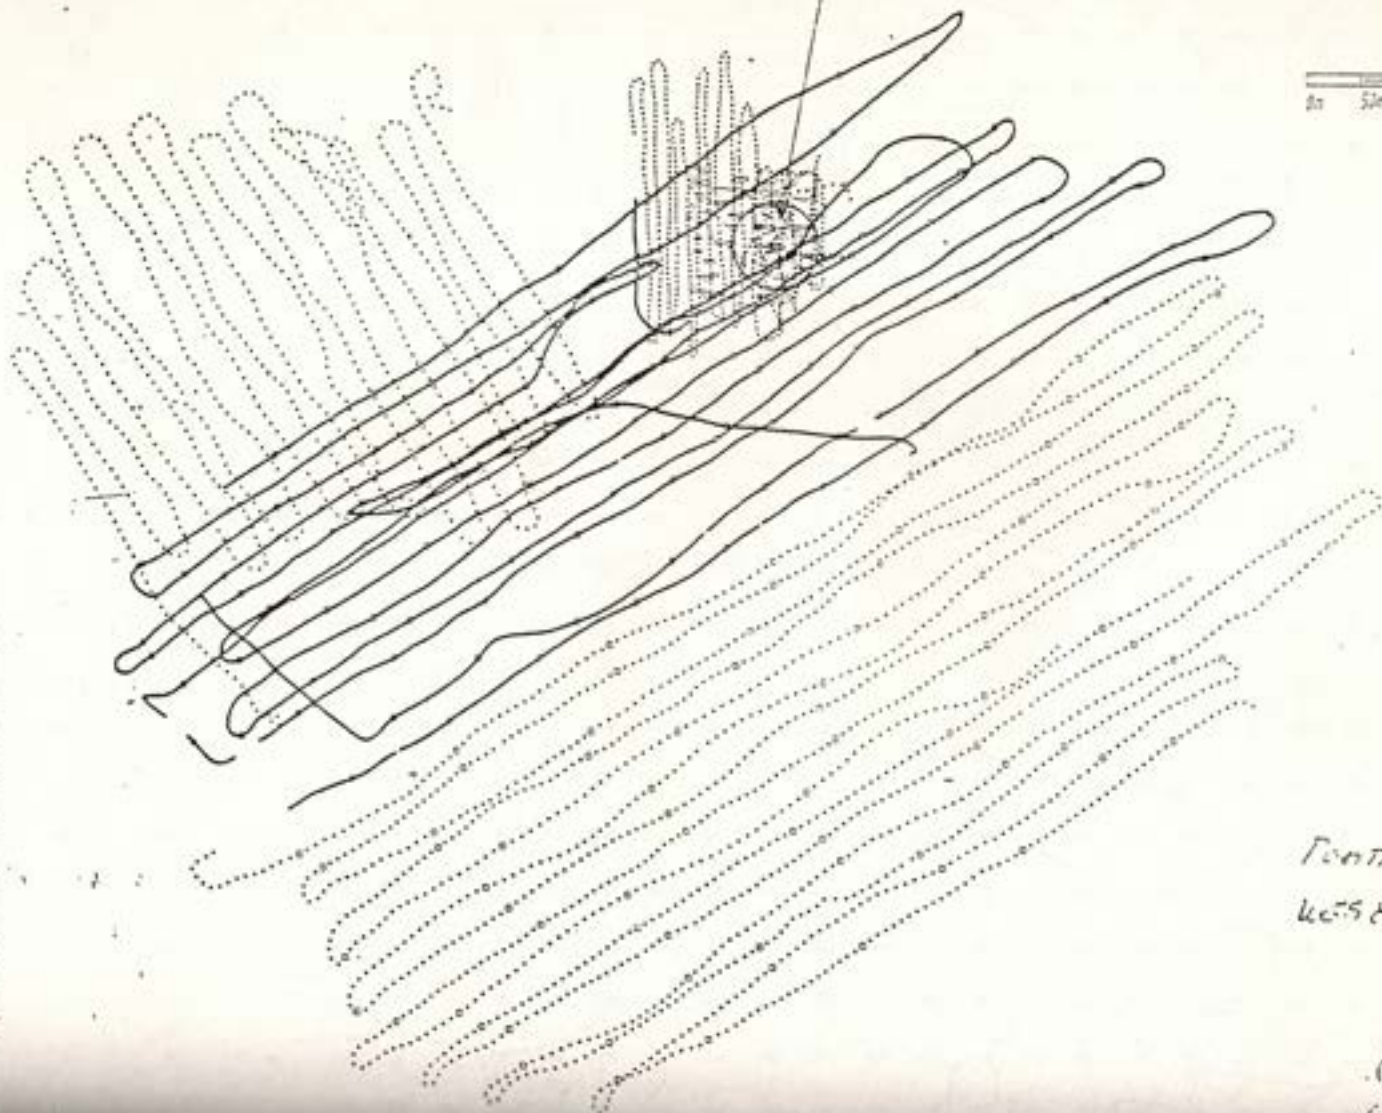
Location center of NETAL 'A'

Scouring tracklines
1000' with heavy brush

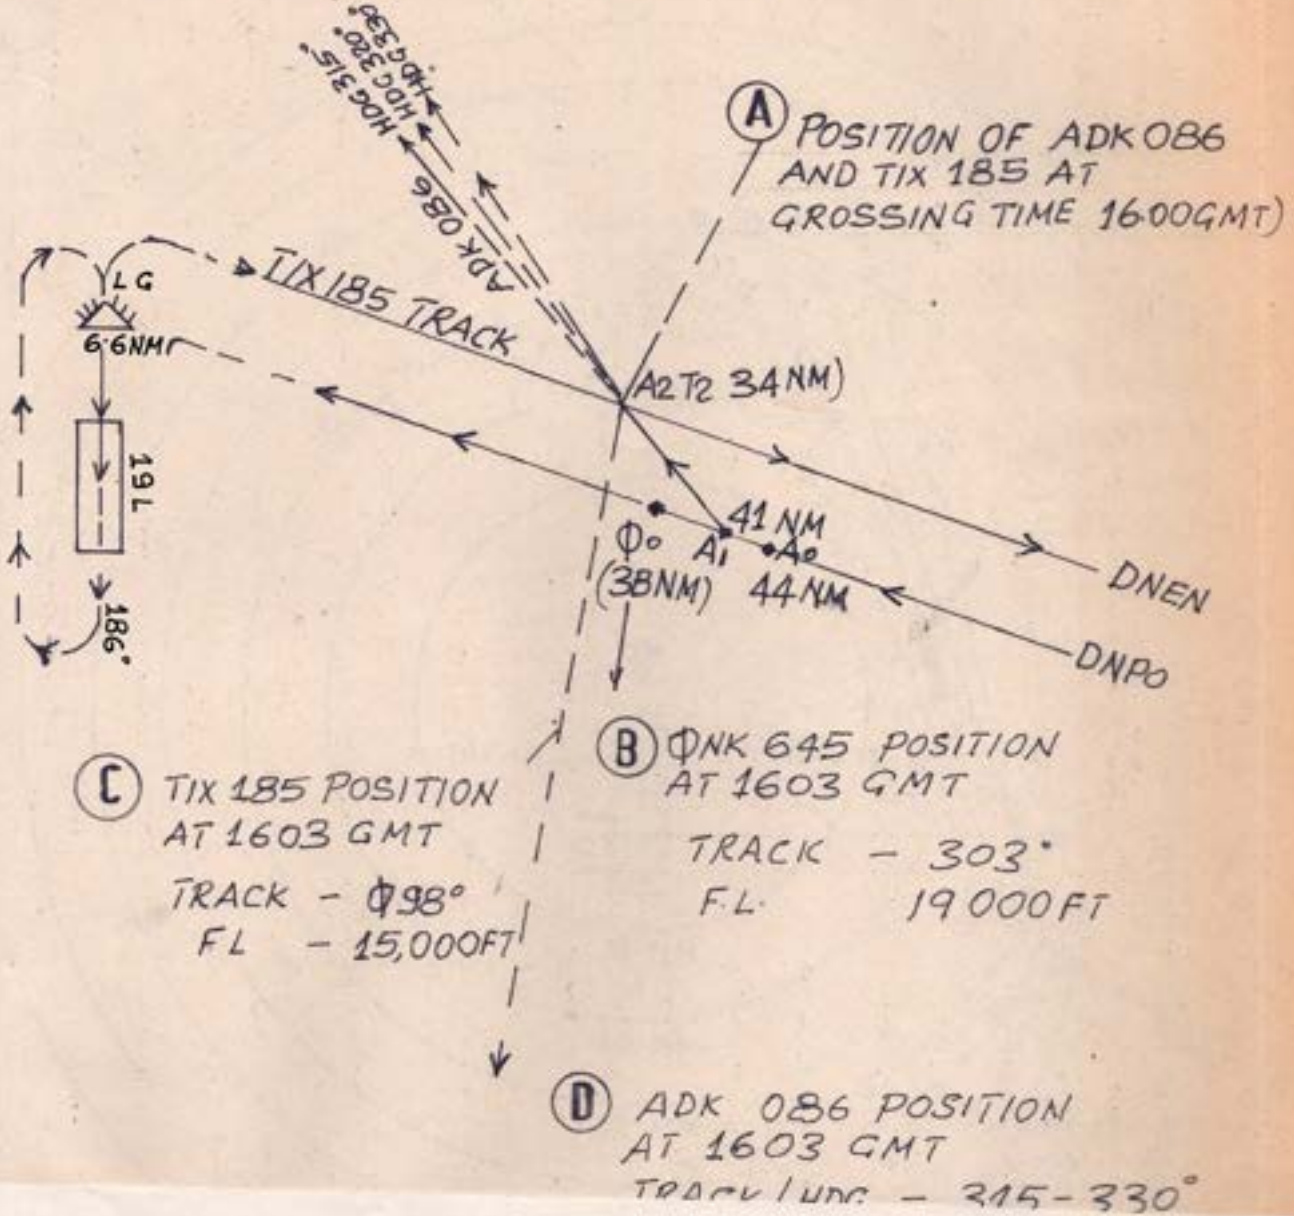
ANNEX A TO ADK 086
 AIRCRASH REPORT
 DATED - 12 FEBRUARY 1997

DIAGRAMATIC ILLUSTRATION OF
 RADAR VECTERING AND RELATIVE
 POSITIONS OF ADK086 TIX185 AND Φ NK 645 AT 1603 GMT
