# AIRCRAFT ACCIDENT REPORT

BOEING 707-331B, N8734

IN THE IONIAN SEA

REPORT NUMBER: NTSB-AAR-75-7

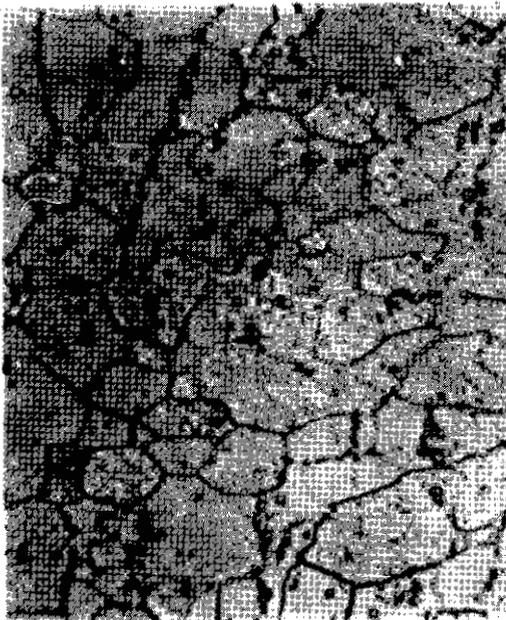
FIG 8a SECTION OF FRAGMENT I  
x 1000

Exhibit I was polished and etched. The micro-structure is that of a low carbon iron with a grain size between 15 and 20 microns (Figure 7). This is considerably finer than that found in commercially available material and is the product of a heavily cold worked structure, recrystallizing rapidly at a high temperature but with grain growth inhibited. This structure is expected in an iron fragment which has undergone extensive deformation and heating at the source of an explosion, followed by drastic cooling on impact with suitcase. Similar structures have been produced in tests at RARDE when high explosives were detonated against iron plates. The similarities between the structure of fragment I with the structures obtained in controlled explosive trials can be seen in Figure 8. Evidence of explosive deformation is apparent in the micro-structure of the strained steel case hinge (Figure 9). The strain in the hinge was small, but deformation twins were found in a portion of the grains. These twins are effective signature of an explosive shock passing through the hinge. Twinned structures were found in the Comet fragments, though the density in these was considerably higher because the fragments suffered greater strain.
