NATIONAL TRANSPORTATION SAFETY BOARD
Washington, D. C. 20591

AIRCRAFT ACCIDENT REPORT

MARTIN 404, N464M
8 STATUTE MILES WEST OF
SILVER PLUME, COLORADO
OCTOBER 2, 1970

REPORT NUMBER: NTSB-AAR-71-4

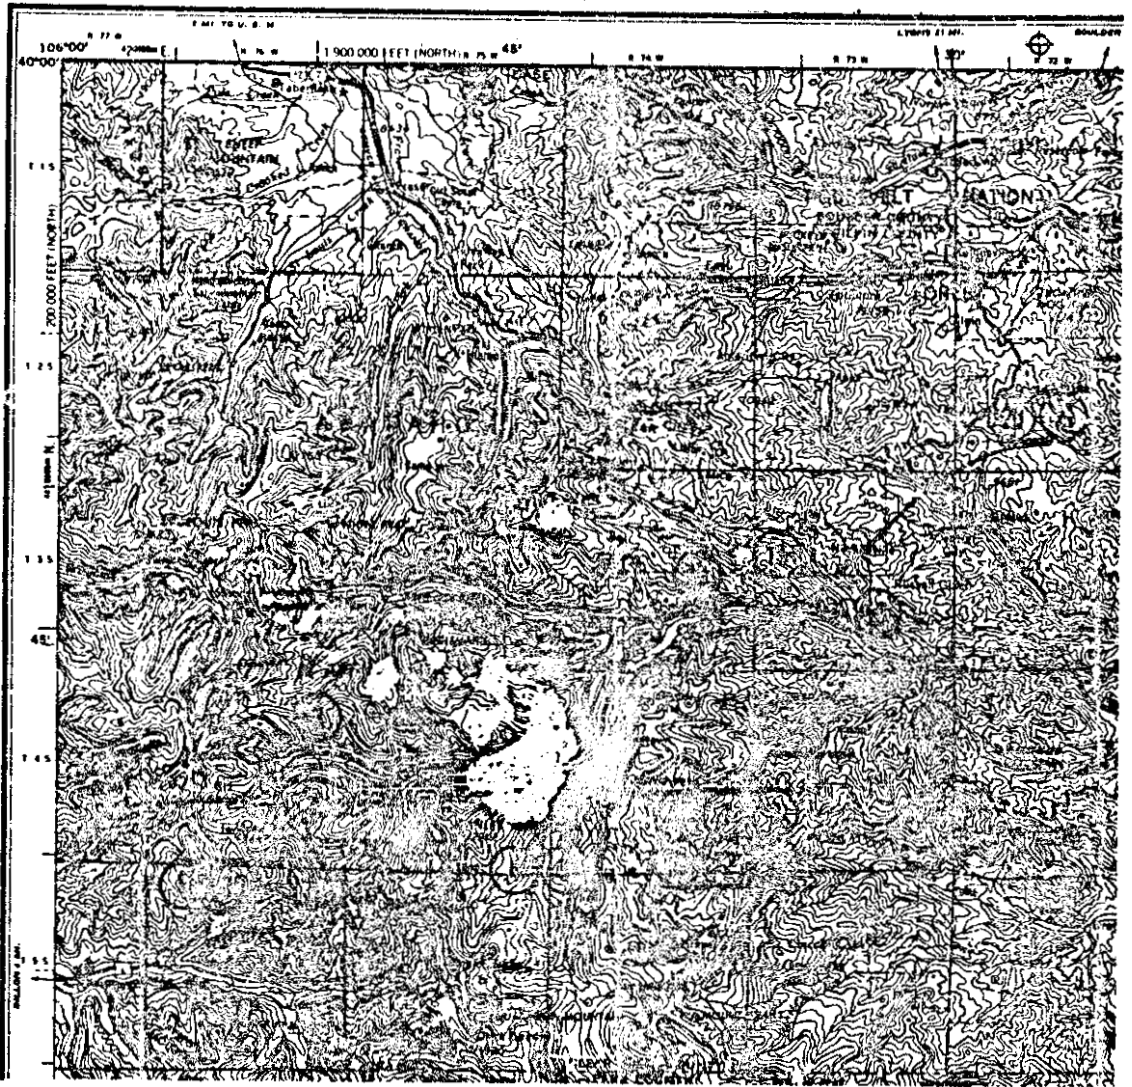
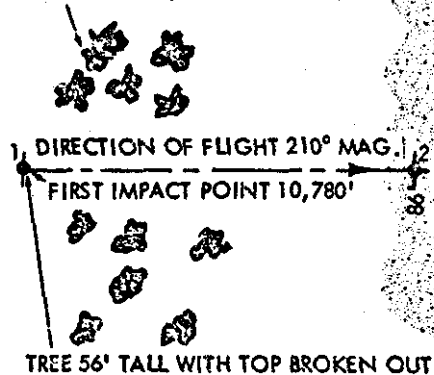
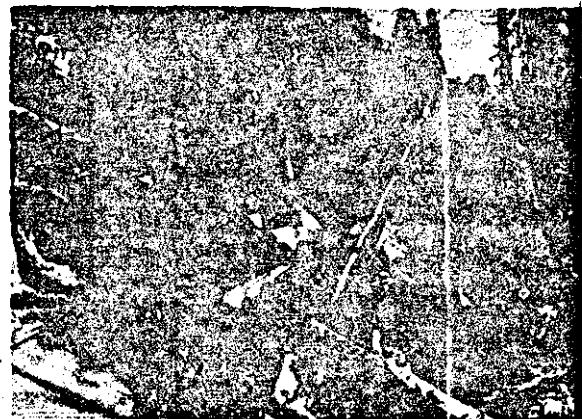
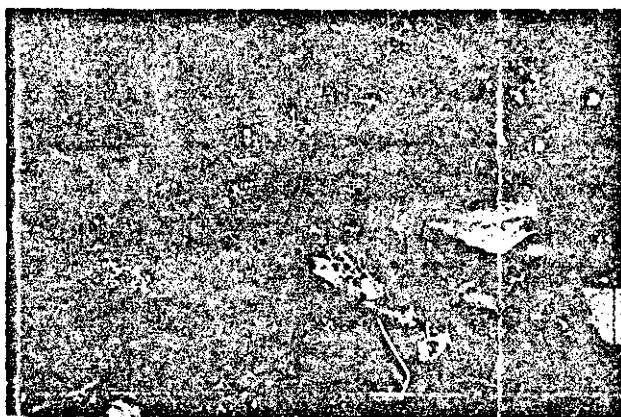
WRECKAGE DISTRIBUTION CHART
 GOLDEN EAGLE AVIATION INCORP. MARTIN 404, N646M
 NEAR SILVER PLUME, COLORADO

- 1) TREE 56' TALL WITH TOP BROKEN OUT
- 2) SHORT PIECE OF 4" DIA. LIMB WITH CLEAN DIAGONAL CUT
- 3) 14" PIECE OF TRIM TAB (ORIGIN UNKNOWN)
- 4) 20" PIECE OF TAB (ORIGIN UNKNOWN)

MANY TREES WITH TOPS
KNOCK OUT (NOT TO SCALE)

SWATH AREA

SMALL SPOT FIRES
(NOT TO SCALE)
GROUND FIRE
AREA BEGINS
