**Aircraft Accident Report. Alaska Airlines, Inc., Boeing  
727-81, N124AS, Ketchikan International Airport  
Ketchikan, Alaska, April 5, 1976**

1. Report No. NTSB-AAR-76-24		2. Government Accession No.		3. Recipient's Catalog No.	
4. Title and Subtitle Aircraft Accident Report Alaska Airlines, Inc., Boeing 727-81, N124AS Ketchikan, Alaska, April 5, 1976				5. Report Date December 22, 1976

ALASKA AIRLINES, INC.  
B-727-81, N124AS  
KETCHIKAN INTERNATIONAL AIRPORT  
KETCHIKAN, ALASKA  
APRIL 5, 1976

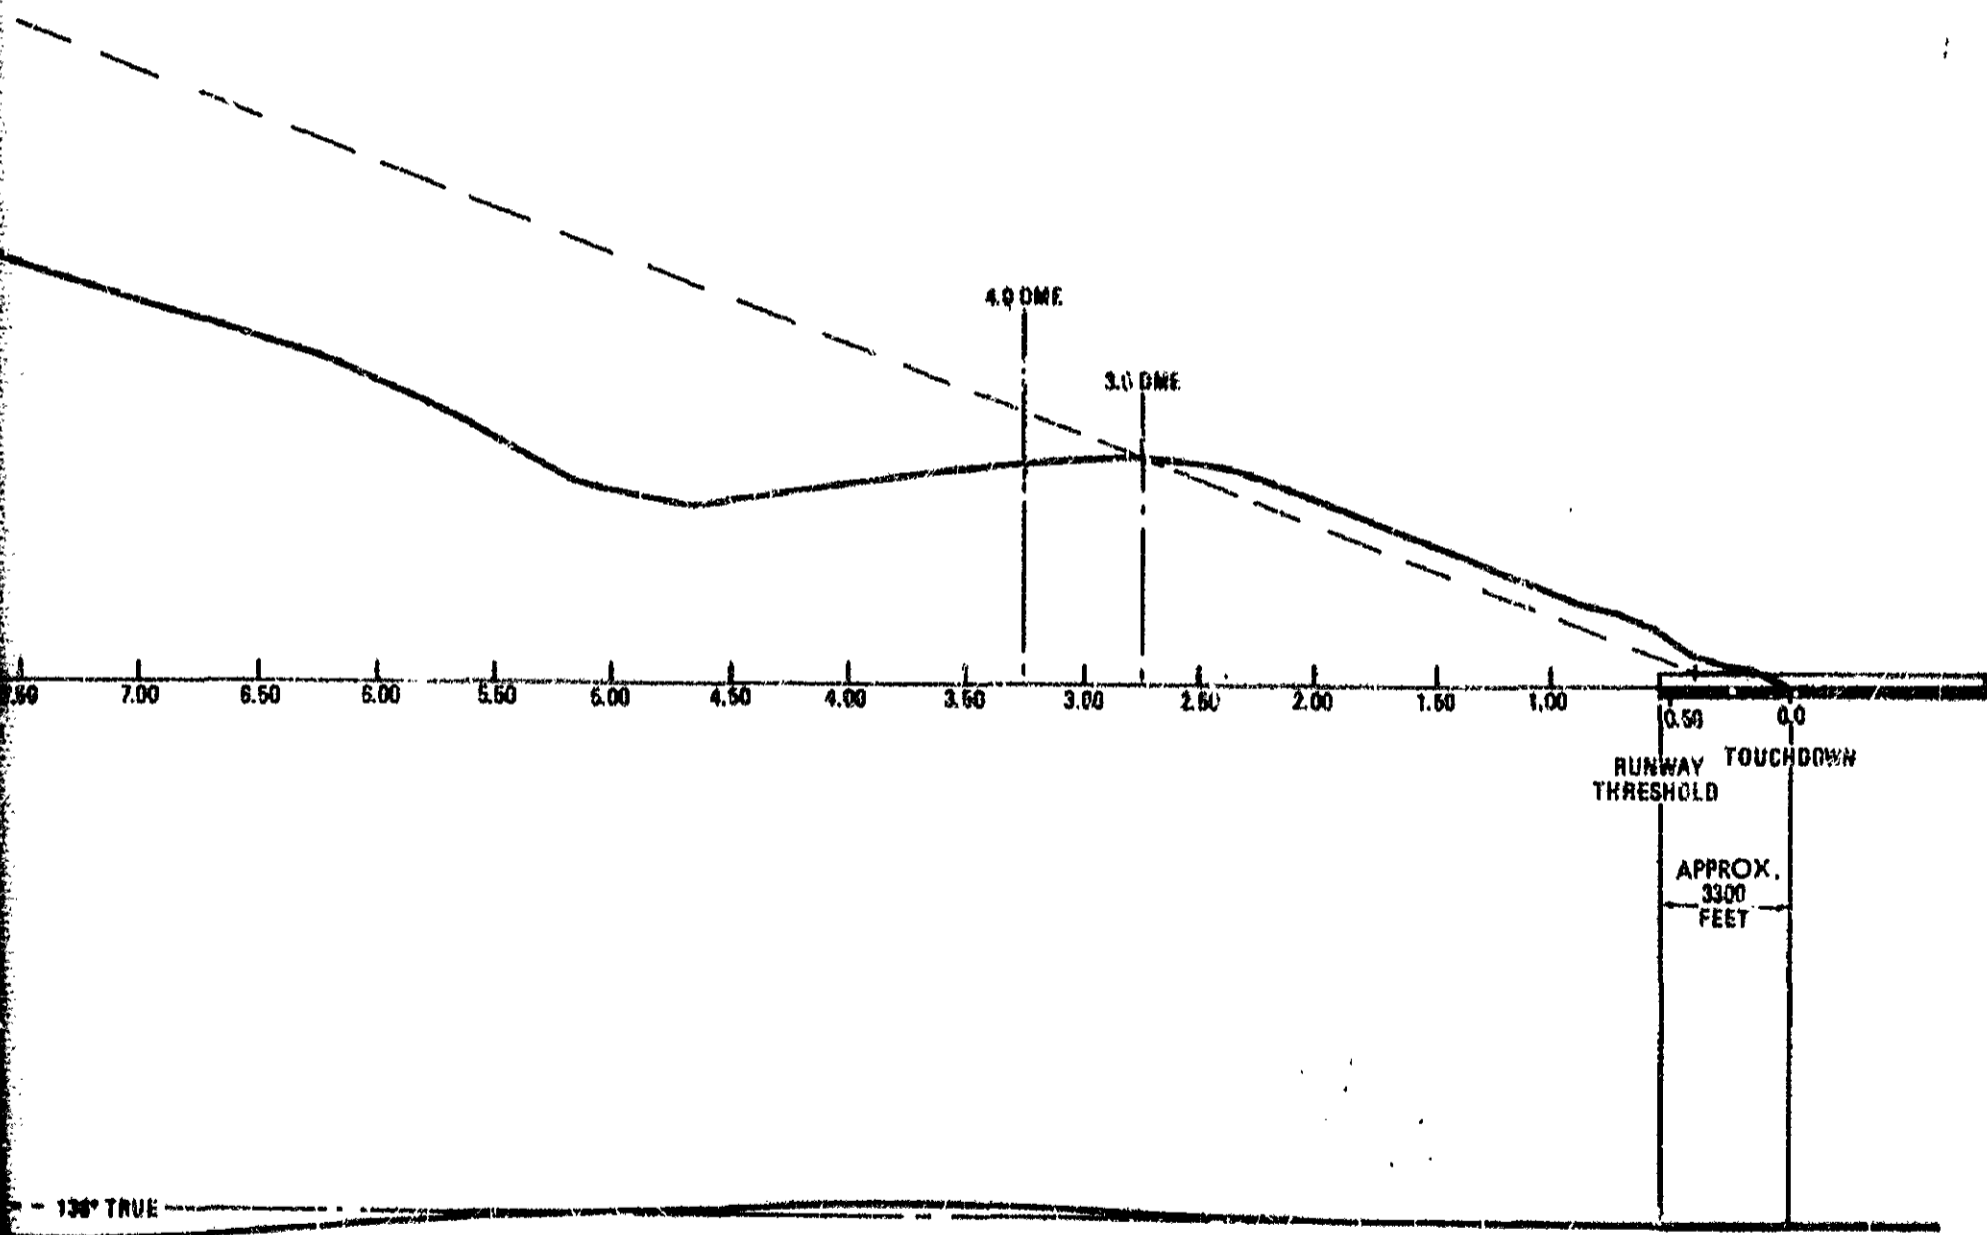
CALCULATED DESCENT PROFILE & GROUND TRACK  
BASED ON FDR DATA FROM ALASKA AIRLINES, INC.  
BOEING 727-81, N124AS  
KETCHIKAN INTERNATIONAL AIRPORT  
KETCHIKAN, ALASKA  
APRIL 5, 1976
