# NATIONAL TRANSPORTATION SAFETY BOARD

## AROCRAFT ACCIDENT REPORT

AMERICAN AIRLINES, INC.,  
DC-10-10, N110AA  
CHICAGO-O'HARE INTERNATIONAL AIRPORT  
CHICAGO, ILLINOIS  
MAY 25, 1979

NTSB-AAR-79-17

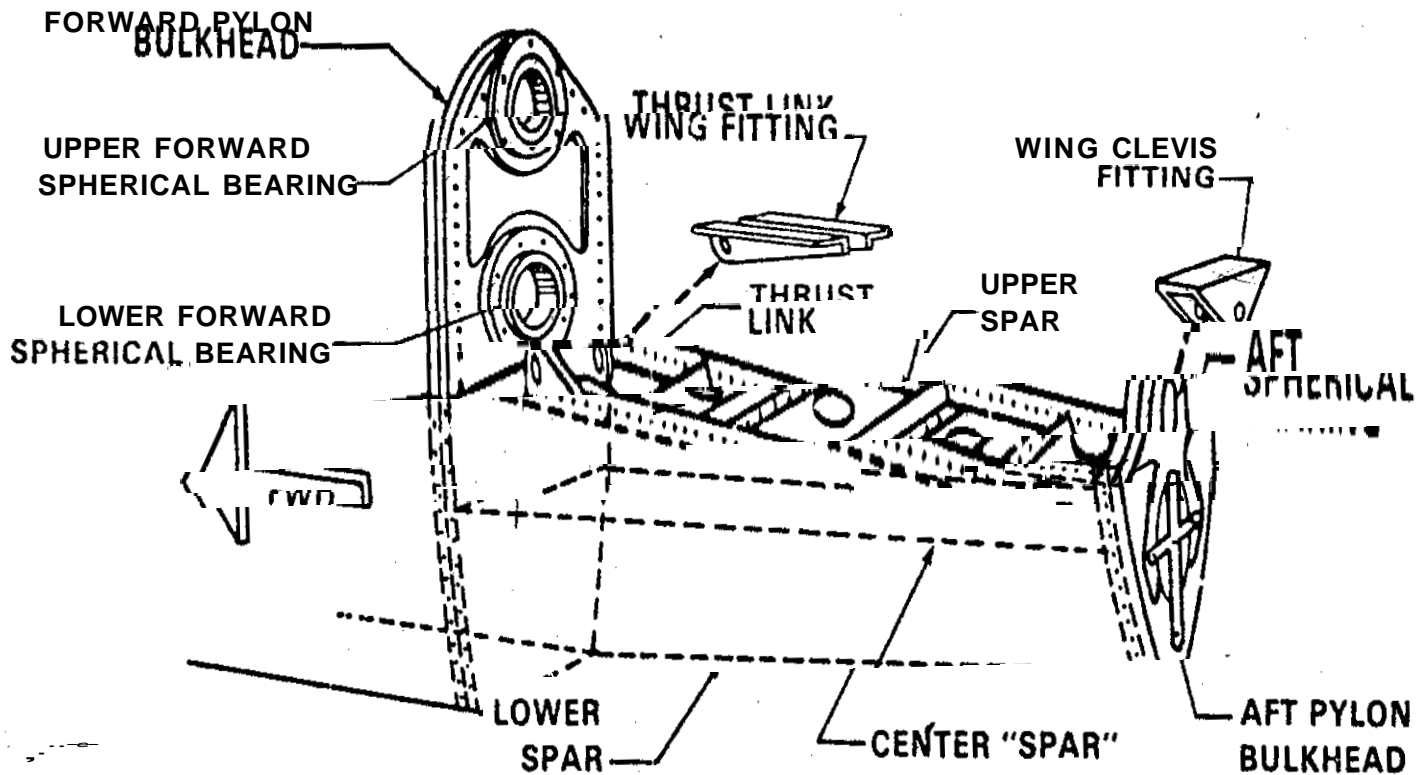
Figure 3. Pylon assembly.

The wing's forward support fitting, which attached the pylon forward bulkhead to the wing at the upper and lower plugs and spherical bearings, was found at the **main** wreckage site. The upper and lower plugs and their attaching hardware were intact, and the upper and lower spherical bearings were attached to the fitting.

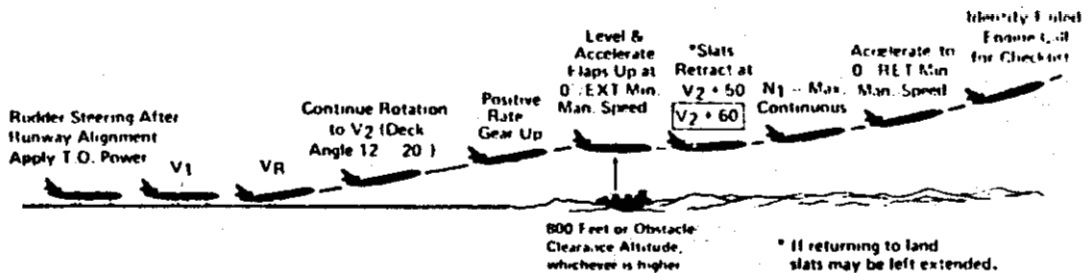
Figure 14. Diagram of AAL emergency procedure.

The Operating Manual's discussion of the procedure contained an annotated profile drawing of the takeoff. (See figure 14.) The annotations accompanying the profile sketch state (after the aircraft is airborne), "Continue rotation to  $V_2$  (Deck angle  $12^\circ$ - $20^\circ$ )." Over the next picture of the aircraft is the note, "Positive rate-Gear up." The next picture shows the aircraft level at 800 ft AGL and contains the accelerate instructions noted above.

On July 23, 1979, American Airlines issued Operations Bulletin No. DC-10-73 which amended the procedure. The bulletin states, in part:

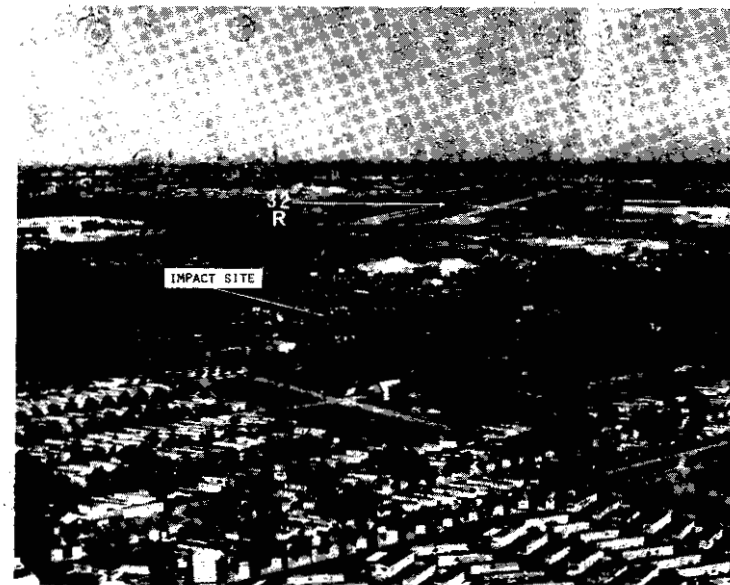
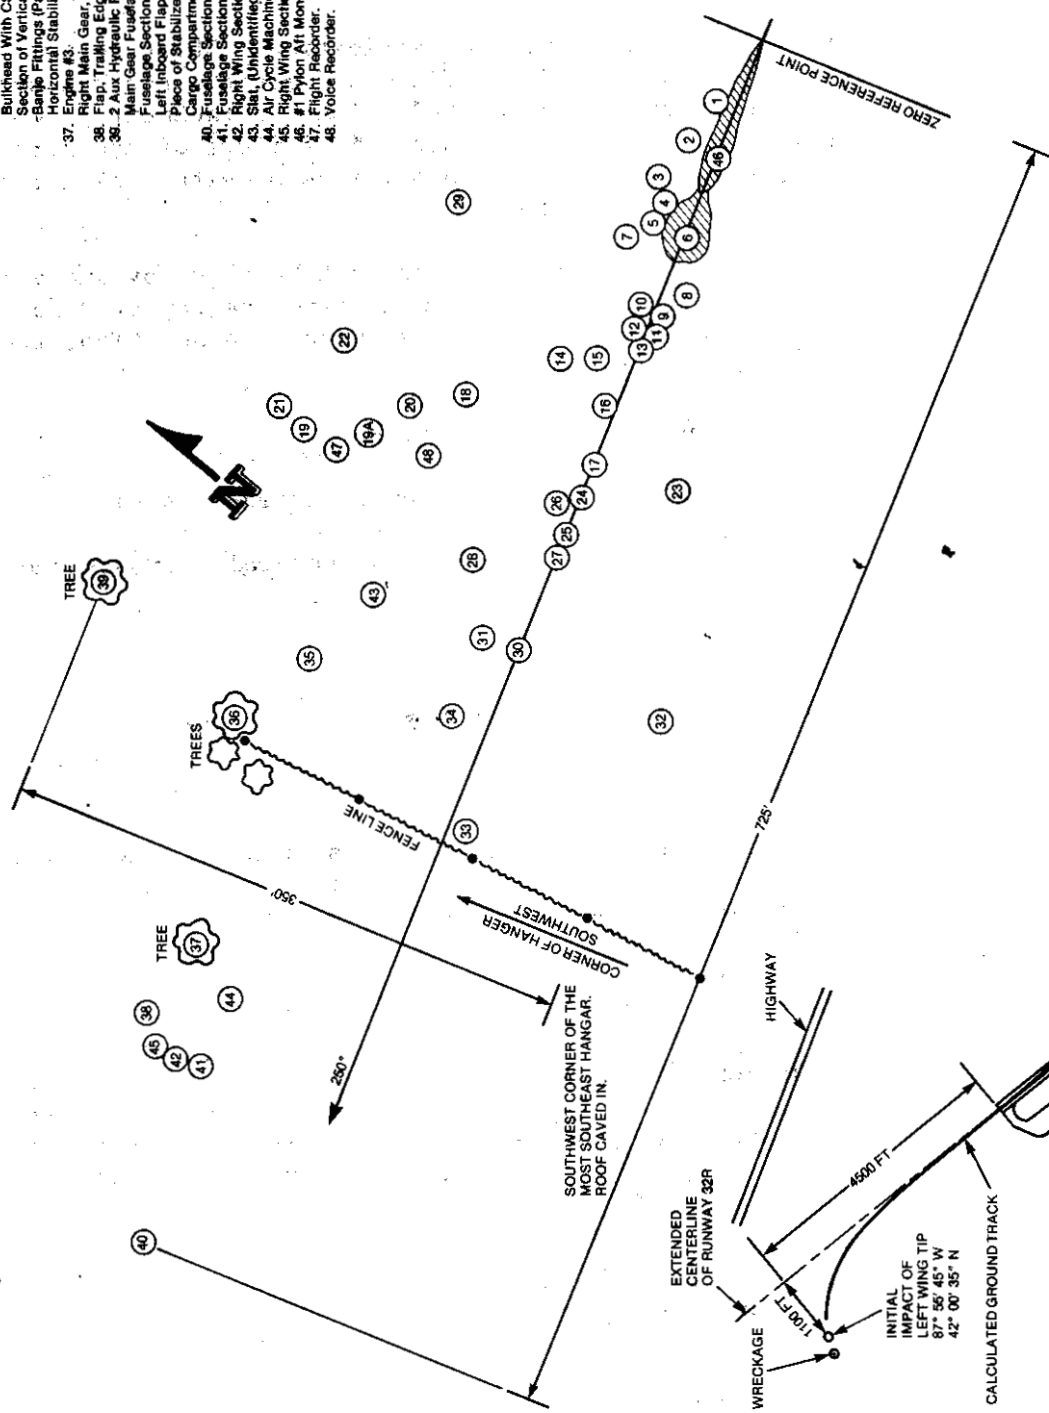
APPENDIX D  
WRECKAGE DIAGRAM

Flight 191 struck the ground in a left wing-down and nosedown attitude. The left wingtip hit first, and the aircraft exploded, broke apart, and was scattered into an open field and a trailer park. The disintegration of the aircraft structure was so extensive that little useful data were obtained from postimpact examination of the wreckage with the exception of the No. 1 pylon, which was found off the right side of runway 32R. (See figure 1.)
