NATIONAL TRANSPORTATION SAFETY BOARD

AIRCRAFT ACCIDENT REPORT

**AMERICAN AIRLINES, INC.,
DC-10-10, N110AA
CHICAGO-O'HARE INTERNATIONAL AIRPORT
CHICAGO, ILLINOIS
MAY 25, 1979**

NTSB-AAR-79-17

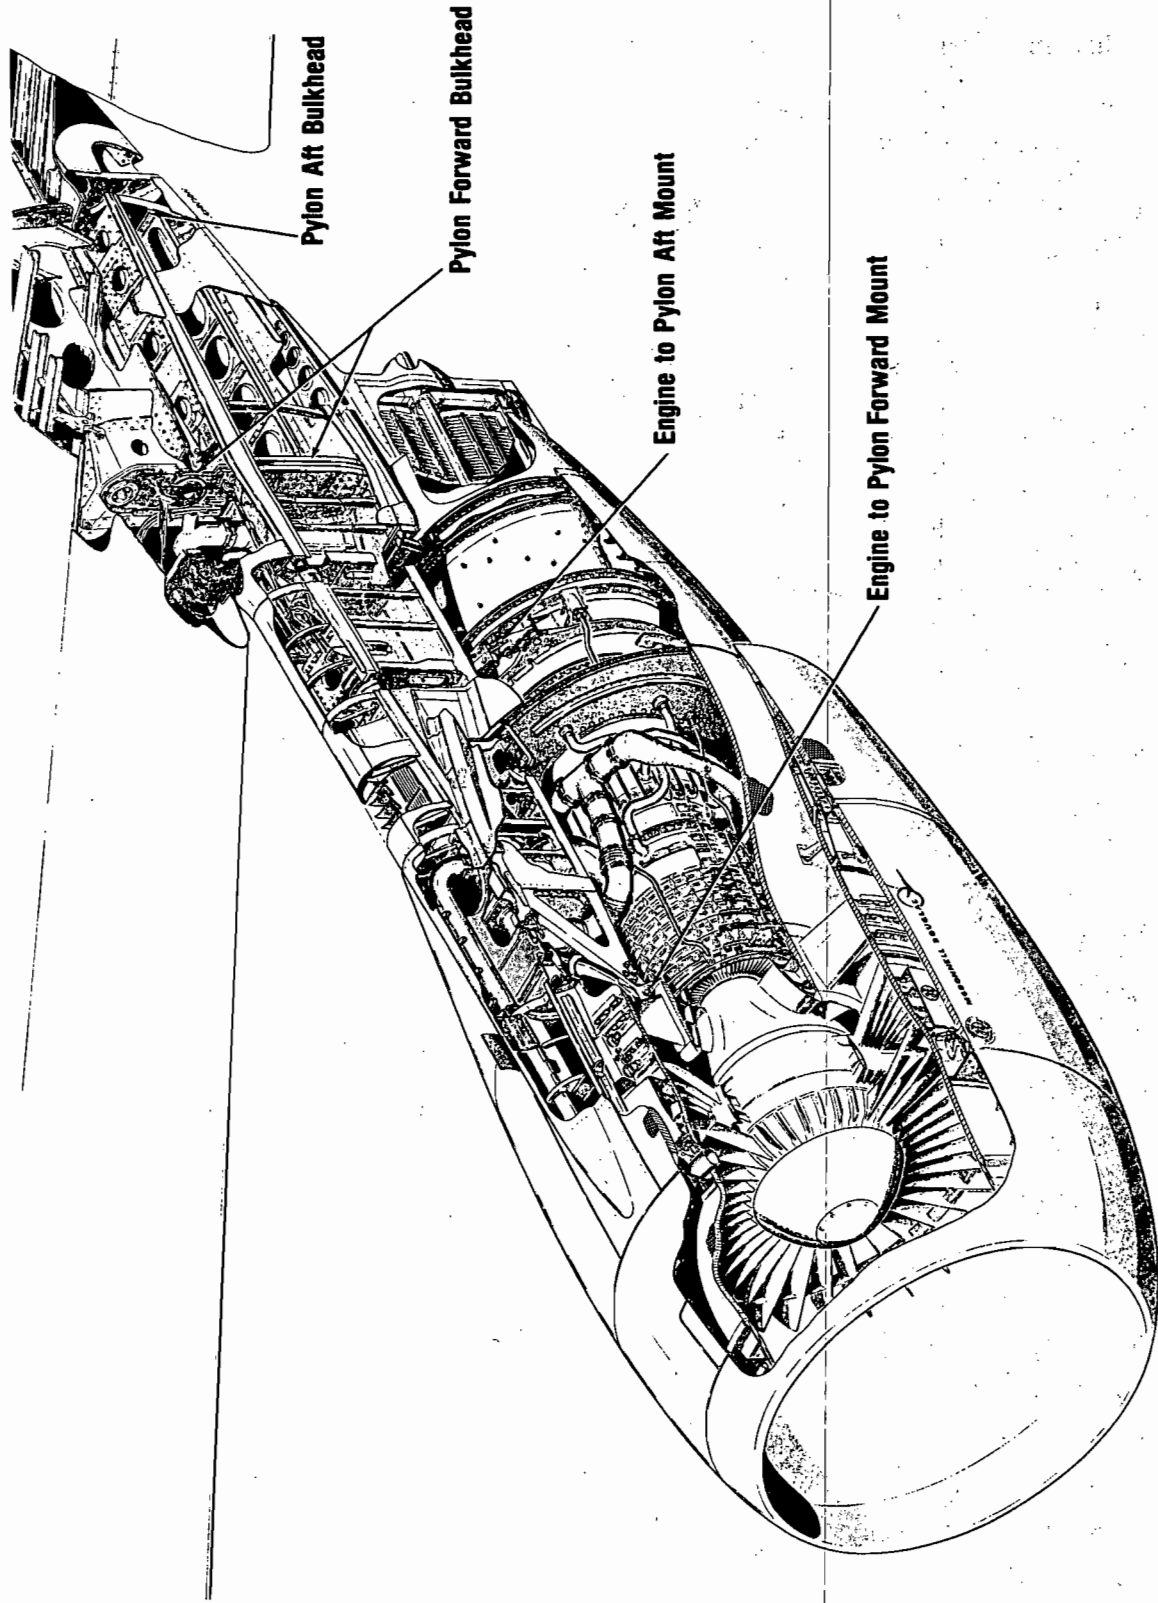
Figure 2. Engine and pylon assembly.

The pylon is attached to the wing using spherical ball joints in three different structural elements. Two of the spherical joints are aligned vertically in a forward bulkhead which is attached to structure in the wing forward of the front spar. Another spherical joint behind the forward bulkhead transmits thrust loads from pylon structure into a thrust link which in turn is connected through another spherical joint to structure on the lower surface of the wing. The third attachment point is a spherical joint in the pylon aft bulkhead which attaches to a clevis mounted on the underside of the wing. The pylon forward bulkhead and portions of the flange from the pylon aft bulkhead either remained with the separated No. 1 pylon or were scattered along the runway. (See figures 2 and 3.) The No. 1 pylon's aft clevis attach assembly and portions of the pylon aft bulkhead, wing thrust angle assembly and thrust link, and pylon forward bulkhead attach assembly remained with the wing.

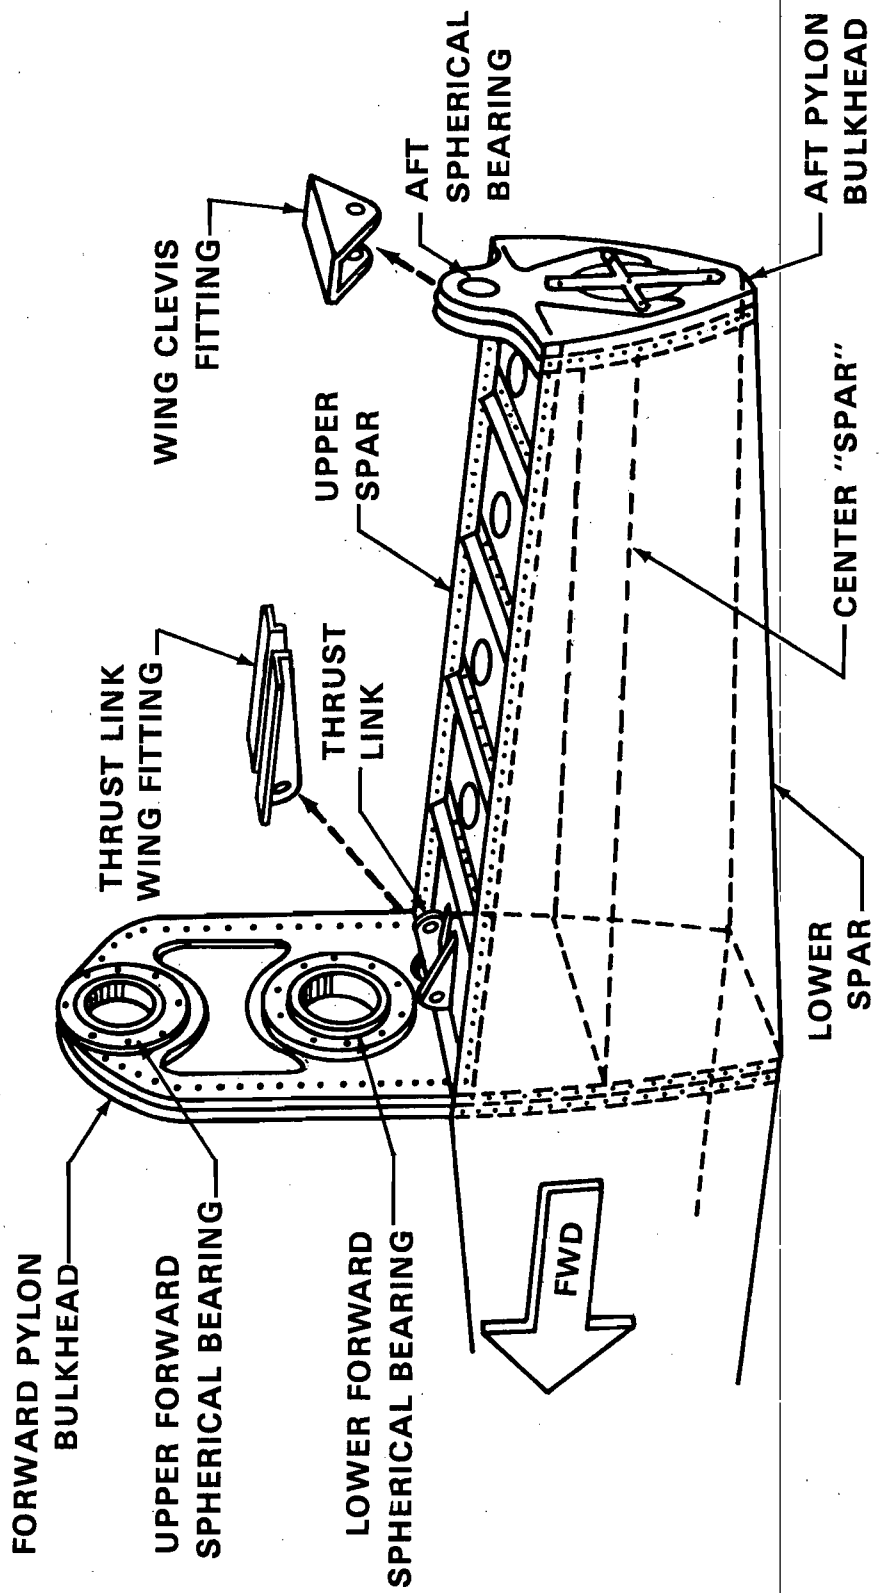
Figure 3. Pylon assembly.

The wing's forward support fitting, which attached the pylon forward bulkhead to the wing at the upper and lower plugs and spherical bearings, was found at the main wreckage site. The upper and lower plugs and their attaching hardware were intact, and the upper and lower spherical bearings were attached to the fitting.

The pylon thrust fitting remained attached to the forward portion of the pylon's aft upper spar web. The pylon thrust link, which attached the pylon thrust fitting to the wing thrust angles, was found at the main wreckage site attached to a portion of the wing thrust angles. Its forward spherical bearing was cocked to the extreme left, and a segment of the bearing which had broken away was found on the runway.

The thrust bushing bolt had broken in two parts, both of which were found in the grass adjacent to the runway. The bolt nut was attached to one of the broken pieces, and the faces of the nut were gouged severely. Except for one lubrication retainer washer, which was not found, the remaining portions of the thrust bushing bolt assembly were found along the runway. One shim spacer from the assembly was crushed severely while the other was relatively undamaged.

The upper two-thirds of the pylon aft bulkhead separated from the flanges around its periphery and was found in the wreckage. The top two pieces of its attach lugs had separated from the bulkhead, and the aft side of the bulkhead was gouged heavily near the lower edge of the wing clevis lug, which attached the aft bulkhead to the wing. The wing clevis was attached to the wing. The aft bulkhead's spherical bearing was attached to the clevis, and the separated pieces of the aft bulkhead's attach lugs were found on top of the spherical bearing.

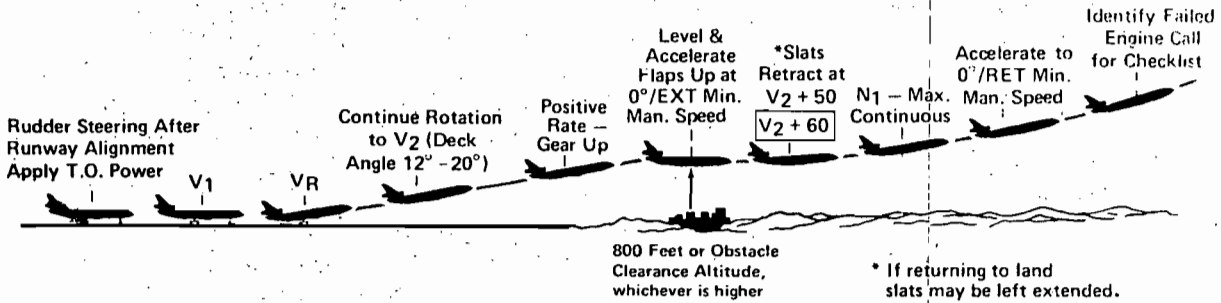
Figure 14. Diagram of AAL emergency procedure.

The Operating Manual's discussion of the procedure contained an annotated profile drawing of the takeoff. (See figure 14.) The annotations accompanying the profile sketch state (after the aircraft is airborne), "Continue rotation to V₂ (Deck angle 12°-20°)." Over the next picture of the aircraft is the note, "Positive rate-Gear up." The next picture shows the aircraft level at 800 ft AGL and contains the accelerate instructions noted above.

On July 23, 1979, American Airlines issued Operations Bulletin No. DC-10-73 which amended the procedure. The bulletin states, in part:
