**AIRCRAFT ACCIDENT REPORT**

**SCANDINAVIAN AIRLINES SYSTEM  
FLIGHT 901**

**MCDONNELL DOUGLAS DC-10-30**

**FEBRUARY 28, 1984**

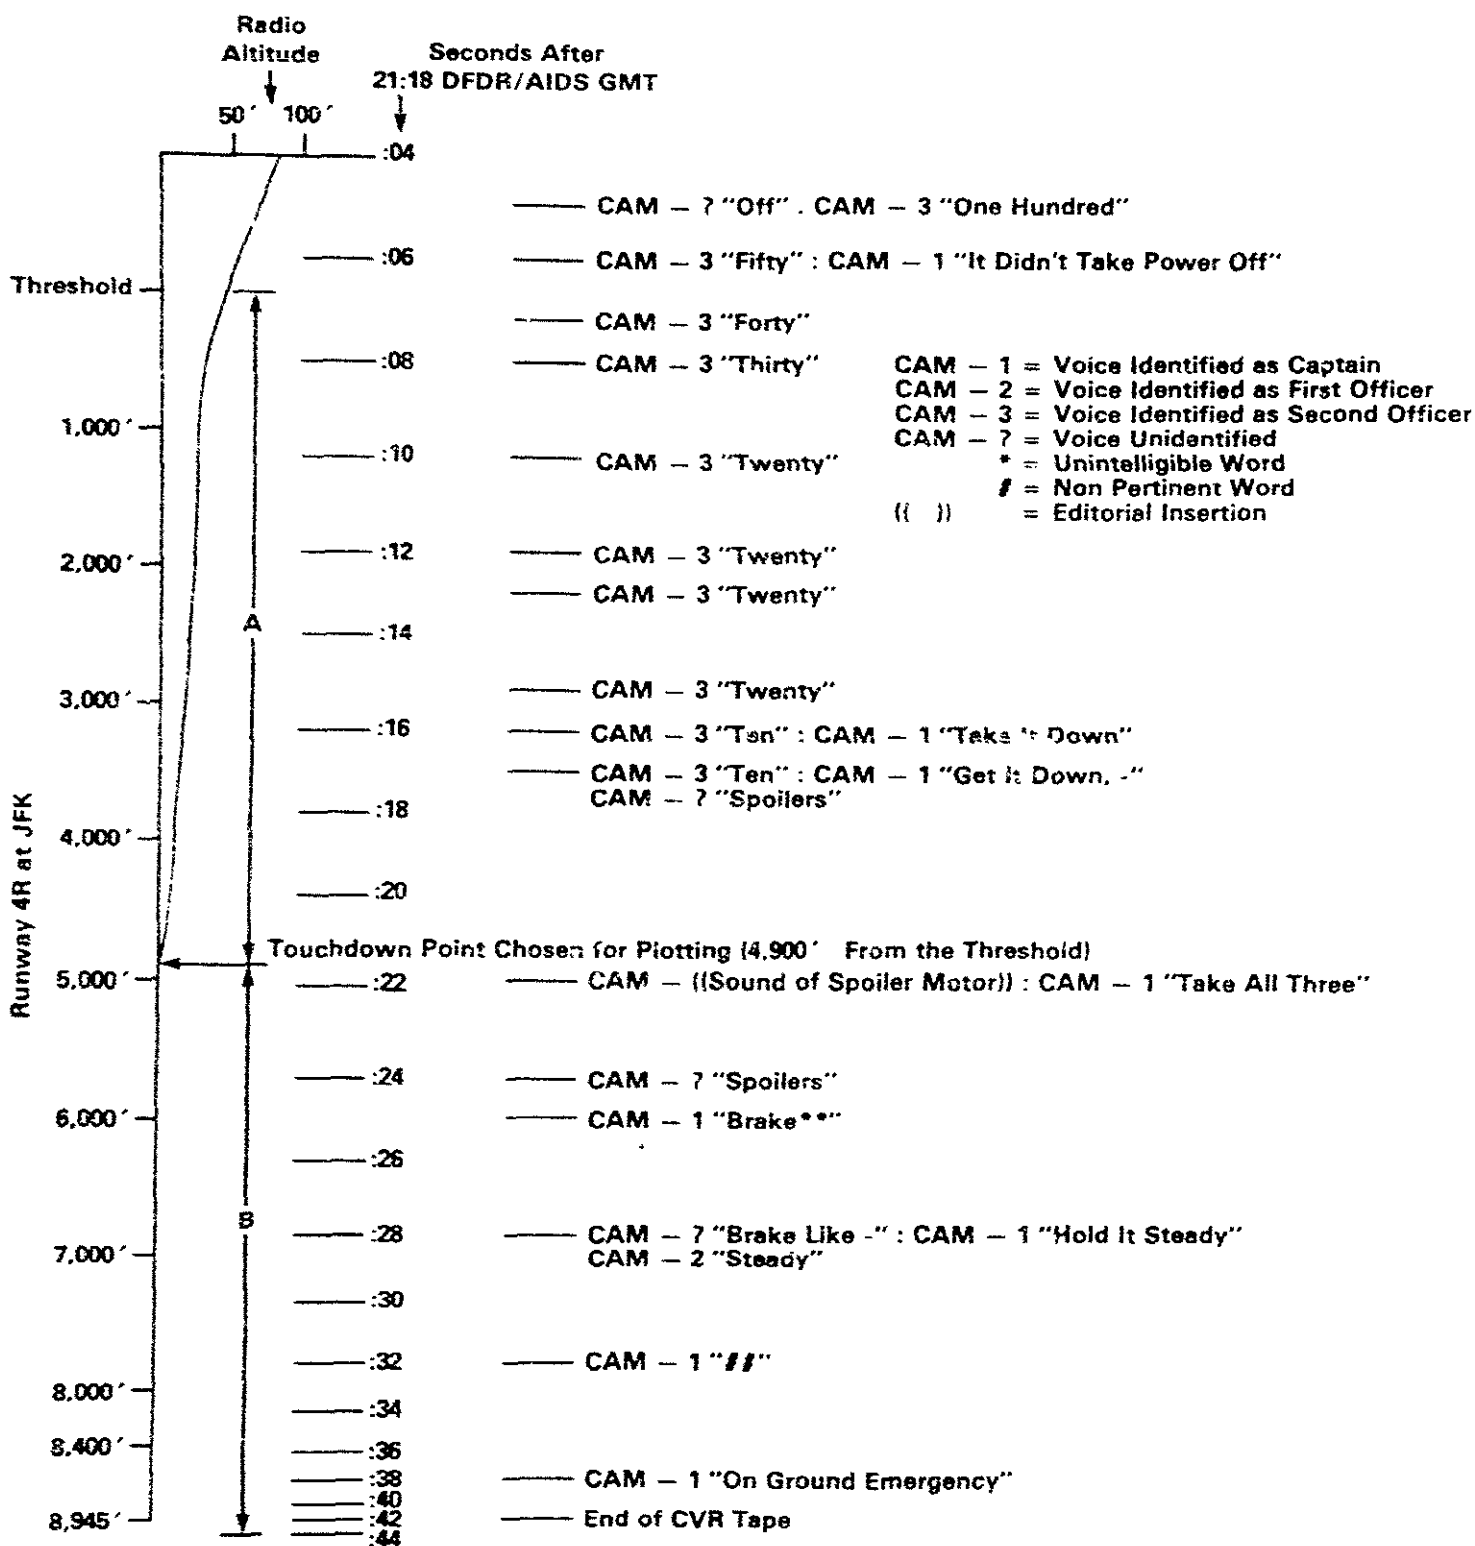
"A" Distance Is Based on AIDS INS Ground Speed Integration From the Middle Marker to Touchdown.

"B" Distance Is Based on the DFDR Longitudinal Acceleration Integration From the Assumed Time of Impact Back to the Time of Touchdown. This Distance Is Anchored at One End to the Approximate Final Position of the Aircraft.
