**NATIONAL  
TRANSPORTATION  
SAFETY  
BOARD**

**AIRCRAFT ACCIDENT REPORT**

**HENSON AIRLINES FLIGHT 1517  
BEECH B99, N339HA  
GROTTOES, VIRGINIA  
SEPTEMBER 23, 1985**

**NTSB/AAR-86/07**

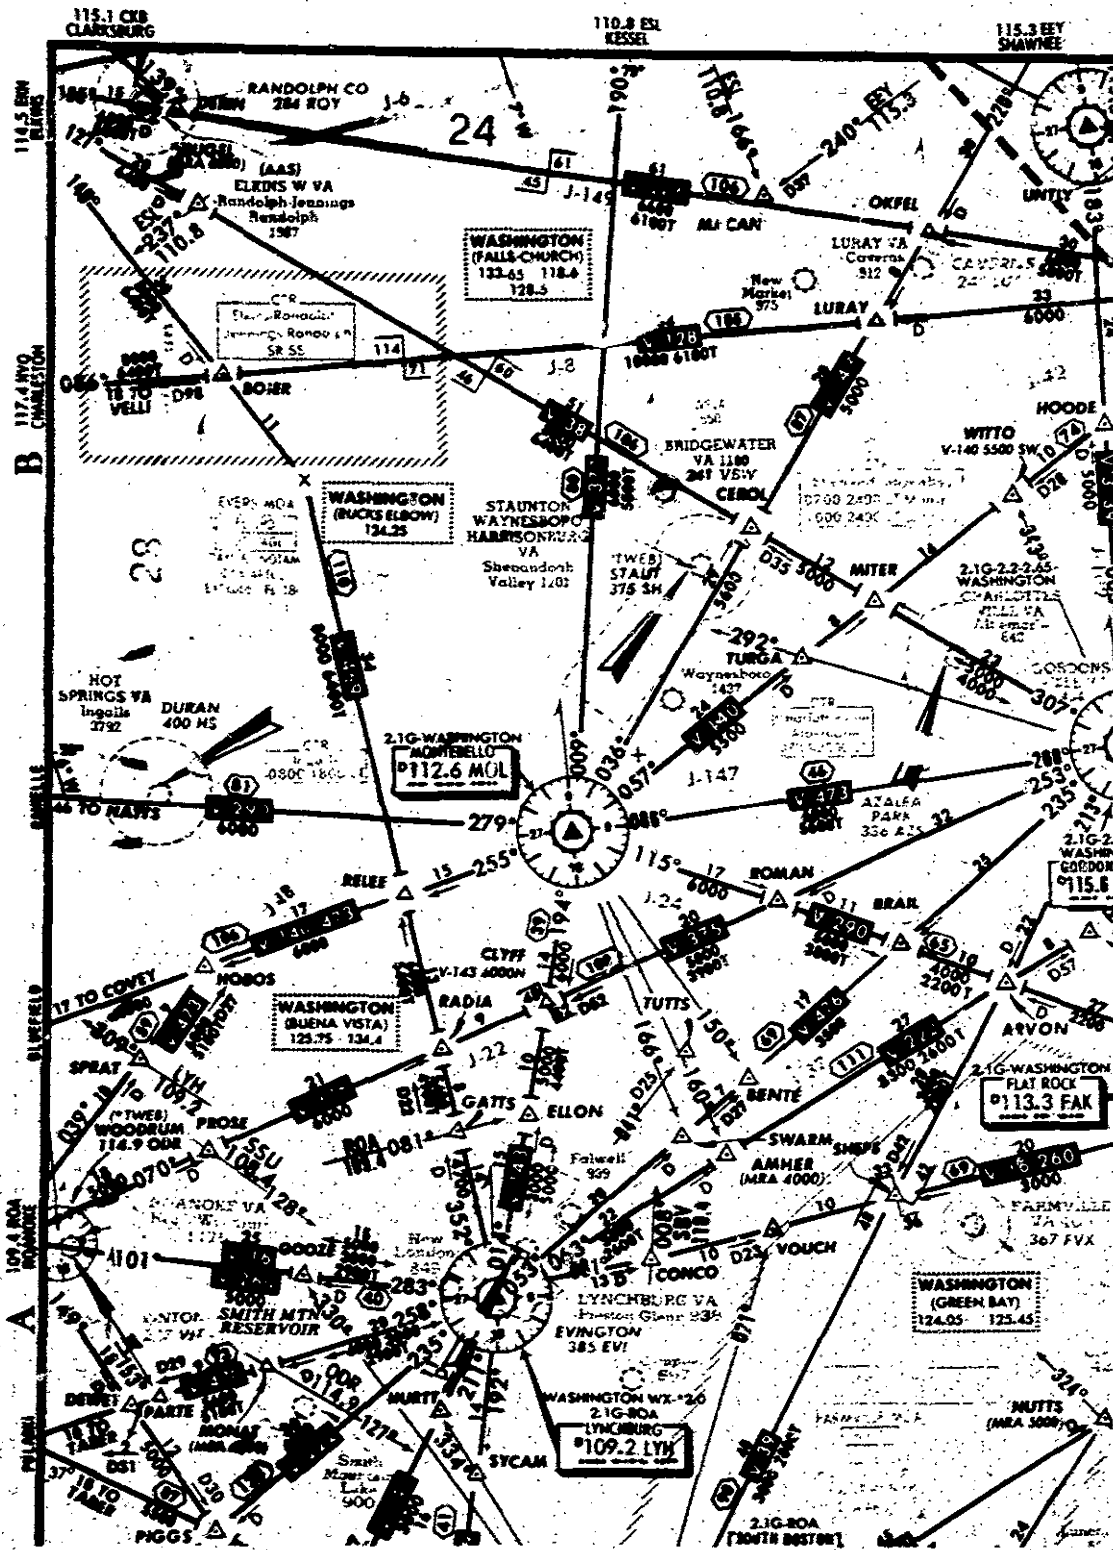
Figure 1.—En route chart.

The computer stored instrument flight rules (IFR) plan for flight 1517 was: BWI, Victor Airway 214, Martinsburg, West Virginia (MRB) VORTAC, 2/ direct to the Linden, Virginia (LDN) VORTAC, direct to Shenandoah Valley Airport (SHD), at a requested cruising altitude of 6,000 feet above mean sea level (m.s.l.). 3/ (See figure 1.)

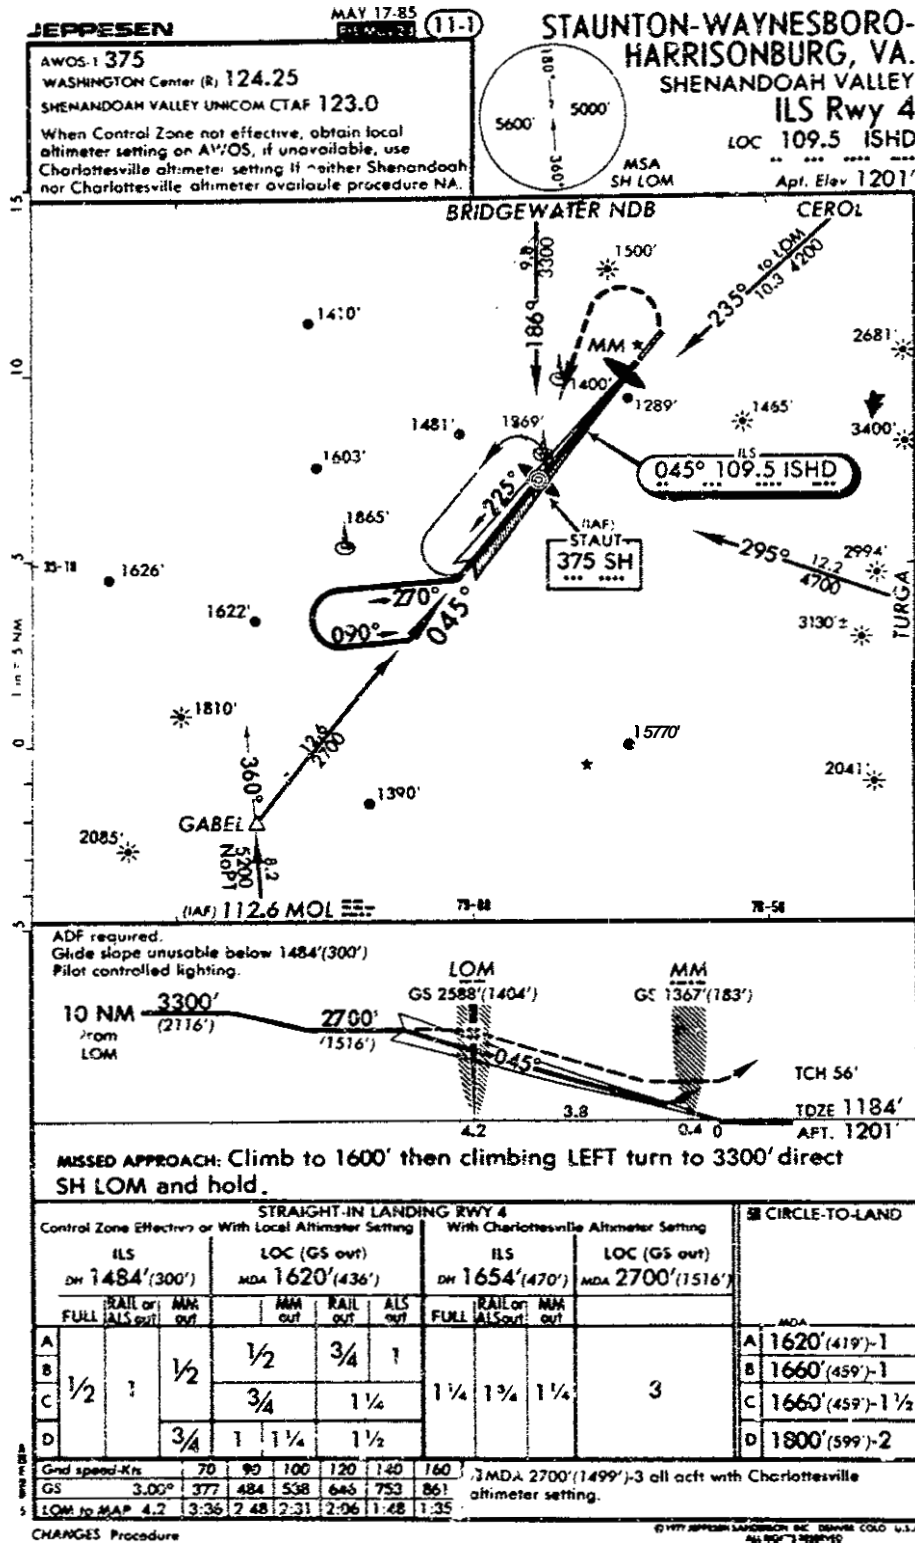
Figure 2.—Approach chart.  
 (Copyright 1978 Jeppesen Sandersen, Inc. All Rights Reserved.)

Air traffic control (ATC) handling of flight 1517 was routine. (See appendix D.) All transmissions from the airplane were made by the captain. The approach clearance to SHD was issued at 0959:14, and radar service was terminated at 1003:25. (See figure 2.) About 1005, the flight crew made an in-range call 4/ to Henson's SHD station agent to report the number of passengers aboard and to request 100 gallons of fuel. Shortly thereafter, the flight crew called the SHD UNICOM 5/ on 123.0 MHz, the Common Traffic Advisory Frequency (CTAF), to request weather and traffic information. The UNICOM operator transmitted the 0945 weather observation and advised that there was no reported traffic. About 1011, flight 1517 crossed the localizer for runway 4 eastbound on a magnetic track of about 075°. (See figure 3.) The last recorded radar return was at 1011:55 when the airplane was at 2,700 feet.

SHD is served by two standard instrument approach procedures (SIAP): an ILS approach to runway 4 (ILS RWY 4) and a nondirectional beacon approach to runway 4 (NDB RWY 4). At the time of the accident, the ILS RWY 4 approach, amendment No. 5, was in use. (See figure 2.) A localizer was installed in 1969, and a glideslope was added
