# **NATIONAL TRANSPORTATION SAFETY BOARD**

## **AIRCRAFT ACCIDENT REPORT**

**FISCHER BROS. AVIATION, INC.,  
dba NORTHWEST AIRLINK, FLIGHT 2268  
CONSTRUCCIONES AERONAUTICAS, S.A. (CASA)  
C-212-CC, N160FB  
DETROIT METROPOLITAN WAYNE COUNTY AIRPORT  
ROMULUS, MICHIGAN  
MARCH 4, 1987**

**NTSB/AAR-88/08**

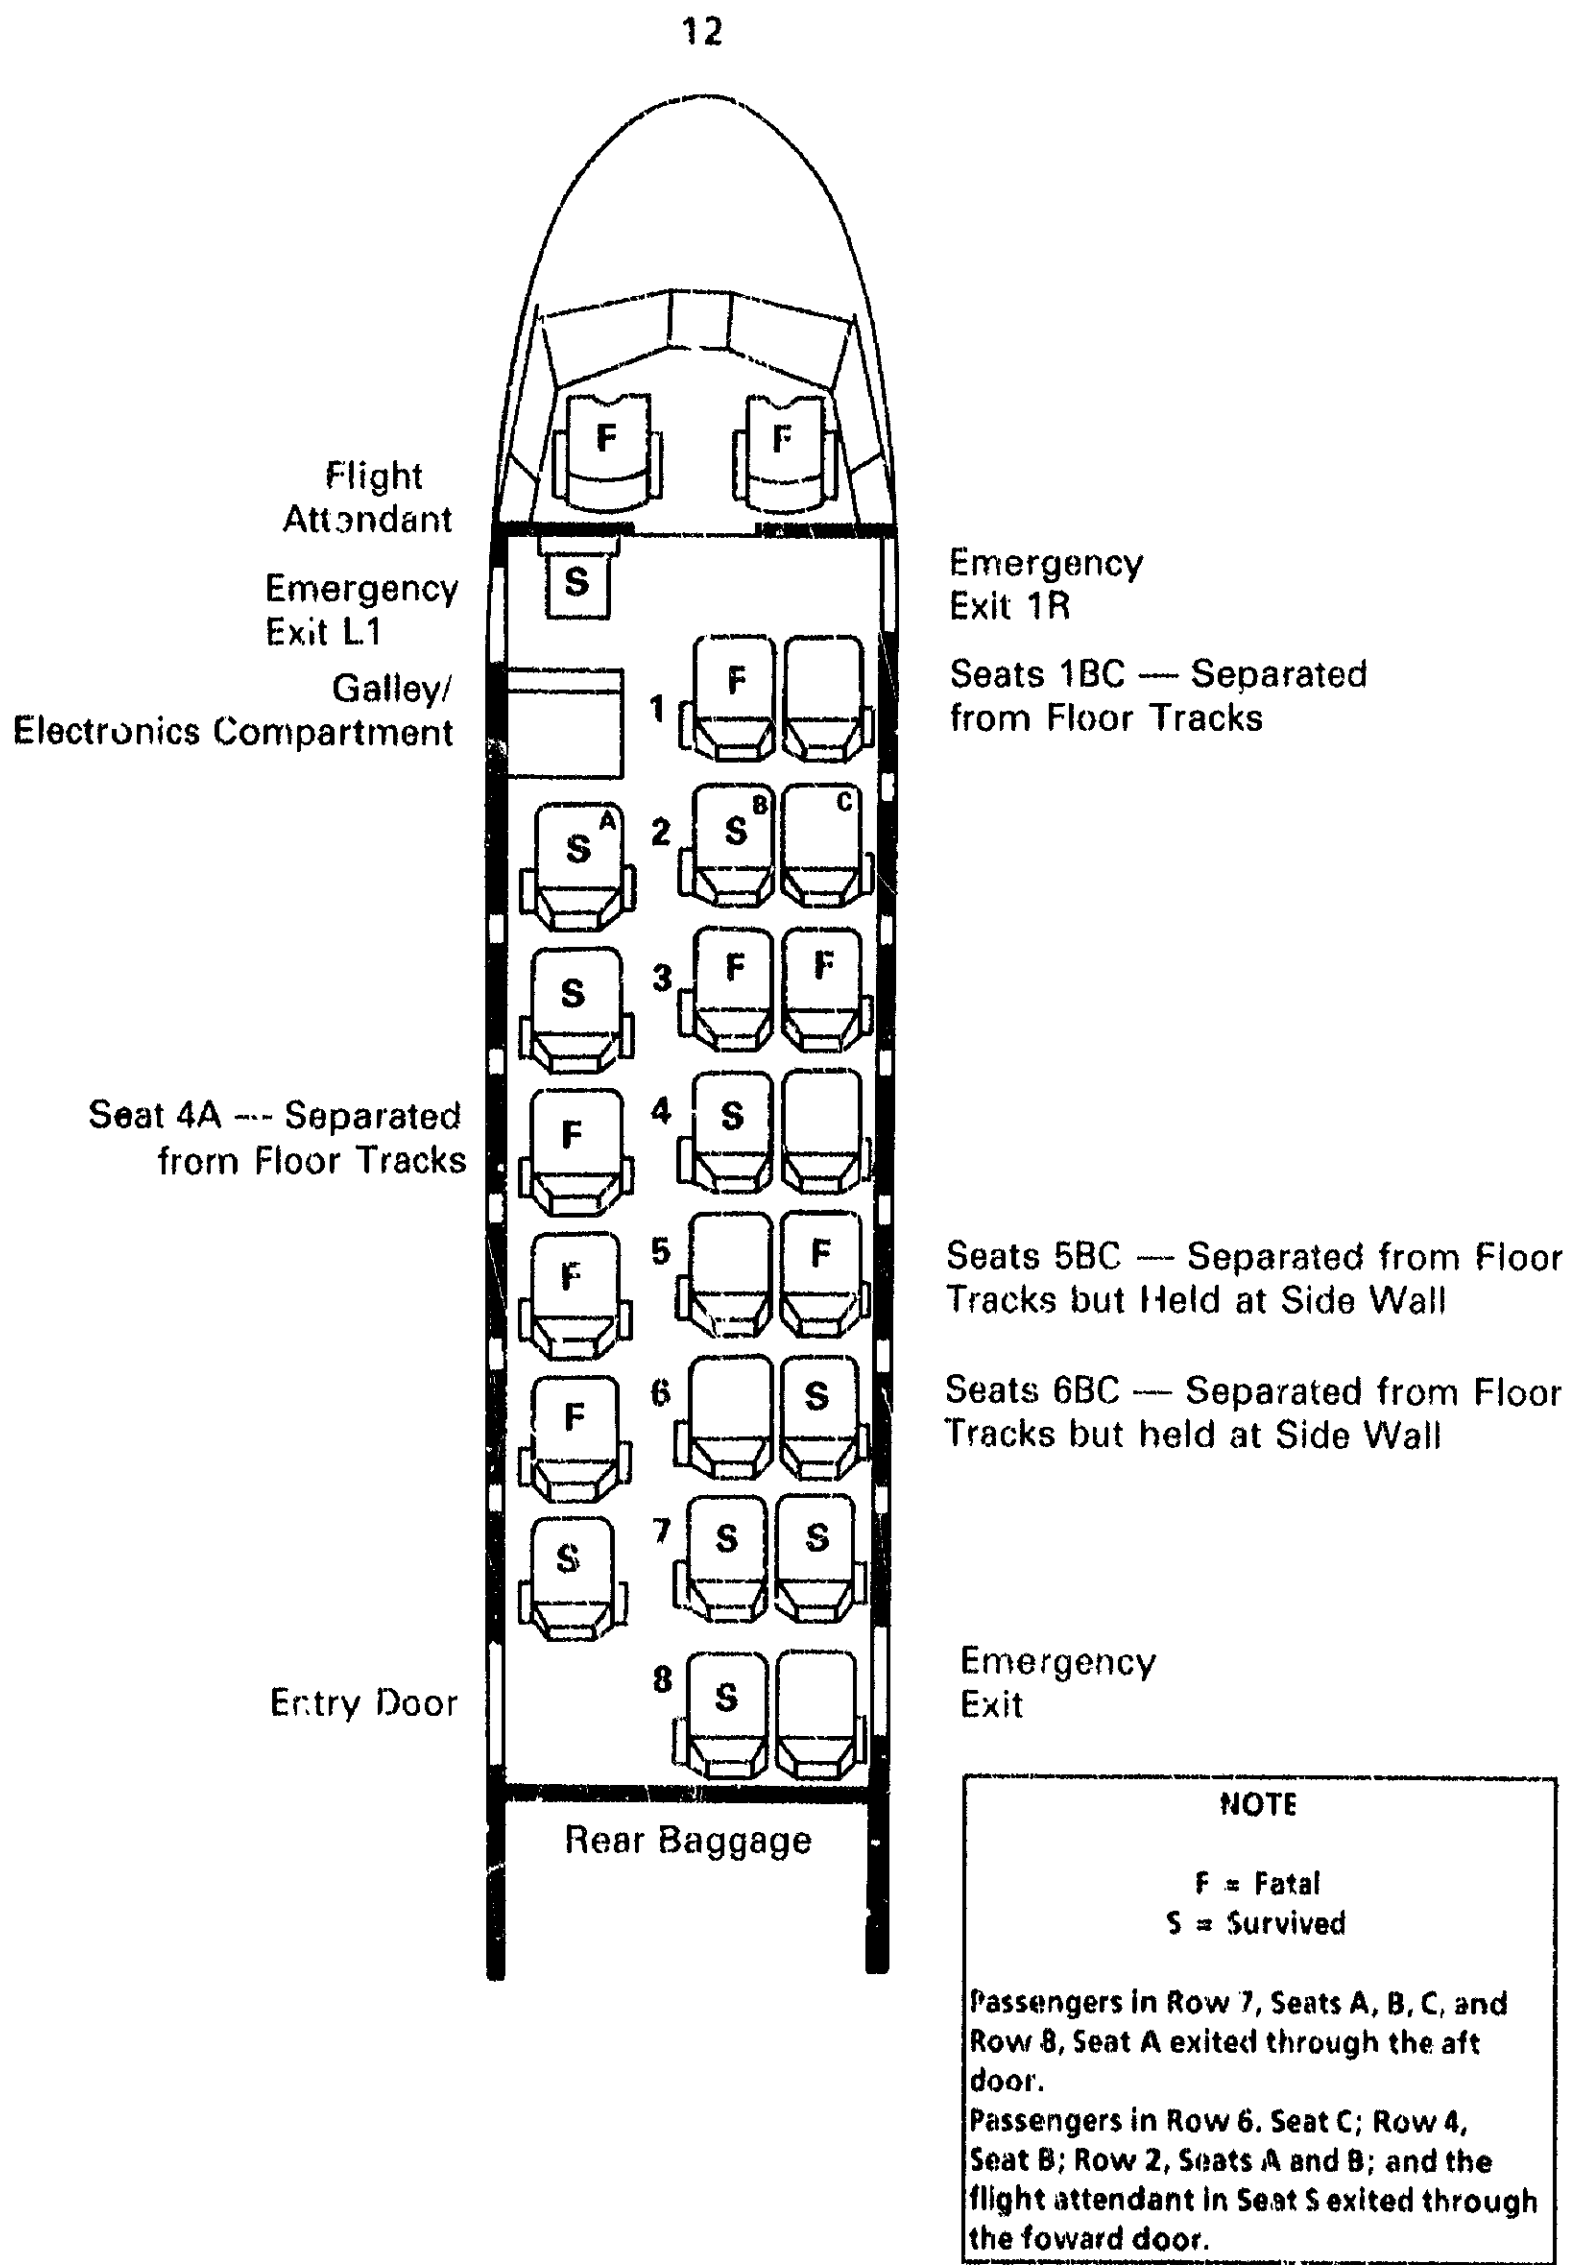
Figure 2.--Fischer Bros. CASA C-212-CC cabin seat configuration.

Because the airplane was upside down, passengers fell to the cabin ceiling after they released their seatbelts. The ceiling area that had to be used as an exit path was obstructed by loose debris and wing flap actuator fairings, which protruded through the ceiling. They reported that they could see light through open exits and rapidly escaped through the exits. The flight attendant and four passengers, including a company ground employee, exited through the left forward emergency exit, and five passengers, including two off-duty pilots and a flight attendant, exited through the rear main entry door on the left side of the fuselage which had sprung open during the impact sequence. (See figure 2 for cabin seat arrangements.)

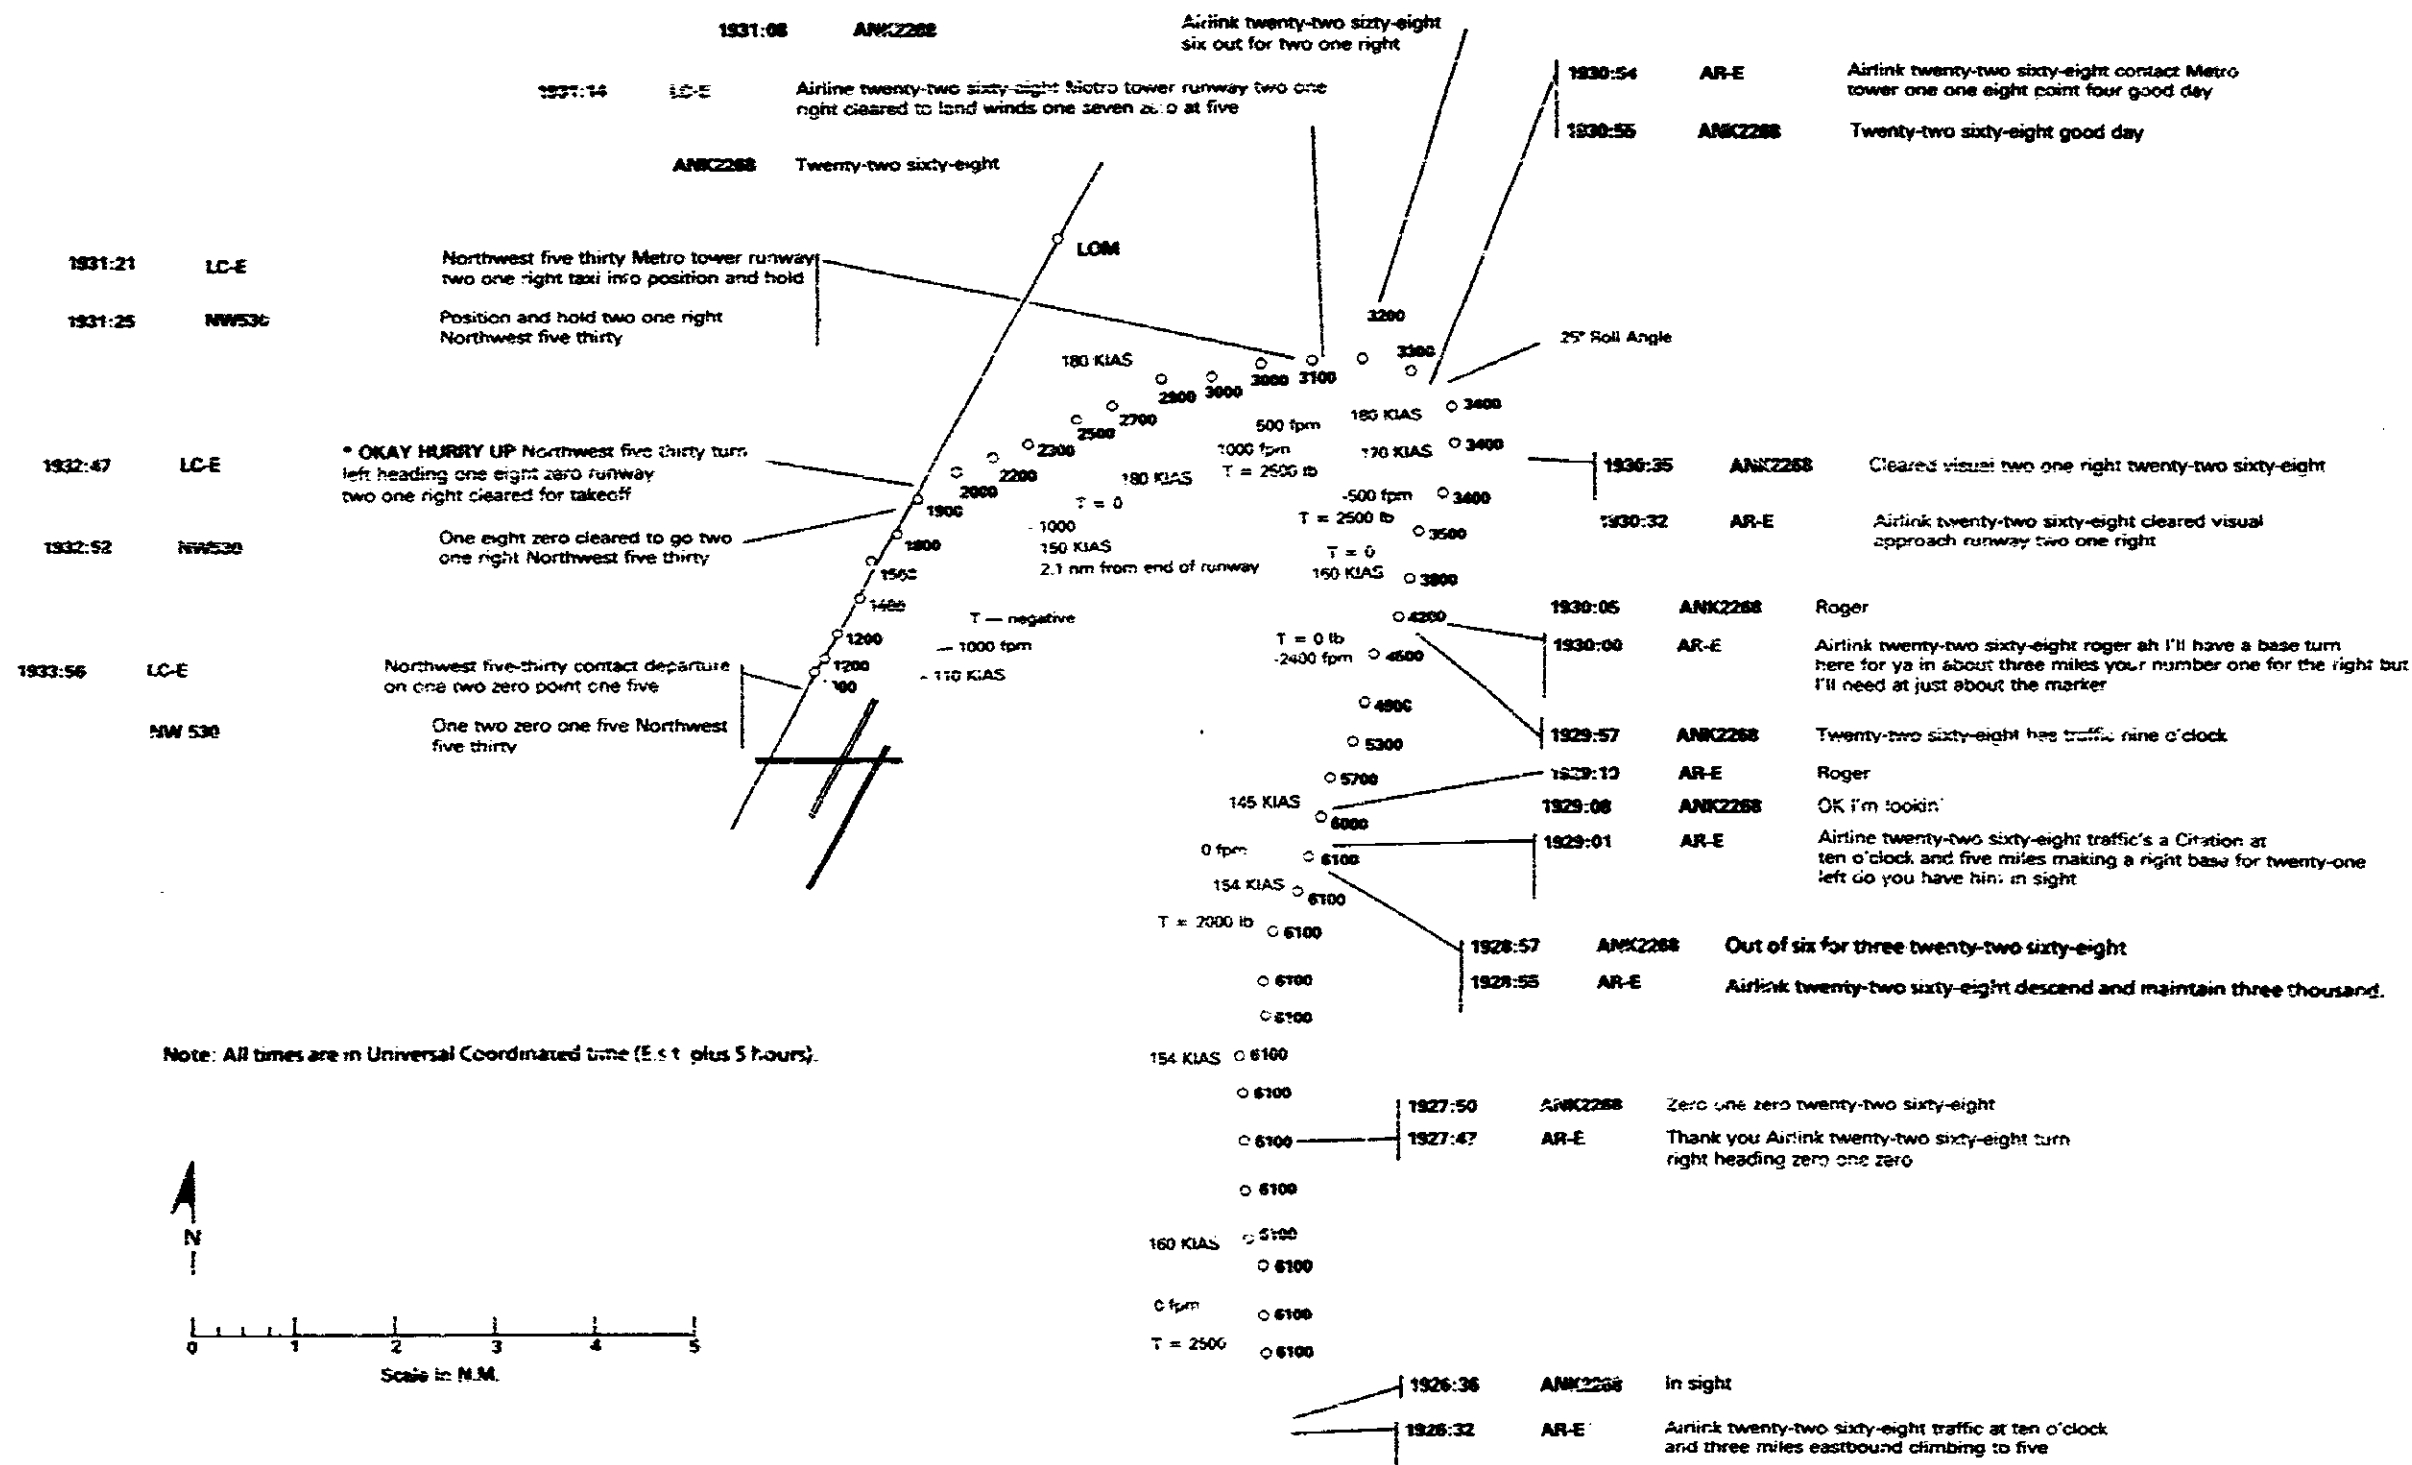
Figure 7.--Computer-generated ground track plot.

Computations indicate that about 3,000 pounds of negative thrust were required to decelerate the airplane to match its computer-generated profile. The PLs would have been in the beta mode near the ground idle gates for 15 to 20 seconds in order to have produced the 3,000 pounds of negative thrust. (See figures 7 and 8).
