PB89-910406
NTSB/AAR-89/04

AIRCRAFT ACCIDENT REPORT

DELTA AIR LINES, INC.
BOEING 727-232, N473DA
DALLAS-FORT WORTH INTERNATIONAL
AIRPORT, TEXAS
AUGUST 31, 1988

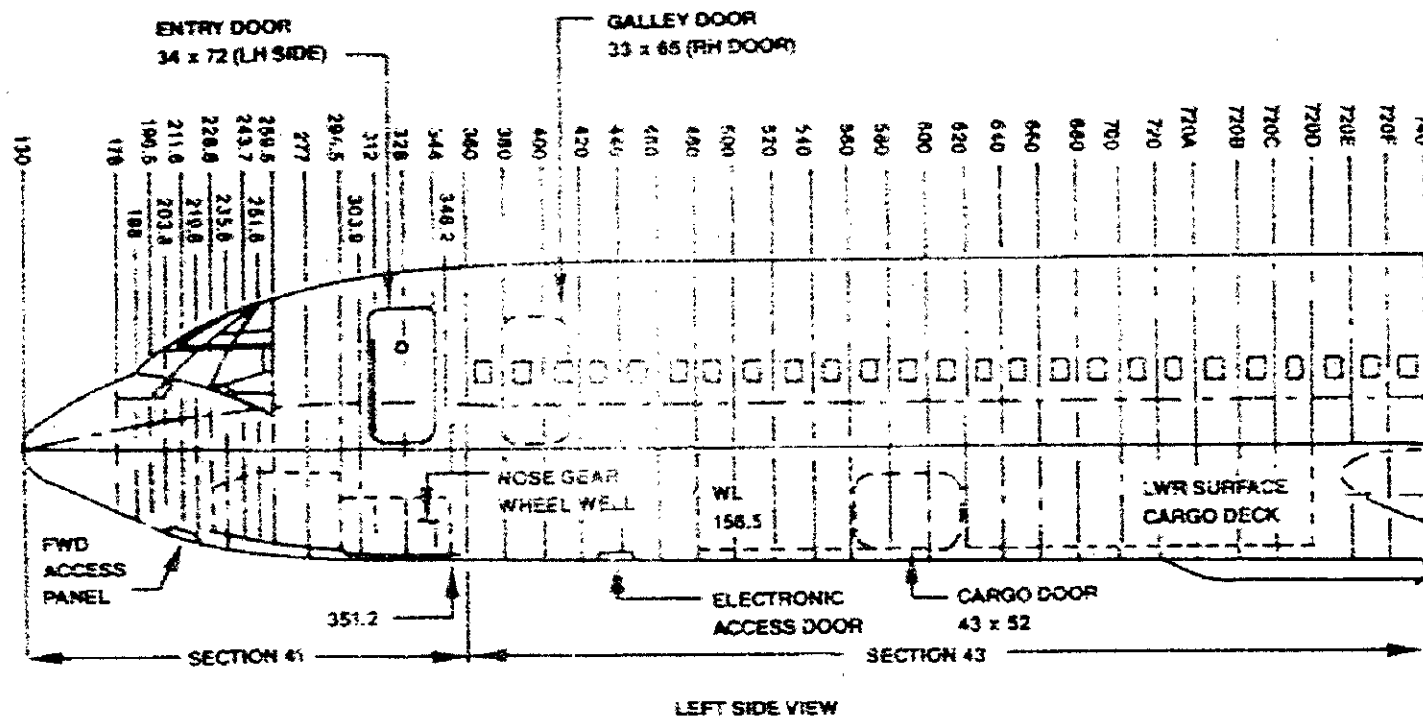
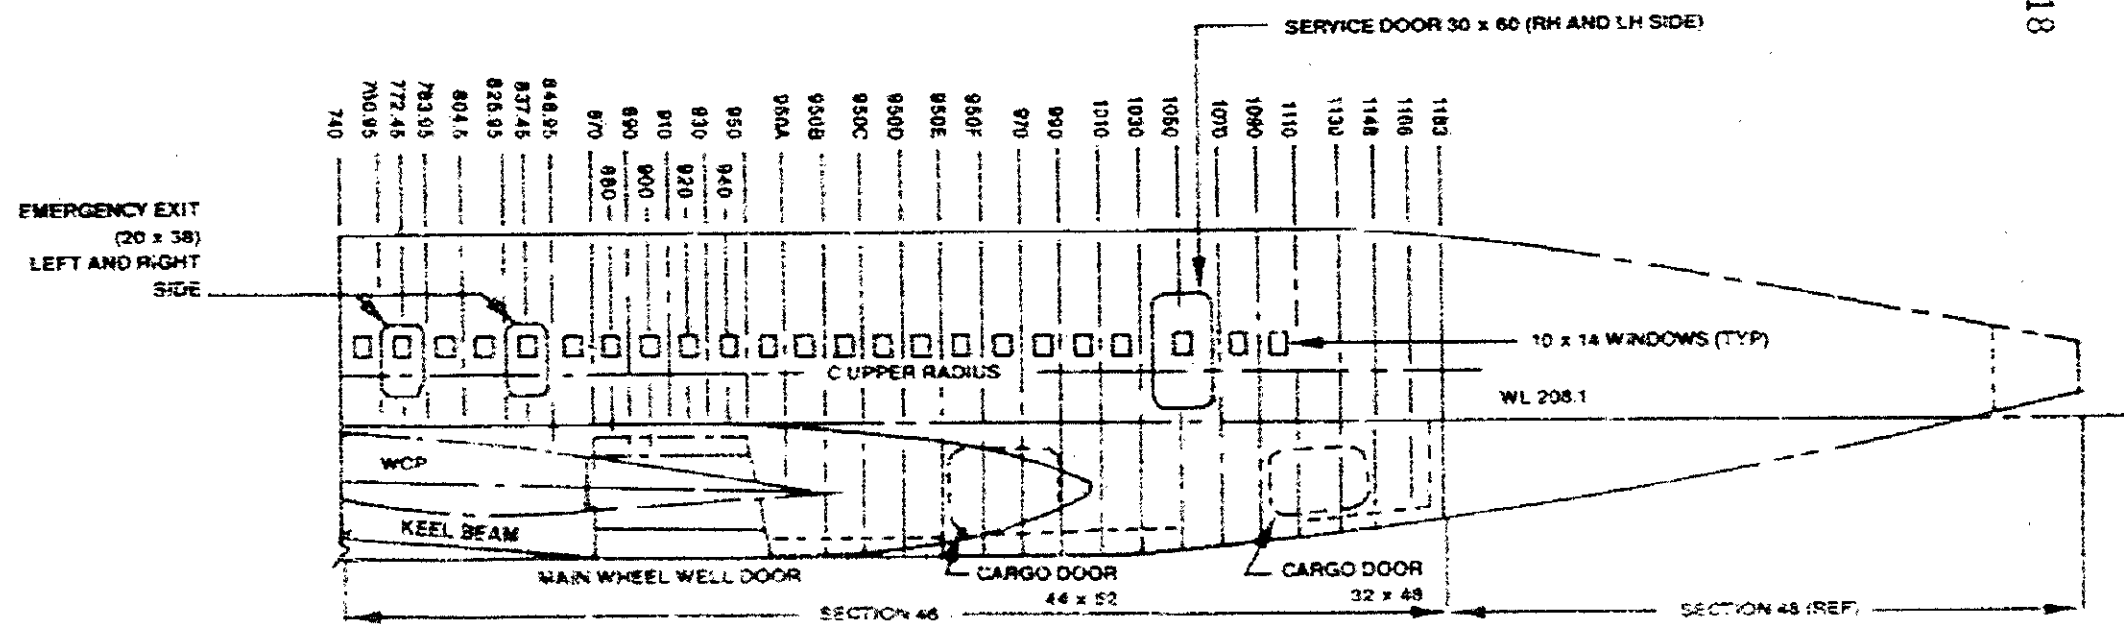
Figure 6.--Fuselage station diagram.

Fuselage and Empennage.--The fuselage had separated into three major sections: (1) the forward section consisted of the nose forward of fuselage station (FS)-420 (see figure 6); (2) the center fuselage section included the body structure between FS-420 and FS-950c; and (3) the aft fuselage section extended from FS-950c aft to the end of the No. 2 engine tailpipe.

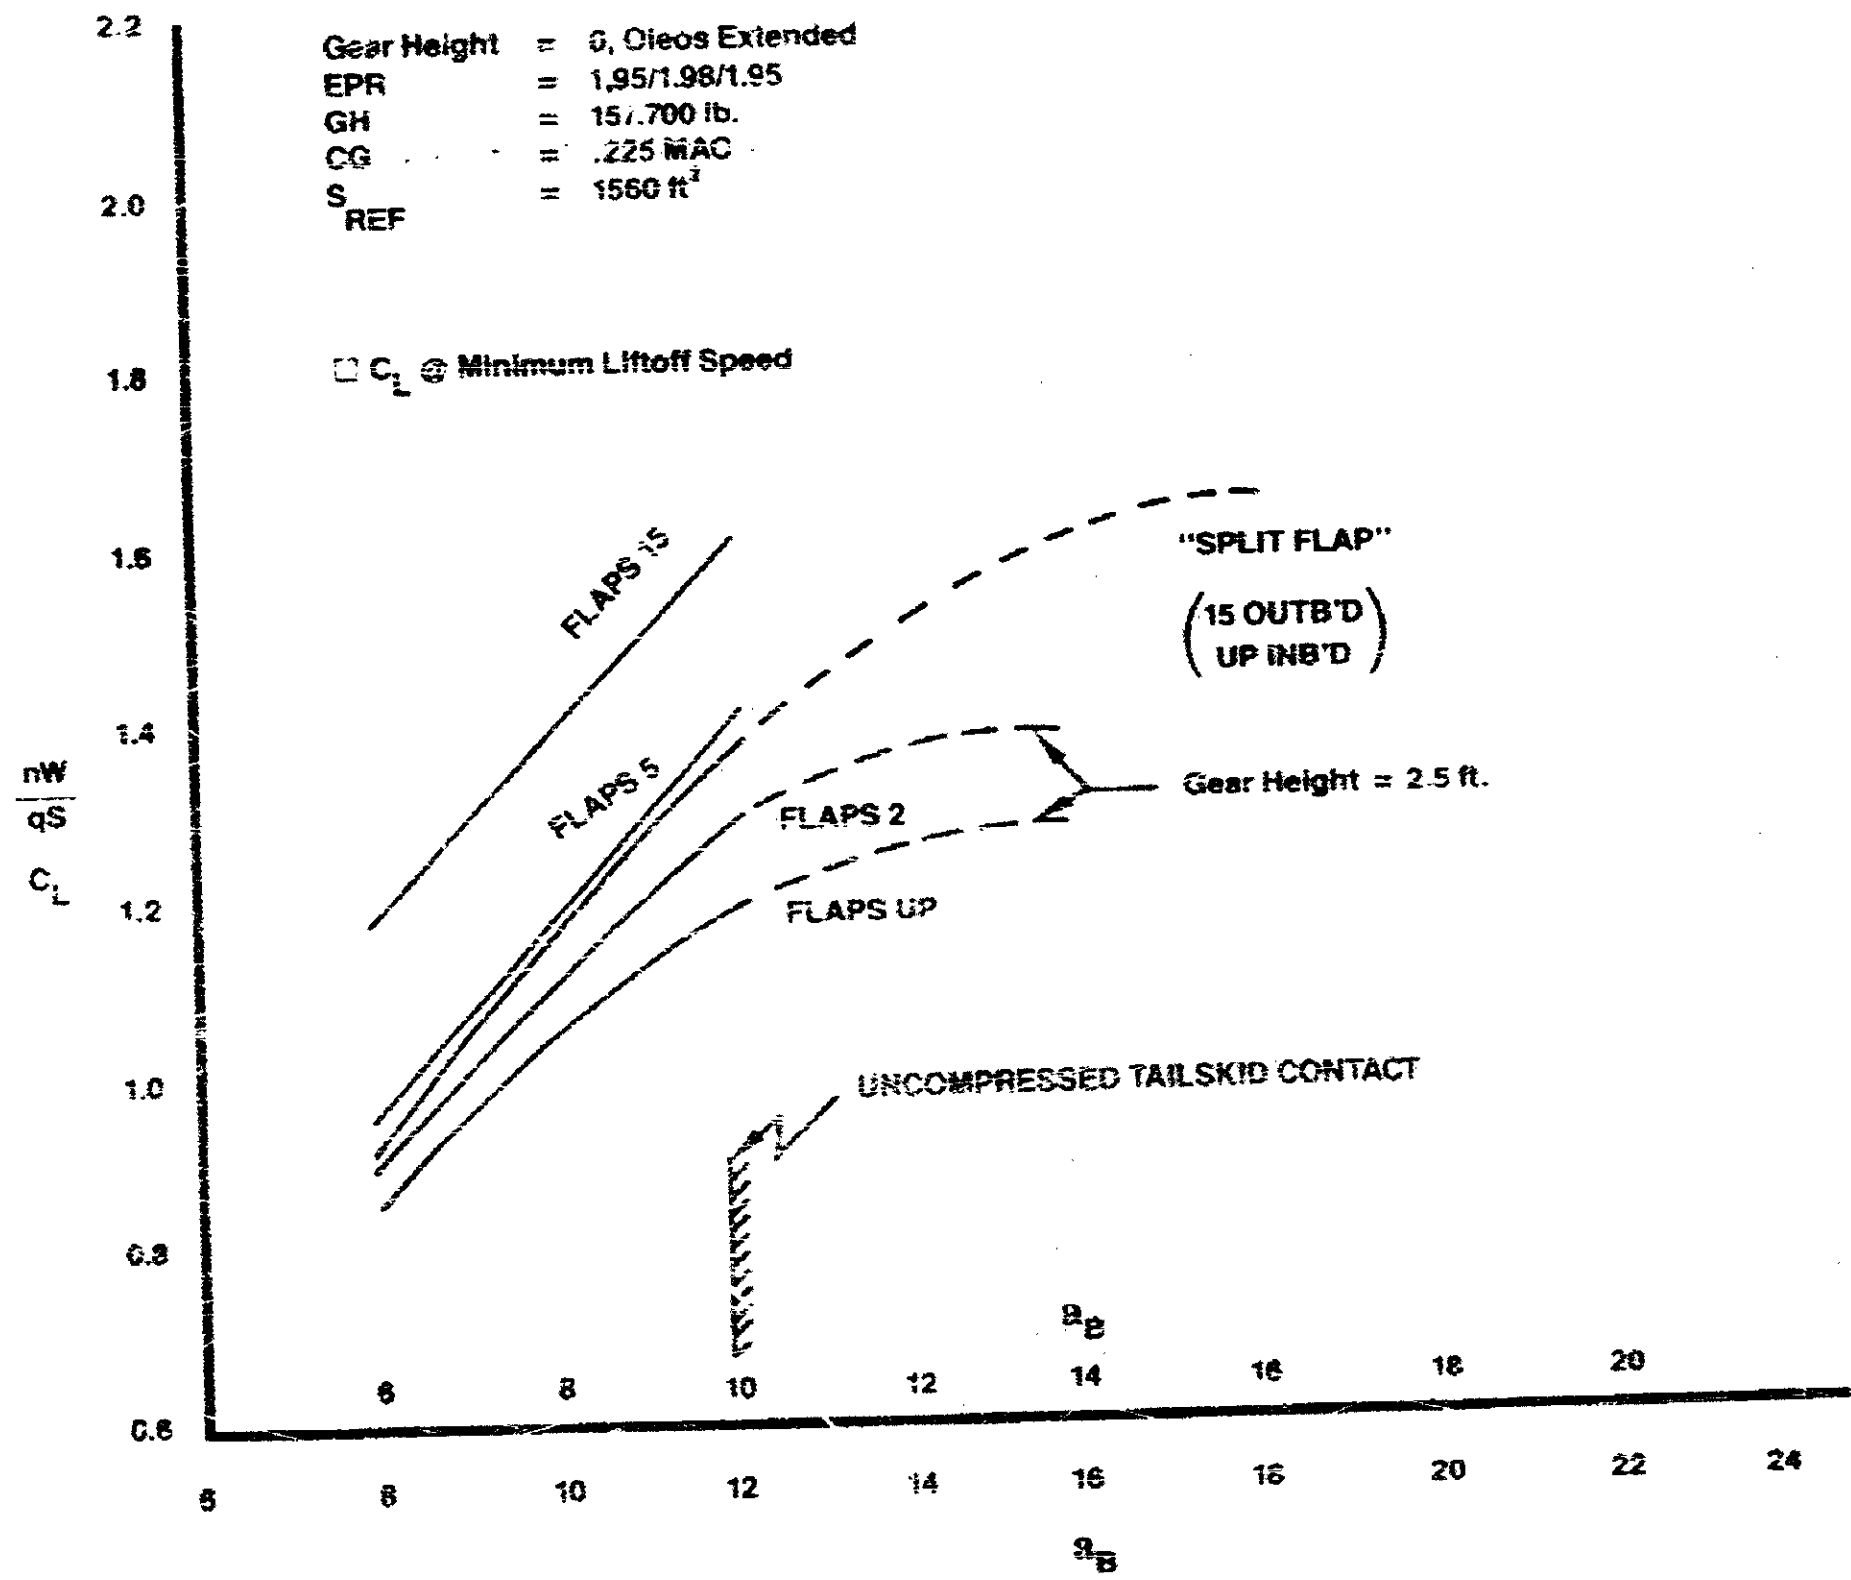
Figure 10.--Boeing 727 city curves, in ground effect zero altitude.

with a normal flap setting of 5°. The stall AOA for "split flaps" is about 9° higher than the stall AOA for flaps at 15° or 5°. (See figures 10 and 11.) The "split flaps" scenario will be discussed later in this report.

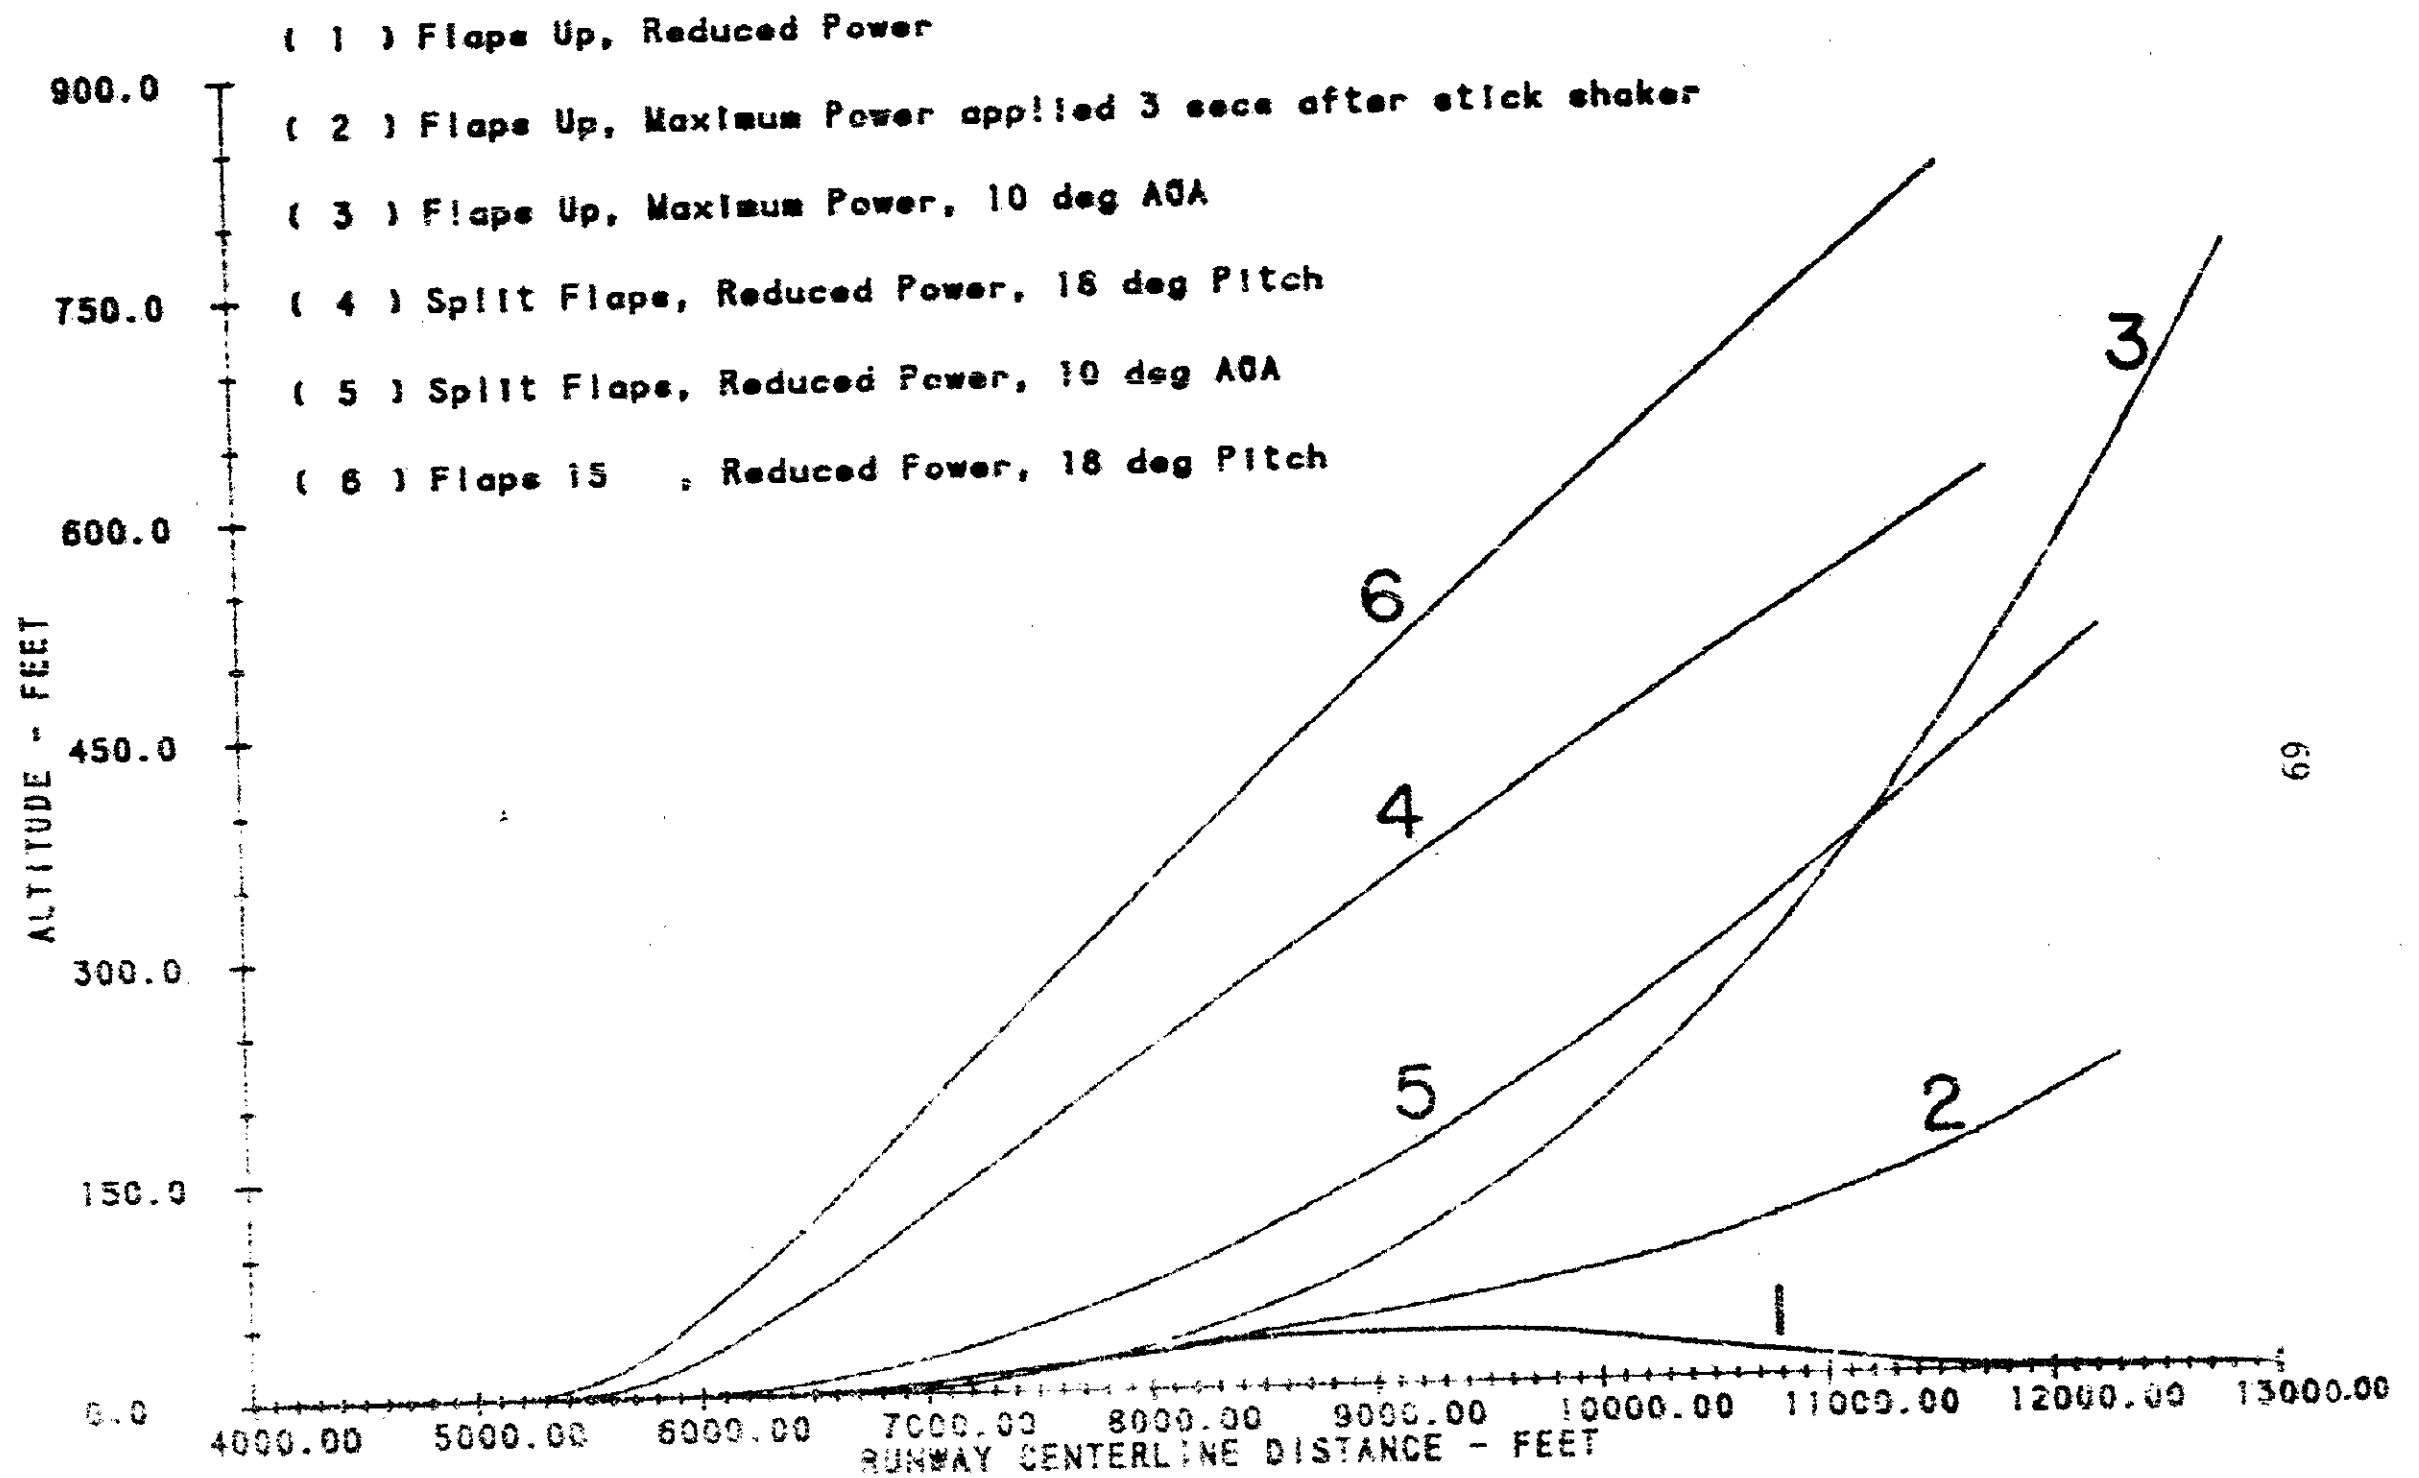
Figure 13.--Takeoff profiles.

edge flaps retracted, the outboard trailing edge flaps extended to 15° , and the leading edge flaps and slats extended was analyzed and compared with the performance achieved by flight 1141. (See figure 13.) It is readily apparent from the calculated aerodynamic effects of trailing edge flaps and leading edge devices that the wing in the "split flap" configuration would have generated less lift at a given airspeed and AOA than it would have with all of the trailing edge flaps extended to 15° ; but it is also apparent that the AOA at which airflow separation would have occurred with "split flaps" would have been about the same (or even slightly higher on the inboard wing section) than it would have been in the normal 15° trailing edge flap configuration. The theoretical aerodynamic data provided for the split flap configuration by the Boeing Company indicate that the stall AOA is about 18° ; the data obtained from the March 23, 1989, demonstration flight indicate that an airplane under the conditions of flight 1141 maintains good flight characteristics without airflow separation (as indicated by buffet or roll instability) up to AOA greater than 15° . However, unlike the takeoff warning system, the stall warning stickshaker circuitry is predicated upon the inboard flap position and an assumption that the leading edge devices are also retracted when the inboard flaps are retracted. Thus, the stickshaker stall warning will alarm at an AOA of 11° appropriate to stall for the clean wing configuration. In the split flap configuration, the 11° AOA stickshaker warning would have provided about 16 percent airspeed and 7° AOA margin to stall. If the stickshaker warning was set at 14° AOA, the more typical 7 percent airspeed and 4° AOA margin to stall would have been available.

The performance analysis, based upon the lift versus AOA data for the split flap configuration, indicates that had flight 1141 been so configured during the takeoff roll, the airplane's tail may have contacted the runway surface as the captain rotated to the takeoff attitude. However, the airplane, with its geometry-limited 10° pitch attitude would have lifted off at about 150 KCAS instead of the actual liftoff speed of 158 KCAS. A continued rotation at a rate greater than 1.5° per second would have resulted in stickshaker activation; but there would have been considerable margin to stall when the warning occurred and the airplane would have transitioned to a climbing flightpath with a vertical acceleration in excess of 1.2G. If the captain had ignored the stickshaker warning and continued to exert sufficient back force on the control column to raise the airplane's nose at a rate of 3° per second, the airplane would have achieved a 3° climbing flightpath at an AOA of about 15° within 2 seconds after liftoff. There would have been no airflow separation to explain the sudden roll of the airplane, and there would have been no engine inlet air turbulence to explain the compressor surges which were evident on the CVR. A more likely and proper flight crew reaction to the stickshaker activation would have been to relax the back force on the control column to silence the stickshaker, provided that that response would not result in a loss of critical altitude. Under such circumstances, the airplane would have continued to accelerate while developing sufficient lift force to transition to a climbing flightpath. These performance data indicate that about 10 seconds after liftoff, the airplane would have been about 100 feet above the ground and climbing at about 1,200 feet per minute. The stickshaker would have activated only momentarily.

The Safety Board concludes that the actual performance of flight 1141 is not explainable by the "split flap" theory. A possibility that one flightcrew member reacted to the delayed liftoff and stickshaker onset by intentionally or inadvertently retracting the flaps to 0° is also implausible, since the 20 seconds required for the trailing edge flaps and leading edge devices to retract with consequent effect on flight performance would place the airplane far beyond the point at which the roll instability and engine compressor surges actually occurred. If the flaps retraction sequence had started at rotation, the airplane would have had sufficient lift to climb several hundred feet prior to the flaps reaching 0° . Furthermore, each of the flightcrew members positively stated that they did not reset the flap control lever after the takeoff was initiated, and that they knew of no situation in which they would have done so.
