**PB90-910406  
NTSB/AAR-90/06**

**AIRCRAFT ACCIDENT REPORT**

**UNITED AIRLINES FLIGHT 232  
McDONNELL DOUGLAS DC-10-10  
SIOUX GATEWAY AIRPORT  
SIOUX CITY, IOWA  
JULY 19, 1989**

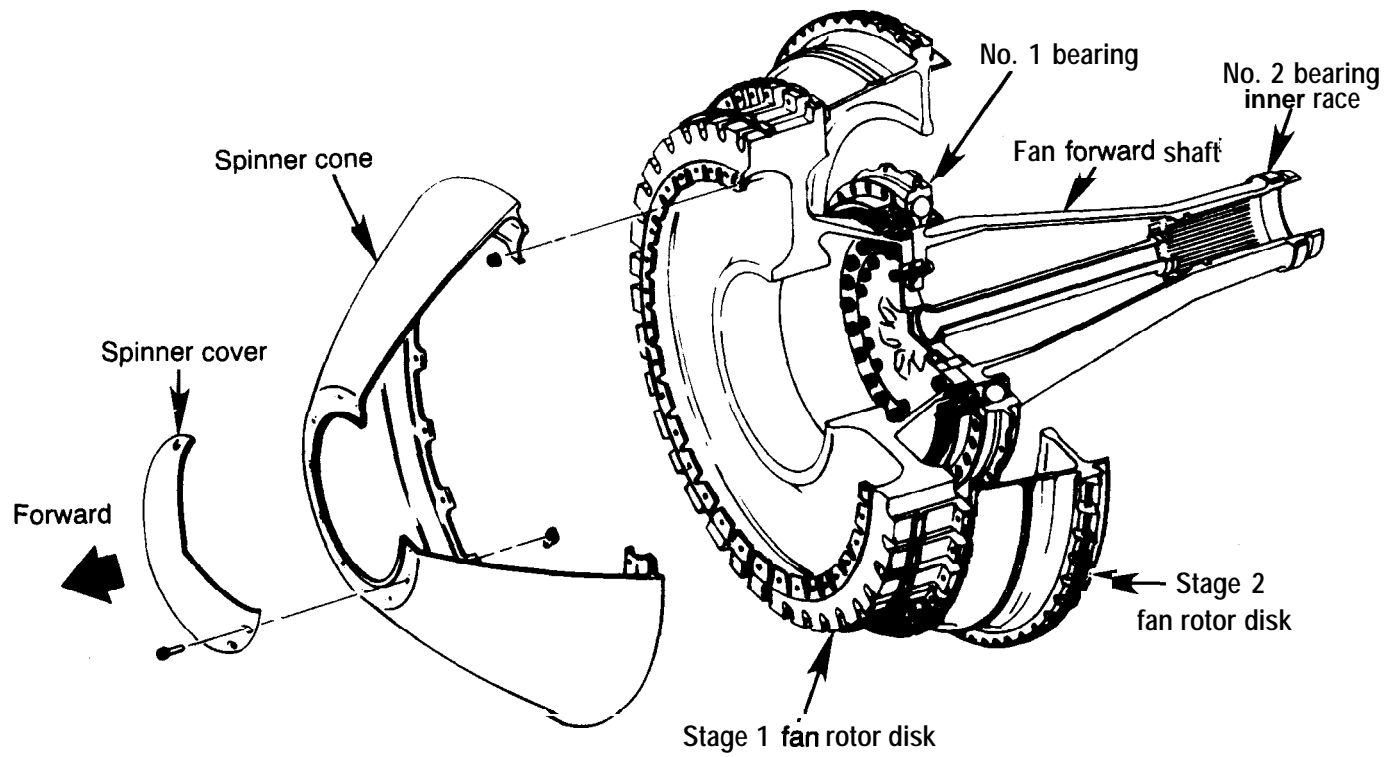
Figure 5. --CF6-6 fan rotor assembly.

Photographs of the airplane were taken by observers on the ground during its final approach to Sioux Gateway Airport. They showed that the No. 2 engine fan cowling and the fuselage tail cone were missing. The remainder of the No. 2 engine appeared intact. Postcrash examination of the wreckage revealed that the No. 2 engine fan rotor components forward of the fan forward shaft, as well as part of the shaft, had separated from the engine in flight. (See figures 3 through 5).

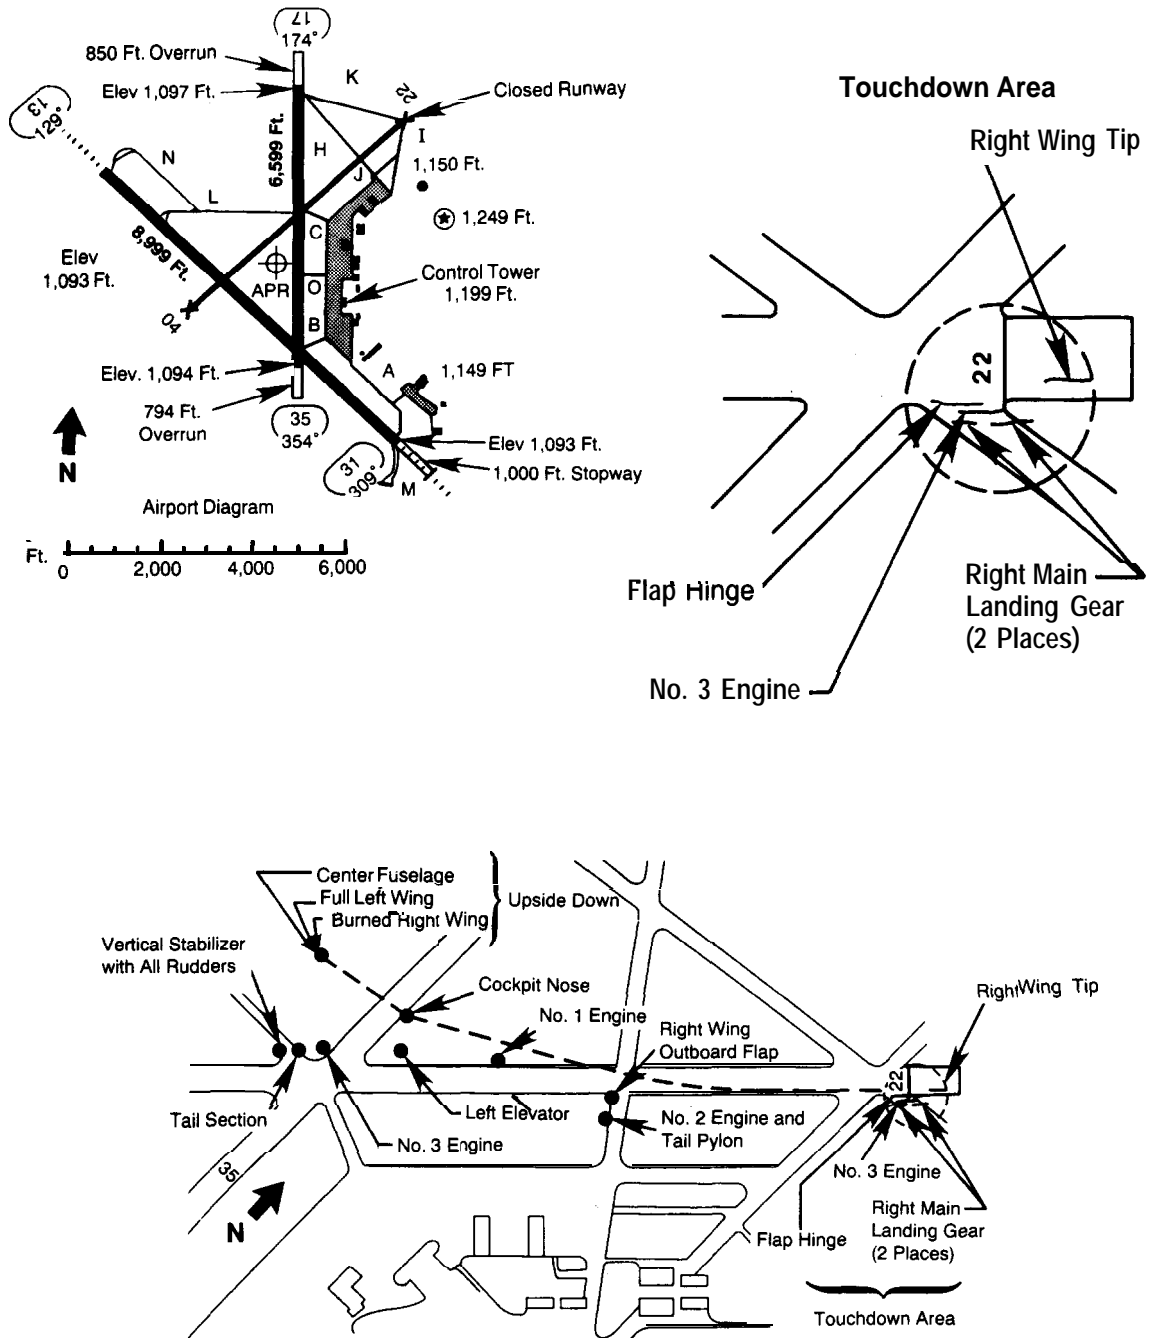
Figure 6. -- Sioux Gateway Airport and wreckage path of UA flight 232.

The cockpit separated early in the sequence and came to rest at the edge of runway 17/35. The largely intact tail section continued down runway 22 and came to rest on taxiway "L." The engines separated during the breakup. The No. 1 and No. 3 engines came to rest near taxiway "L" and the intersection of runway 17/35, between 3,000 and 3,500 feet from the point of first impact. (See figure 6).

The No. 2 engine came to rest on taxiway "J" to the left of runway 22, about 1,850 feet from the point of first impact. The majority of the No. 2 engine fan module was not found at the airport.

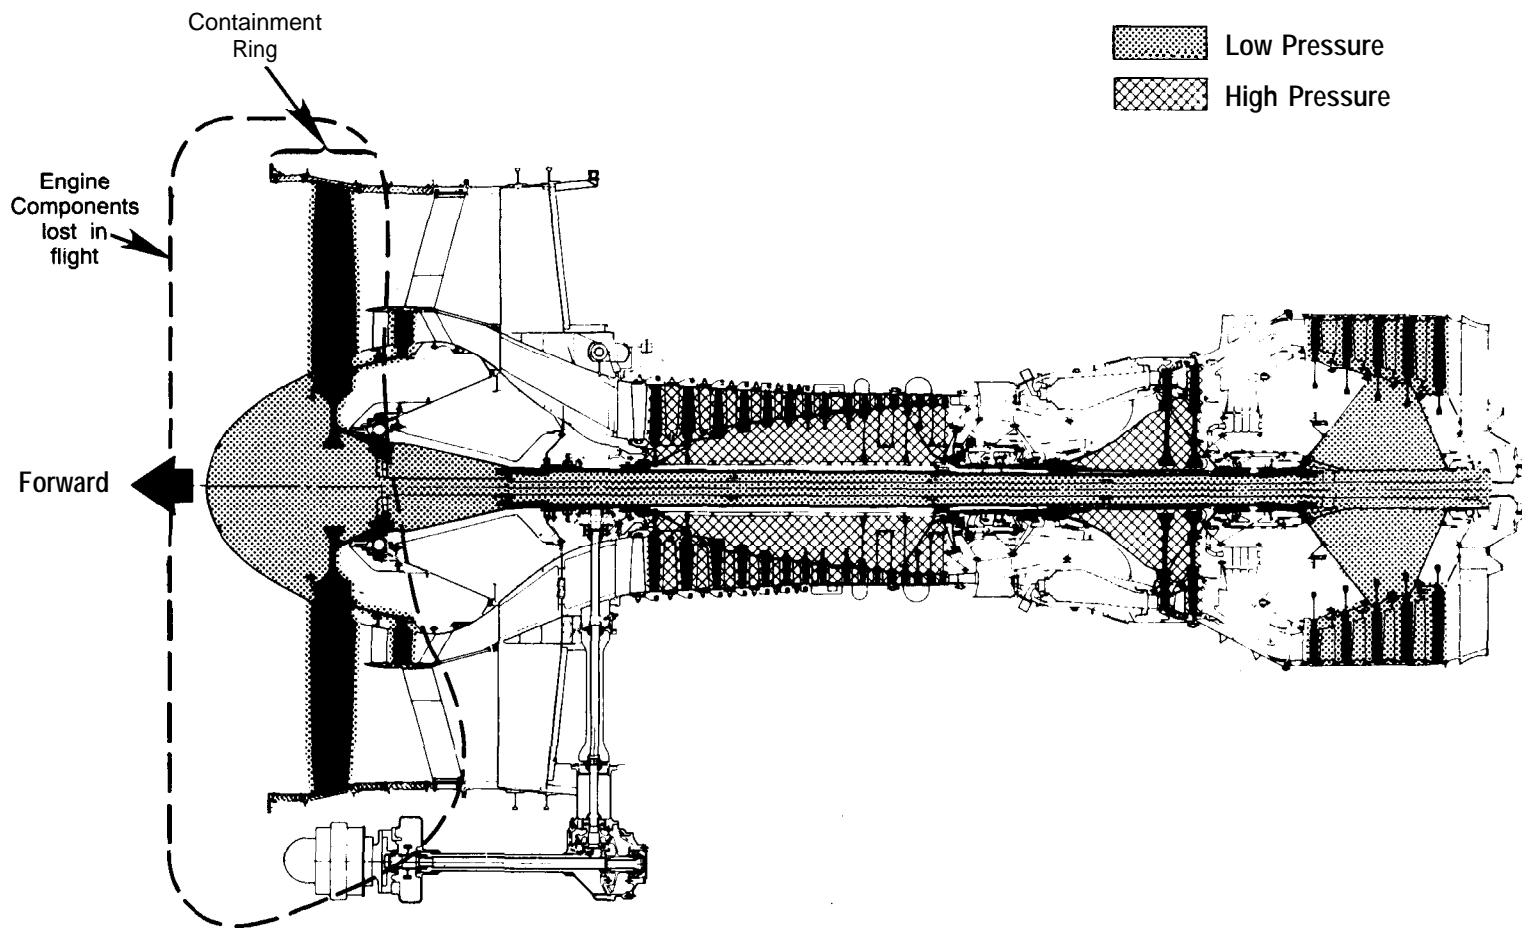
Figure 8. --CF6-6 rotating assemblies.

Figure 7 contains a cutaway sectional drawing of the flow path and construction of the CF6-6 engine. The figure also shows the fan and accessory drive sections. Figure 8 displays the CF6-6 rotating assemblies. The portion of the No. 2 engine that departed the airplane is outlined by the dashed lines.

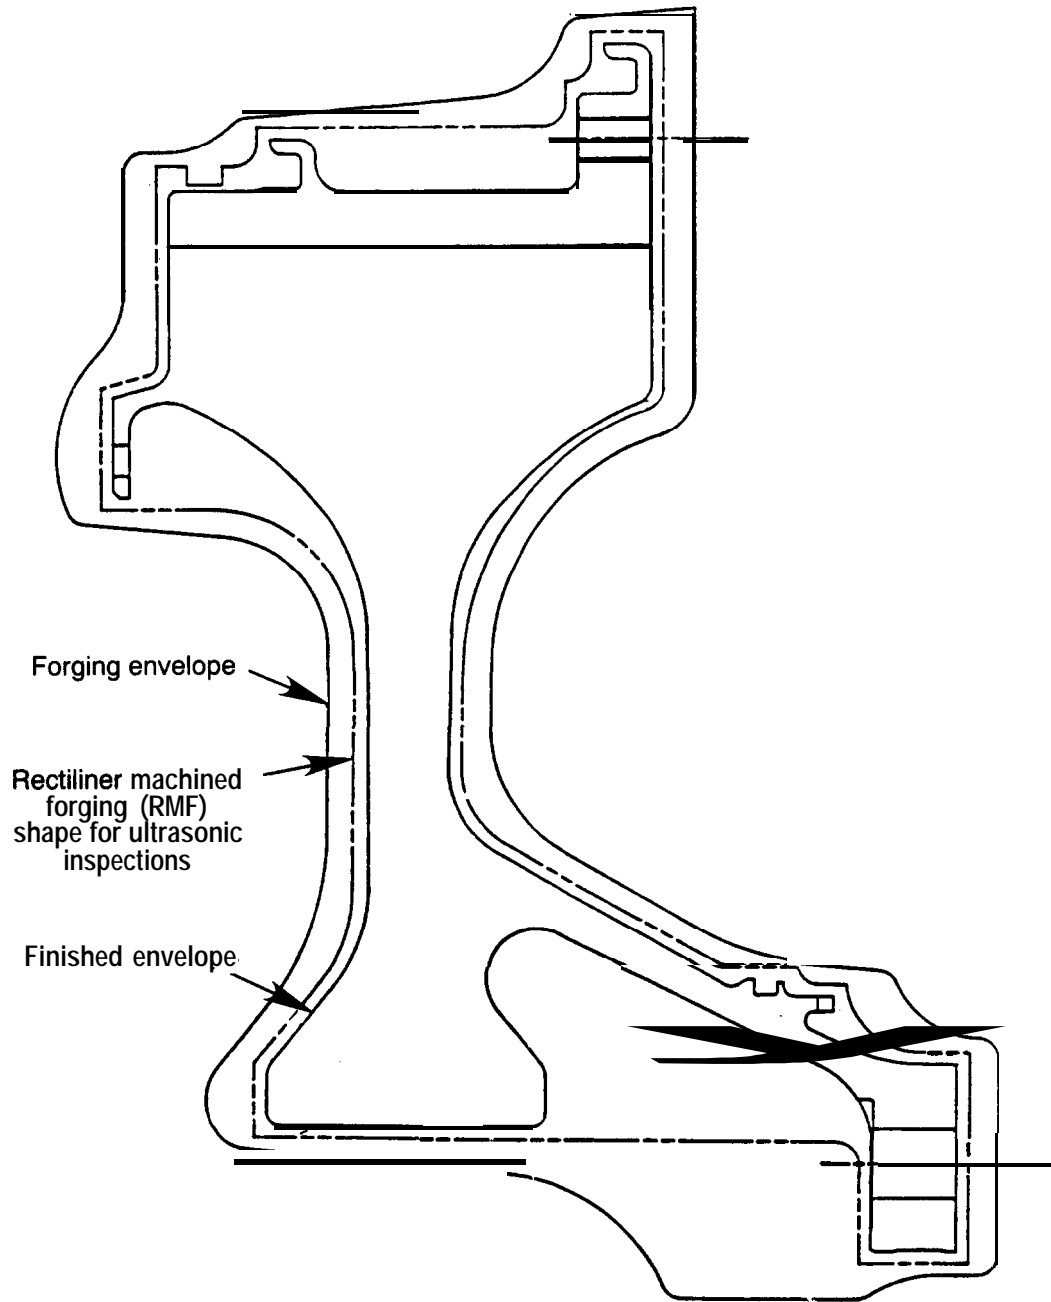
*Figure 20. --CF6-6 stage 1 fan disk envelopes at various stages of manufacture.*

During the records search for the manufacturing routing package of stage 1 fan disk S/N MPO 00385, it was learned that two rough machined forgings<sup>9</sup> (referred to as disk "A" and "B") having this same serial number had been routed through GEAE manufacturing. Actual receiving documentation at GEAE could not be located. Figure 20 depicts the three shapes of the disk during the manufacturing process.
