PB91-910409
NTSB/AAR-91/08

**NATIONAL
TRANSPORTATION
SAFETY
BOARD**

AIRCRAFT ACCIDENT REPORT

**RUNWAY COLLISION
OF USAIR FLIGHT 1493, BOEING 737
AND SKYWEST FLIGHT 5569 FAIRCHILD METROLINER
LOS ANGELES INTERNATIONAL AIRPORT
LOS ANGELES, CALIFORNIA
FEBRUARY 1, 1991**

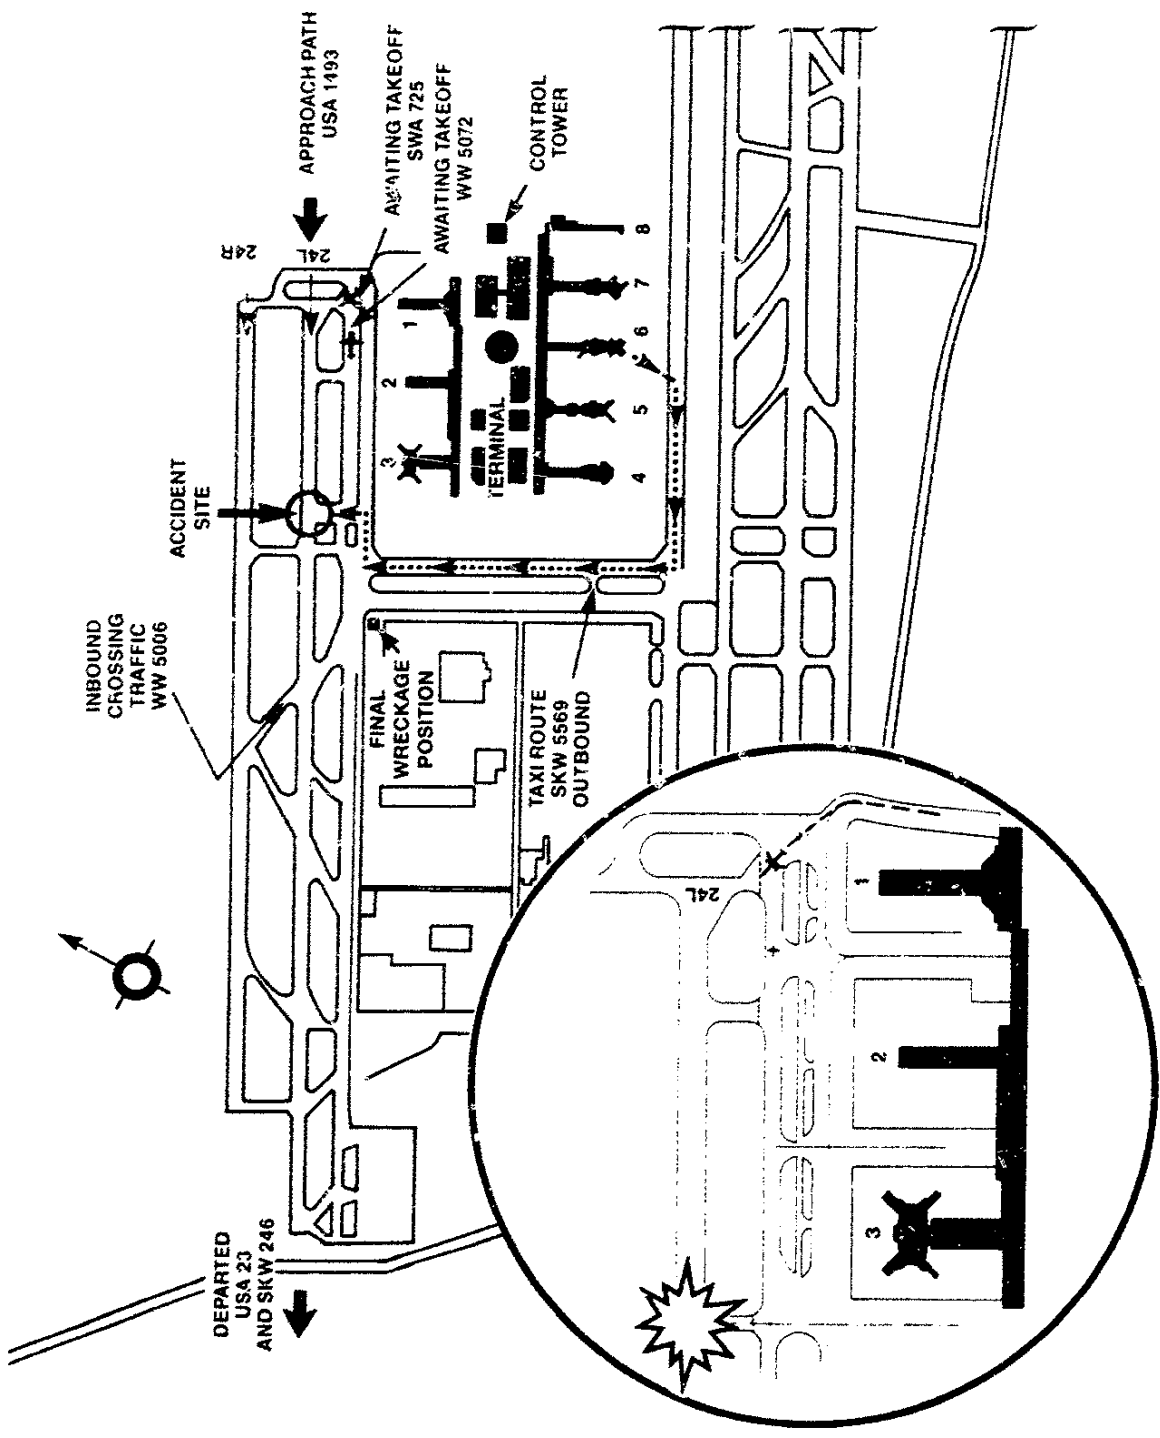
Figure 3.--Airport layout with traffic movements.

About 5 minutes earlier, around 1758, SKW5569 had begun to taxi via the north route from Terminal 6, Gate 32 to runway 24 left for departure (See figure 3). At 1801:43, SKW5569 advised the ATC tower's north ground controller (GC2) "...number two at [taxiway] Tango behind an Aero Mexico airplane." At 1801:49, the GC2 advised SKW5569, "...roger, hold short Tango for right now, Aero Mexico will be moving in just a minute."

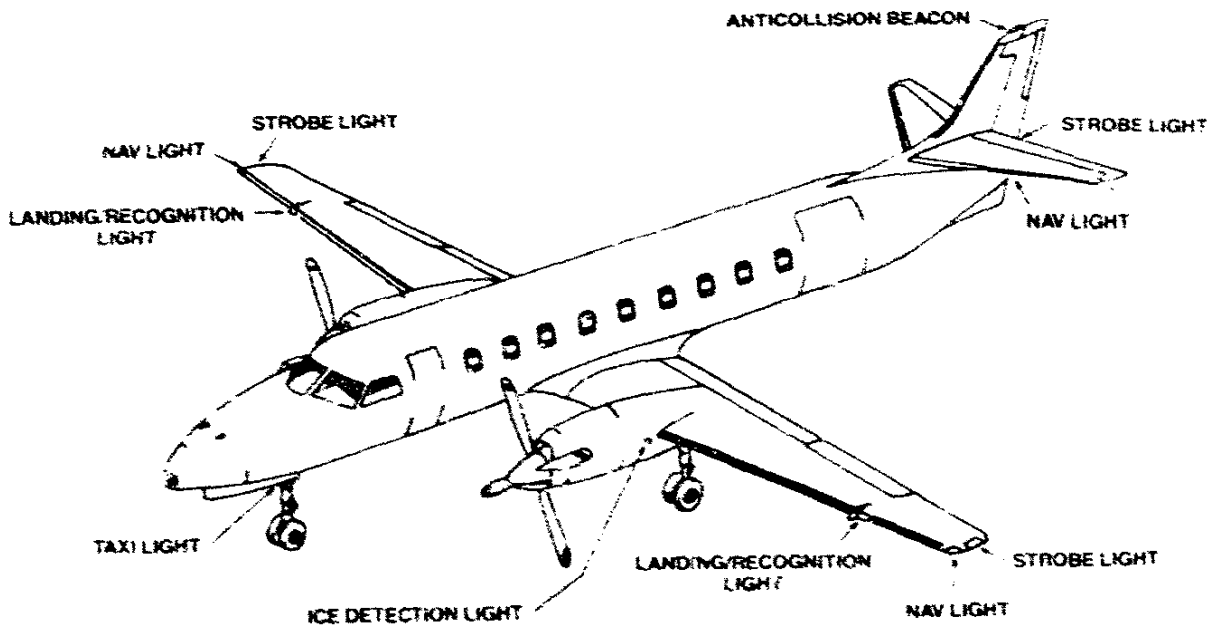
Figure 4.--Metroliner external lighting.

External lighting on N683AV consisted of navigation lights, landing/recognition lights, a taxi light, ice detection lights, strobe lights, and a red anticollision beacon (See figure 4). The beacon light assembly is located on top of the vertical stabilizer forward and below the rudder cap and rudder trailing edge (See figure 5). The location of the beacon light relative to the rudder cap results in some light obstruction; 14 CFR Part 23 permits such obstruction. The rudder cap blocks visibility of the light to an angle of 5.4 degrees above the horizontal and 2.6 degrees left and right of the centerline directly to the rear of the airplane. The beacon light luminance for certification was a candle power of 100 candles; actual luminance was 110 candles.
