## AIRCRAFT ACCIDENT REPORT

Uncontrolled Descent and Collision With Terrain  
United Airlines Flight 585  
Boeing 737-200, N999UA  
4 Miles South of Colorado Springs  
Municipal Airport  
Colorado Springs, Colorado  
March 3, 1991

**NTSB/AAR-01/01  
PB2001-910401  
Notation 5498C  
Adopted March 27, 2001**

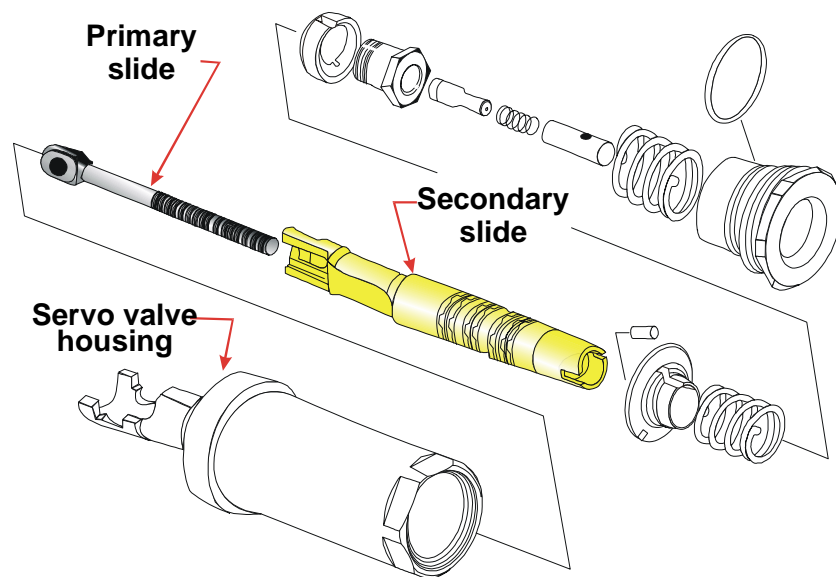
**Figure 7.** Boeing 737 main rudder PCU servo valve.

The 737 main PCU servo valve was designed by Boeing and is manufactured to Boeing specifications by Parker Hannifin Corporation. It is a dual-concentric tandem valve composed of a primary slide that moves within a secondary slide that, in turn, moves within the servo valve housing. The primary and secondary concentric slides are moved by primary and secondary internal summing levers, which translate inputs from the yaw damper<sup>15</sup> and/or the external input crank (which moves when a pilot steps on the rudder pedals) into axial movement of the slides. Figure 7 shows an expanded view of the servo valve.

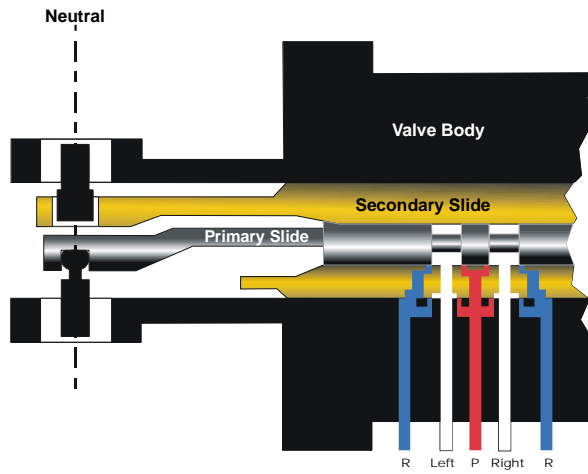
**Figure 12.** Normal operation of the 737 PCU servo valve with slides in the neutral position (no jam).

**Primary and Secondary Slides at Neutral**  
Rudder Rate = 0

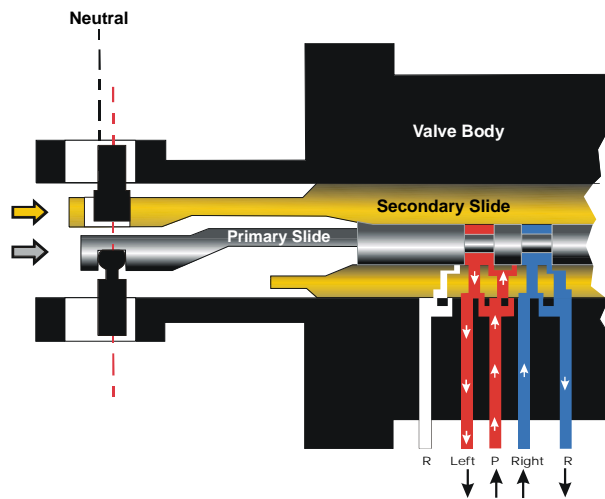
**Figure 13.** Normal operation of the 737 PCU servo valve with slides in the extend command position (no jam).

**Normal Full Rate Command-  
Primary & Secondary Slides Full Open**  
Rudder Rate TEL

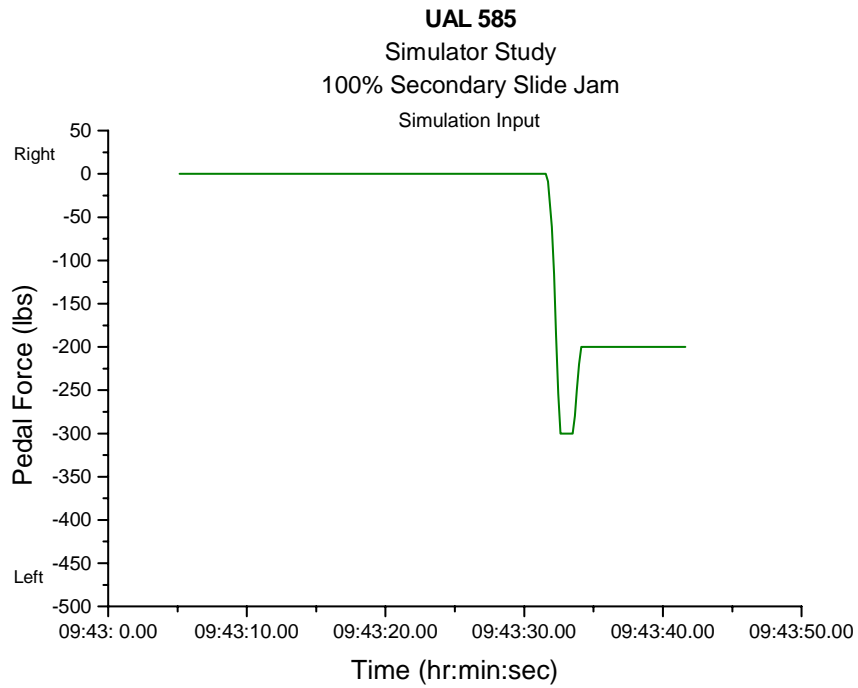
**Figure 16.** Pilot rudder pedal force positions for United flight 585.

<sup>72</sup> The Safety Board's best-match simulation used 300 pounds of force reducing to 200 pounds, based on ergonomic and other research data (see section 1.18.3). The Safety Board was also able to match the United flight 585 FDR data using only the minimum pedal force necessary to sustain full rudder authority (about 70 pounds).

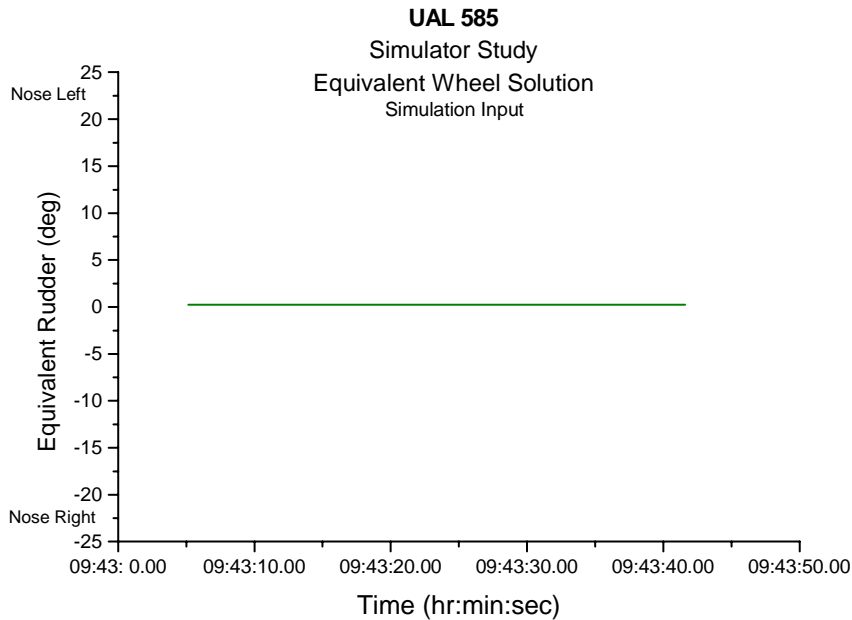
**Figure 17.** Rudder surface positions for United flight 585 assuming a sustained equivalent control wheel input.

One of the Safety Board simulation scenarios that produced a good match with the FDR data and other physical evidence assumed a sustained equivalent control wheel input

to the right with no rudder input. The equivalent control wheel input could represent a pilot command, a rotational wind, or a combination of the two. Figures 17 through 17f show the resultant data for rudder surface and control wheel positions and heading, normal load factor, calibrated airspeed, pitch angle, and bank angle data, respectively. Figures 17e and 17f also show CVR data.

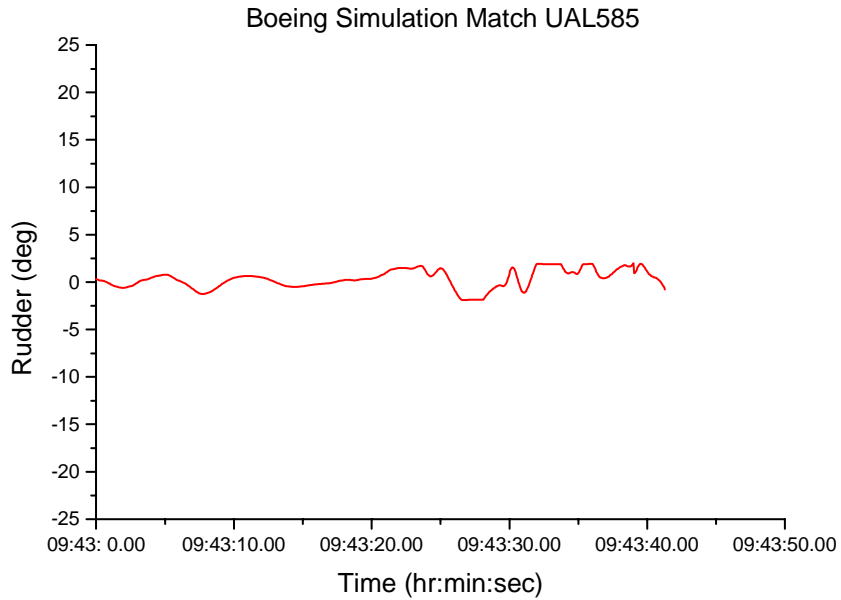
**Figure 18.** United flight 585 rudder surface positions according to Boeing’s new rotor model.

In a June 23, 1997, letter to the Safety Board, Boeing provided its analysis of the United flight 585 accident.<sup>73</sup> Boeing’s analysis concluded that a rudder hardover scenario did not fit the FDR data and that a “new rotor model” did match the data.<sup>74</sup> Further, Boeing derived this new rotor model to match the available data and introduced a rotational effect of near zero just before 0943:28, which increased linearly to about 0.4 radians per second just before 0943:29 and then increased linearly to about 1.8 radians per second about the time the airplane impacted the ground (just before 0943:42).

Boeing’s simulation using the new rotor model produced the data shown in figures 18 through 18f for rudder surface positions, windshear, control wheel positions, heading, bank angle, normal load factor, and pitch angle, respectively. As shown in figure 18b, Boeing’s simulation assumed a left control wheel input by the flight crew just after 0943:30.

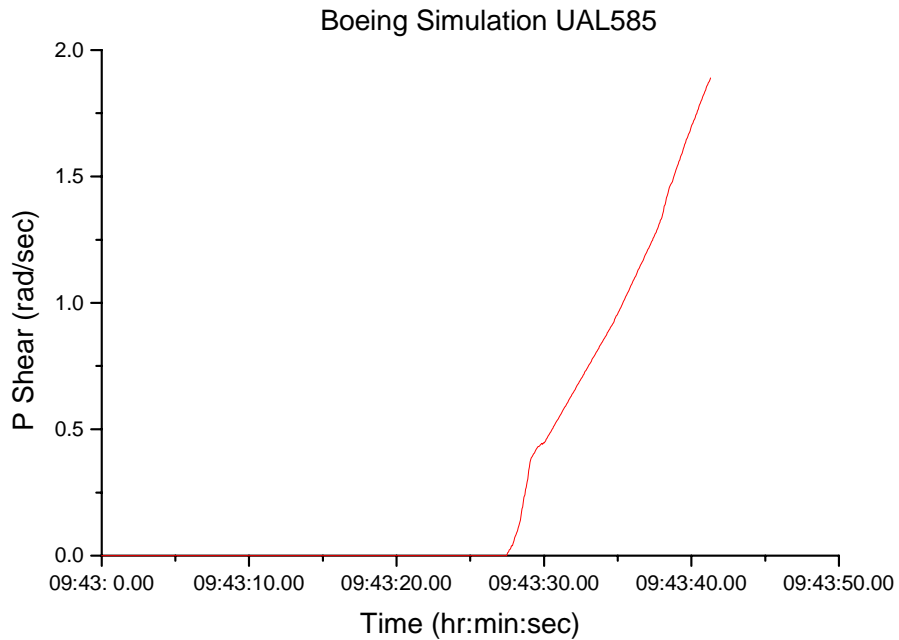
**Figure 18a.** Rotational windshear encountered by United flight 585 according to Boeing’s new rotor model.

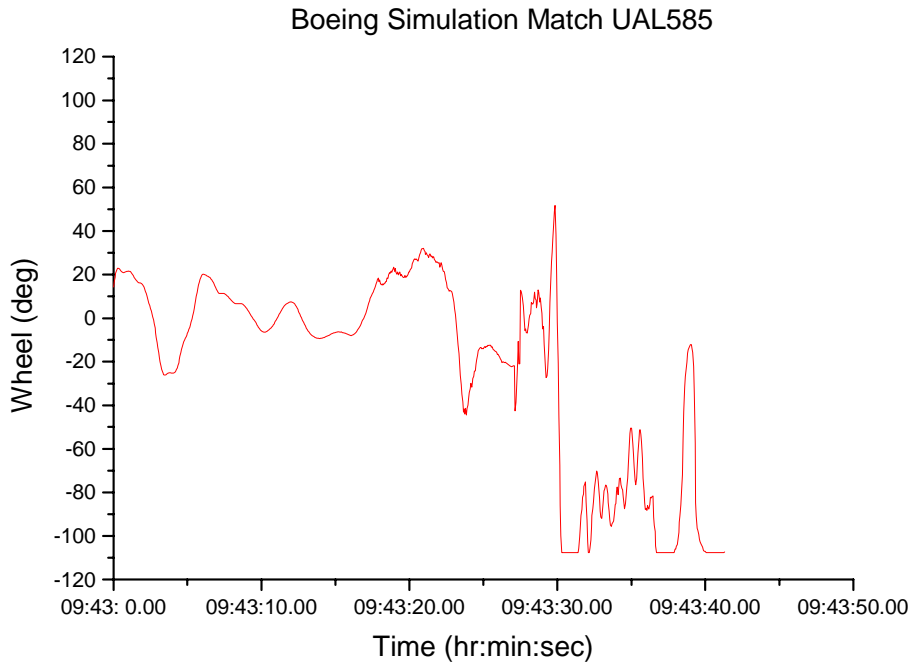
**Figure 18b.** United flight 585 control wheel positions according to Boeing's new rotor model.

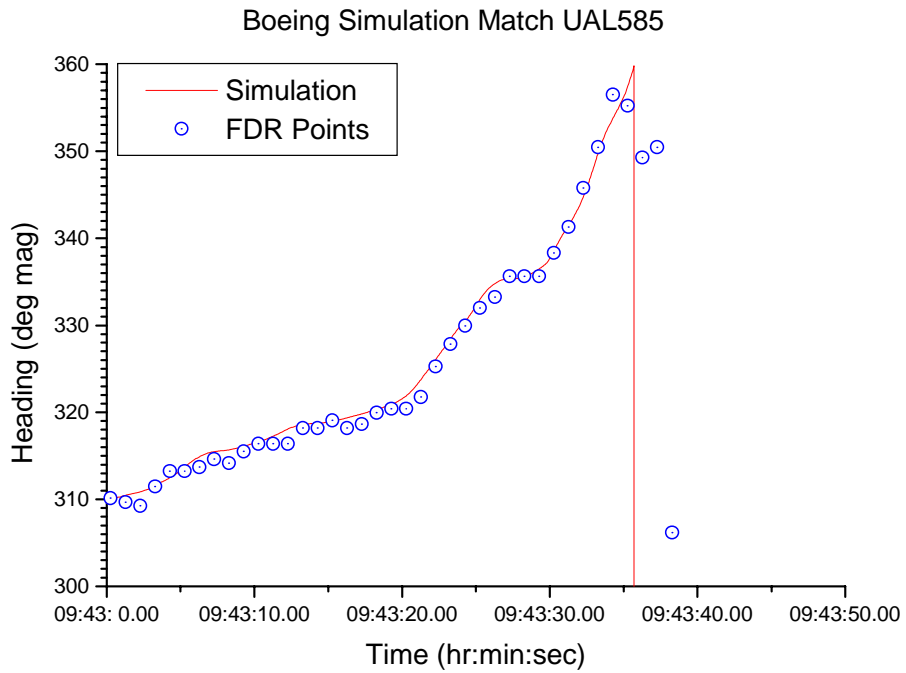
**Figure 18c.** United flight 585 heading data according to Boeing's new rotor model.

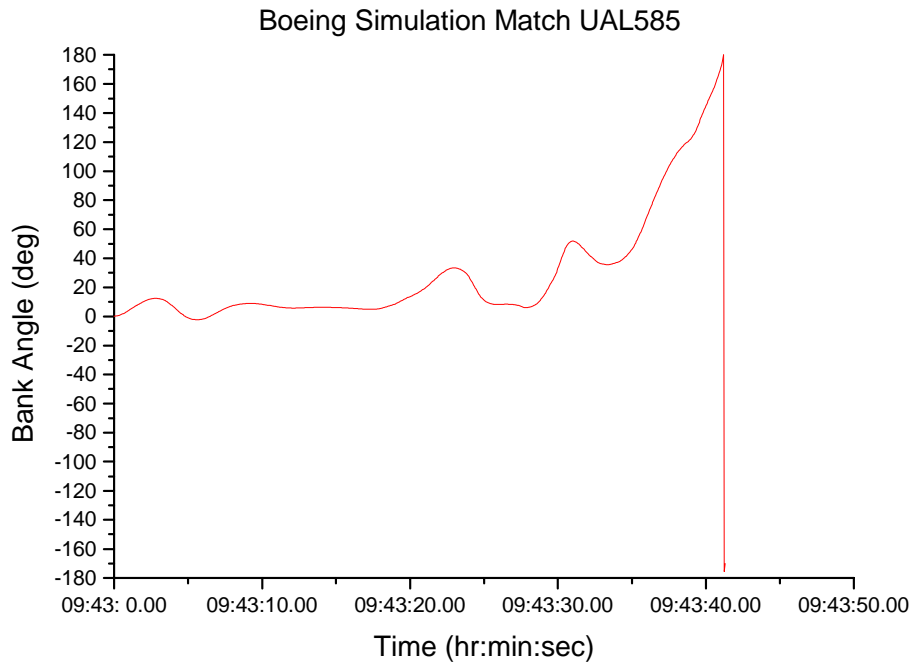
Figure 18d. United flight 585 bank angle data according to Boeing’s new rotor model.

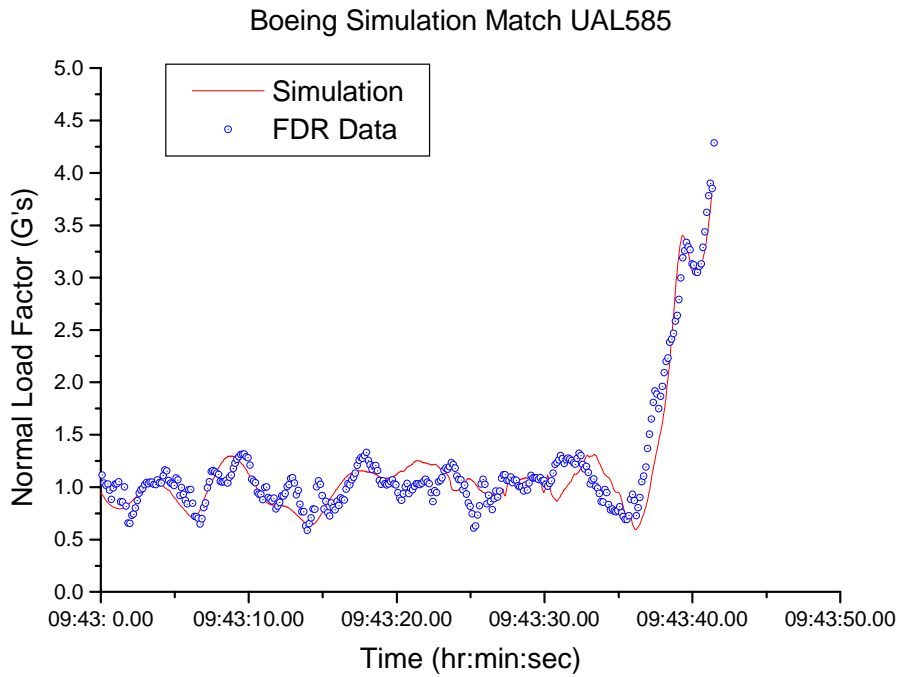
Figure 18e. United flight 585 normal load factor data according to Boeing’s new rotor model.

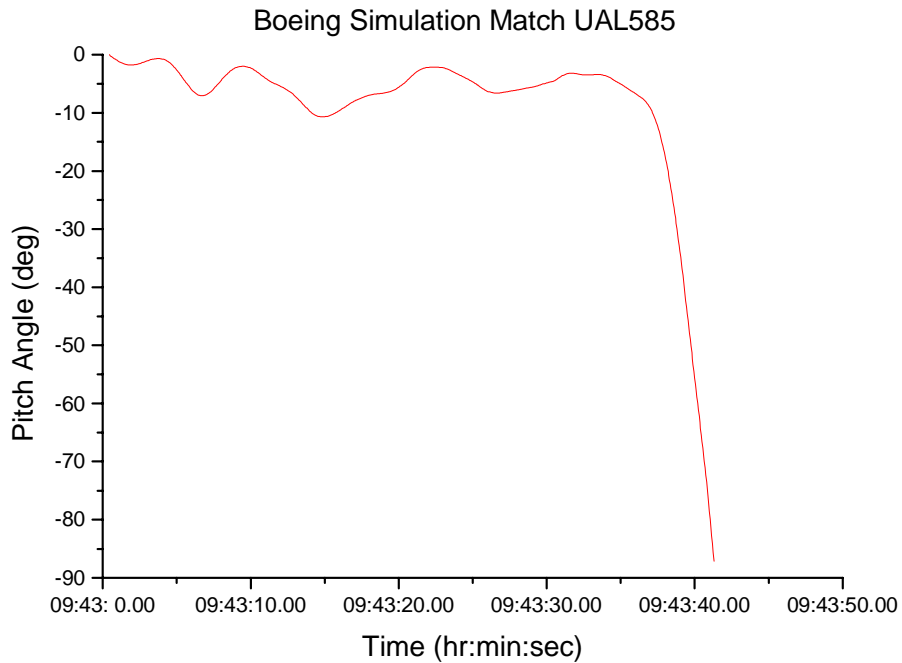
**Figure 18f.** United flight 585 pitch angle according to Boeing's new rotor model.

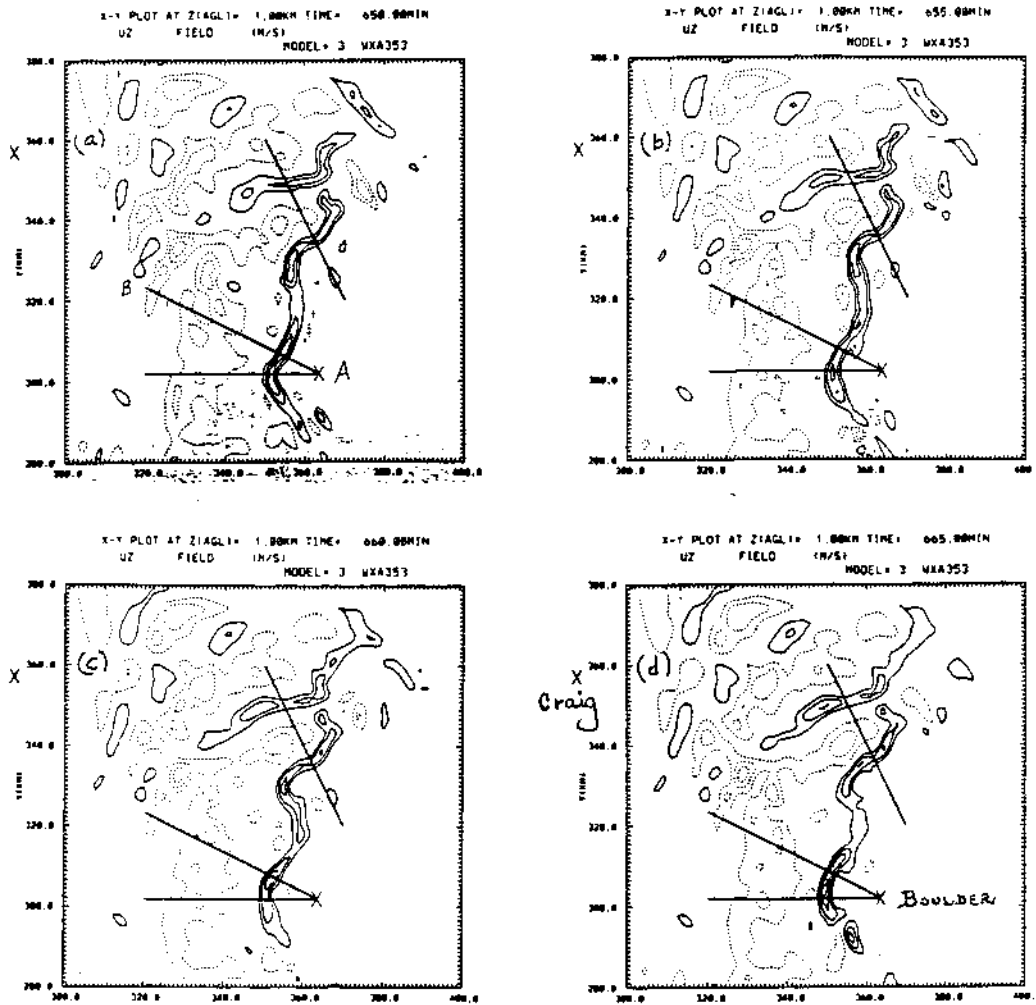
What the simulations show is a strong concentrated region of upward motion (or jump) with upward velocities exceeding 40 m/sec snaking up and down the Front Range, basically along the foothills of the Rockies in the Boulder region. Fig. 2 shows vertical velocity,  $w$ , at four different times spaced 5 minutes apart at 1 km above ground level (AGL). These plots are from the high resolution Boulder area subdomain (Fig. 1a). The jump surges to and from the plains at times which can be seen in the temporal and spatial variability of  $w$  in Fig. 2.

Fig. 2 Horizontal cross sections of  $w$  at 1 km Above Ground Level (AGL) over the Boulder region high-resolution domain. Four times are shown and are indicated on plots. The contour interval for  $w$  is 5 m/s where positive values are shown with solid and negative values with dashed contours. The crosses mark Boulder and Craig in these plots.

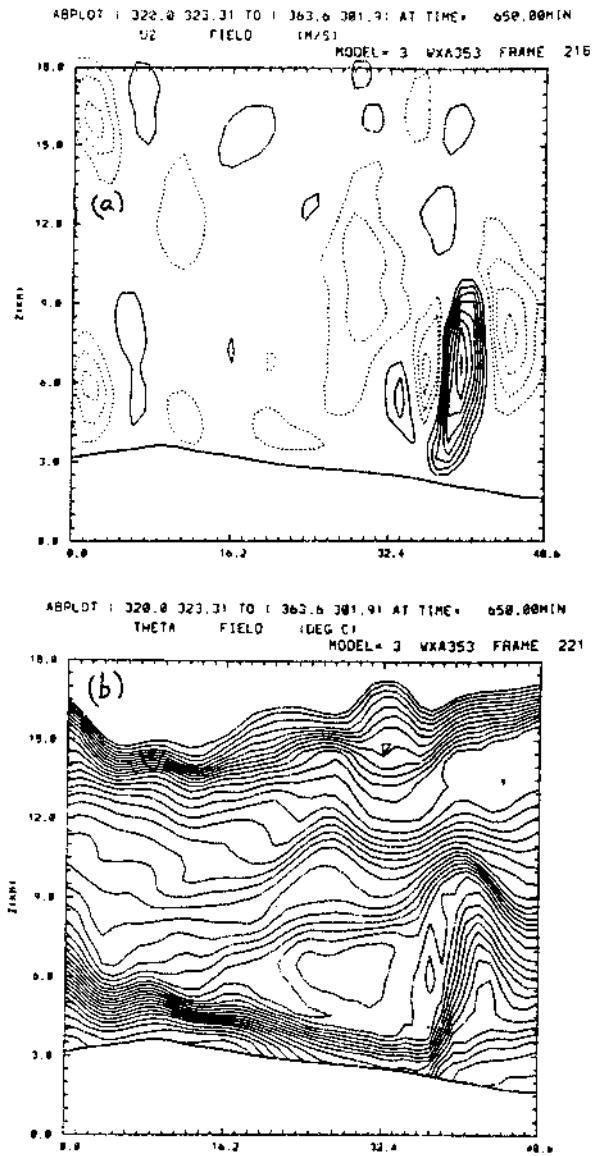
Fig. 3 shows vertical cross sections of  $w$  and  $\theta$  (potential temperature) for the solid line marked A-B in Fig. 2. Note how the width of this updraft is about  $4 \Delta x$  wide which means it is resolution limited. The plot of  $\theta$  along A-B gives a good approximation of the air motion. Since  $\theta$  is approximately conserved, the contours of  $\theta$  represent trajectories of the air. The rebounding nature of the flow can be seen in this figure.

Fig. 3 Vertical cross sections of  $w$  and  $\theta$  along line A-B shown in Fig. 2. The contour interval for  $w$  is 5 m/s and for  $\theta$  is 3 degrees Kelvin. Both plots are for  $t=050$  minutes.

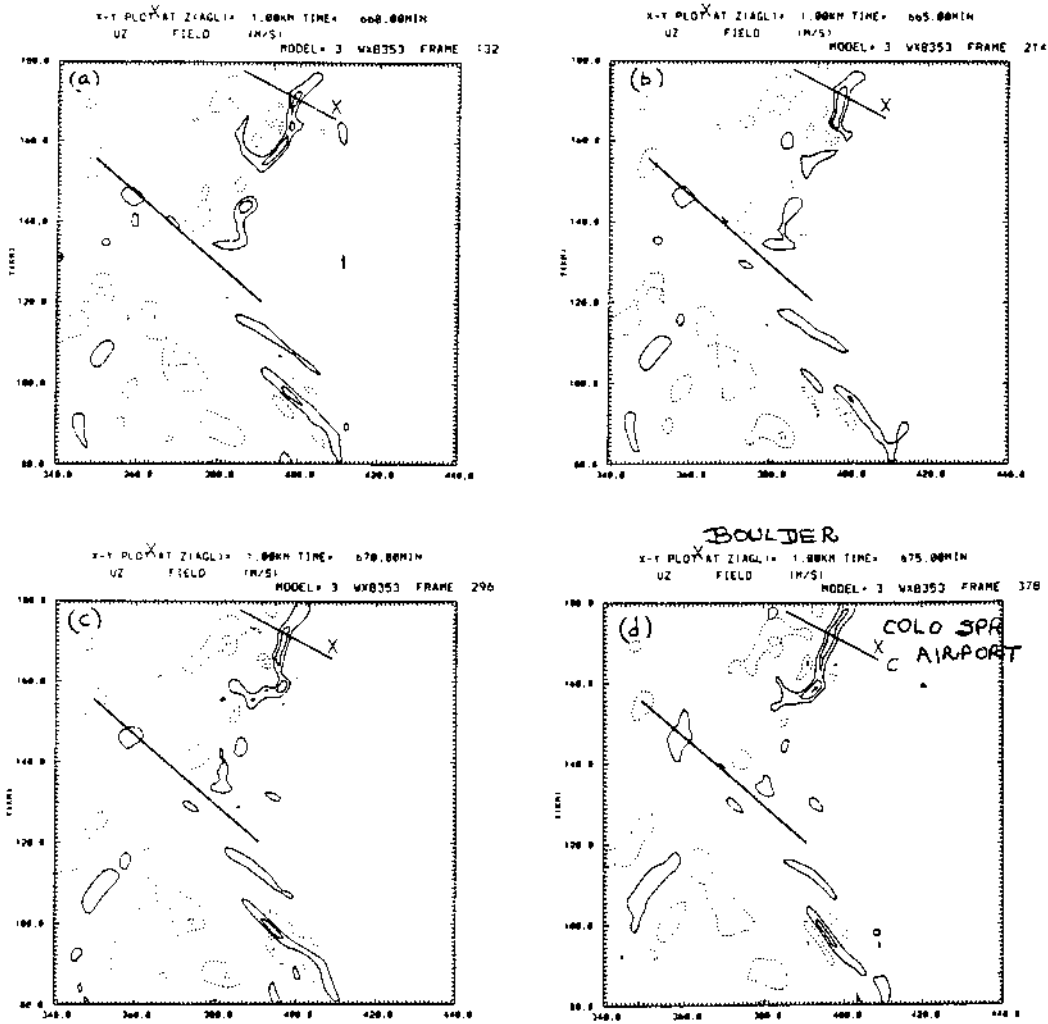
In the Colorado Springs area the jumps exhibit much more variability than along the Boulder region front range. As noted earlier the orography is highly structured in the Colorado Springs area and dominated by the presence of Pikes Peak and the Palmer divide. Fig. 4 shows  $w$  at 1 km AGL for the Colorado Springs subdomain (Fig. 1b) for four times spaced 5 minutes apart. The updraft associated

Fig. 4 Horizontal cross sections of  $w$  at 1 km Above Ground Level (AGL) over the Colorado Springs region high-resolution domain. Four times are shown and are indicated on plots. The contour interval for  $w$  is 5 m/s where positive values are shown with solid and negative values with dashed contours. The crosses mark Boulder (outside the domain) and Colorado Springs airport in these plots.

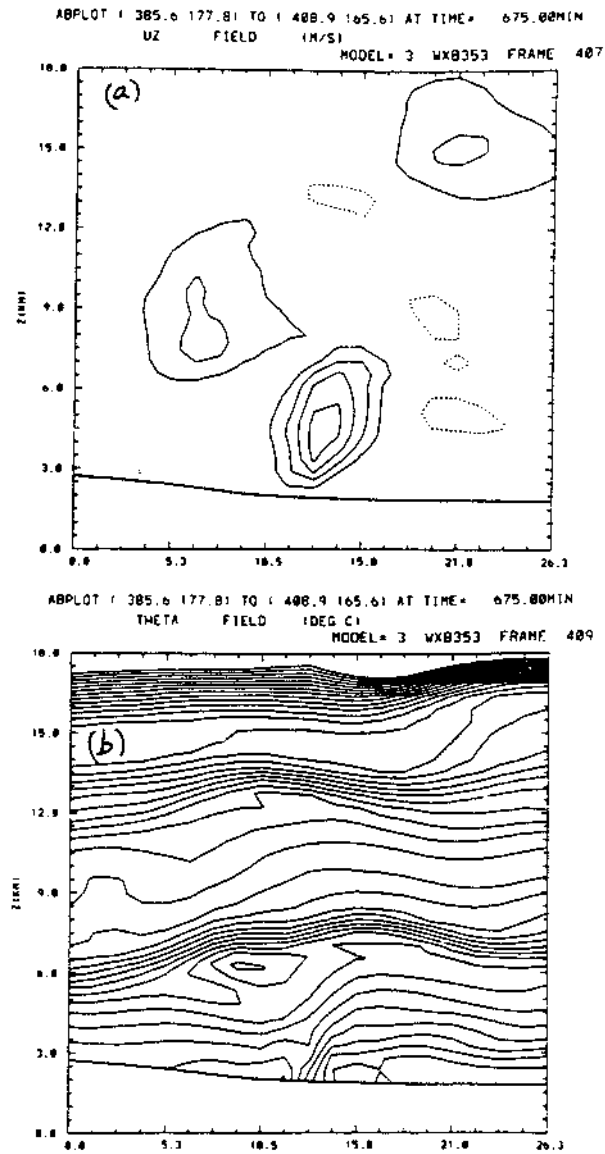
with the flow coming off the valley between Pikes Peak and the Palmer divide shows a fair amount of time variability in this figure. Fig. 5 shows vertical cross sections of  $w$  and  $\theta$  for the heavy line marked C-D in Fig. 4. Once again we see that the width of the updraft (20 m/s amplitude in this case) is four grid points wide indicating poor model resolution. The  $\theta$  field again shows a jump like nature to the air trajectories but not as clearly as in Fig. 3. We conclude from these results that the horizontal shears associated with these jumps are resolution-limited (the shear is forced by the model to be spread out over about 4 km) and are therefore about 10 m/s per km. We fully expect that higher resolution simulations would show much larger shear values since, when a model selects the narrowest scales it can resolve for its largest gradients, we usually find the gradients are even larger when we are able to use still higher resolutions.

Fig. 5 Vertical cross sections of  $w$  and  $\theta$  along line C-D shown in Fig. 4. The contour interval for  $w$  is 5 m/s and for  $\theta$  is 3 degrees Kelvin. Both plots are for  $t=675$  minutes.
