# NATIONAL TRANSPORTATION SAFETY BOARD

TAKEOFF STALL IN ICING CONDITIONS  
USAIR FLIGHT 405  
FOKKER F-28, N485US  
LAGUARDIA AIRPORT  
FLUSHING, NEW YORK  
MARCH 22, 1992

**Adopted: February 17, 1993  
Notation 5732A**

**(NTSB/AAR-93/02 PB93-910402)**

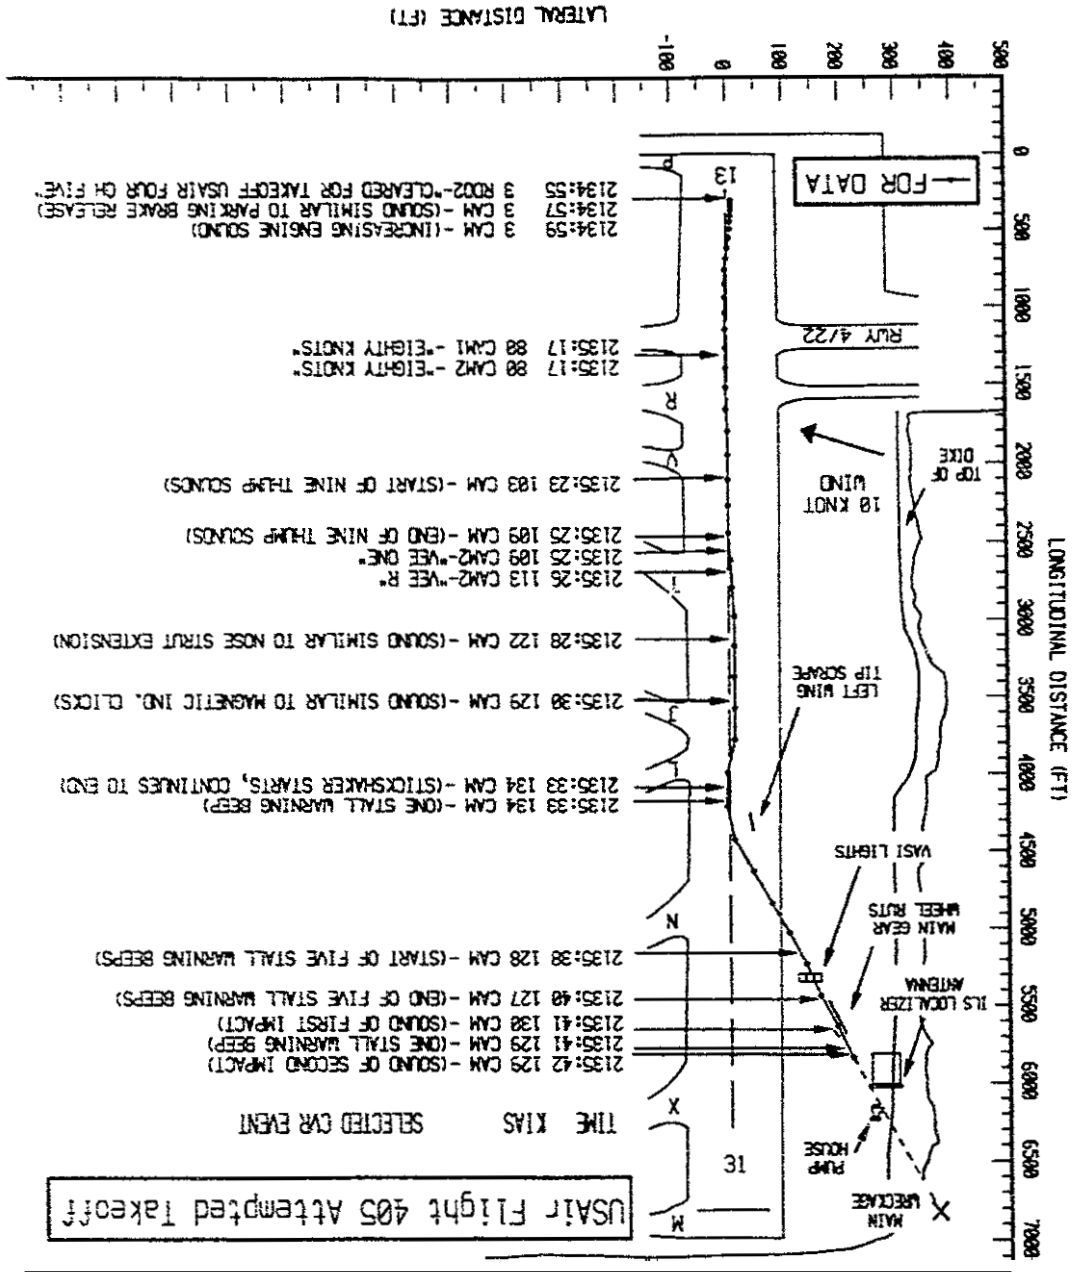
Figure 1.--Ground track and selected CVR sounds.

**The ground track** of the airplane was determined **using FDR data on** indicated air speed, magnetic heading, and time. **The altitudes that the airplane** reached were assumed **to be negligible in these** calculations. Microphone **keying** information was used to establish a time correlation between the **CVR and FDR** recordings. Normal acceleration **data** from the **FDR** are shown in **Figure 3**. **Altitude data**, recorded in 30-foot increments, are **shown in Figure 4**. The **ground track** and selected CVR sounds are shown in **Figure 1**.
