NATIONAL TRANSPORTATION SAFETY BOARD

AIRCRAFT ACCIDENT REPORT

**ABORTED TAKEOFF SHORTLY AFTER LIFTOFF
TRANS WORLD AIRLINES FLIGHT 843
LOCKHEED E-1011, N11002
JOHN F. KENNEDY INTERNATIONAL AIRPORT
JAMAICA, NEW YORK
JULY 30, 1992**

**Adopted: March 31, 1993
Notation 5868B**

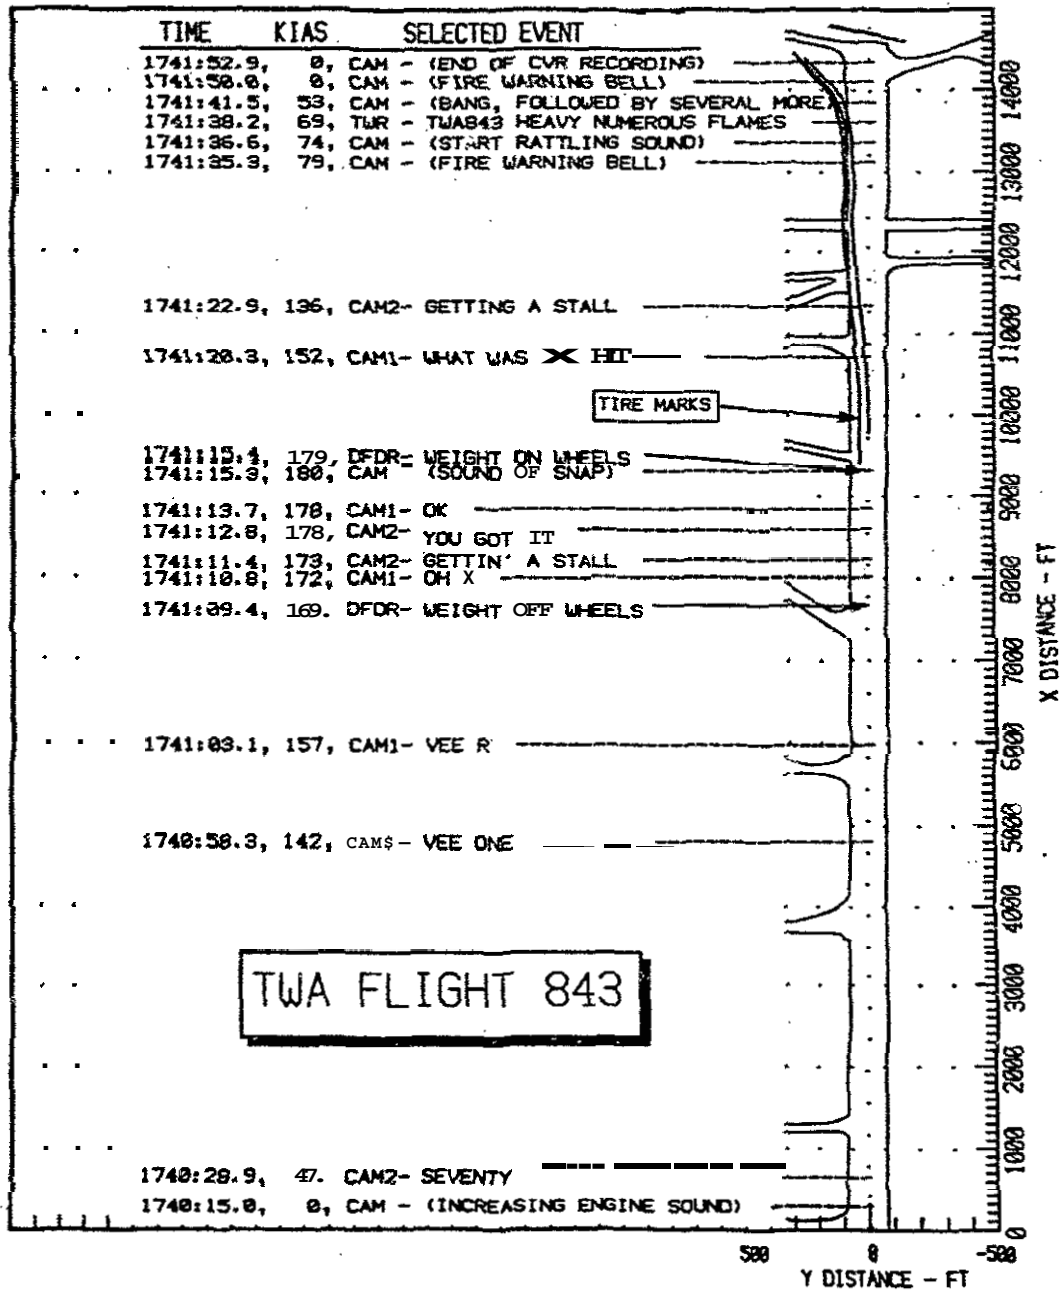
Figure 2.--Selected CVR and FDR data.

As recorded on the cockpit voice recorder (CVR), at 1740:58, the captain called out "V₁." (See appendix D). At 1741:03, he called "V_R." At 1741:11, the first officer said, "Gettin' a stall," and 1.4 seconds later he said; "You got it." The captain said "O.K." at 1741:13. At 1741:15, there was a sound of a snap, followed by the captain saying, "Oh Jes--." The first officer then said, "Abort, get it on." The flight engineer said, "Get it off." The first officer again said, "Get it off." The flight engineer again said, "Get it off." At 1741:20, the captain said, "What was the matter?" The first officer said, "Getting a stall." At 1741:32, the first officer said, "Stay with it." Then he said, "Stay on the brakes, stay on the brakes." At 1741:38, the JFK tower broadcast, "TWA eight forty three heavy, numerous flames." As recorded on the flight data recorder (FDR), the airplane was airborne for about 6 seconds. Figure 2 depicts selected CVR and FDR derived times and events during the takeoff and landing back on the runway.

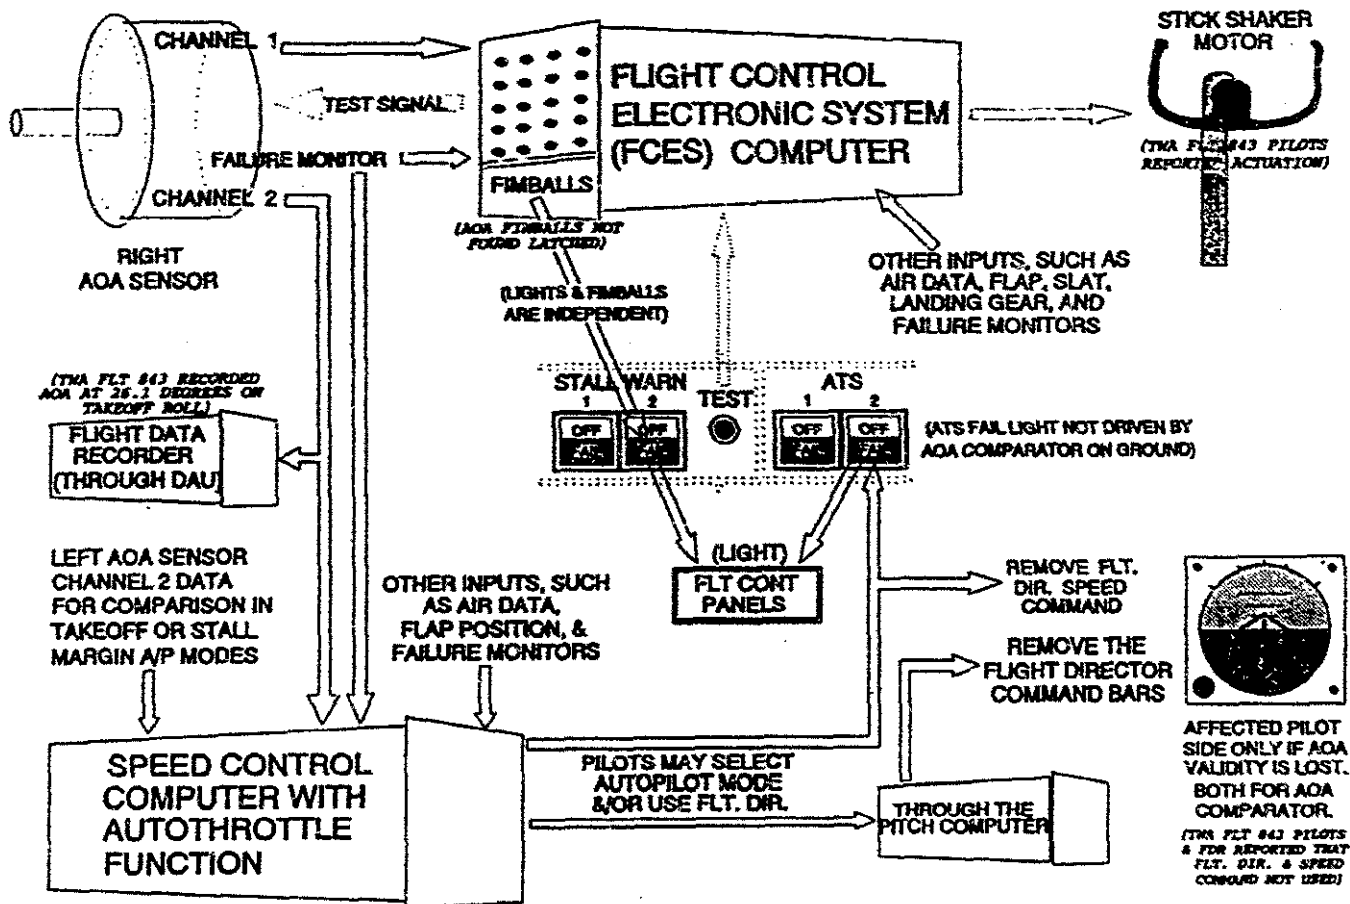
Figure 8.--Stall warning and ATS fail block diagram.

that persists for more than 10 seconds will cause a system fail indication. The illumination of the fail light would also cause an amber light, with the legend FLT CONT PANELS, to illuminate on the lower part of the pilot's center instrument panel. The purpose of this light is to direct the pilot's attention to the overhead panel to ascertain the source of the problem.³

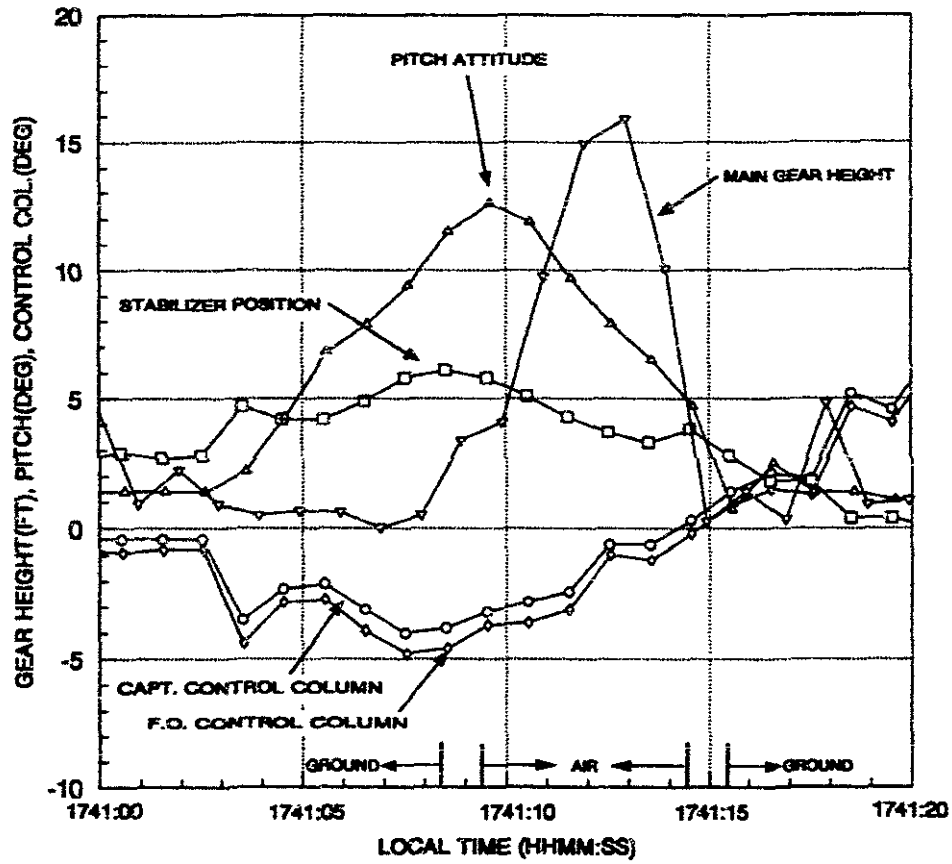
Figure 9.--Flight control inputs and airplane response.

Figure 9 depicts the flight control inputs and response of N11002 during the accident takeoff. The control column positions recorded for the captain and first officer agree within approximately 1 degree. The two control column curves track each other and appear normal. The stabilizer movement is consistent with changes in control column position, and the pitch attitude curve responds to changes in stabilizer position. The actual altitude of the main landing gear (derived from FDR radar altitude) indicates that the airplane climbed to a peak altitude of approximately 16 feet. Altitude values then begin to decrease, consistent with the decreasing pitch attitude of the airplane shortly after liftoff.

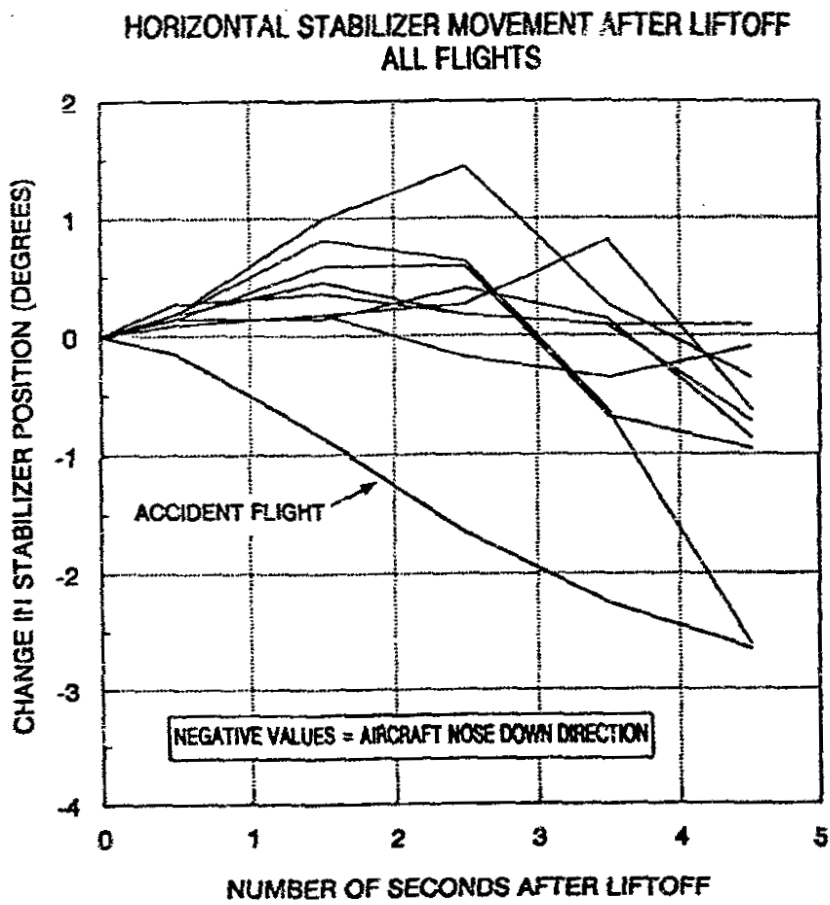
Figure 10.--Horizontal stabilizer movement after liftoff.

Figure 10 shows the horizontal stabilizer movement after liftoff for the accident and eight previous takeoffs. This figure shows the change in horizontal stabilizer position with respect to its position at liftoff.

During the first 3 seconds after liftoff, the previous takeoffs show a positive trend (airplane nose up, A.N.U.) of horizontal stabilizer movement during the initial climbout. Stabilizer positions for the accident flight reveal a negative (airplane nose down, A.N.D.) rotation of the horizontal stabilizer during the first 3 second time period.

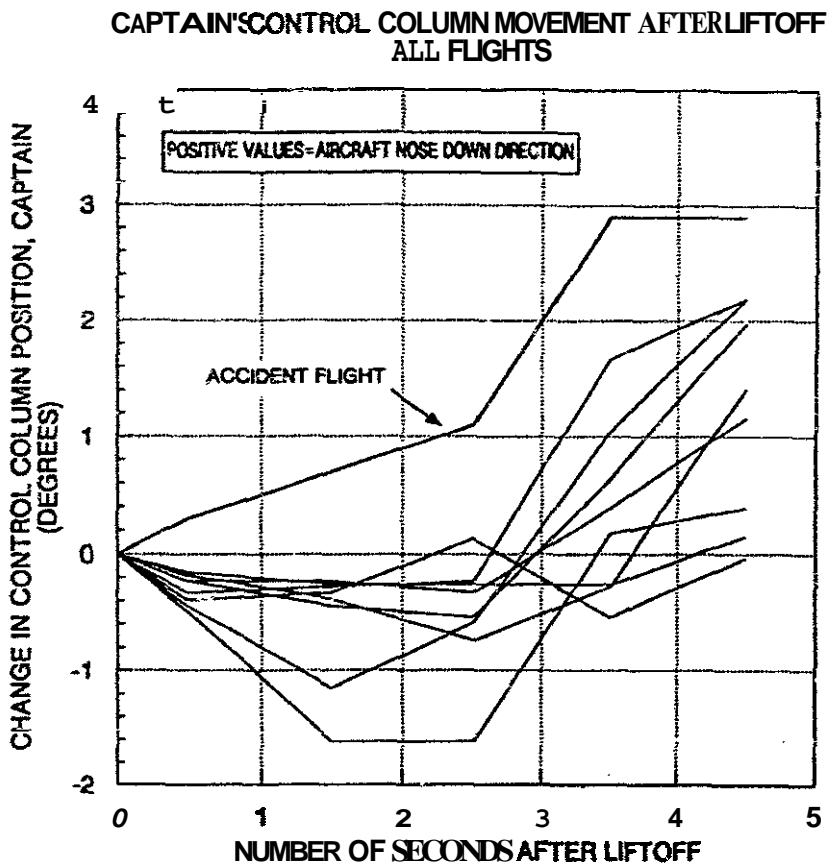
Figure 11.--Captain's control column movement after liftoff.

Figures 11 and 12 show the pilots' control column movements after liftoff. These plots show the change in control column position with respect to the control column position at liftoff. During the first 2 to 3 seconds after liftoff, the previous takeoffs show a negative, or *aft* control column trend (aft A.N.U.) during the initial climbout. The accident flight control column positions reveal a positive, or forward control column movement (forward A.N.D.) during the first 3 seconds.

The movements of the control columns and horizontal stabilizer after liftoff indicate that a forward movement of the control column occurred earlier on the accident flight than on the previous eight takeoffs. The control column on the accident flight moved forward immediately after liftoff, several seconds earlier than any previous takeoff recorded by the FDR. The forward control column movement occurred at an altitude of only 4 feet, which is inconsistent with FDR data from previous takeoffs. The FDR does not record the control forces used by the pilot; it records only column position. Figure 13 shows the overall flight performance data of the airplane.
