# RAAD VOOR DE LUCHTVAART

AIRCRAFT ACCIDENT REPORT  
93-01

PALAIR FLIGHT PMK301,  
FOKKER 100, PH-KXL,  
SKOPJE, REPUBLIC OF MACEDONIA  
MARCH 5, 1993

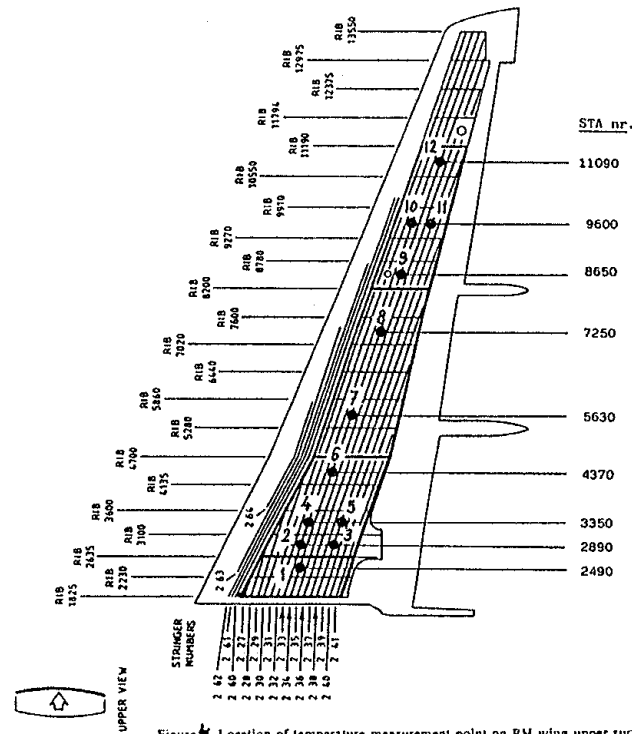
Figure 4. Location of temperature measurement point on RH wing upper surface.

The results of this test are shown in figure 2 and 3 (page 27) for the right wing and the left wing respectively. The numbered traces show the wing skin temperature change during and after refuelling for each of the probe positions shown in figure 4 (page 27). The Fokker 100 fuel temperature test report has been inserted in appendix 7.

Above table outlines the measurement location number for the LH - and RH wing at each wing station and stringer number (Str. - ).

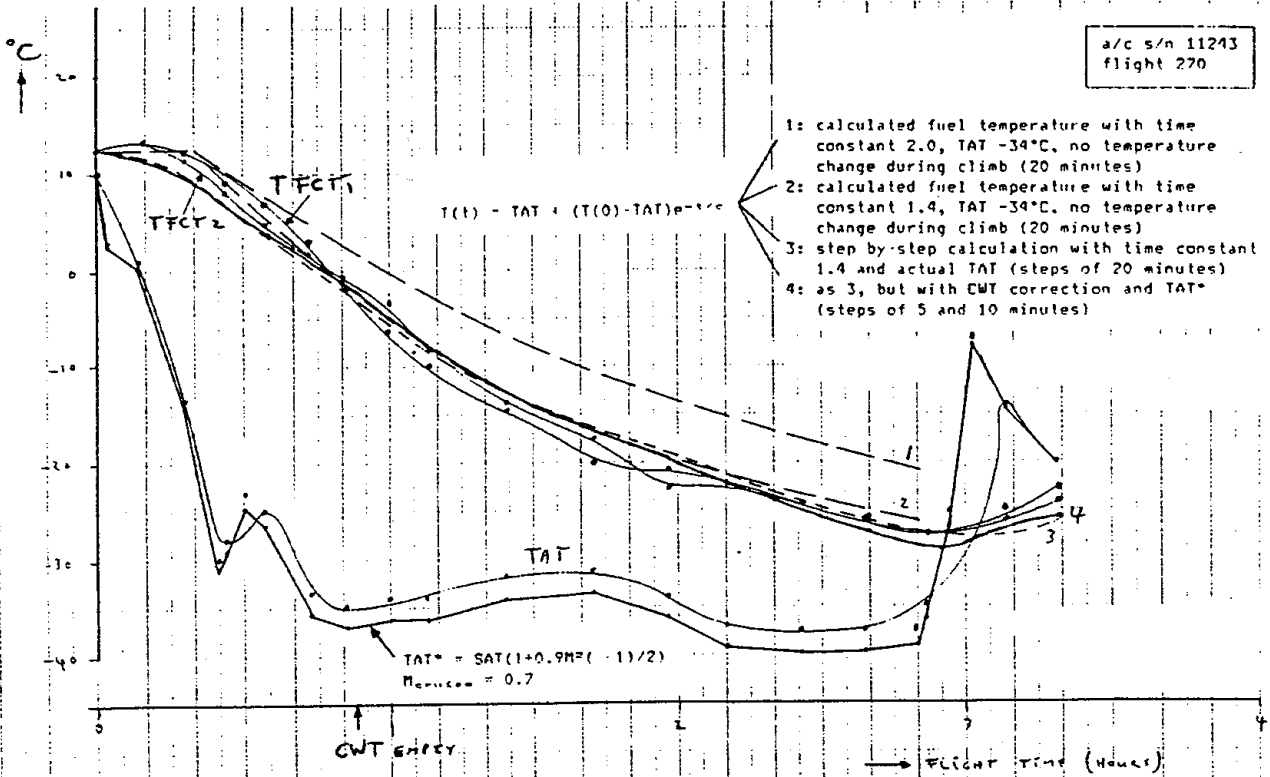
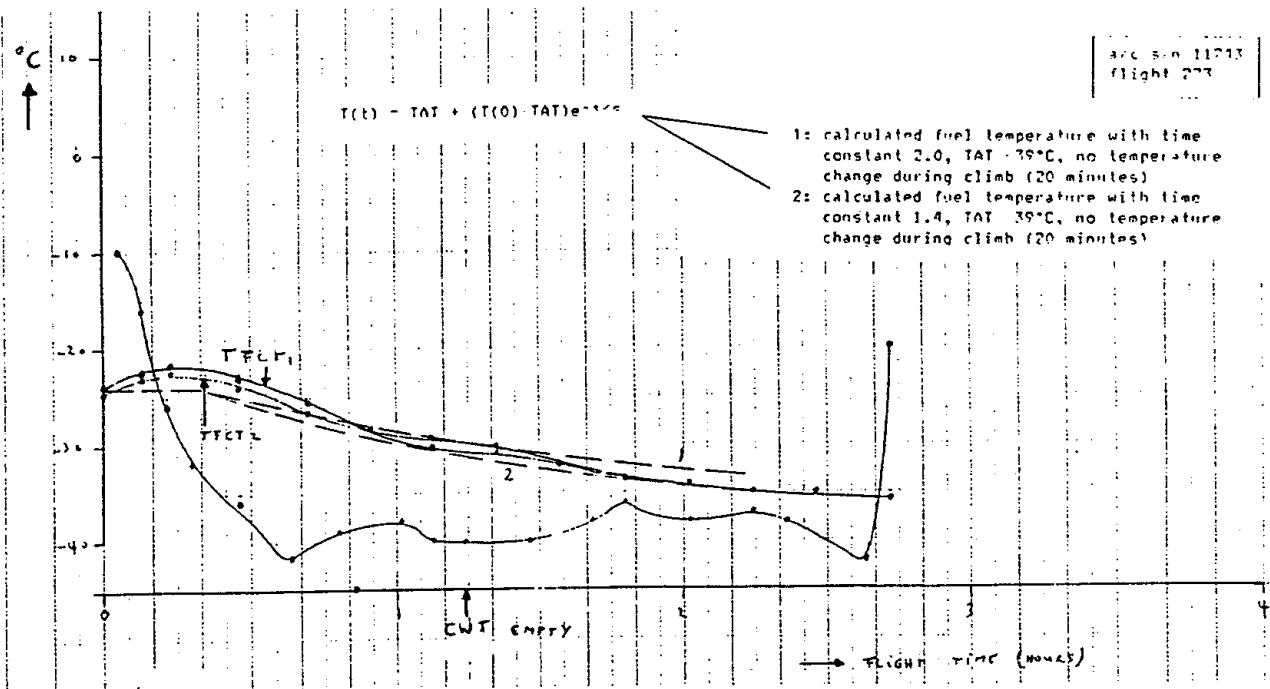
Figure 1 - Verification of empirical equation with Fokker 100 test data

It turns out that both refinements (using TAT\* in lieu of TAT and correction for the influence of the higher temperature in the center wing tank) tend to more or less cancel each other for flights up to about 2 hours, see figure 1 where these refinements have been applied to flight 270 of the Fokker 100 Q1 prototype. For longer flights the TAT\* effect will, of course, dominate.

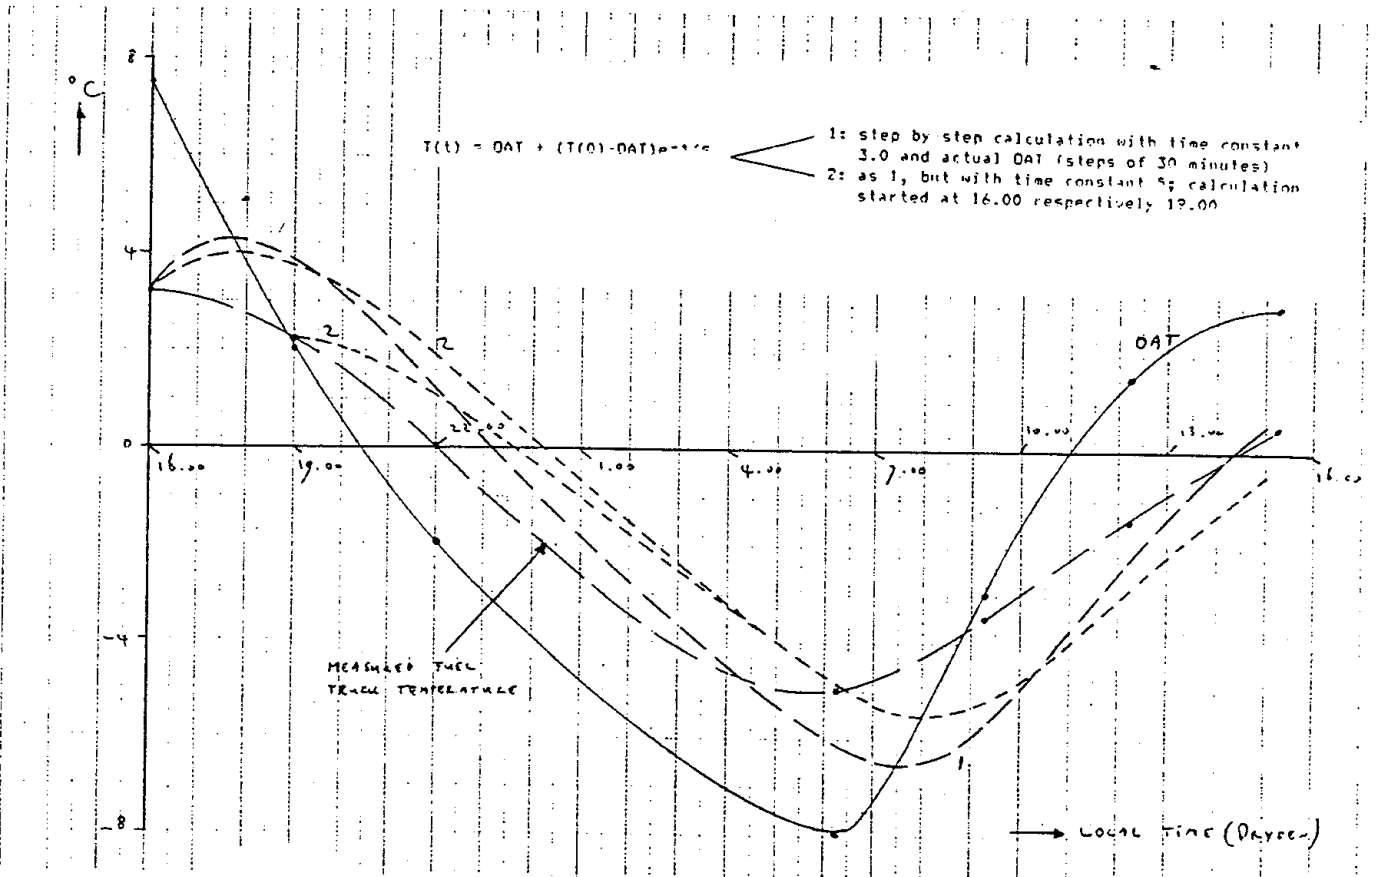
Figure 2 - Verification of empirical equation with Dryden fuel truck test data

The time constant of 5 hours has been derived from measurements at Dryden, Ontario, Canada on April 5 and 6, 1989 providing OAT and fuel truck temperatures over a 24 hour period (ref. National Research Council Canada Technical Report IME-CRE-TR-003, NRC No. 82124). These measurements are presented in figure 3, together with two lines which follow from the numerical evaluation of the above equation with time constant of 3, respectively 5 hours. Since with the time constant of 5 hours the gradient of the calculated line is very close to the gradient of the measured line in the areas where the OAT does not show gradient reversion, it is considered that with this value sufficient accuracy has been obtained to calculate the temperature of the fuel in the fuel truck.

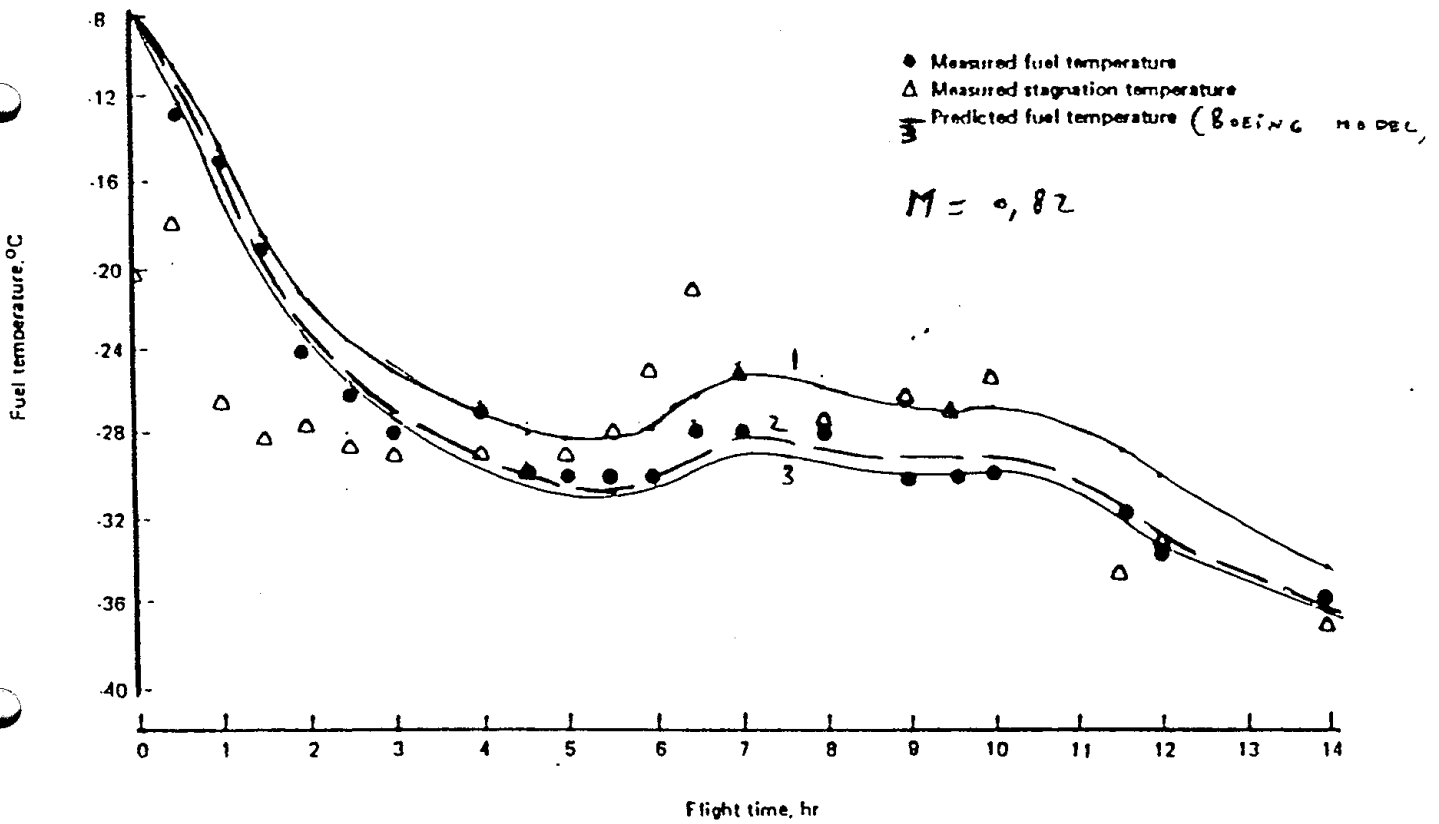
Figure 4 - Correlation Between Predicted and Measured Fuel Temperatures (8747)

Two further refinements have been done after a comparison between measured fuel temperature data on a very long B747 flight and the results of the above equation (with time constant 1.4 hours) applied to that flight (ref. figure 4, taken from NASA Contractor Report 135198). The refinement suggested by figure 4 is that TAT is not the governing parameter, but TAT\*, representing a 90% effective recovery term added up to static air temperature (SAT):

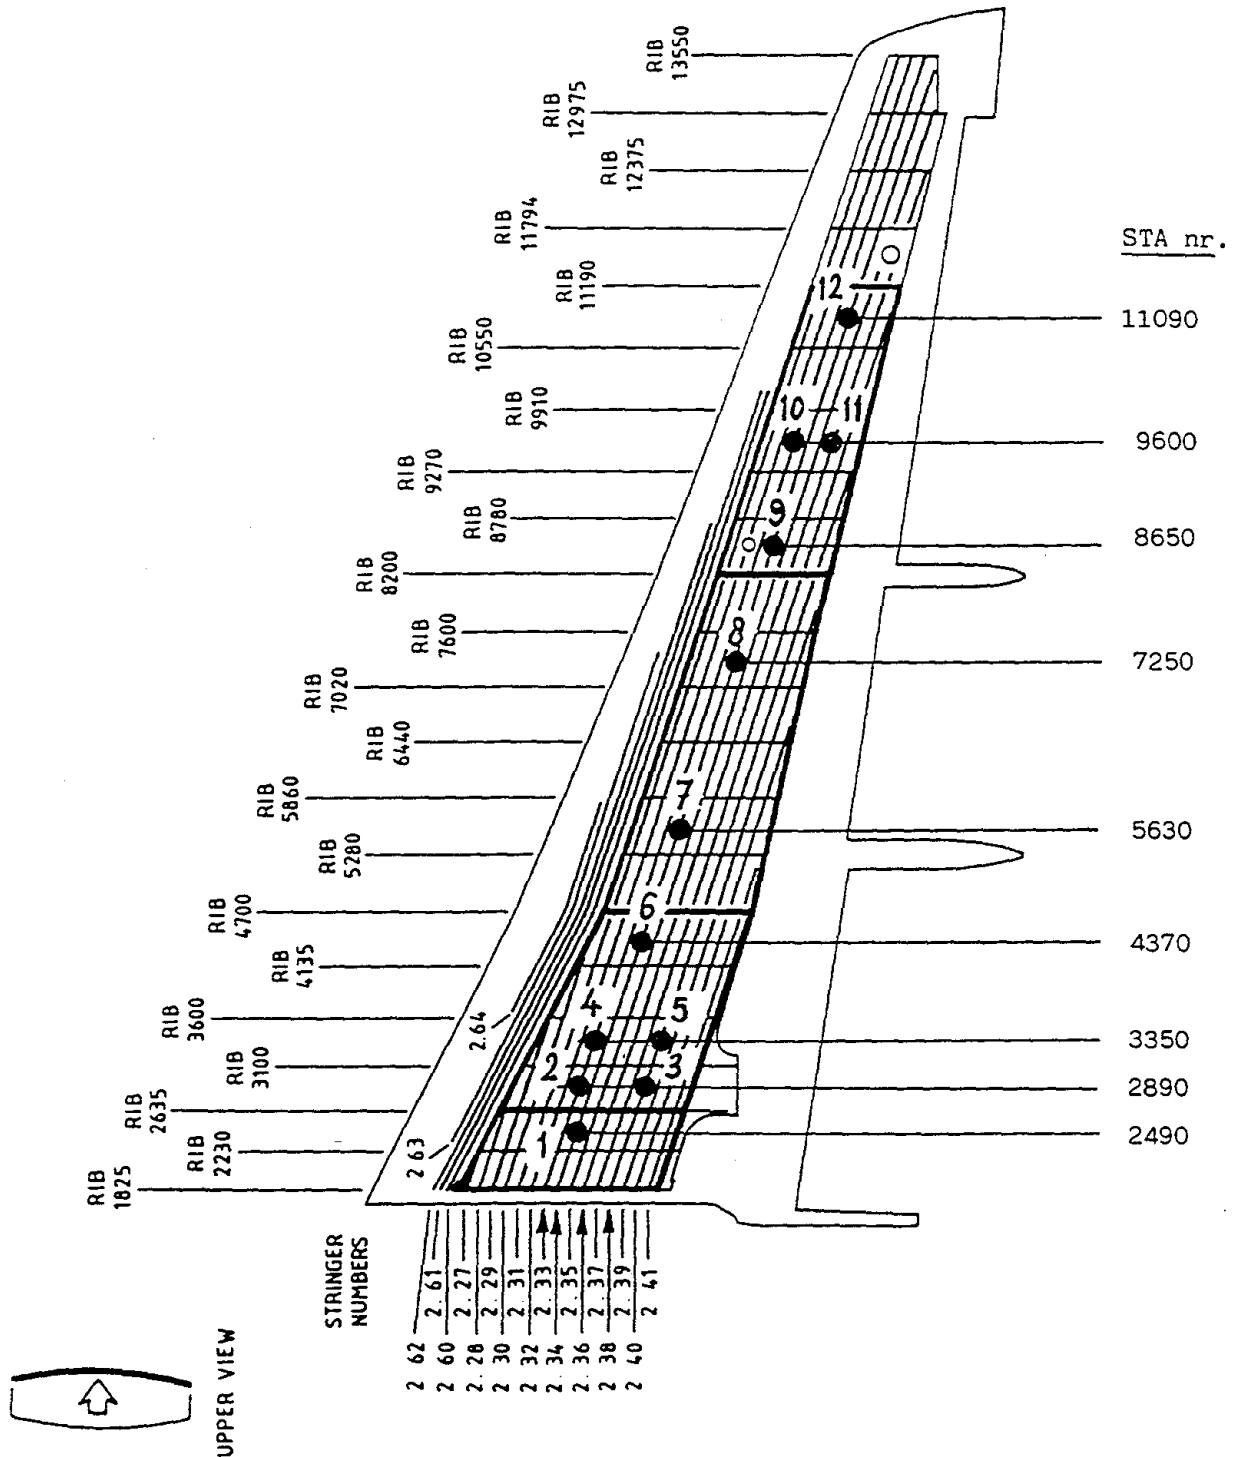
Figure 3. Location of temperature measurement point on RH wing upper surface.

A matrix of measurement locations for the contact temperature sensors had to be pasted on the LH - and RH wing upper surface as indicated in figure 3. The appropriate numbers are indicated in table 1. In order to get the lowest possible initial fuel temperature the aircraft has to be parked outside the hangar longer than 12 hours (overnight) with a total fuel content of approx. 5340 kg in the main tanks.

The surface temperature at the specified locations (see figure 3 and table 1) were measured once before fuelling and during fuelling and stabilization approximately every five minutes from the start of fuelling.
