AIRCRAFT ACCIDENT REPORT

IN-FLIGHT ENGINE SEPARATION
JAPAN AIRLINES, INC., FLIGHT 46E
BOEING 747-121, N473EV
ANCHORAGE, ALASKA
MARCH 31, 1993

**Adopted: October 13, 1993
Notation 6081A**

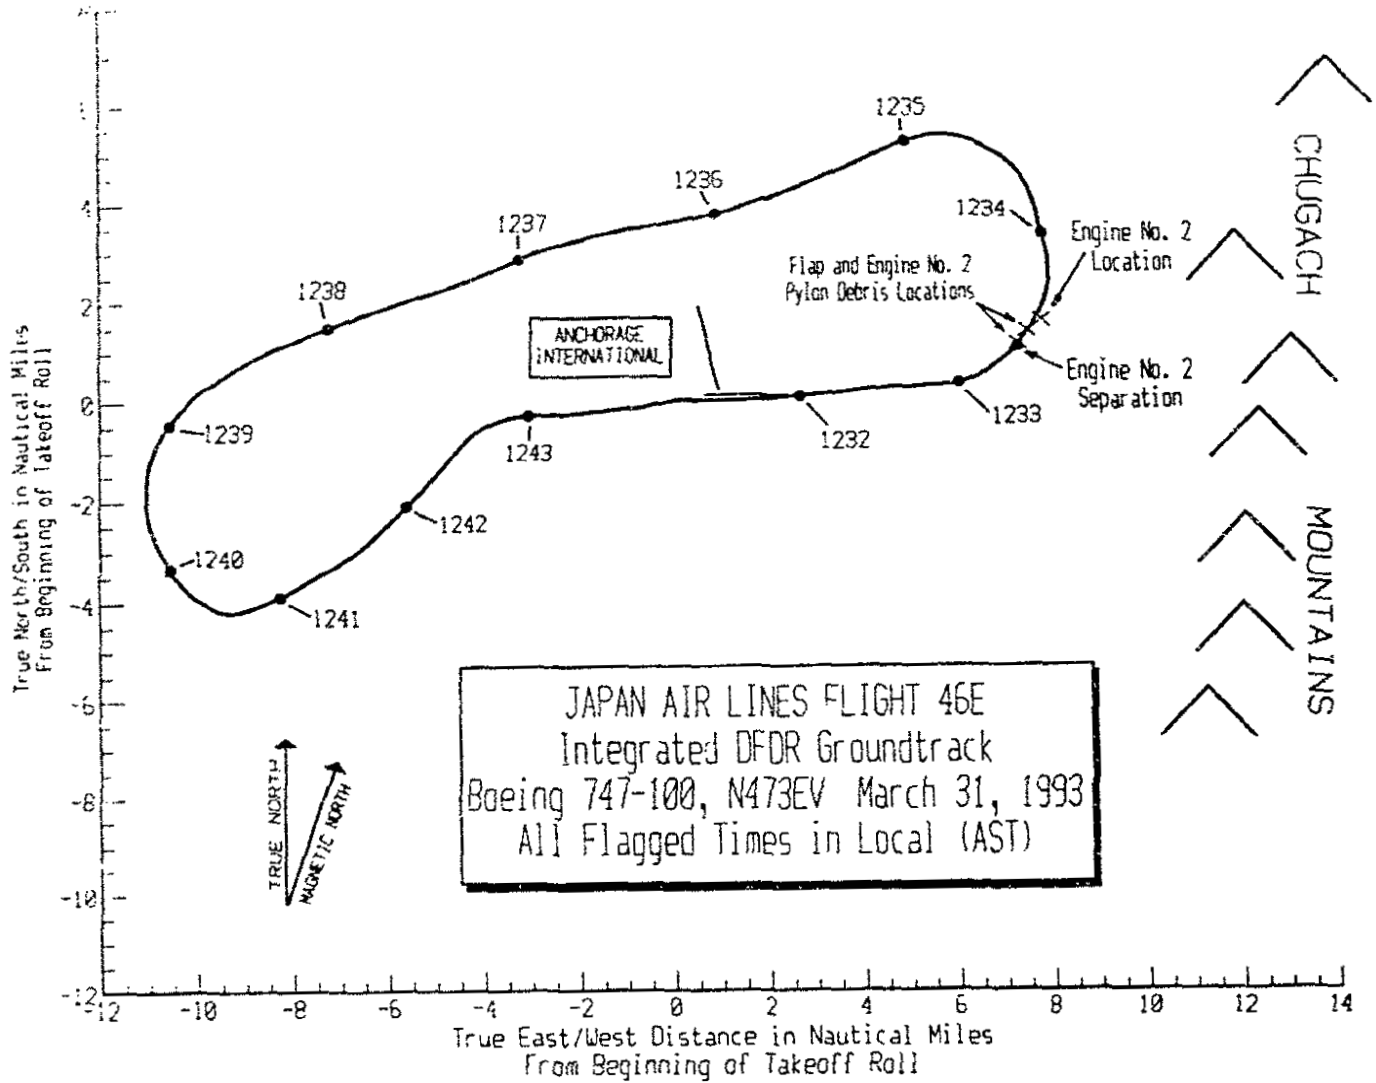
Figure 1.--Flight path and wreckage location.

Several private dwellings, automobiles, and landscaping were damaged by the impact of the No. 2 engine and various parts of the engine pylon and wing LEDs. Figure 1 is a diagram of the airplane's flightpath and the wreckage location.
