NATIONAL TRANSPORTATION SAFETY BOARD

AIRCRAFT ACCIDENT REPORT

RUNWAY DEPARTURE FOLLOWING LANDING
AMERICAN AIRLINES FLIGHT 102
McDONNELL DOUGLAS DC-10-30, N139AA
DALLAS/FORT WORTH INTERNATIONAL AIRPORT, TEXAS
APRIL 14, 1993

Abstract: This report explains the runway departure of American Airlines flight 102, a DC-10-30, after landing at Dallas/Fort Worth International Airport, Texas, on April 14, 1993. The safety issues discussed in the report include weather conditions affecting the flight, flightcrew and air traffic control training and procedures, airplane emergency evacuation lighting, and runway maintenance. Recommendations concerning these issues were made to the Federal Aviation Administration, Dallas/Fort Worth International Airport, and American Airlines, Inc.

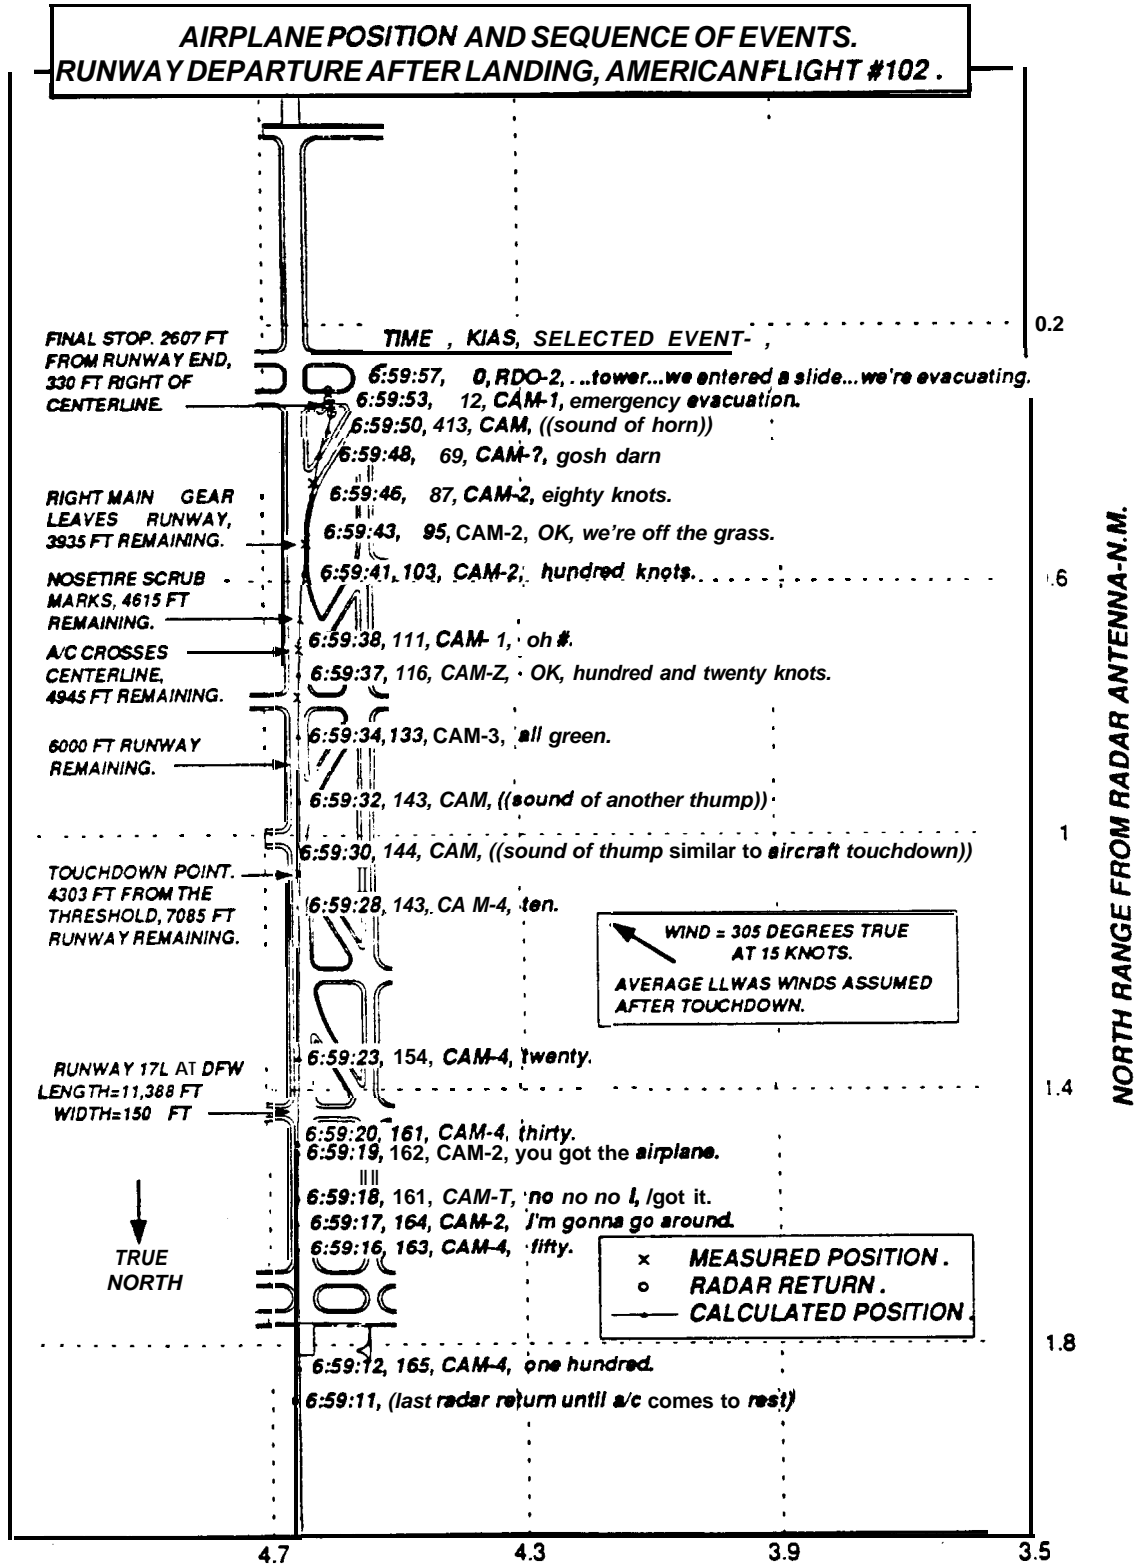
Figure 2.--Approach and landing.
History of airplane motion and events.

Investigators examined the landing runway after the accident and found three long sets of lightly shaded tire traces that paralleled the centerline but then angled to the right and departed the runway. The tracks from the right main landing gear continued as furrows in the soil.

Then the airplane traveled across high speed **taxiway 3S** before returning to the soft soil. The airplane came to rest, upright, about 2,607 feet from the departure end of 17L and about 250 feet from the right edge of the runway, with the nose on perpendicular **taxiway 3 1**. (See figures 2, 3 and 4).

The first tire marks found on the runway were traced to the left and right main landing gear, and started at 4,303 feet from the beginning of the runway. The tracks approximately paralleled the runway centerline for about 1,700 feet, then turned gradually to the right until they departed the runway.

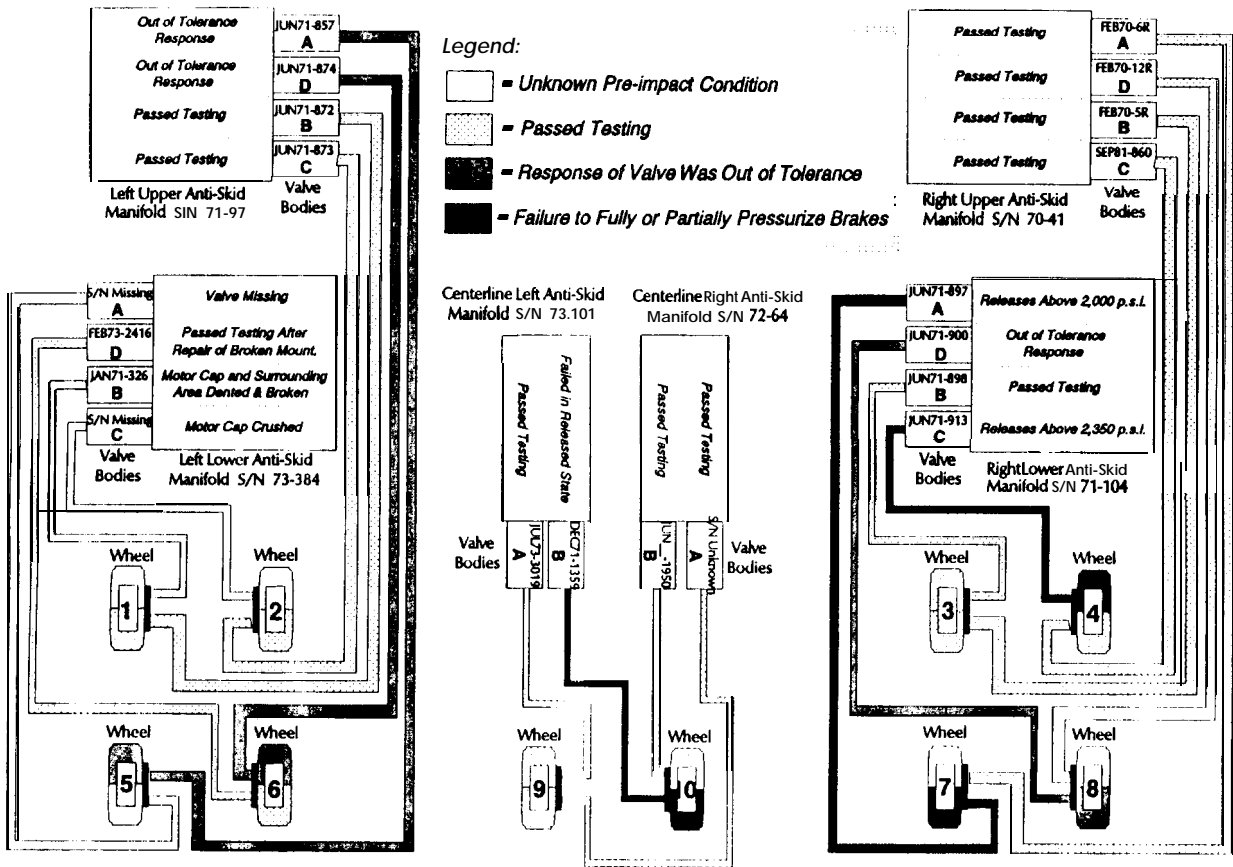
Figure 8.--Brake manifold system.

As described in the operator's DC-10 Maintenance Manual, the accident airplane was equipped with 20 antiskid pressure control valves, mounted in six manifolds. Two valves led to the brake assembly at each wheel. Testing revealed that 16 of the valves responded to electrical signal applications, signal step changes, and signal releases. One valve was found to be inoperative, and three had damaged or missing valve motor caps that prevented testing. Five of the 16 valves that responded were found out of tolerance. (Reference diagram of brake manifold system, figure 8).

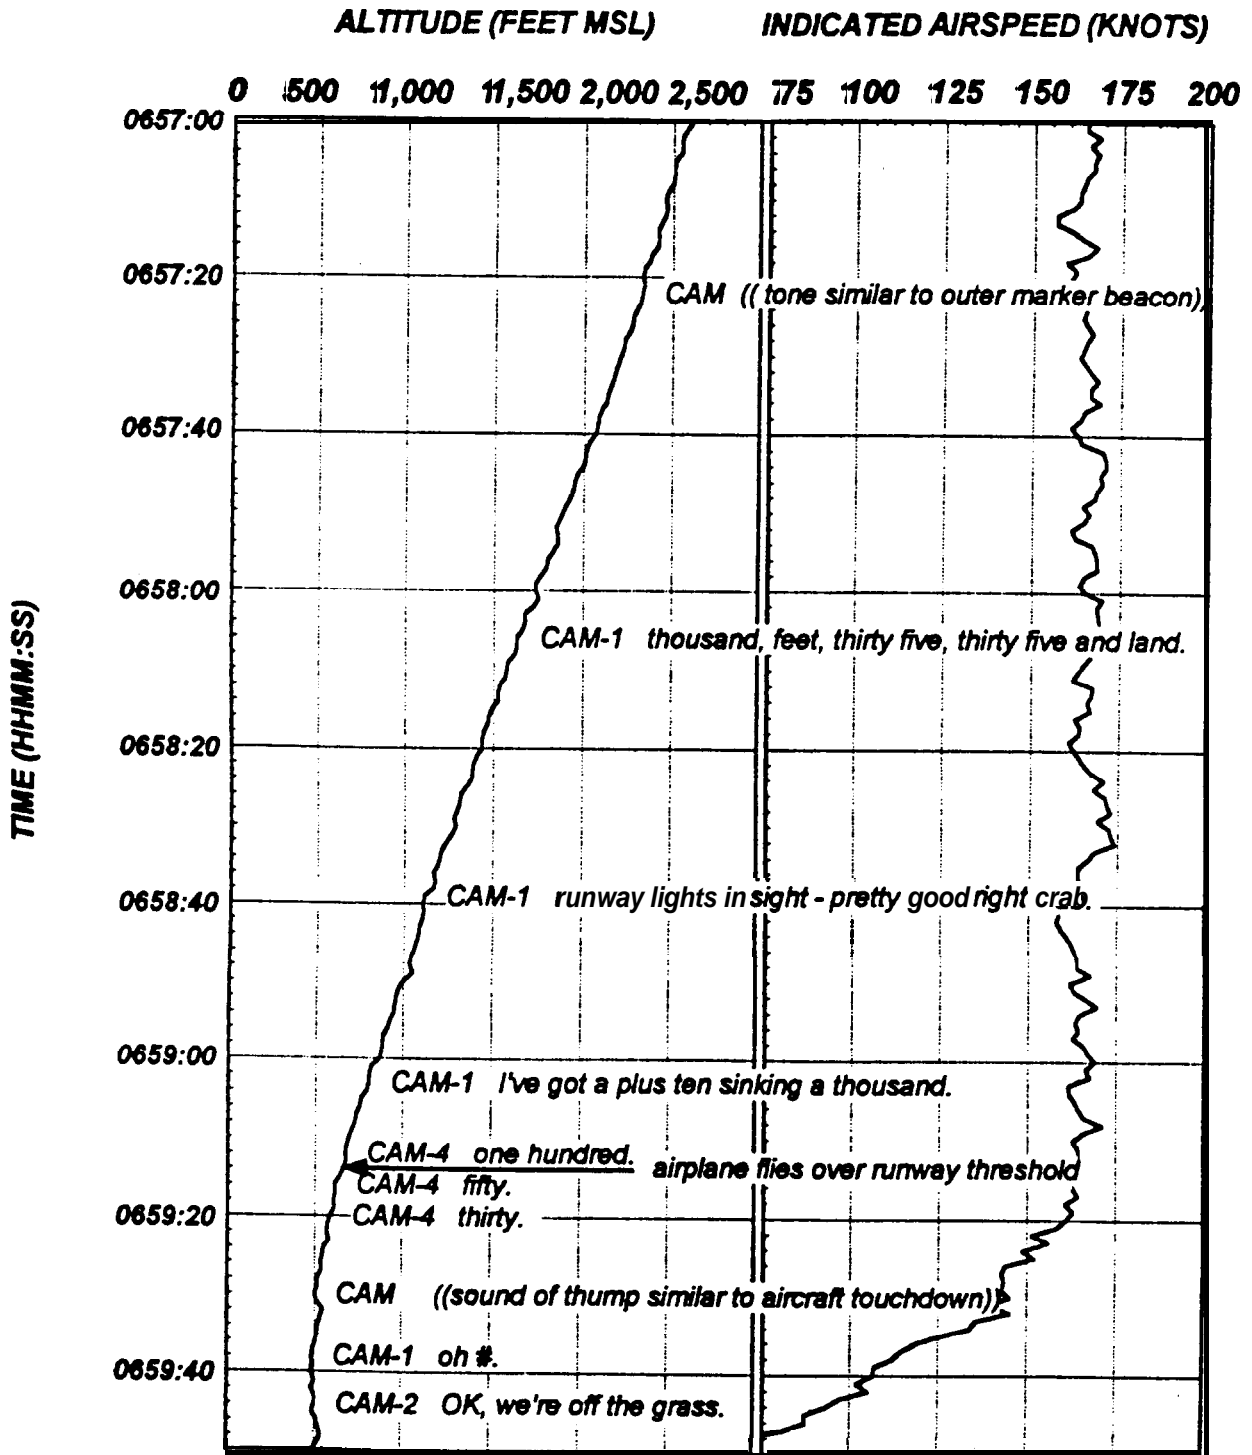
Figure 10.--Airplane airspeeds and altitudes versus time.

Data from ATC radar, weather, CVR, FDR, and information from the examination of the aircraft wreckage and the accident runway were used to develop a time history of the accident flight's motion during the approach and landing. (See figure 10 for airspeeds and altitudes during the landing sequence). Calculations were made of the crosswind component during the final 2 1/2 minutes before landing. A composite plot was developed that shows, in a graphical format, the flight control positions and airplane headings when key events occurred during the landing sequence. (See figures 1 la and 1 lb).

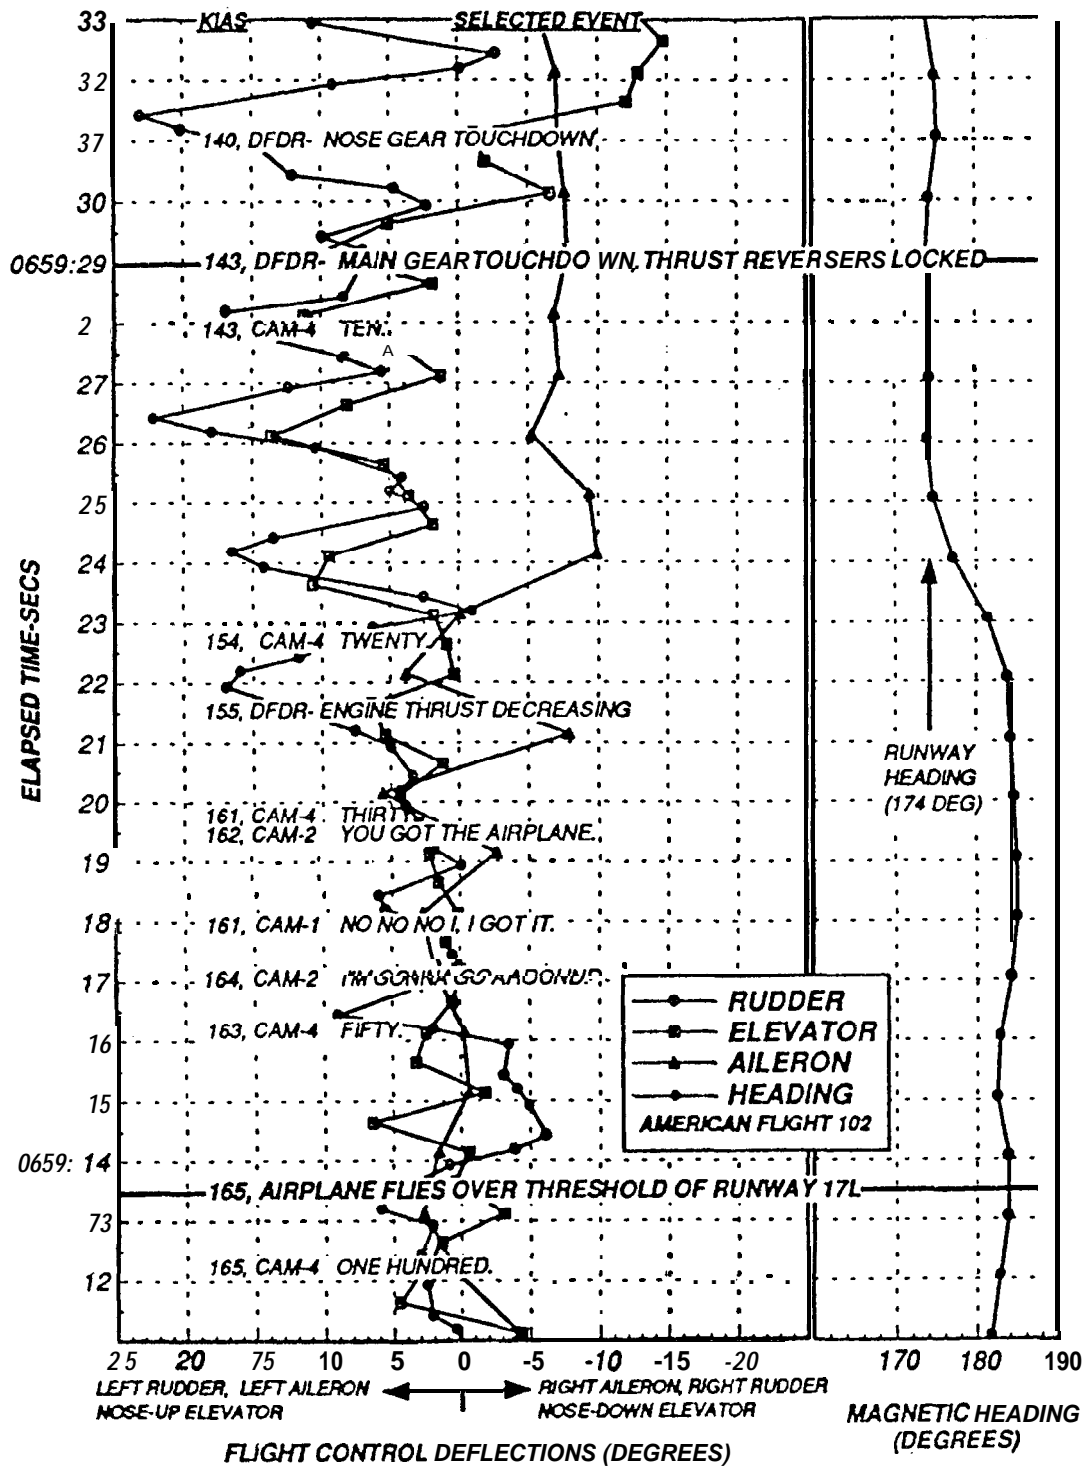
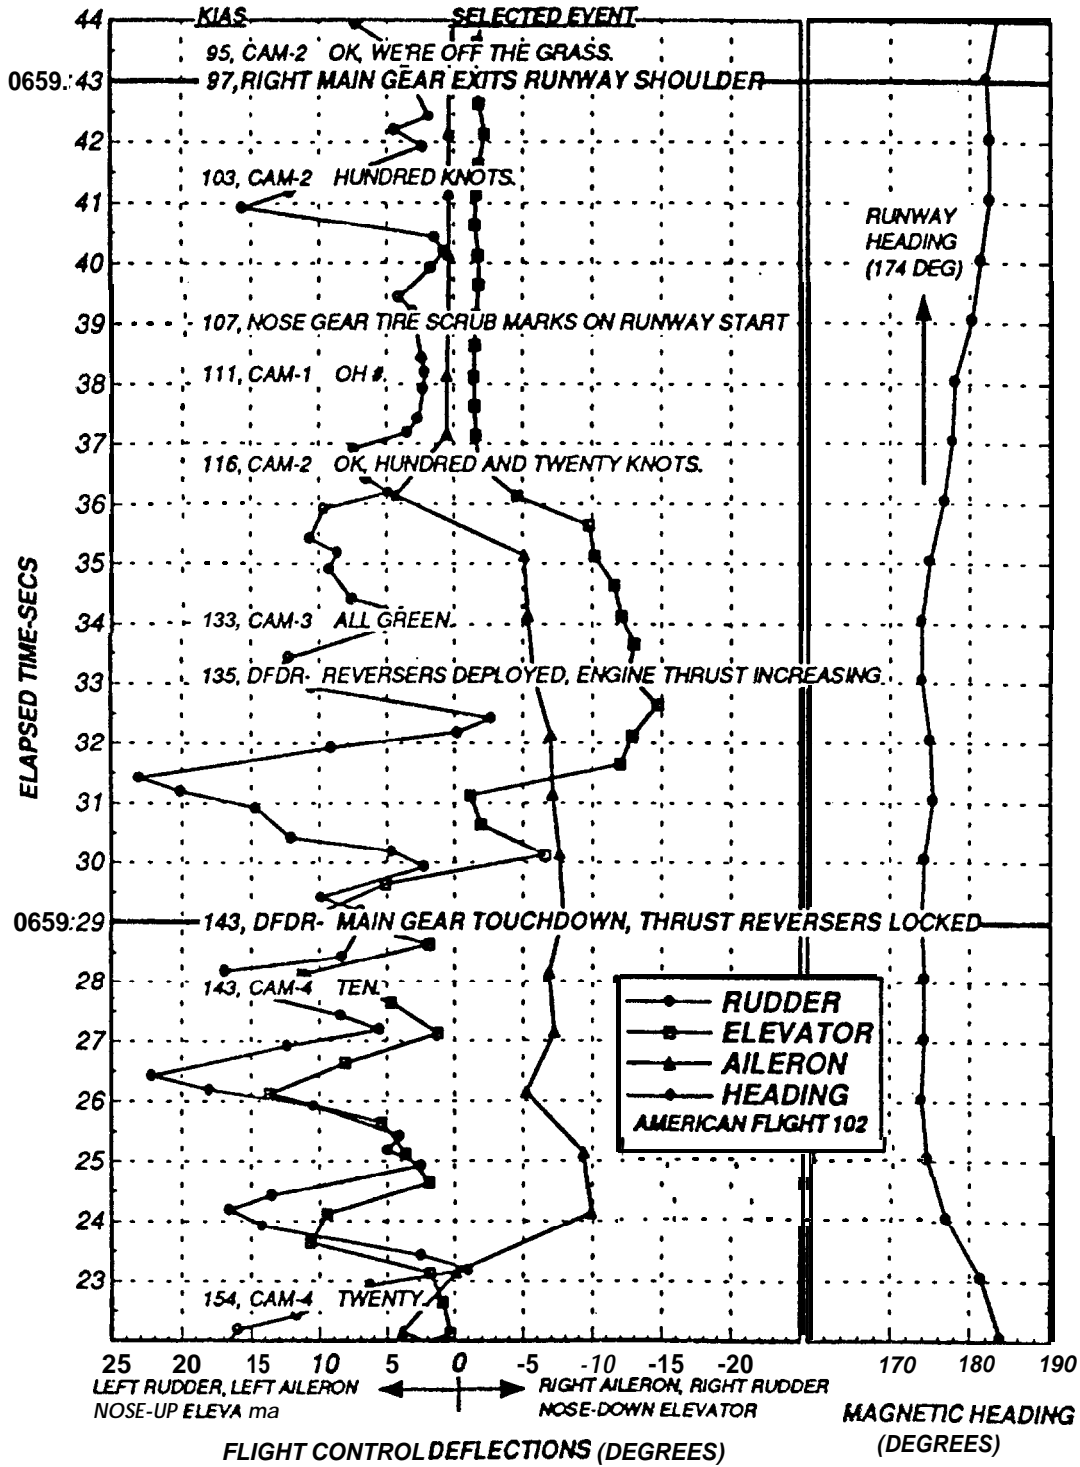
Figure 11 a.--Flight control positions and airplane headings during landing sequence.

Prior to touchdown, the airplane transitioned from a 10-degree right crab to a 2-degree right-wing-down (RWD) roll and a 10-degree airplane-nose-left (ANL) rudder deflection. The data show that the airplane touched down at 0659:29 and tracked near the centerline of 17L for about 8 seconds, averaging an 8-degree ANL rudder deflection. During the 8 seconds after touchdown, the airplane decelerated to 116 knots indicated airspeed (KIAS), while the rudder was deflected on average about 8 degrees ANL, the aileron position averaged 5 degree RWD, and the elevator averaged 7 degrees airplane nose down (AND).
