In-flight Breakup Over the Atlantic Ocean
Trans World Airlines Flight 800
Boeing 747-131, N93119
Near East Moriches, New York
July 17, 1996

**NTSB/AAR-00/03
DCA96MA070
PB2000-910403
Notation 6788G
Adopted August 23, 2000**

The National Transportation Safety Board determines that the probable cause of the TWA flight 800 accident was an explosion of the center wing fuel tank (CWT), resulting from ignition of the flammable fuel/air mixture in the tank. The source of ignition energy for the explosion could not be determined with certainty, but, of the sources evaluated by the investigation, the most likely was a short circuit outside of the CWT that allowed excessive voltage to enter it through electrical wiring associated with the fuel quantity indication system.

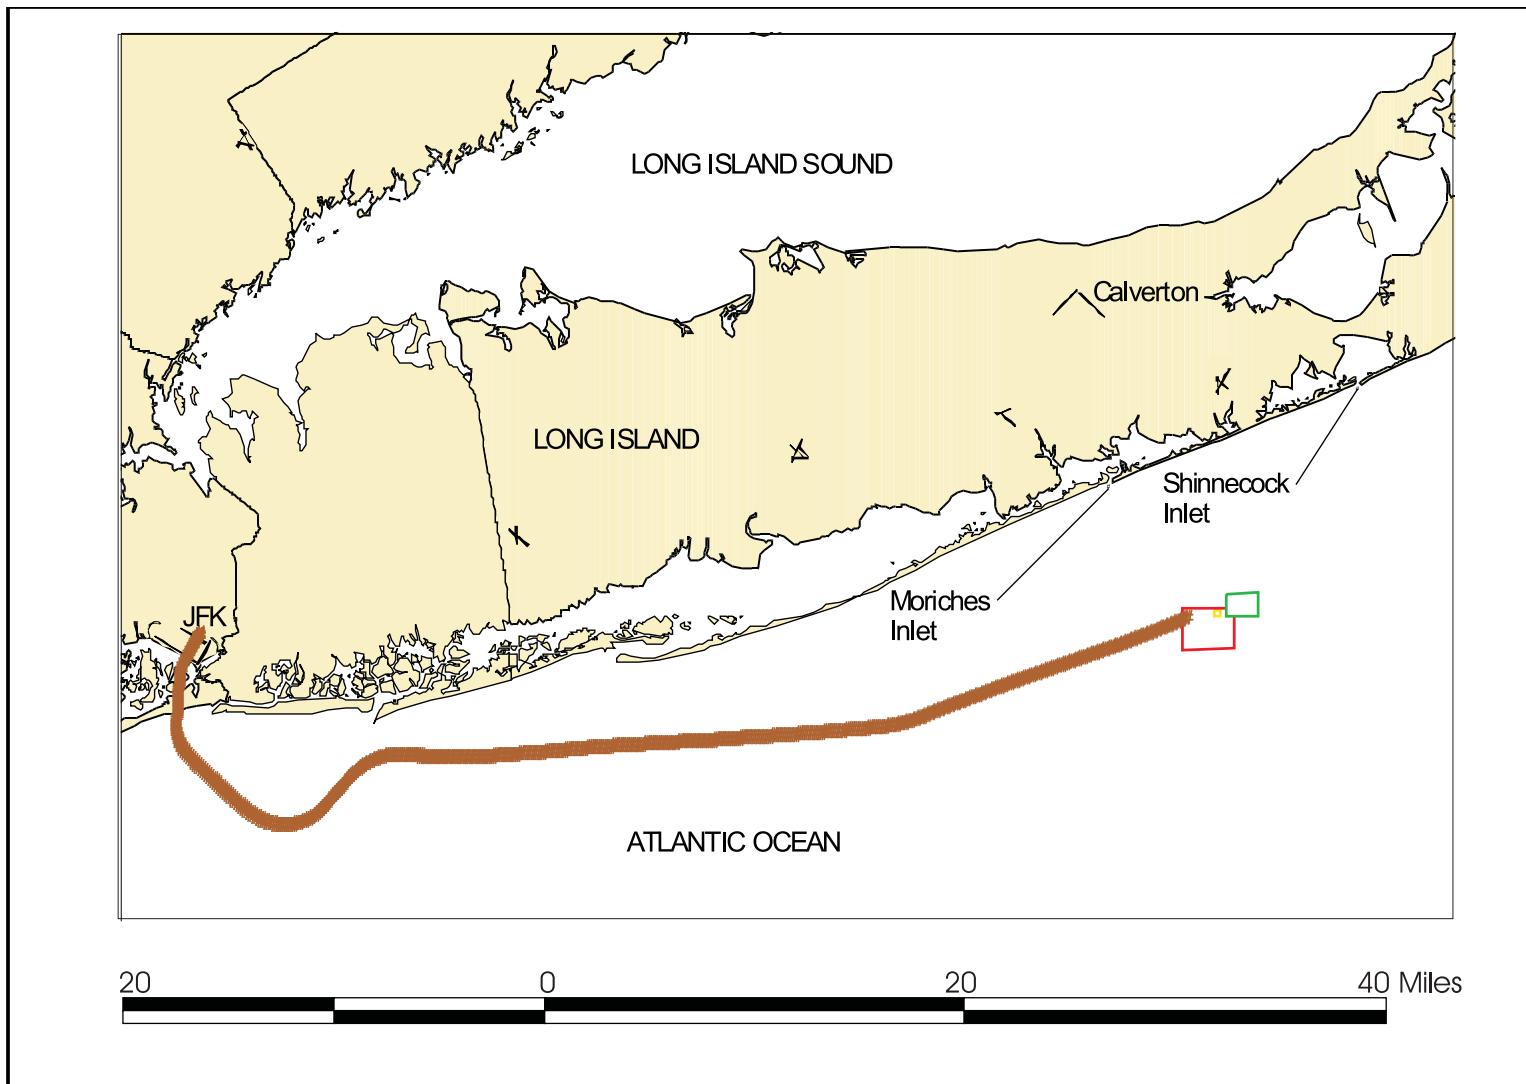
Pieces of the wreckage were distributed along a northeasterly¹²³ path about 4 miles long by 3 1/2 miles wide in the Atlantic Ocean off the coast of Long Island. (Figure 21 shows the wreckage location relative to the airplane’s flightpath, JFK, and Long Island.)

Figure 21. The wreckage location relative to the airplane's flightpath, JFK, and Long Island.

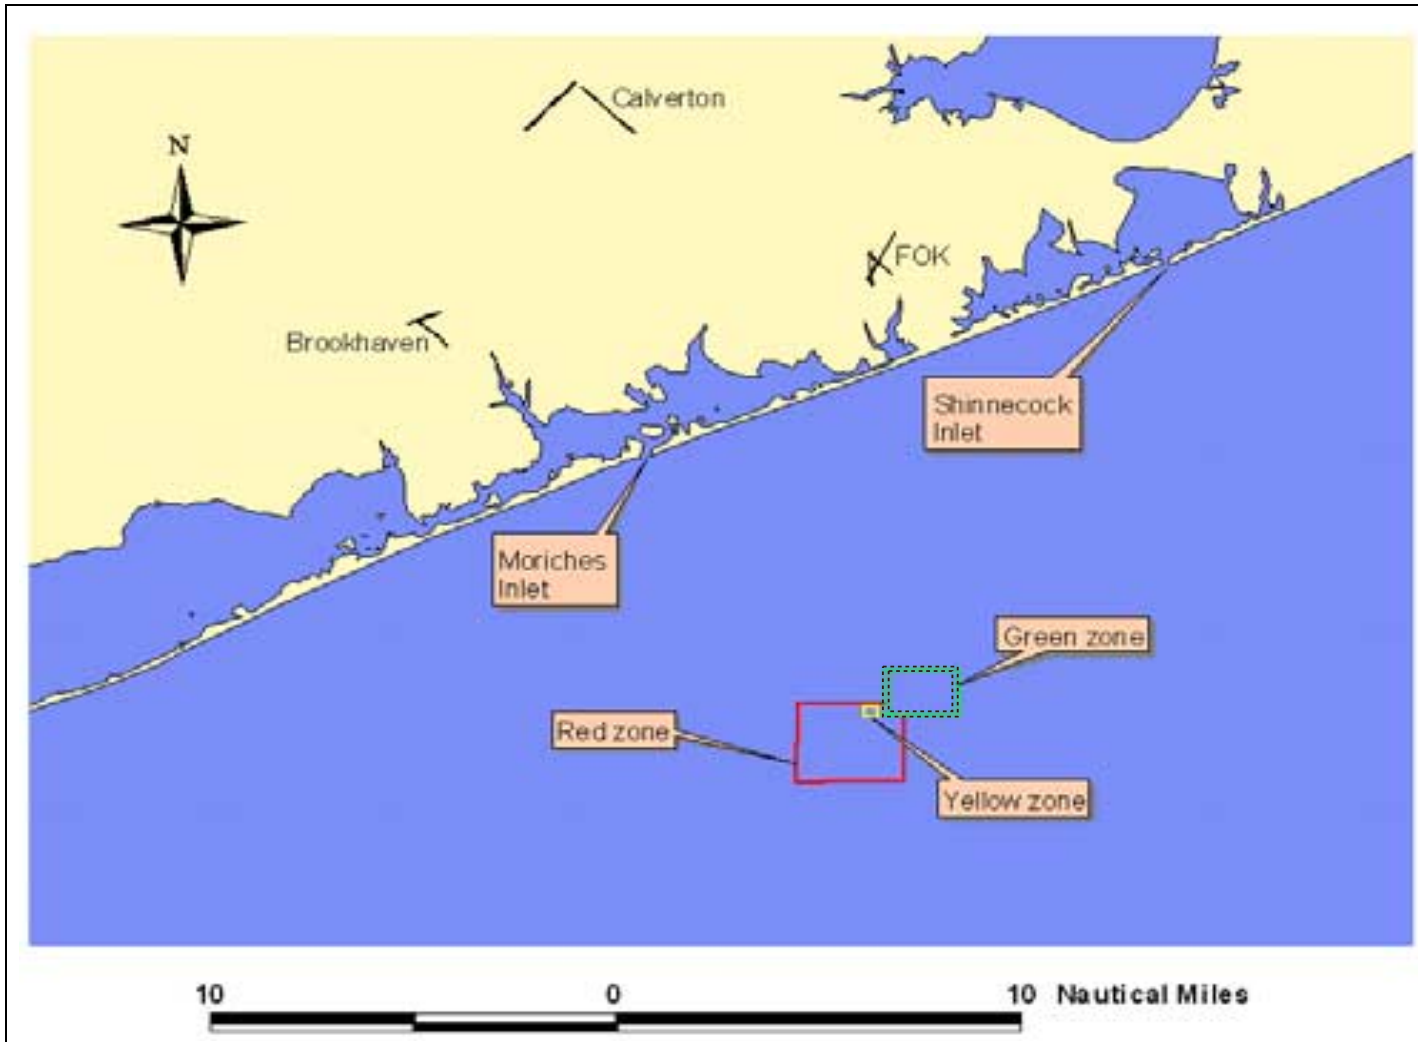
Figure 22a. Map showing the locations of the red, yellow, and green zones.

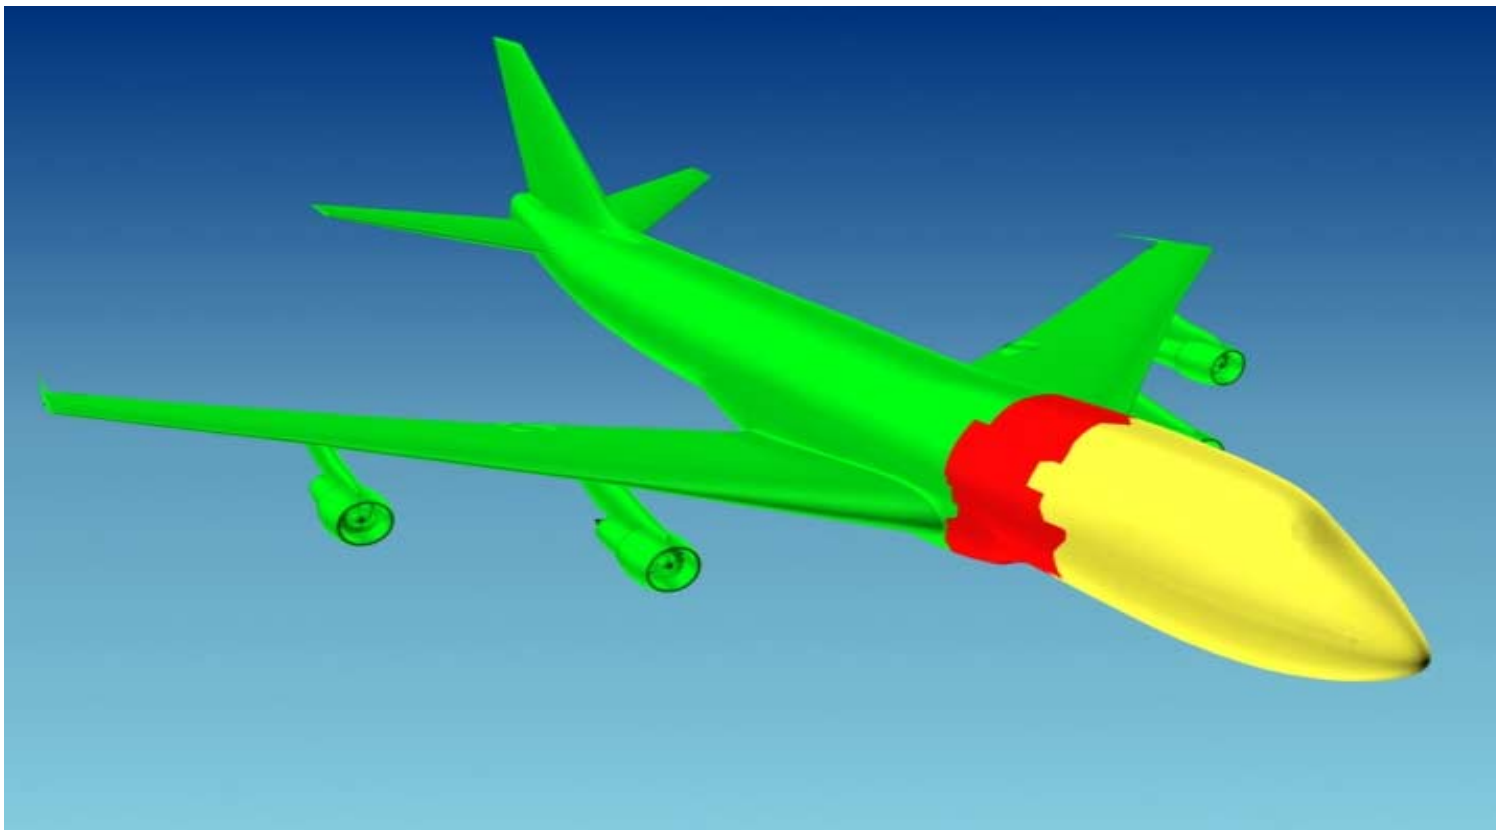
Figure 22b. A 747, color-coded to indicate the debris fields from which corresponding wreckage was recovered.

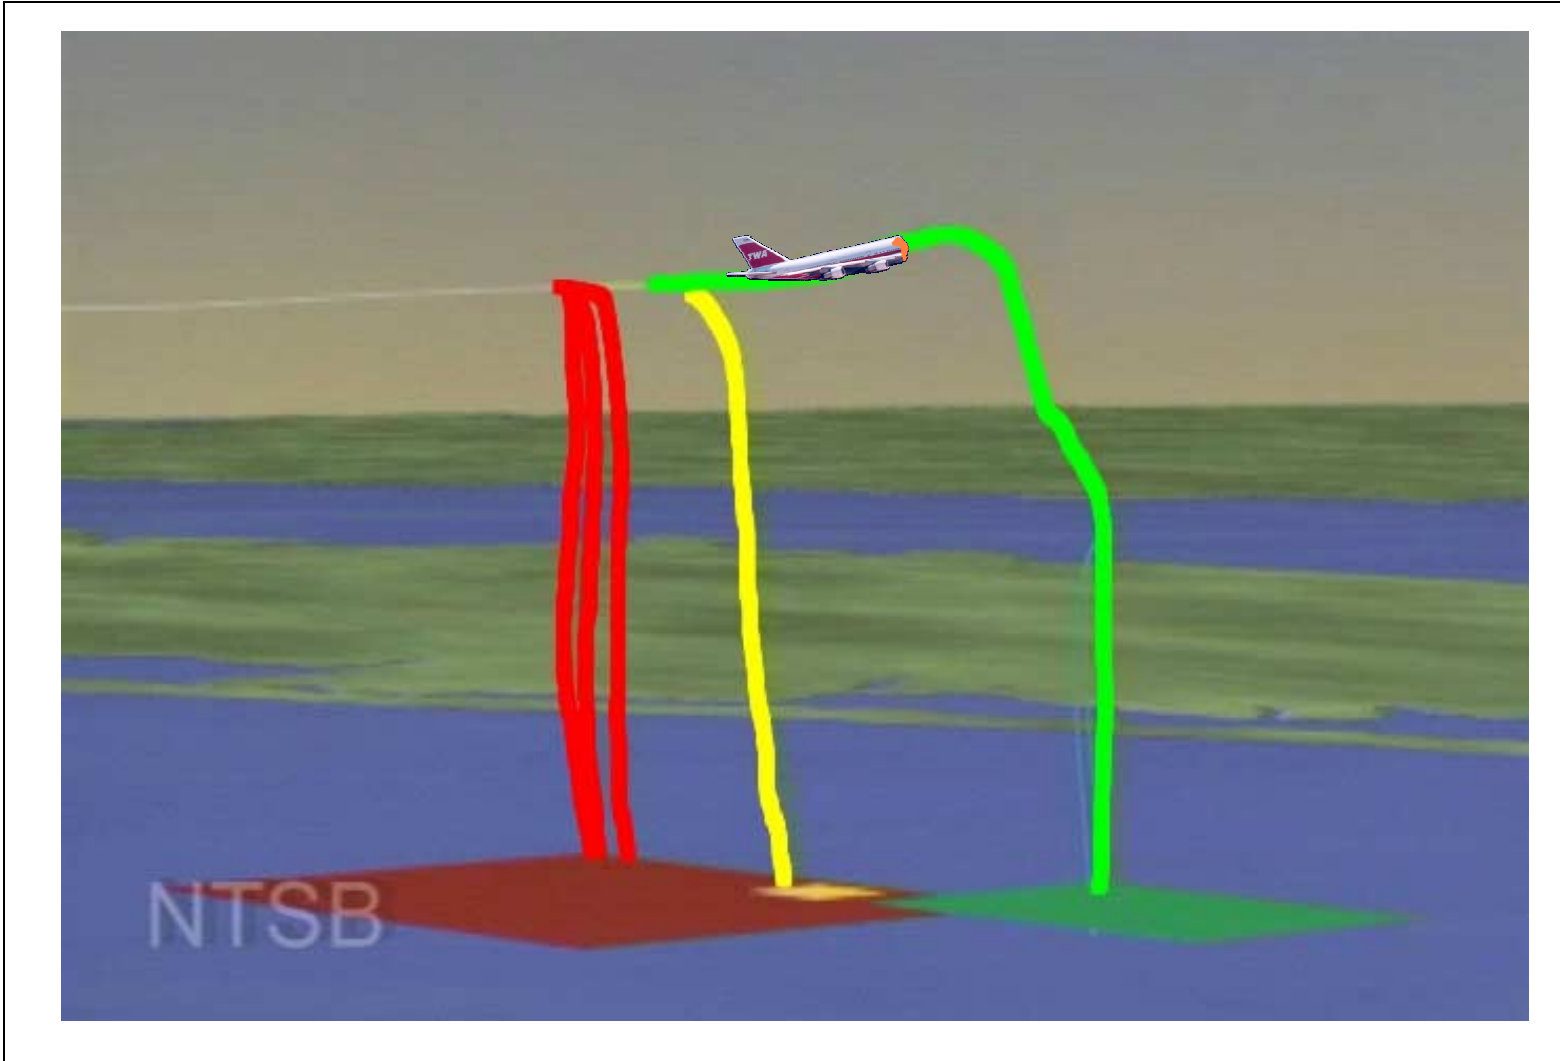
¹²⁹ During the hours after the accident, there were numerous fuel-fed fires on the surface of the water around debris in the green zone. Thus, some of the fire damage and soot deposits found on pieces of wreckage discovered in the green zone may have occurred postimpact.

Figure 22c. The accident airplane's flightpath, color-coded to indicate the debris fields from which corresponding wreckage was recovered.

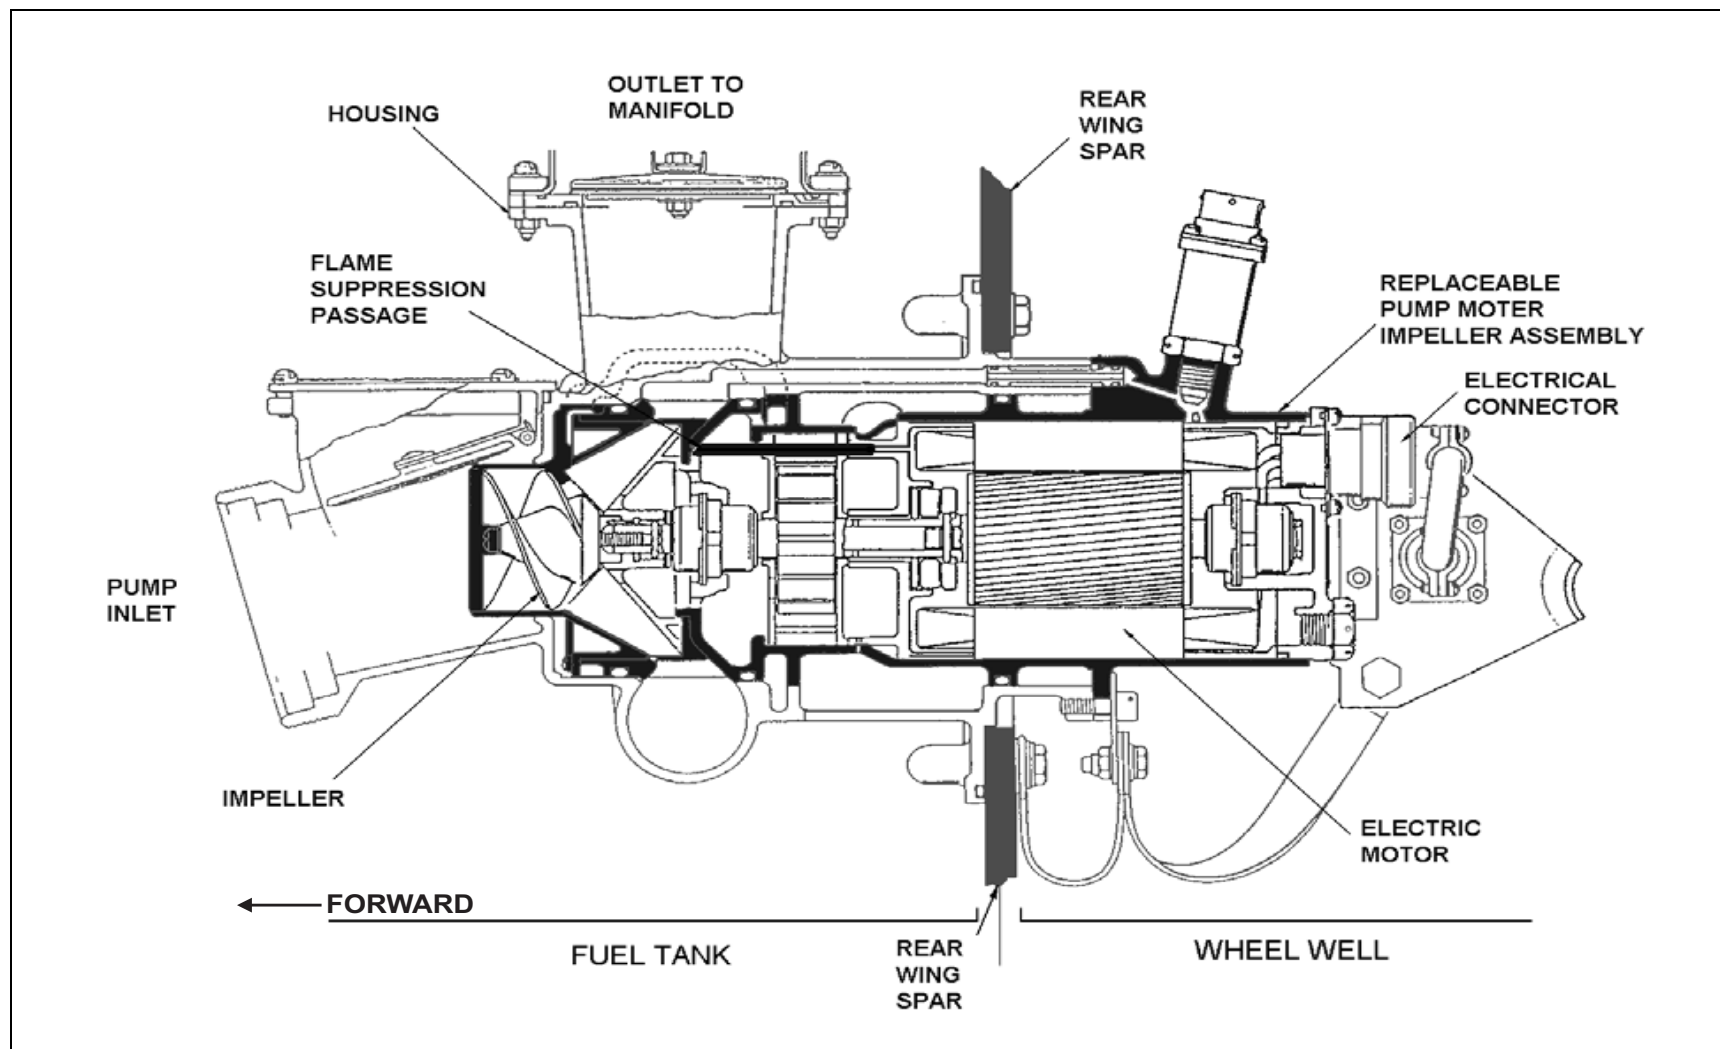
¹⁴⁷ Similar, but extensively deeper rubbing damage was found in jettison/override pumps in the Philippine Airlines 737 that had a CWT explosion on May 11, 1990. The Safety Board conducted tests for 2 weeks to determine whether galling between aluminum surfaces within the pump could have ignited flammable vapors. The investigative group was not able to ignite flammable vapors by impeller rubbing or by other types of contact between internal fuel pump components.

Figure 23. A diagram of a jettison/override fuel pump.

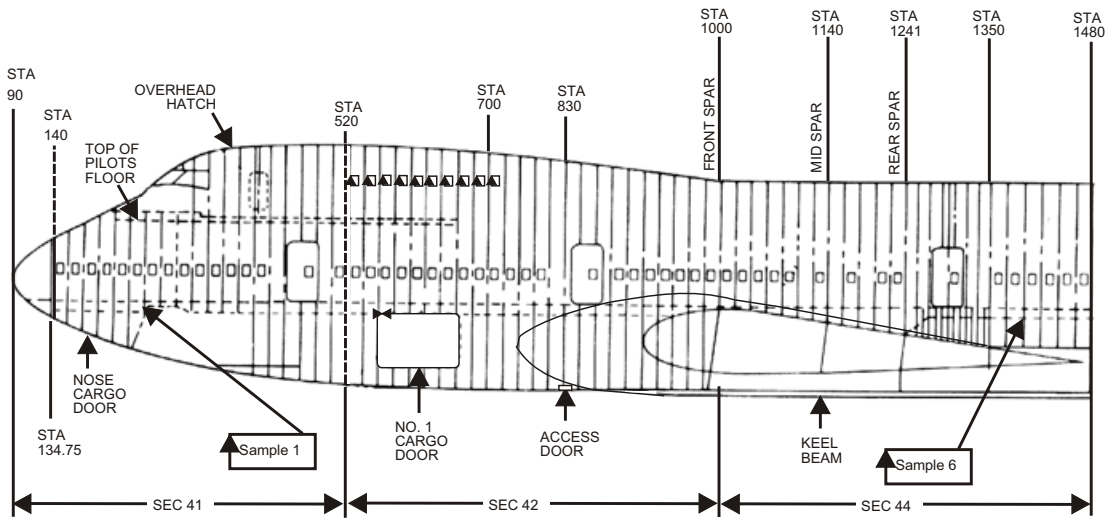
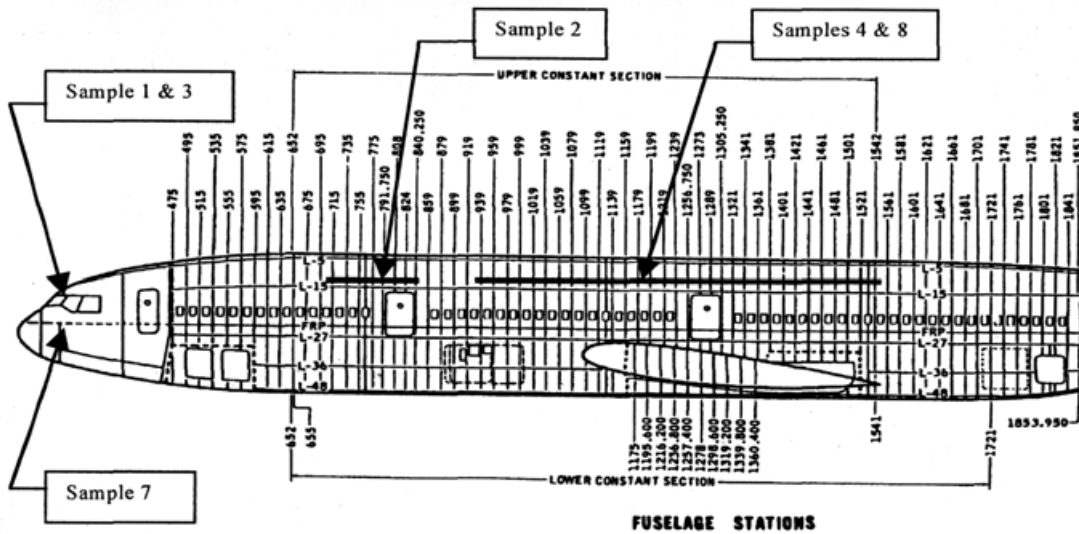
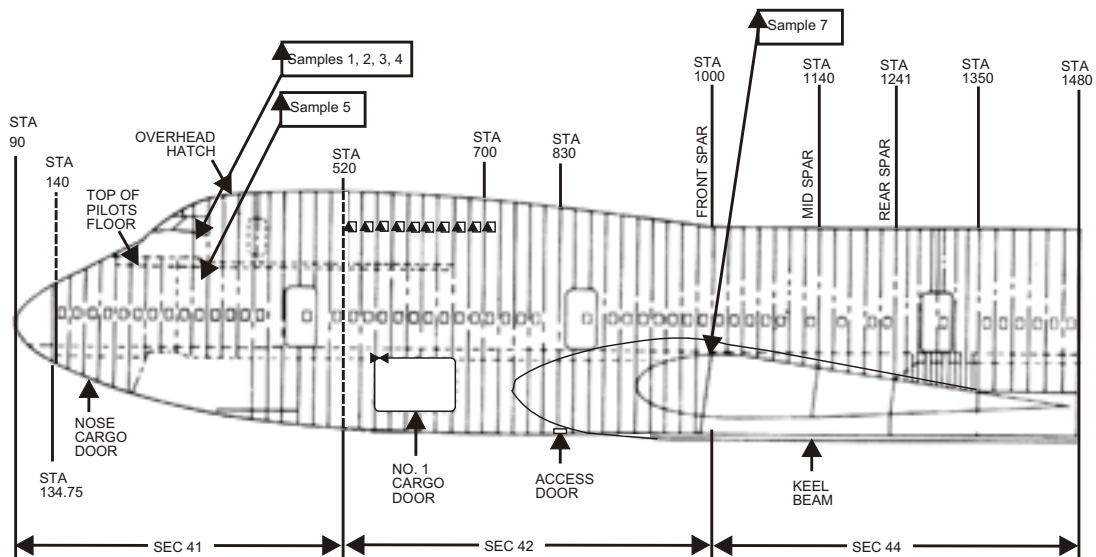
Figure 35a. Sample origination locations for the 747 manufactured in 1970.

Figure 35b. Sample origination locations for the DC-10 manufactured in 1973.

Figure 35c. Sample origination locations for the 747 manufactured in 1973.

4. The weak point in this wire type appears to be the lack of ability to maintain physical and electrical integrity during extended elevated thermal exposure with mechanical stress. As the wire ages, there is an increased risk of dielectric problems [breakdown of wire insulation integrity], mechanical damage and loss of electrical integrity.
5. No wire was submitted that was exposed to high levels of environmental exposure (such as wires from wheel wells, wing leading edges, etc.). Wire from these areas, would be expected to perform worse than the wire submitted. [See figures 35a, 35b, and 35c for sample locations.]

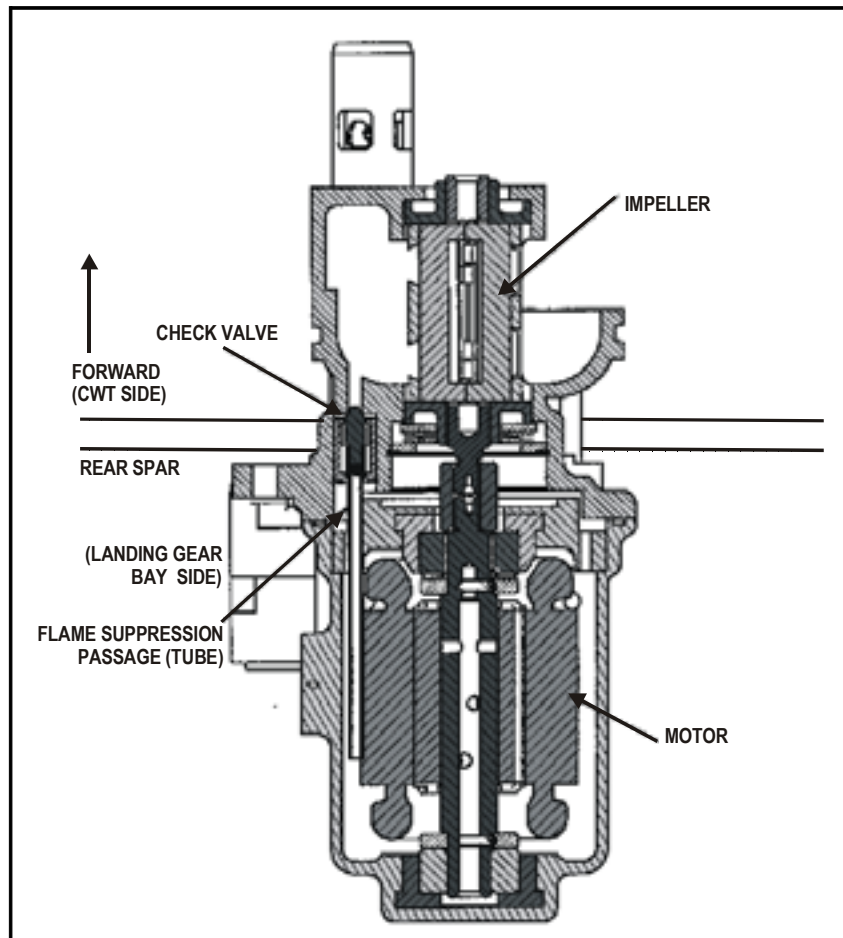
contained multiple explosions that were intentionally ignited within the pump motor cavity, preventing the ignition from transferring to the fuel tank. (Figure 37 is a diagram of a scavenge pump.) Because the Board became aware of instances in which the flame arrestor tube was broken or missing, investigators also conducted a series of tests to determine whether the scavenge pump motor housing would contain explosions with only one of the flame suppression system components (either the flame arrestor tube or the check valve) functioning. In all tests, the scavenge pump housing contained the explosions, and the explosive atmosphere surrounding the test pump did not ignite.

During its postaccident examination of other transport-category airplanes, the Safety Board observed that components in the electrical connector on a scavenge pump in a retired 747 were deteriorated. (Boeing ASBs 747-28A2194 and 747-28A0043, both dated January 18, 1996, “encouraged” operators to inspect for degradation in connectors.) Investigators observed that several scavenge pump electrical connectors had been manufactured of a material that degraded with long-term exposure to fuel. Boeing provided the Board with a service history for the 747 scavenge pump for the 10 years preceding the accident. When queried about the brevity of this history, Boeing indicated that most operators did not return the scavenge pumps to the manufacturer for overhaul.

Figure 37. A diagram of a scavenge pump.

As a result of these findings, Boeing issued ASB 747-28A2206, dated September 25, 1997, and AD 97-25-06, effective December 16, 1997. AD 97-25-06 contained the following summary:

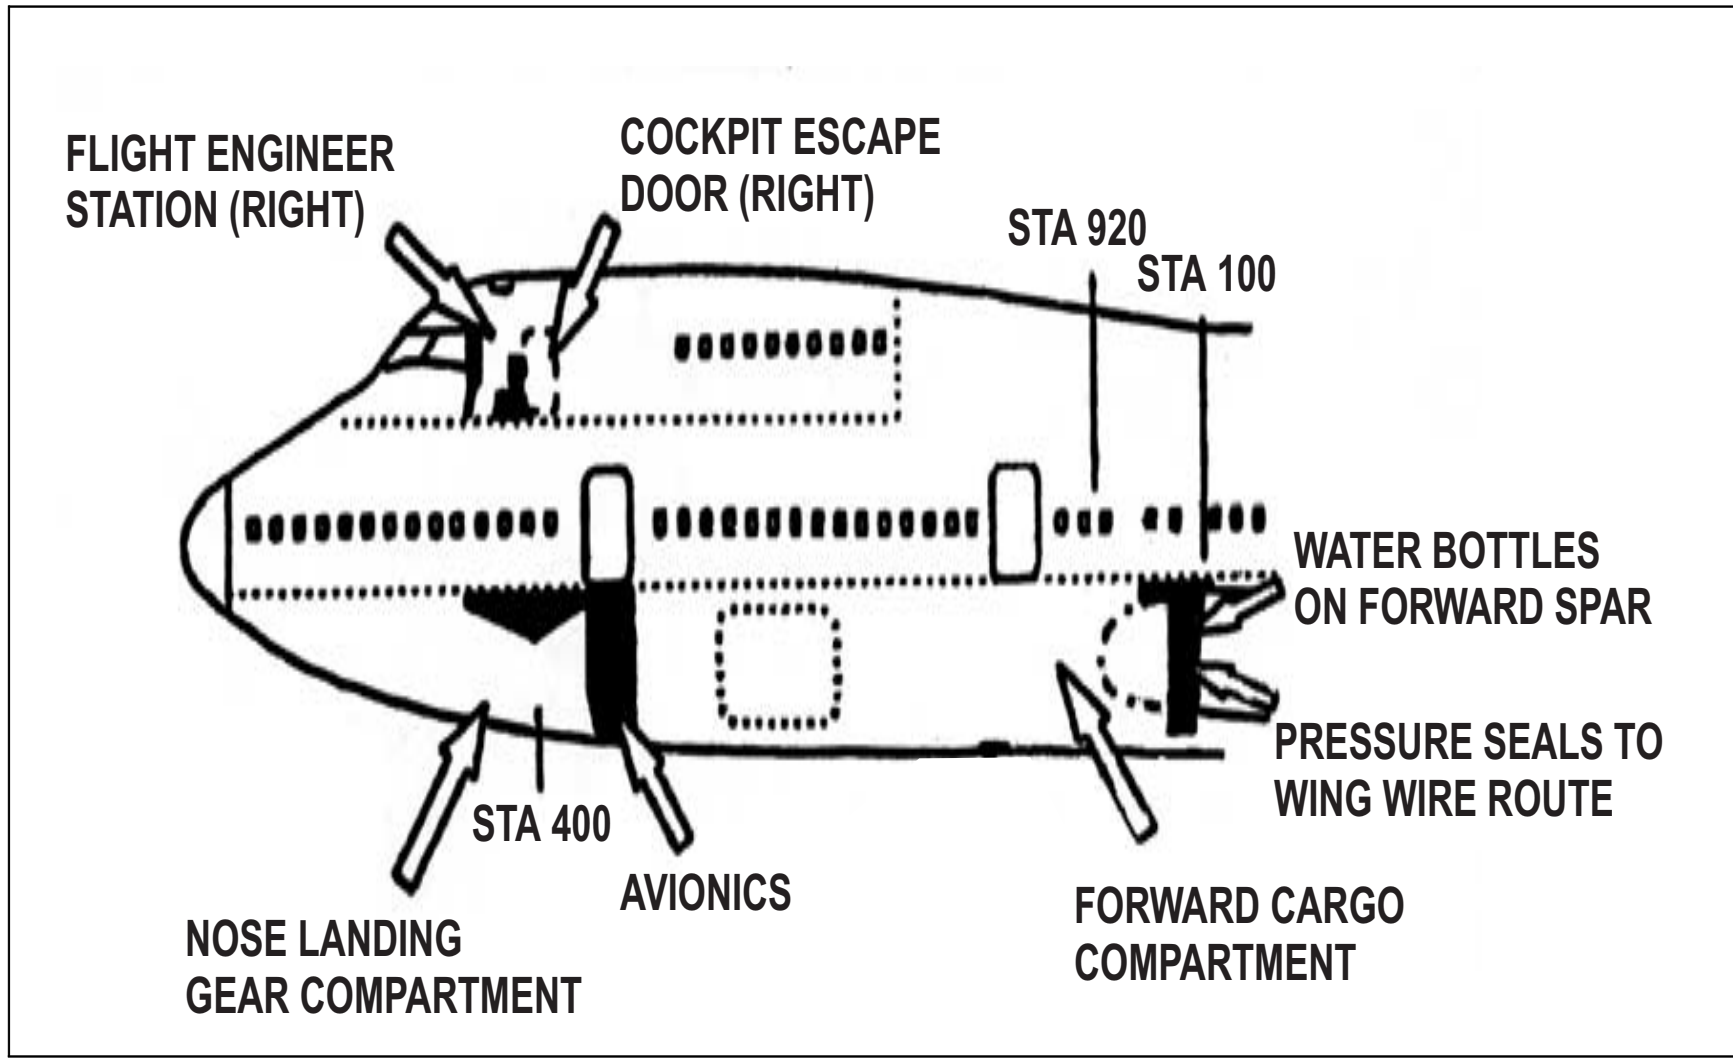
Figure 38. Diagram showing the areas typically inspected on 747 airplanes.

In one airplane (its last known flight was in January 1997), wires in the raceway over the CWT were not bundled (as indicated by Boeing's PIs) but were randomly laid in a tray, such that individual wires crossed from one side of the tray to the other. Higher-voltage generator and galley power cables were clamped to the adjacent structure (not routed in the tray). Inspection of the inside of this airplane's CWT revealed the following: the scavenge pump inlet screen contained a nearly 1-inch-long uninsulated wire fragment, a vertically routed FQIS wire was chafed where it contacted a horizontal structural flange, and a horizontally routed FQIS wire was chafed where it contacted a vertical row of rivets between two supporting clamps. Examination of this airplane's CWT fuel quantity probes by the AFRL experts revealed sulfide deposits on the bare wire ends and terminal sleeves, and some of the wires were loose under the clamps; two of the wires exhibited striation marks that resembled jaw marks of a wire stripping tool.

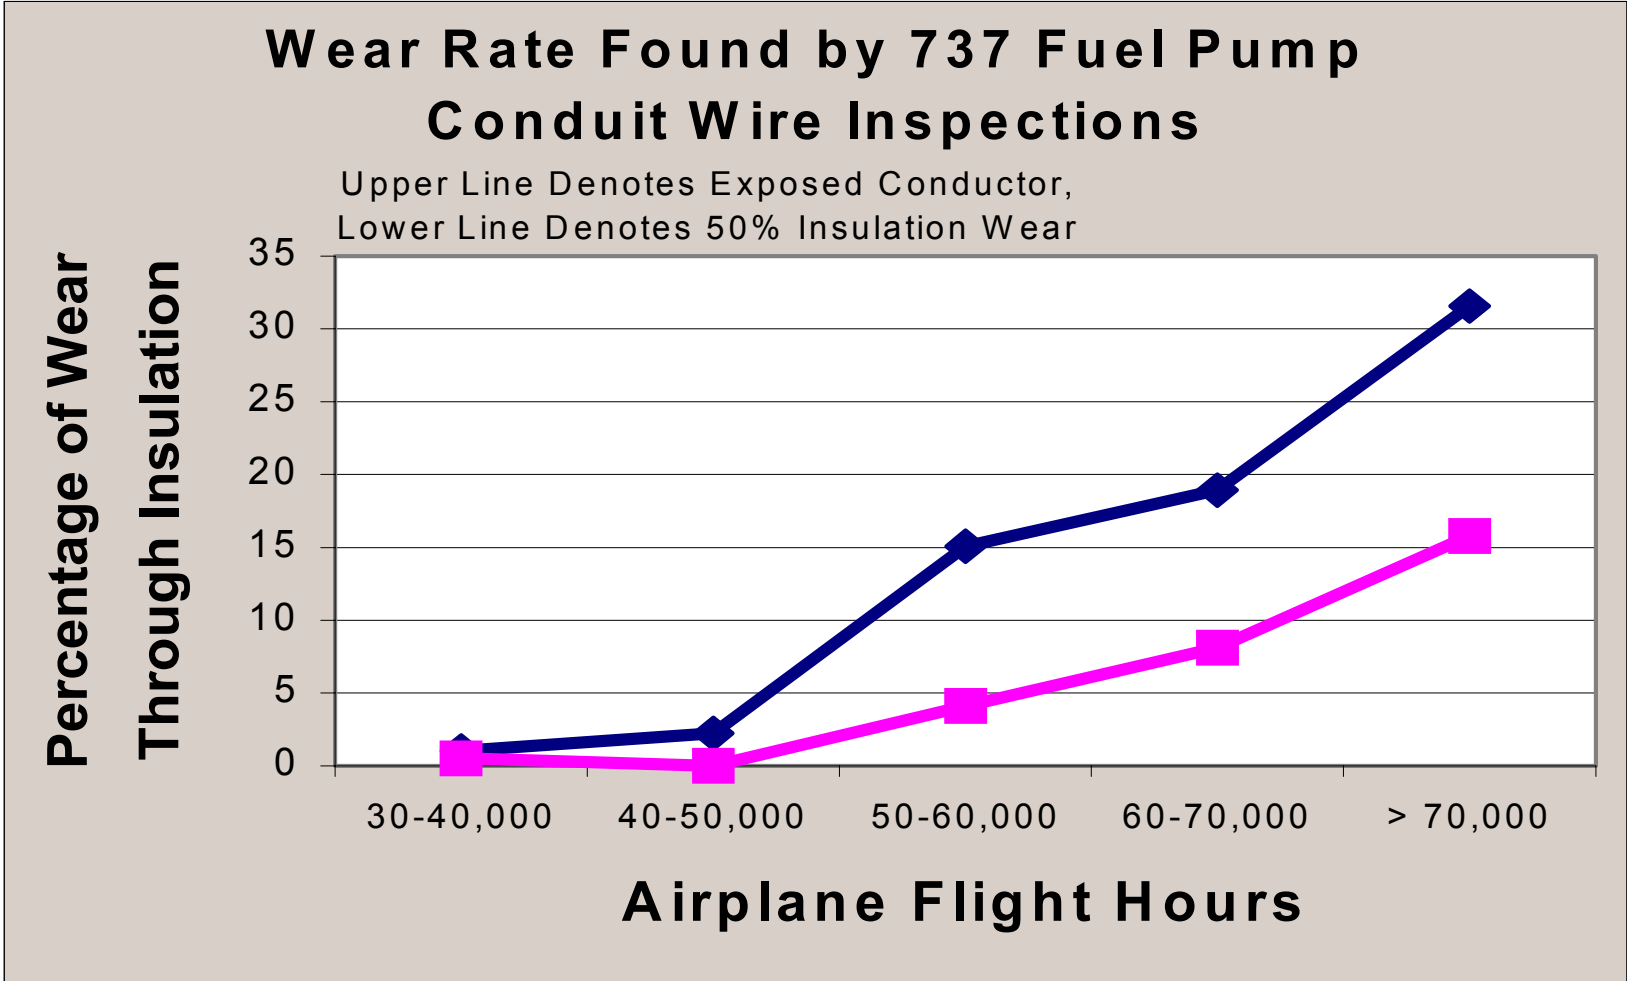
Figure 39. A chart showing the 737 fuel pump conduit wear rate that was identified by the FAA during representative 500 wire inspections.

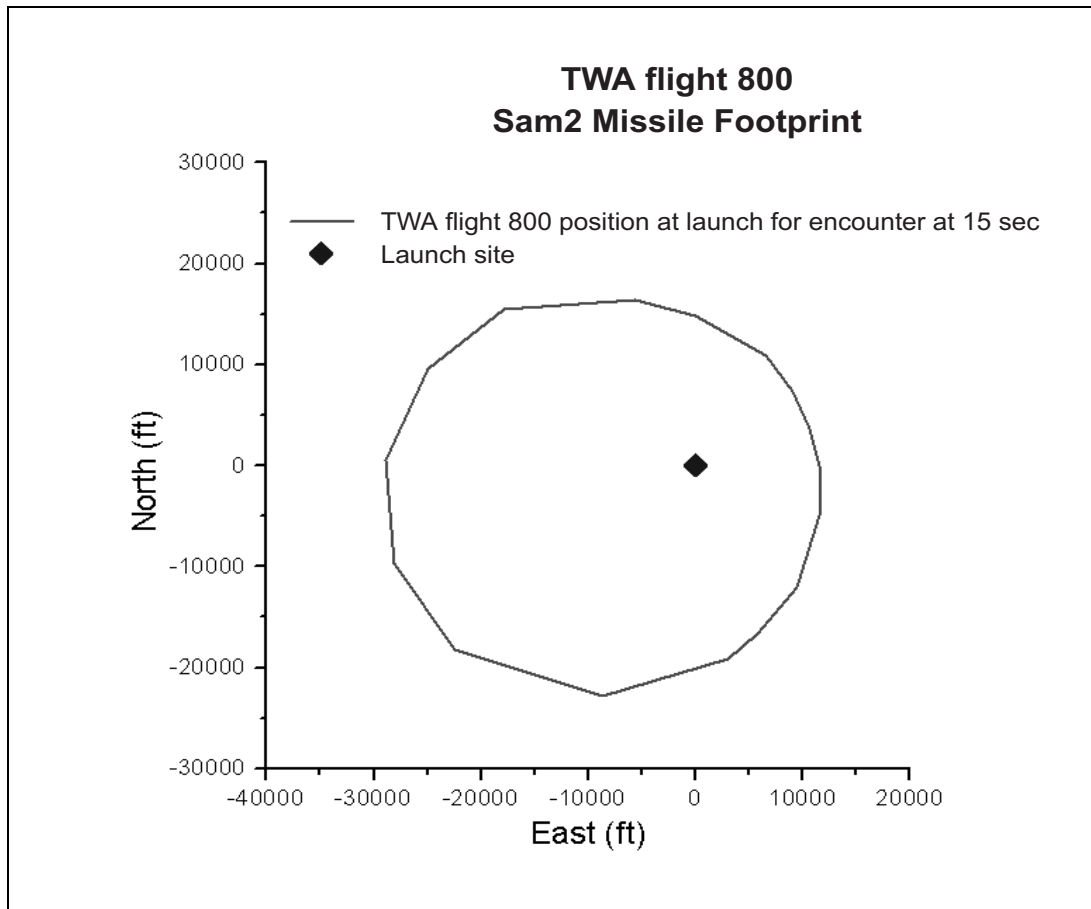
The Safety Board's computer simulations (using this missile performance data and taking into account the winds at the time of the accident) showed that the locations on the surface from which a missile launched at TWA flight 800 would result in selfdestruction within 40 feet of the airplane were extremely limited. Figure 44 shows airplane locations at which, if a high-performance missile were launched at the airplane, the missile would selfdestruct within 40 feet of the airplane. Note that, at the scale shown, the launch area that would result in a selfdestruction within 40 feet of the airplane is not as wide as the line showing the 15-second perimeter in this figure.

Simulations further showed that, because of the pattern in which missile fragments are dispersed after selfdestruction (see figure 43), launches from many of these positions would result in no fragments having a trajectory that would result in penetration of the CWT. For example, because of the nature of missile guidance, a launch from most positions on the perimeter shown in figure 44 would result in the missile catching the aircraft from behind. The area in front of the missile is not in the fragment dispersal area.

Figure 44. Diagram showing airplane and missile launch site locations that could result in missile selfdestruct within 40 feet of the plane.

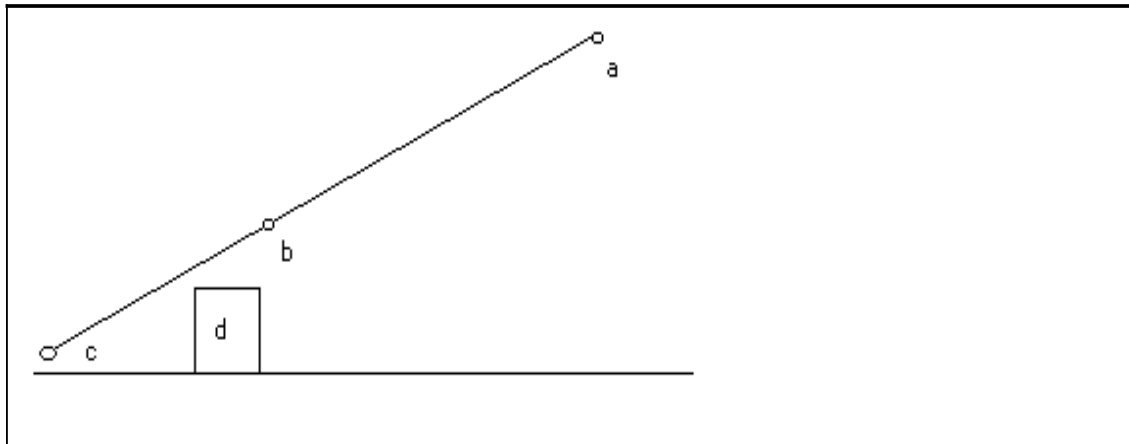
It should also be noted that witnesses observing the accident from Long Island would have been viewing it against a featureless background and, therefore, would have had few, if any, depth perception cues. Consequently, because of the tendency to perceive more distant objects as being about the same distance away as intervening objects (the equidistance tendency), the streak of light could have appeared closer to them than it actually was. The equidistance tendency is illustrated in figure 45, which depicts a person at point “c” observing an object at point “a” that appears at point “b” at the same perceptual distance as an intervening building at point “d.”

Figure 45. A graphical illustration of the equidistance tendency.

in the sky than it actually was, which explains why the streak of light may have been reported by some witnesses as having originated at the surface of the earth. It should be noted that almost all of the witnesses who reported that the streak of light originated at the surface viewed the streak of light on the far side of intervening terrain features, such as houses or the barrier island. These witnesses would have perceived the streak of light to be about the same distance as the intervening object because the elevation angle of the object would have been perceptually reduced.

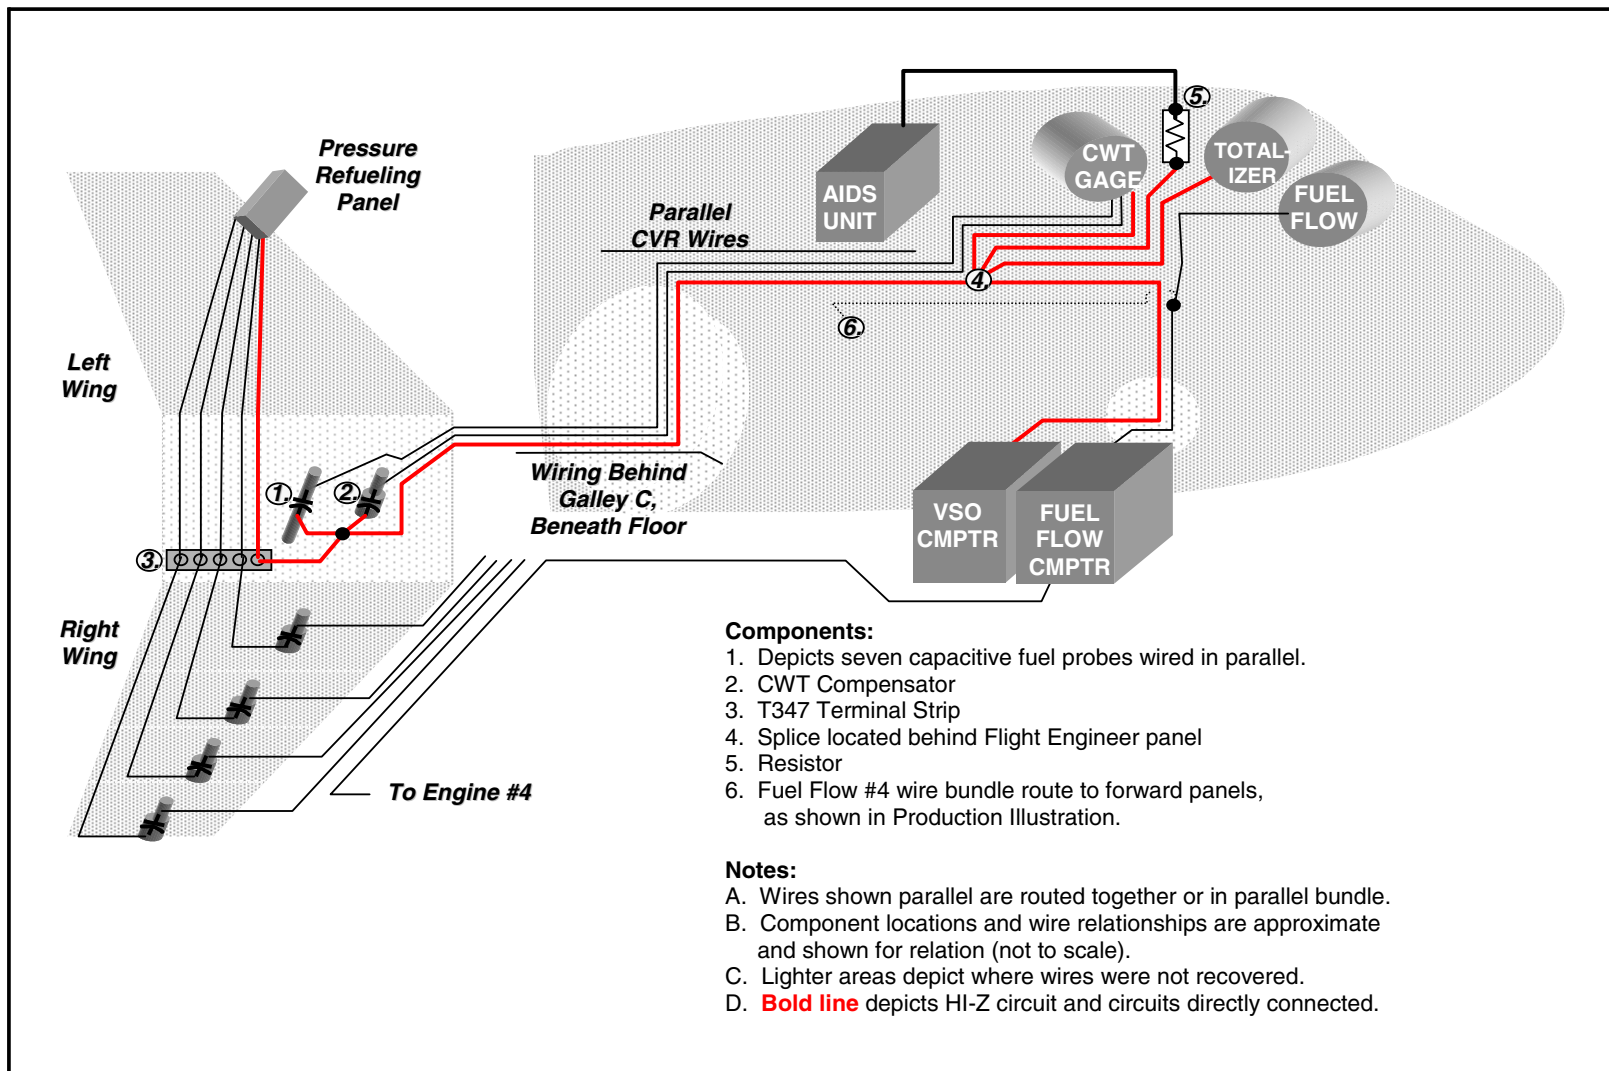
Metal Shaving Abrasion Tests (Dry)

The CWT FQIS wiring in the 747 terminates at common connectors with the fuel quantity indicator, the totalizer gauge, the airborne integrated data system (AIDS), the volumetric shutoff (VSO), and the left wing refueling station; each of these connectors also includes terminating wires from circuits that carry 115 volts.⁶⁰⁵ (See figure 46.) Short circuits in connectors have caused incidents in the past. For example, an October 22, 1995, incident involving roll/yaw oscillations on a 737 near Manchester, England, was attributed to a short circuit in the rudder circuitry of the incident airplane that resulted from lavatory fluid bridging the pins within an electrical conductor.

28 years old) revealed that all of the older airplanes exhibited numerous examples of mechanically damaged, chafed, cracked, and contaminated wires. The examinations also found sharp-edged metal drill shavings (which can damage wire insulation), fluid stains, and other potentially hazardous material in or near the aircraft wiring of old and new airplanes.
