INTERSTATE COMMERCE COMMISSION
WASHINGTON

REPORT OF THE DIRECTOR
BUREAU OF SAFETY

ACCIDENT ON THE
NEW YORK CENTRAL RAILROAD

APRIL 19, 1940

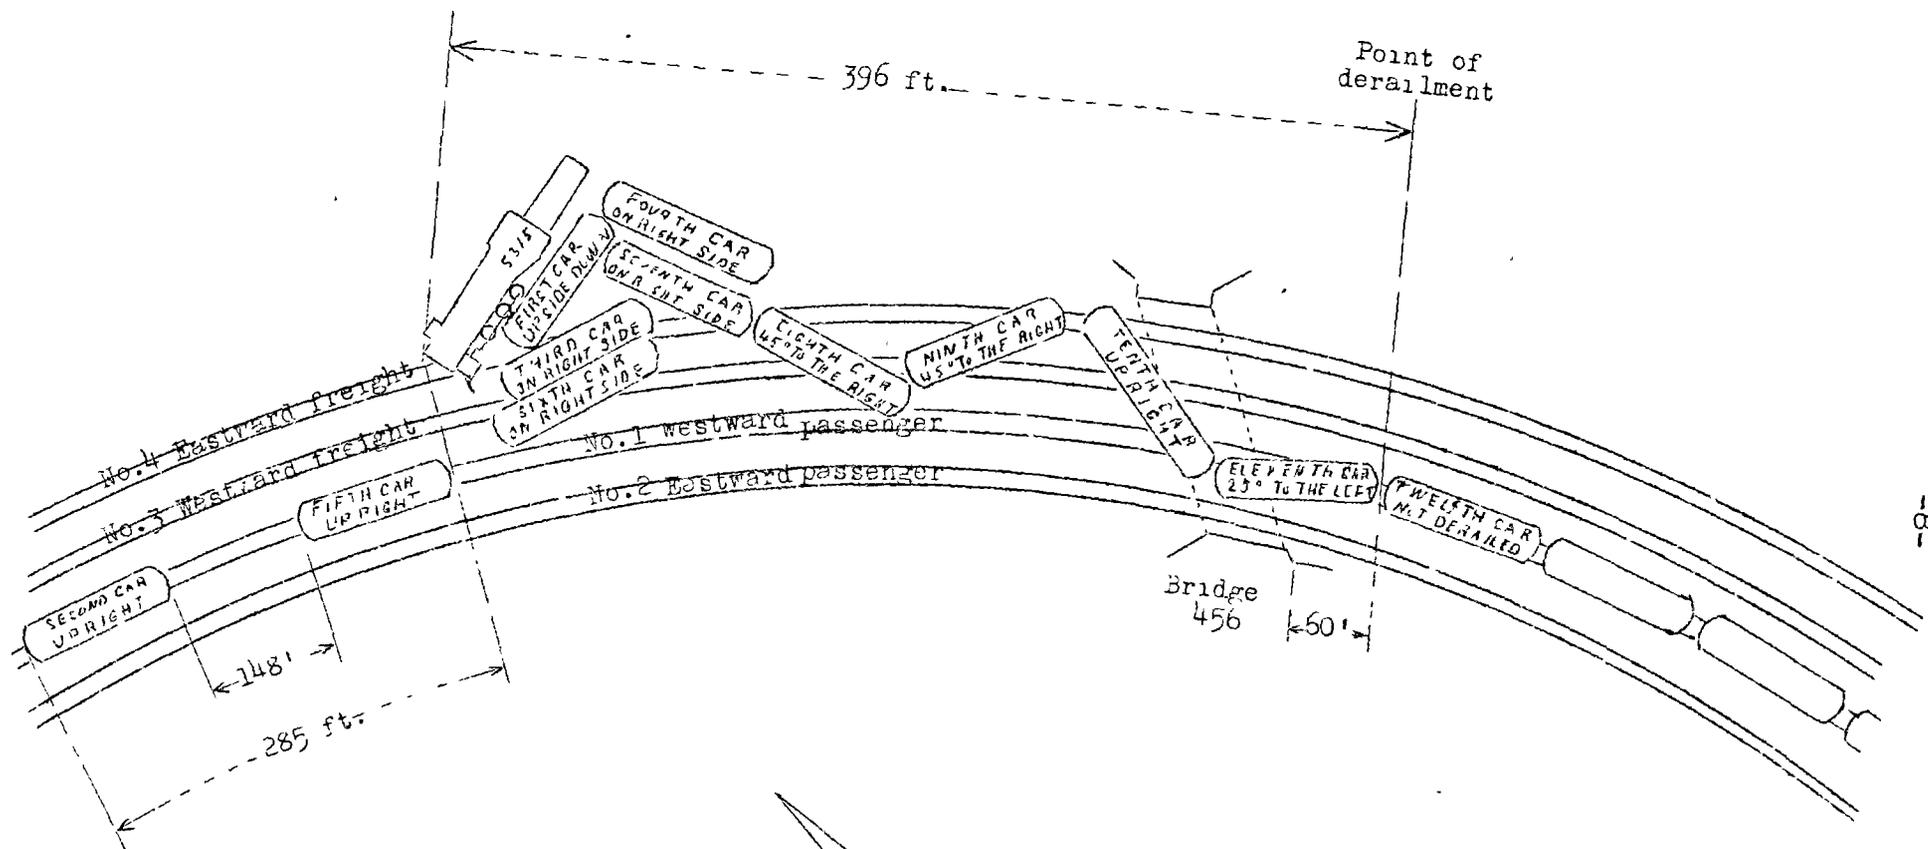
Inv. No. 2423
 New York Central R.R.
 Little Falls, N.Y.
 April 19, 1940

After becoming derailed, engine 5315 continued a distance of 396 feet diagonally across tracks Nos. 3 and 4 and stopped on its right side against the pinnacle of rock which rises between track No. 4 and East Main Street. The engine stopped with the front end of the smokebox on track No. 4 and the rear end of the boiler suspended on top of the rock pinnacle; the boiler lay at an angle of about 30 degrees to the line of track and the rear end was about 15 feet above the rails. Rock penetrated the firebox wrapper sheet just in front of the backhead, and the crown sheet and the right side-sheet were torn loose and the grate-bars were blown out as a result of an explosion which followed. The right injector, the right boiler-check, and the safety valves were knocked off. The engine truck was torn loose from the engine and stopped on track No. 3 about 5 feet ahead of the engine. The engine frame was broken on the right and left sides through the top and bottom rails between driving boxes Nos. 1 and 2; the frame, with the Nos. 2 and 3 pairs of driving wheels in place, jack-knifed, and the No. 3 pair of driving wheels stopped ahead of the No. 1 pair of driving wheels. The main and the parallel rods on both sides were badly twisted. The throttle lever and its quadrant were distorted badly; the throttle extension-rod to the front-end throttle-box was broken off. The tender, remaining coupled, stopped on its right side, at an angle of 105 degrees from upright, on top of the rock pinnacle; both trucks were torn loose; the rear coupler was broken off. The first car, N. Y. C. express car 3476, became derailed, stopped upside down and parallel to the engine, and fouled tracks Nos. 3 and 4; the superstructure was demolished, the front coupler broken off, the rear coupler shank bent, and both

pairs of wheels from the rear truck were detached and lying 15 feet southeast of the rear end of the car; the truck frame was lodged on the roof of the third car. The second car, N. Y. C. baggage car 8120, became uncoupled at both ends and stopped, upright, on track No. 1 at a point 285 feet west of the front end of the engine; the front truck was derailed; the front and the rear coupler shanks were bent; the right side-sheet and the left front corner-post were damaged. The third car, N. Y. C. coach 2419, became derailed and stopped on its right side diagonally across tracks Nos. 3 and 4; the roof was bent and torn, and the frame distorted; the end frames and vestibules were demolished, and all side sheets bent and twisted; both couplers were torn out. The fourth car, N. Y. C. coach 2337, became derailed and stopped, in East Main Street, on its right side with its front end against the tender; it was badly damaged; both trucks were torn loose, and the rear coupler was missing. The fifth car, Pullman Red Ash, became derailed and stopped upright in line with track No. 1 and about 80 feet ahead of the engine; the roof was torn off almost its entire length, the right side-sheets were torn away about two-thirds its length, and the interior was destroyed; both trucks were badly damaged and the front coupler-head was broken. The sixth car, Pullman Poplar Arch, became derailed and stopped on its right side diagonally across tracks Nos. 1, 3, and 4; half of the roof was sheared off, the steel center-sills were broken at the front body end-sill, the front end-frame and sheets were bent and torn, and both sides were badly bent and buckled; both couplers were missing; both trucks were torn loose and stopped between tracks Nos. 1 and 3. The seventh car, Pullman Elkhart Valley, was derailed and stopped on its right side diagonally across track No. 4, parallel to the body of the fourth car and on top of the trucks of the fourth car; the front end of the seventh car crushed into the side of the first car; both trucks were in place but the wheels of the front truck were about 15 feet distant from the front end of the car; the superstructure at the front end was demolished and the front coupler-head was broken; the superstructure at the rear end was twisted and bent, the body end-sill and the left side-sill were broken, and the side sheets on the right side were torn, bent, and buckled the entire length of the car. The eighth car, Pullman Poplar Dome, was derailed, stopped diagonally across tracks Nos. 1, 3, and 4, and leaned at an angle of 45 degrees to the north; the front truck was torn loose and stopped, badly damaged, against the rear truck, both vestibule frames were badly distorted, the roof at the rear end was bent and torn, and the right side-sill was distorted; the right side sheets were bent, several of them were torn, and all bore raking marks; the front coupler-pocket was broken and the coupler was missing. The ninth car, N. Y. C. dining car 560, was derailed and stopped across tracks Nos. 1,

3, and 4 and leaned at an angle of 45 degrees to the right; the rear end was about 27 feet distant from track No. 1; the roof sheets and the end frames were bent and broken, the side sheets were bent, and most of the interior was destroyed; the front coupler-head was broken and the rear coupler was missing. The tenth car, Pullman Lake Bruin, was derailed and stopped diagonally across tracks Nos. 2, 1, 3, and 4 and leaned to the right at an angle of about 45 degrees; both trucks remained in place but were badly damaged; the front end-frame, the front sheets, and the roof sheets were bent and broken inward; the front coupler-head was cracked and the rear coupler-head was broken. The front end of the eleventh car, Pullman East Bernard, was derailed; this car stopped with the front end fouling track No. 2 and leaning to the left at an angle of 25 degrees; the side sheets on both sides, the front end roof-sheet, and the front end-sheet were bent. The remaining cars in the train were not derailed and sustained but slight damage.
