**INTERSTATE AVIATION COMMITTEE
AIR ACCIDENT INVESTIGATION COMMISSION**

**INTERIM REPORT
(PRELIMINARY REFERENCE INFORMATION)
ON ACCIDENT INVESTIGATION**

Type of occurrence	Accident
Type of aircraft	RRJ-95 (RRJ-95B)
Registration	RA-89098
Owner	JSC «VEB-Leasing»
Operator	«Aeroflot » PJSC
Aviation authority	Federal Air Transport Agency (Rosaviatsiya)
Place of occurrence	Russia, Moscow region, Sheremetyevo airport, coordinates: 55°58'06.20" N, 37°24'07.20" E.
Date and time of occurrence	05.05.2019, 18:30 local time (15:30 UTC), daytime

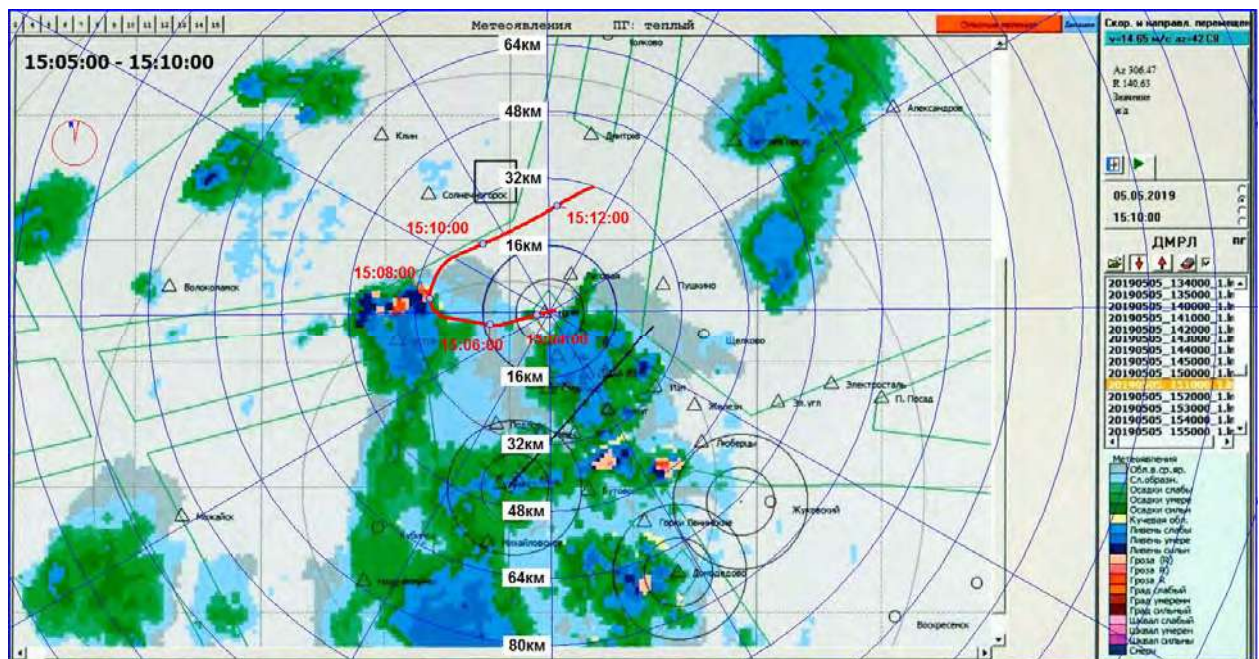
Fig. 2. Flight path combined with the DMRL-C Vnukovo weather radar for the time 15:05 – 15:10

At 15:07:10, the «HEADING» / «HDG» mode was engaged in the lateral control channel, and the selected heading was set to 327° . According to the Vnukovo⁷ doppler weather radar, the aircraft was flying through the active thunderstorm area (Fig. 3), that was moving from the south-west to north-east with the speed of 40-45 km/h. The transition to the selected heading mode caused the aircraft to initiate the right turn earlier than it is prescribed by SID KN 24E (Fig. 4). The crew did not requested the active thunderstorm area avoidance clearance. Section 1.18.1 of the present

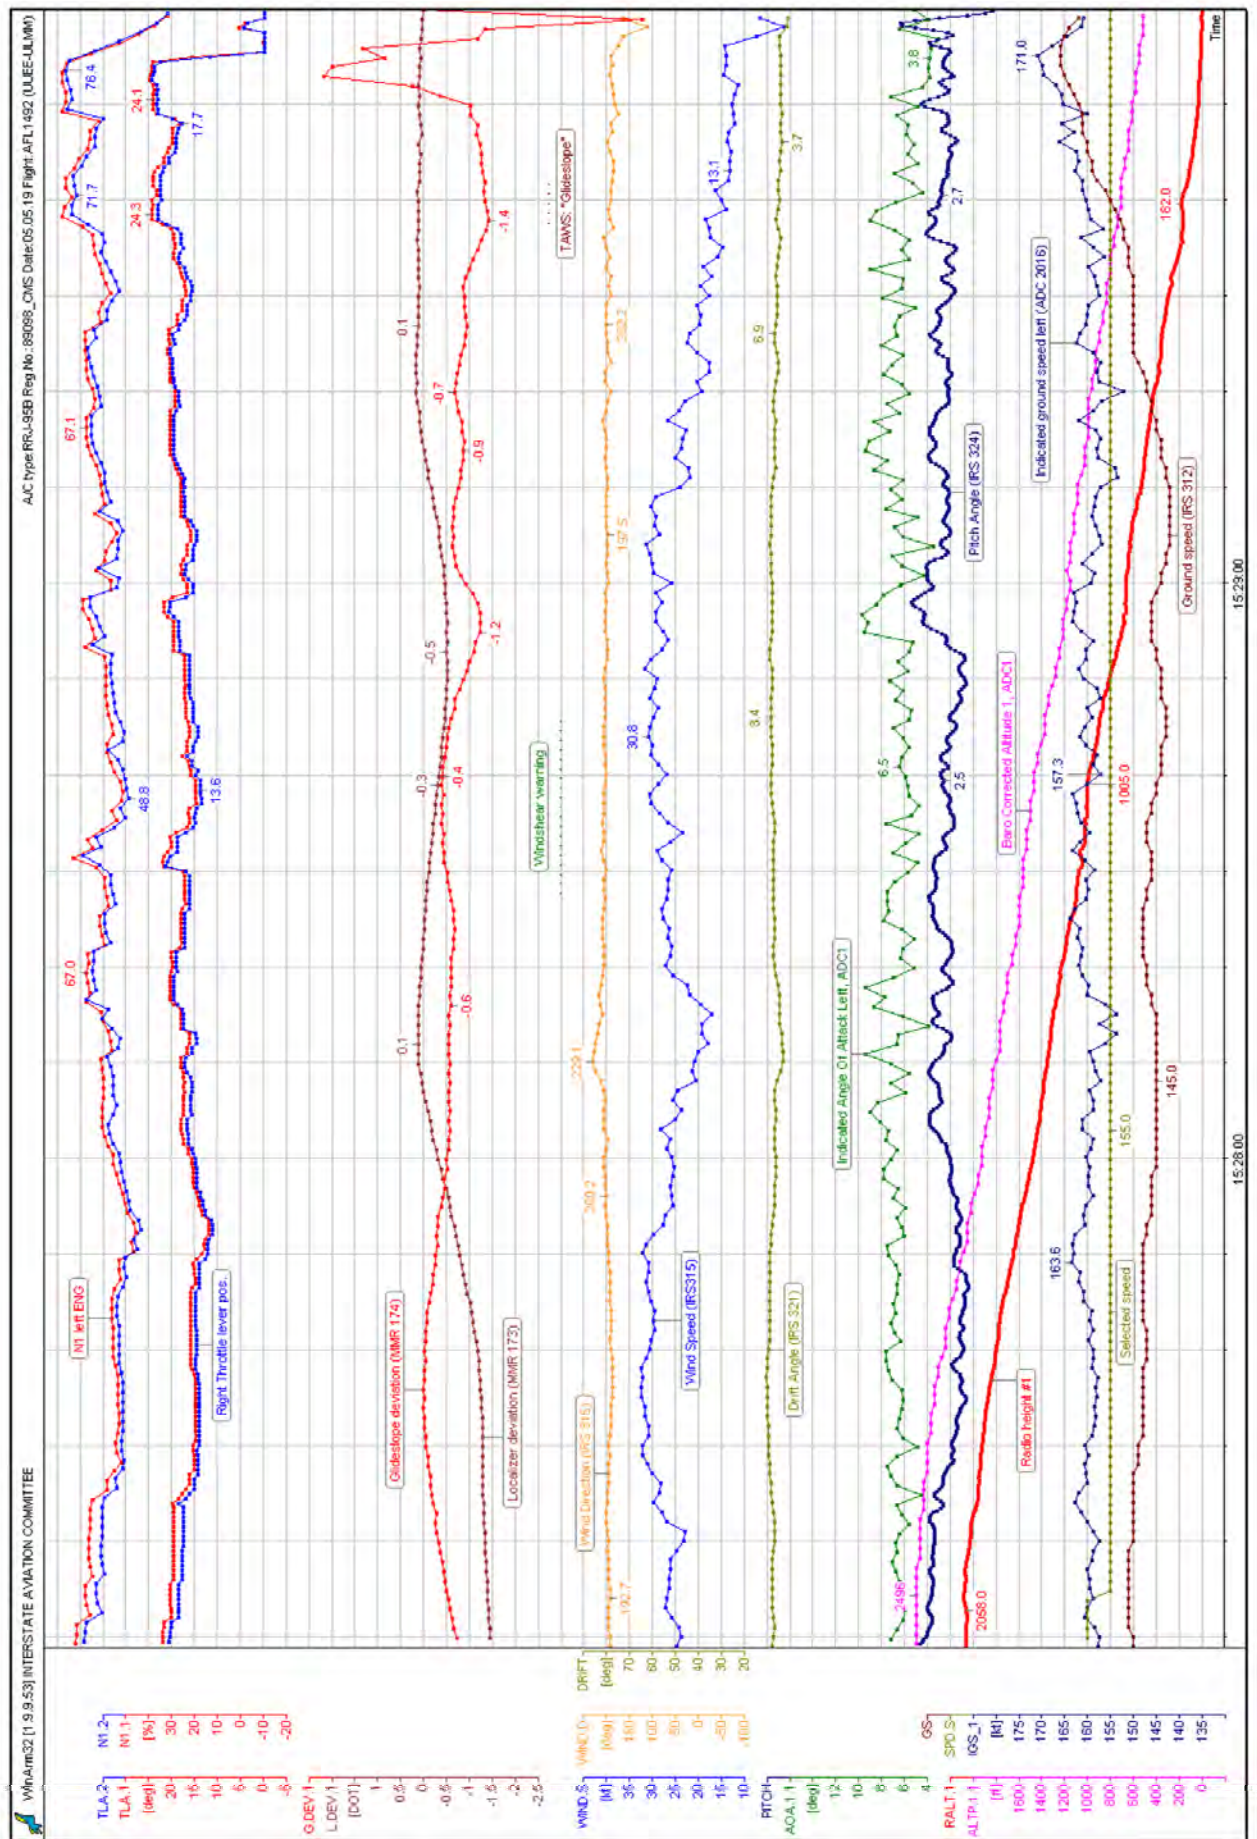
Fig. 6. Flight parameters while approach at the glide path

At 15:27:20, the glideslope descent was initiated. The go-around altitude was not set by the crew. The flight parameters during the glideslope descent are provided in Fig. 6 and Fig. 7.

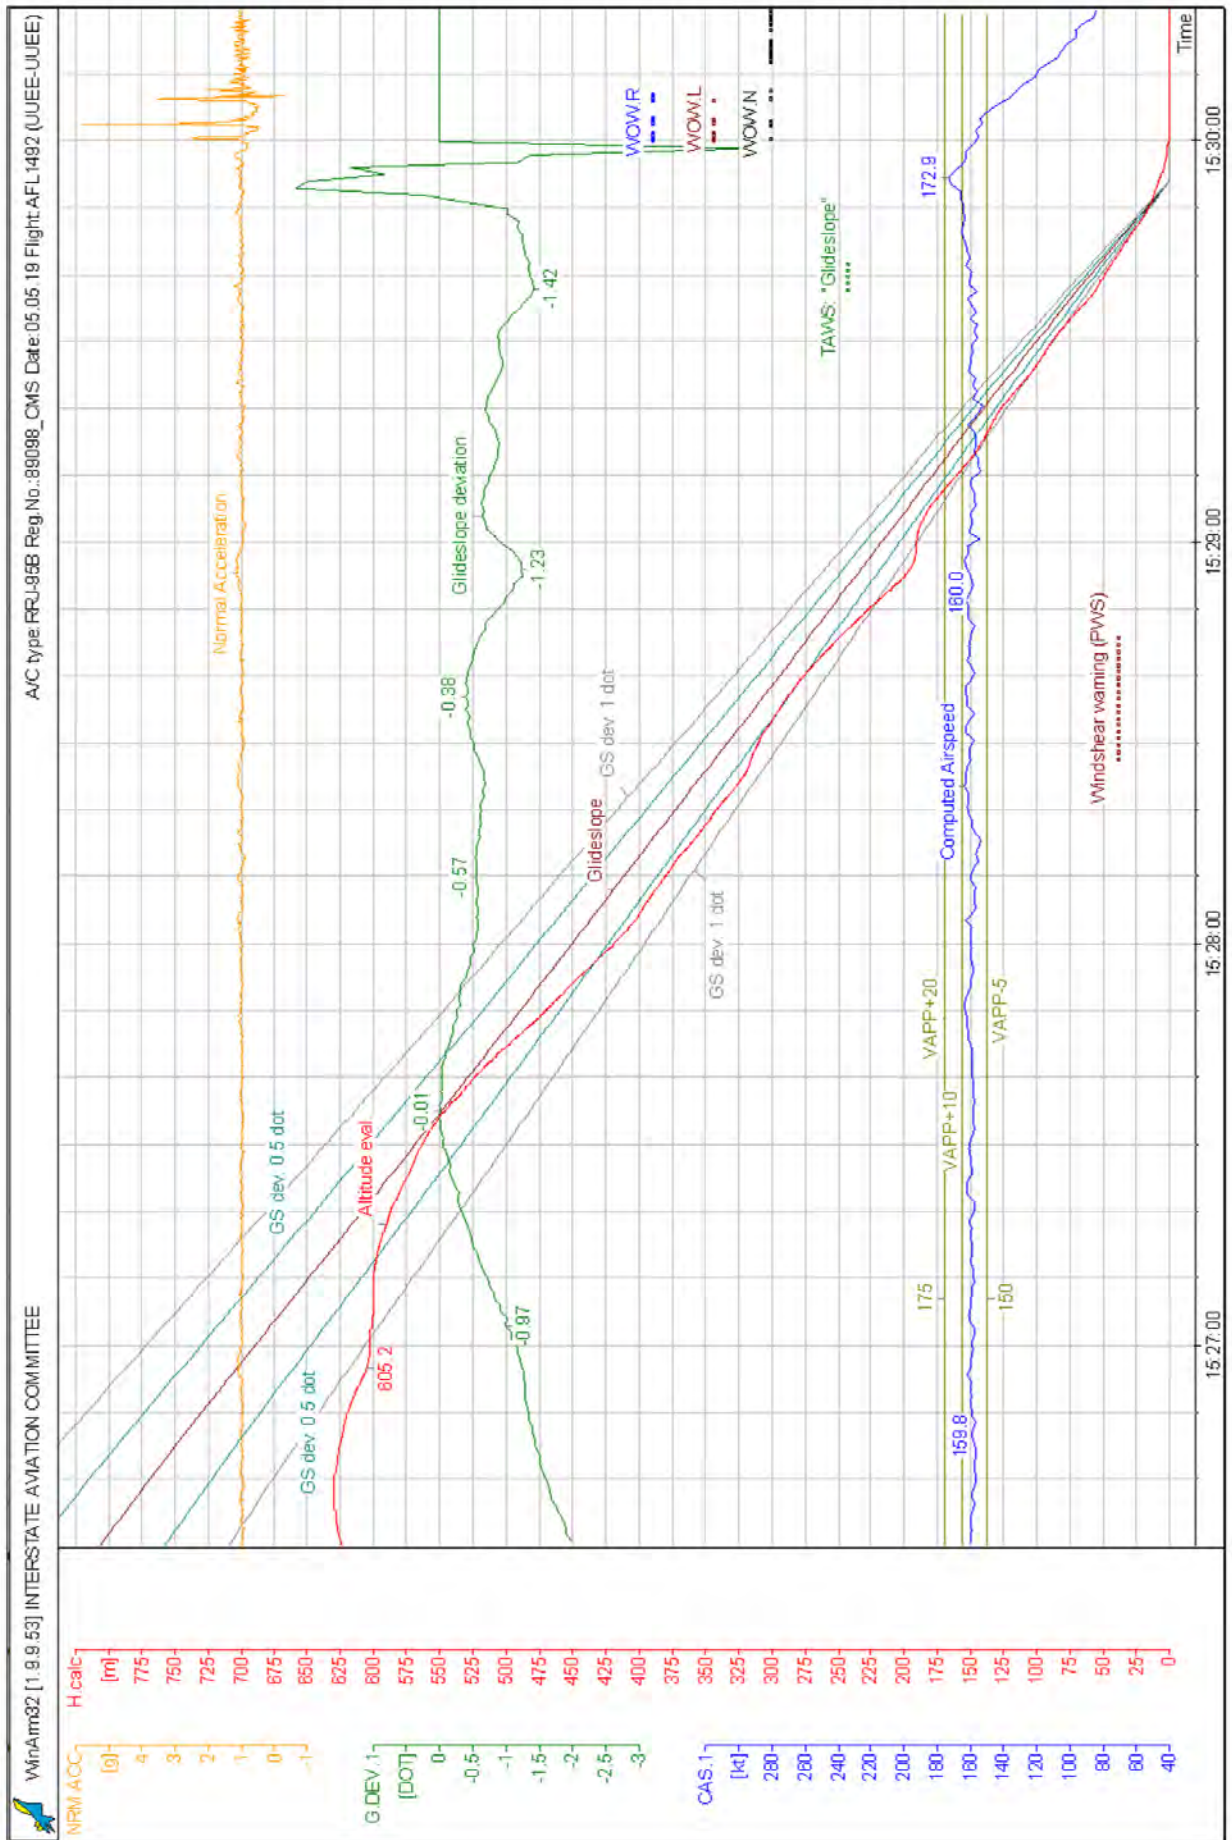
Fig. 7. Vertical approach profile via the glideslope

The descent was performed at the indicated air speed of 155...160 kt (287...296 km/h) parallel to (lower) the prescribed glideslope (Fig. 7). The heading deviation did not exceed 0.5 dot.

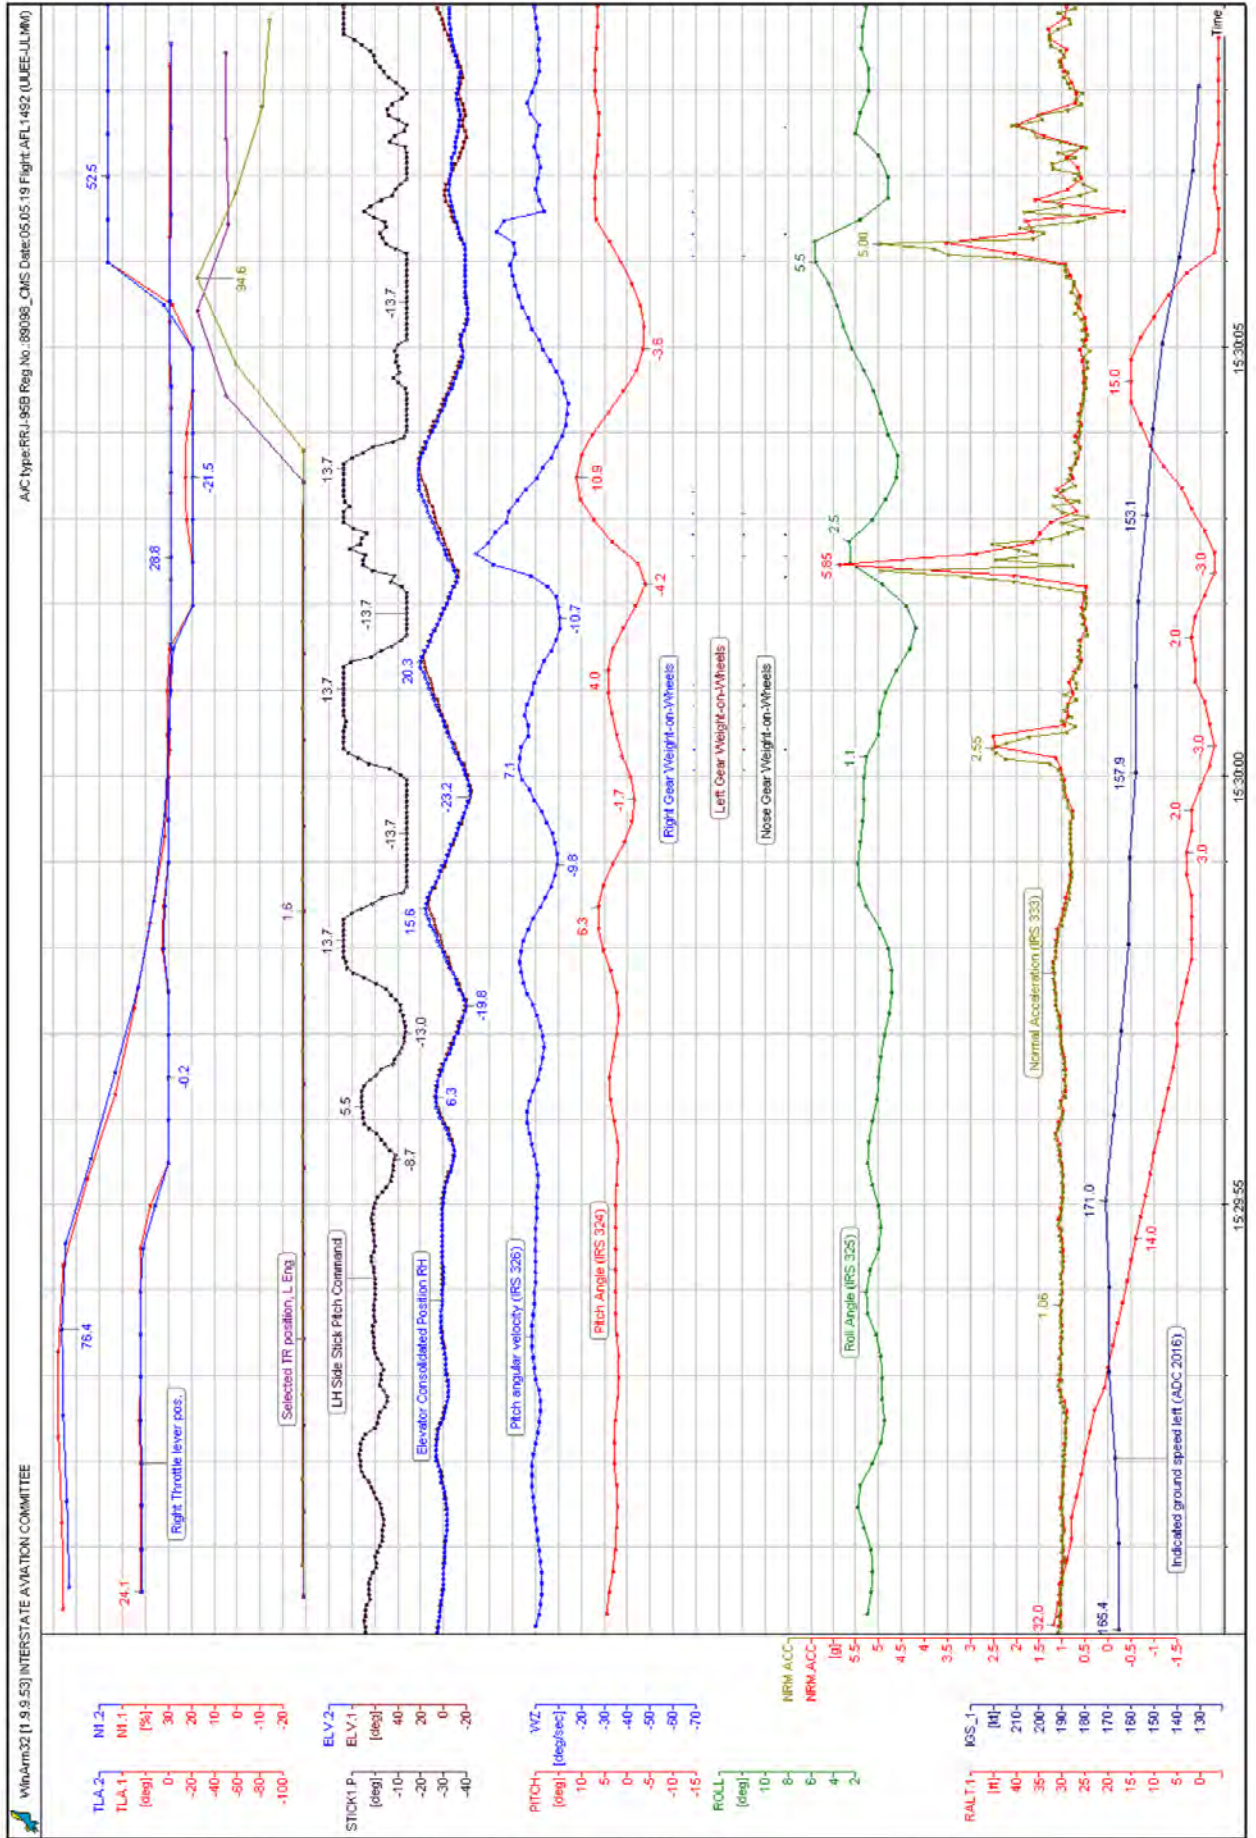
Fig. 8. Flight parameters while landing

Over the RWY threshold, the glideslope deviation was minus 0.9 dot (i.e. below the glideslope). After passing the RWY threshold, the the vertical speed of descent was decreased. The flight parameters during landing are provided in Fig. 8.

Almost simultaneously with the thrust levers positions changed to "IDLE", the PIC initiated the flare by pulling the sidestick by 8.8° (65% of its travel range). Further on, the PIC's ever-amplitude increasing pitch sidestick inputs were recorded up to the both maximum advanced and maximum retarded positions with a relatively long holding period in the both maximum positions. These inputs caused counter-reversal pitch change (+6...-2°). At 15:30:00, at a distance of ≈900 m from the RWY threshold at indicated air speed of 158 kt (293 km/h), first touchdown occurred. The touchdown occurred at the pitch angle close to zero (7 pitch up rate; at the moment of the touchdown, the sidestick was in the maximum retarded position; and during the landing within 0.4 seconds, its position was changed for the maximum advanced), for "threedots", with vertical g-force of no less than 2.55 g.

According to the information, provided in Aircraft Maintenance Manual Section 17-51-00, Task 200-801, Page 606, the aircraft landing with exceeded maximum landing weight and the vertical g-force of 1.94 to 2.25 g are classified as hard landing, landing with vertical g-force exceeding 2.25 g are classified as very hard landing.

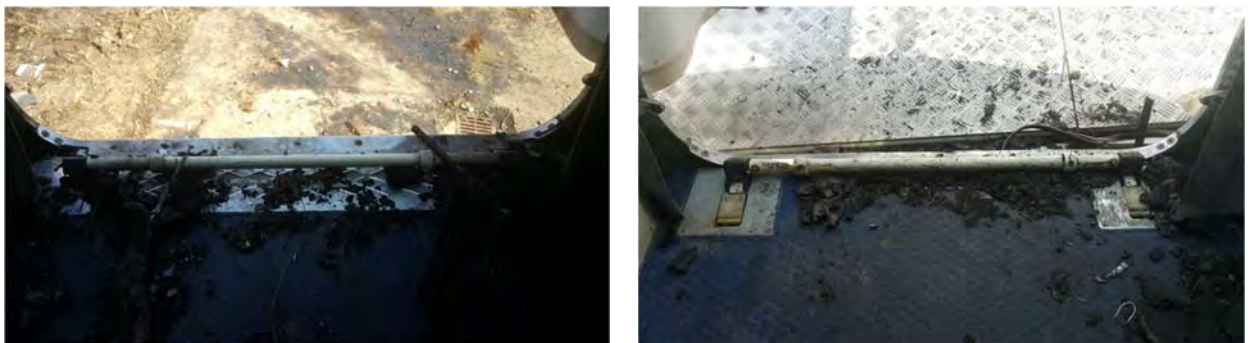
Fig. 17. External view of the front doors (left, right)

Front right and left doors of the cabin are opened, bars of the safety slides connected to brackets of door beams (Fig. 17).

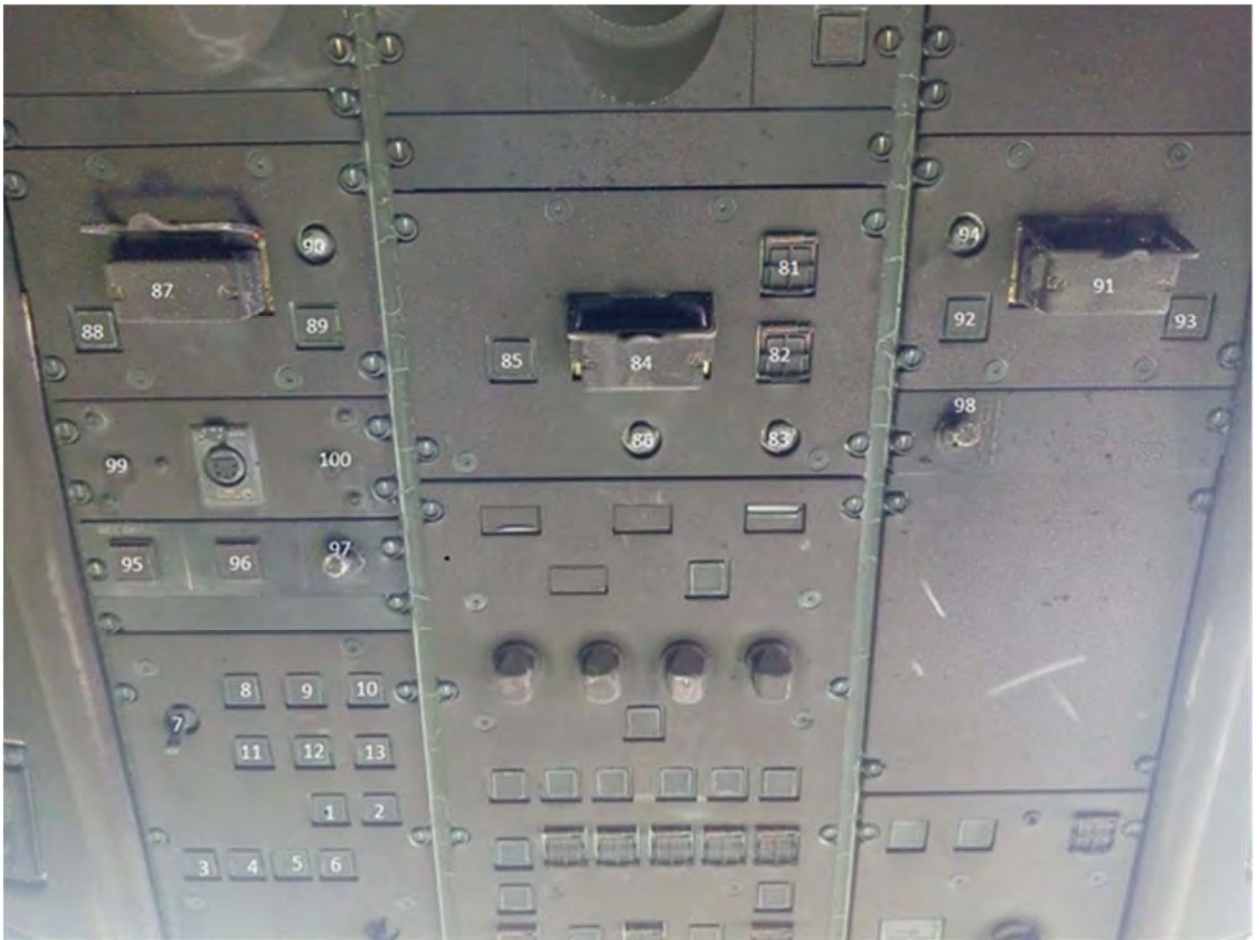
Fig. 21. Engines and APU fire extinguish systems switch condition after the accident

The examination of the cockpit equipment after the accident showed that APU FIRE (APU fire protection system, Fig. 21, position № 84), L ENG FIRE (left engine fire protection system, Fig. 21, position № 87) and R ENG FIRE (right engine fire protection system, Fig. 21, position № 91) were «Activated».

The fire extinguish system containers were weighted in order to determine whether they were used during the last flight. It was determined that all the containers were full. The APU fire extinguish system container was not detected.

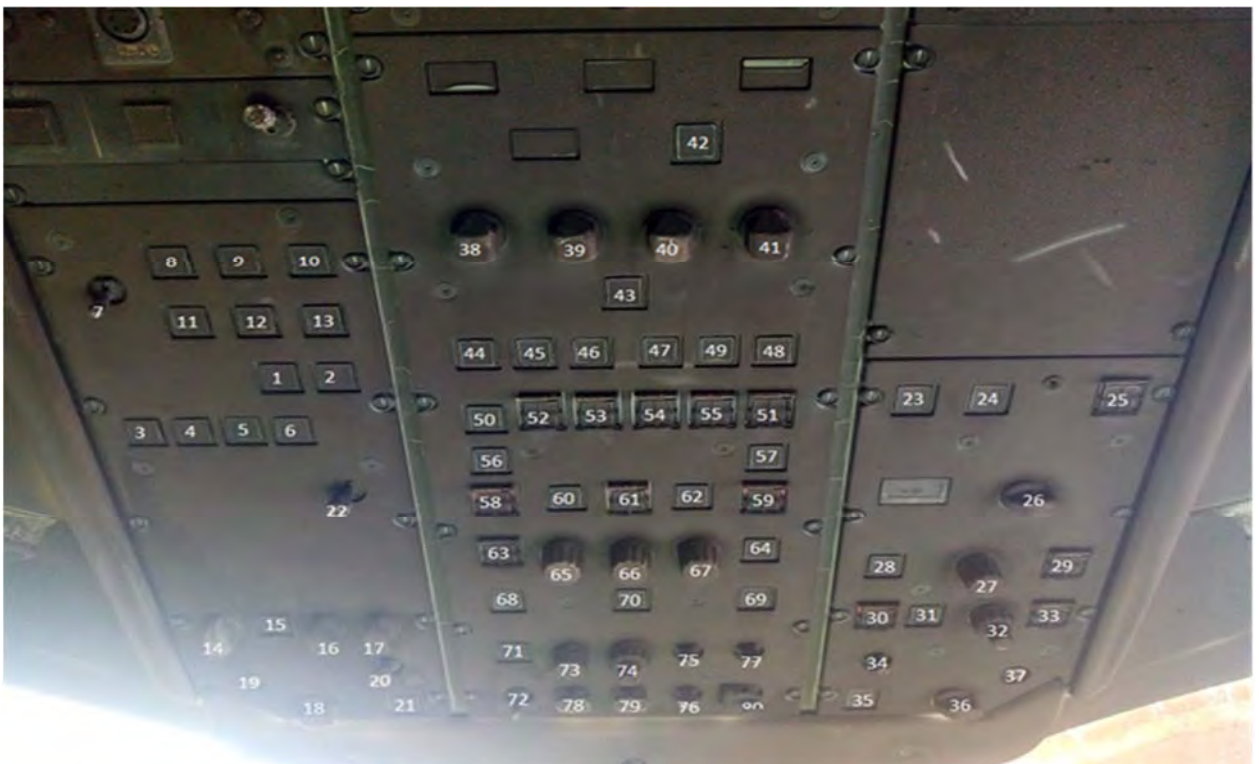
Fig. 22. Electrical batteries buttons condition after the accident

The buttons of all the for electrical batteries are off. (Fig. 22, positions №№ 52, 53, 54, 55).

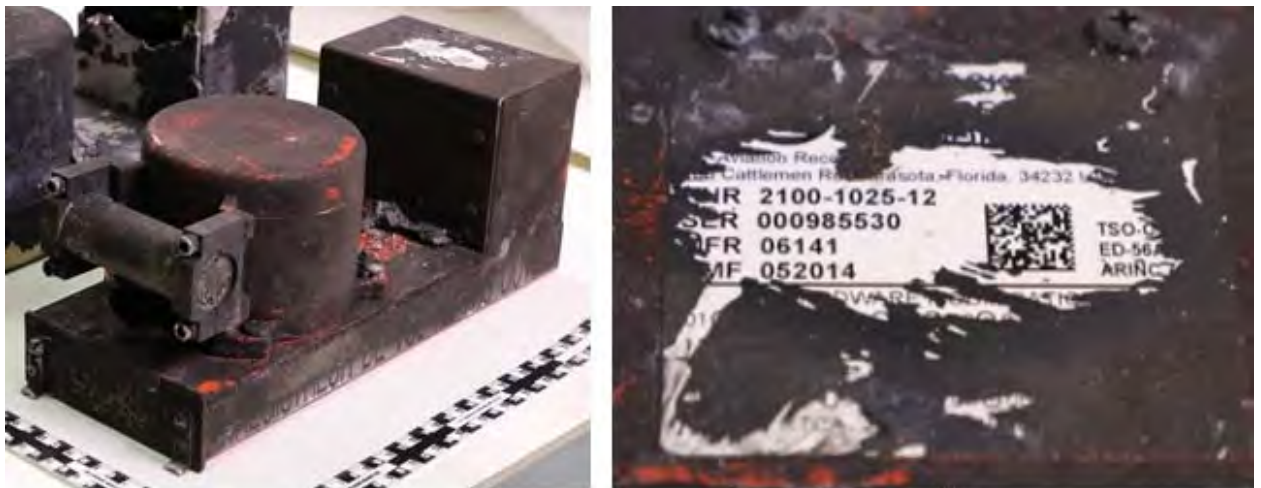
Fig. 31. CVR L3 FA2100: a) general view, б) device label

- CVR L3 FA2100 PNR 2100-1025-12 was damaged, its housings and protected memory module are covered with soot, no deformation (Fig. 31);
- Integrated Data Management Unit (iDMU) PNR 223560006 with a PCMCIA Flash-card s/n 2088-51M. The body of the iDMU is not damaged, was not exposed to fire, is in satisfactory condition (Fig. 32).

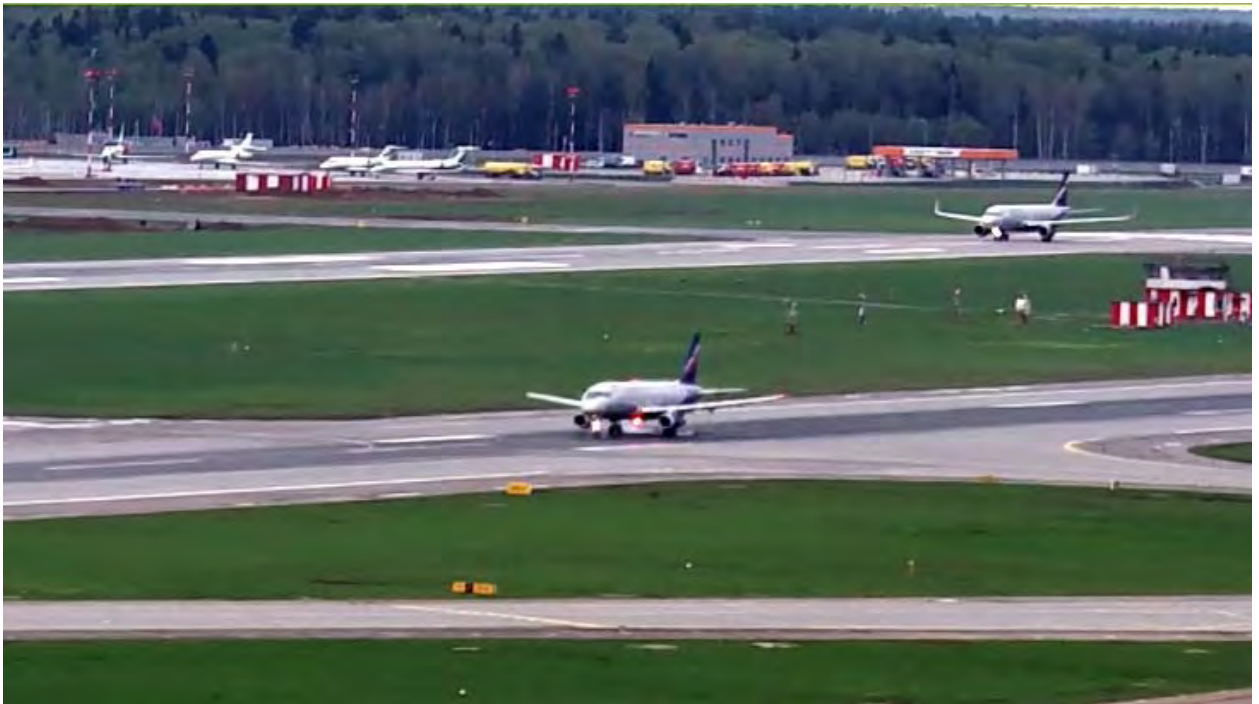
Fig. 33. First touchdown point

As per the records of the Sheremetyevo CCTV the first touchdown occurred with all the three landing gear legs at once at the A8 TWY at a distance \approx 890 m off the RWY 24L threshold (Fig. 33), the aircraft bounce off the RWY occurred afterwards (Fig. 34).

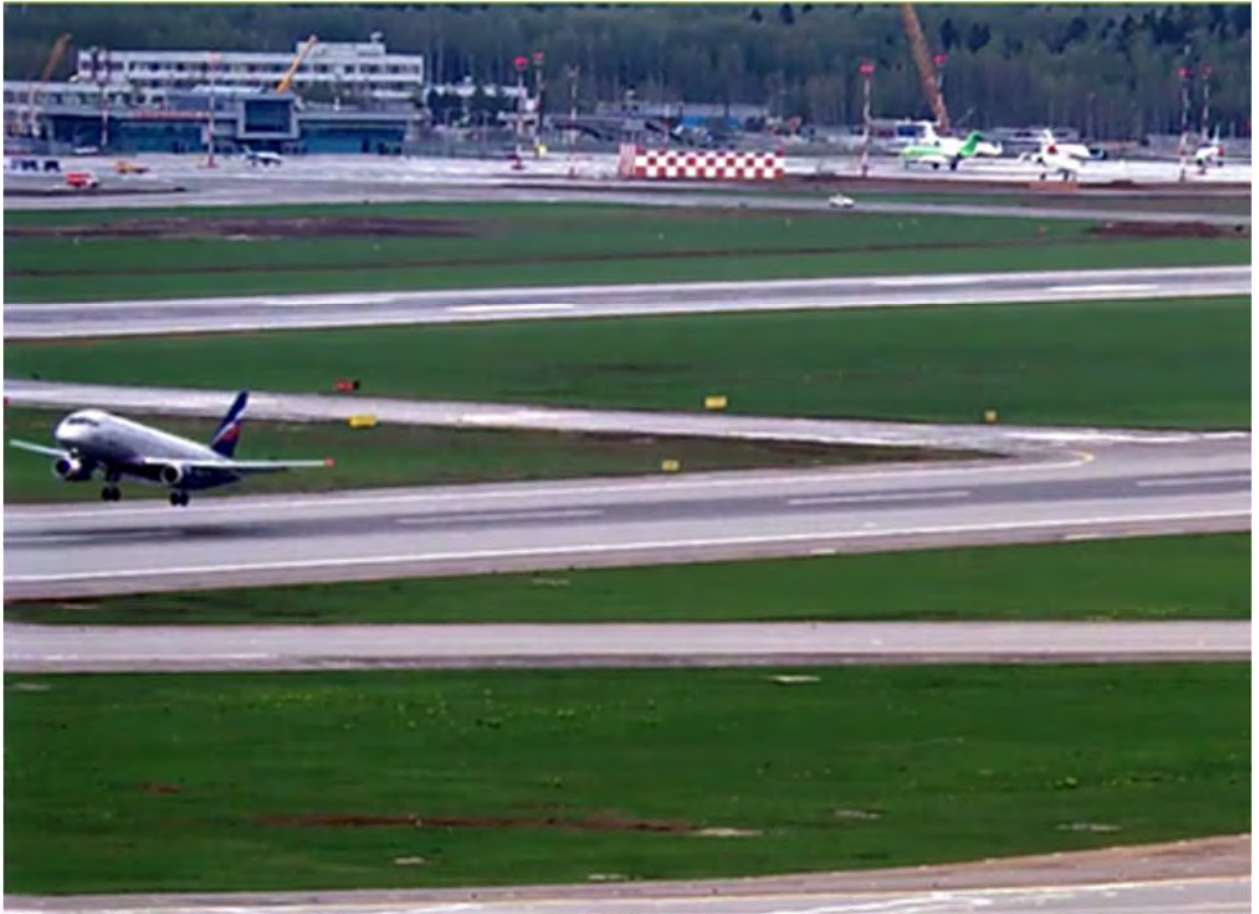
Fig. 36. The aircraft bounce after the second touchdown

The second touchdown occurred at the distance of \approx 1070 m from the RWY 24L threshold, first by the nose gear leg with the further main gear legs impact with the RWY (Fig. 35), another bounce off the RWY occurred afterwards (Fig. 36). At the area of the second impact there were no fuel traces or aircraft fragments found.

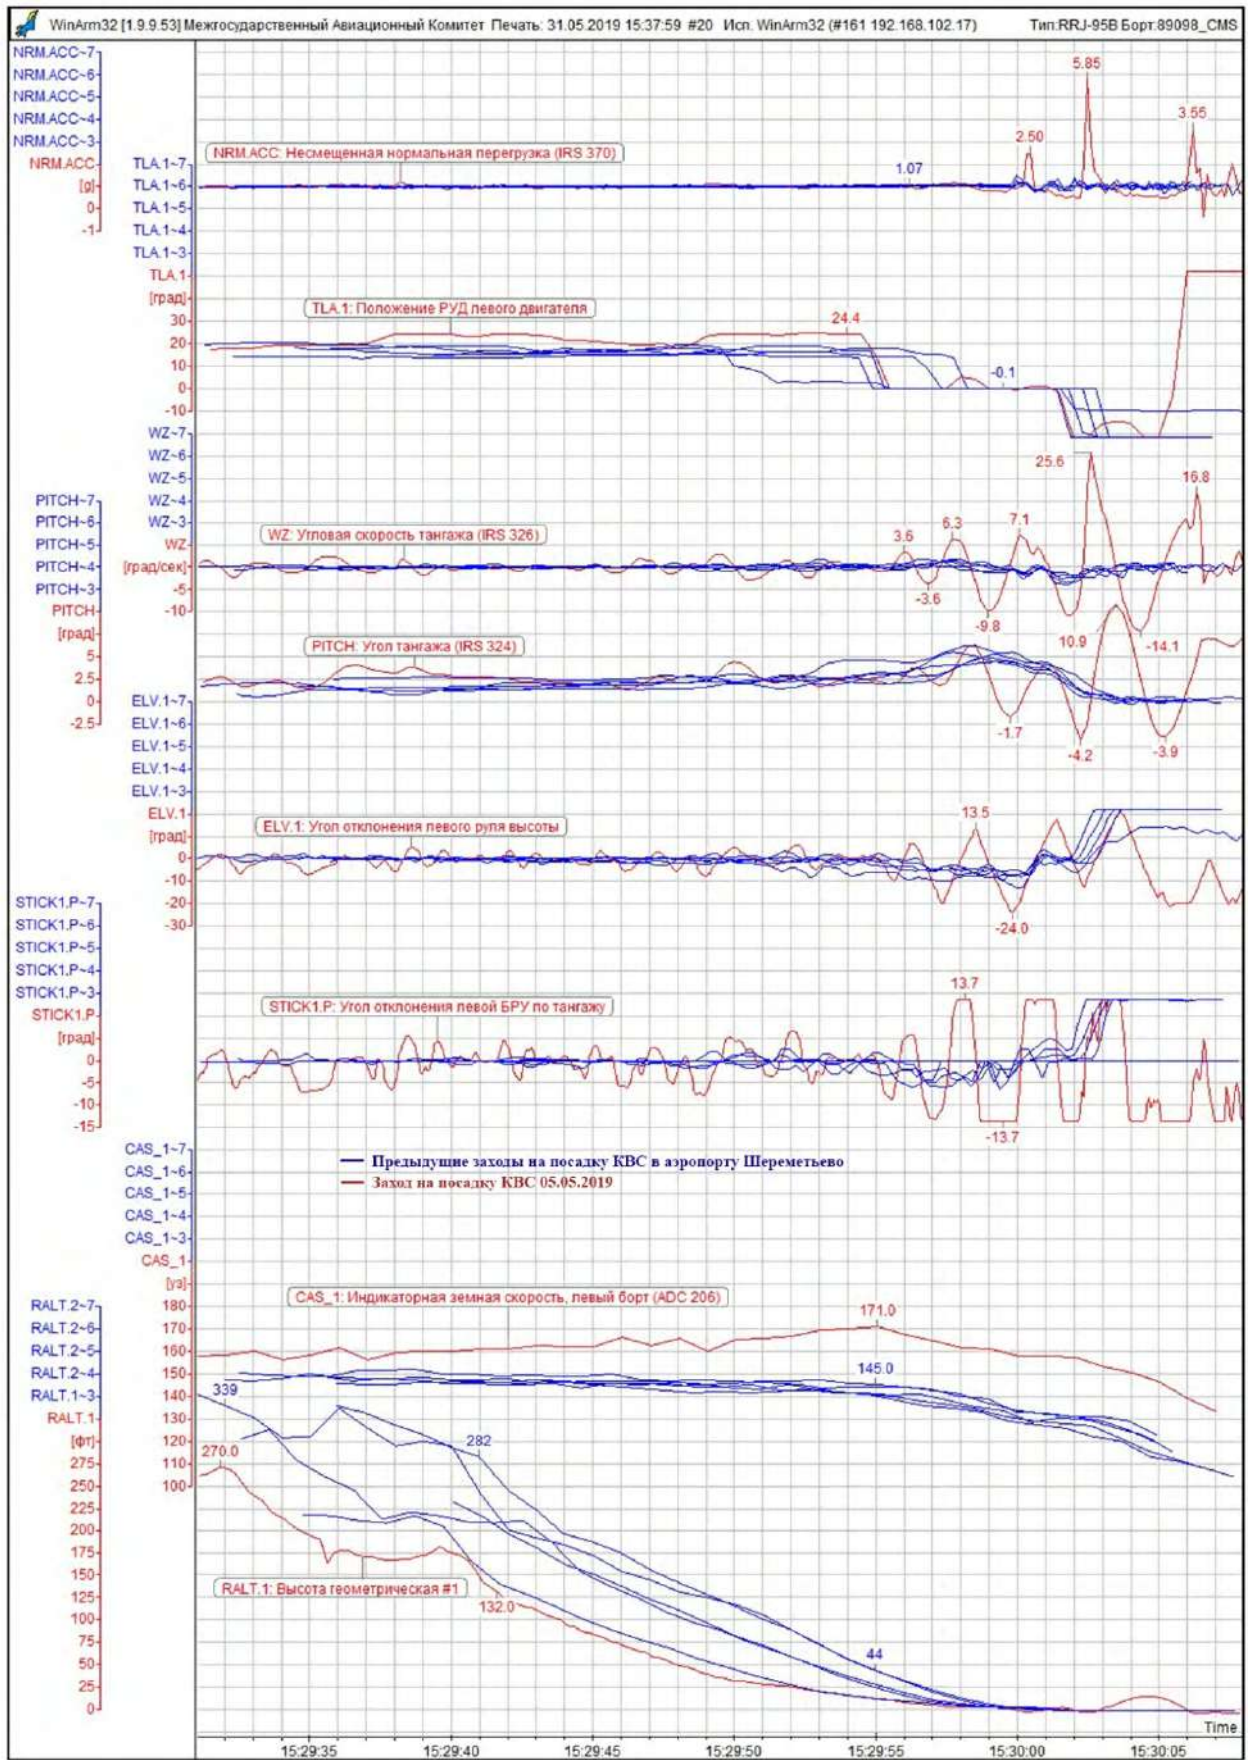
Fig. 42. PIC approach comparative analysis

The Commission carried out preliminary comparative analysis of the approaches performed by the PIC manually (with disengaged autopilot) in «NORMAL MODE», with the emergency flight (Fig. 42). The figure shows that the sidestick movements for the pitch in the emergency flight are characterized by significantly wider amplitude, and are oscillatory, which caused significant changes of longitudinal motion parameters.

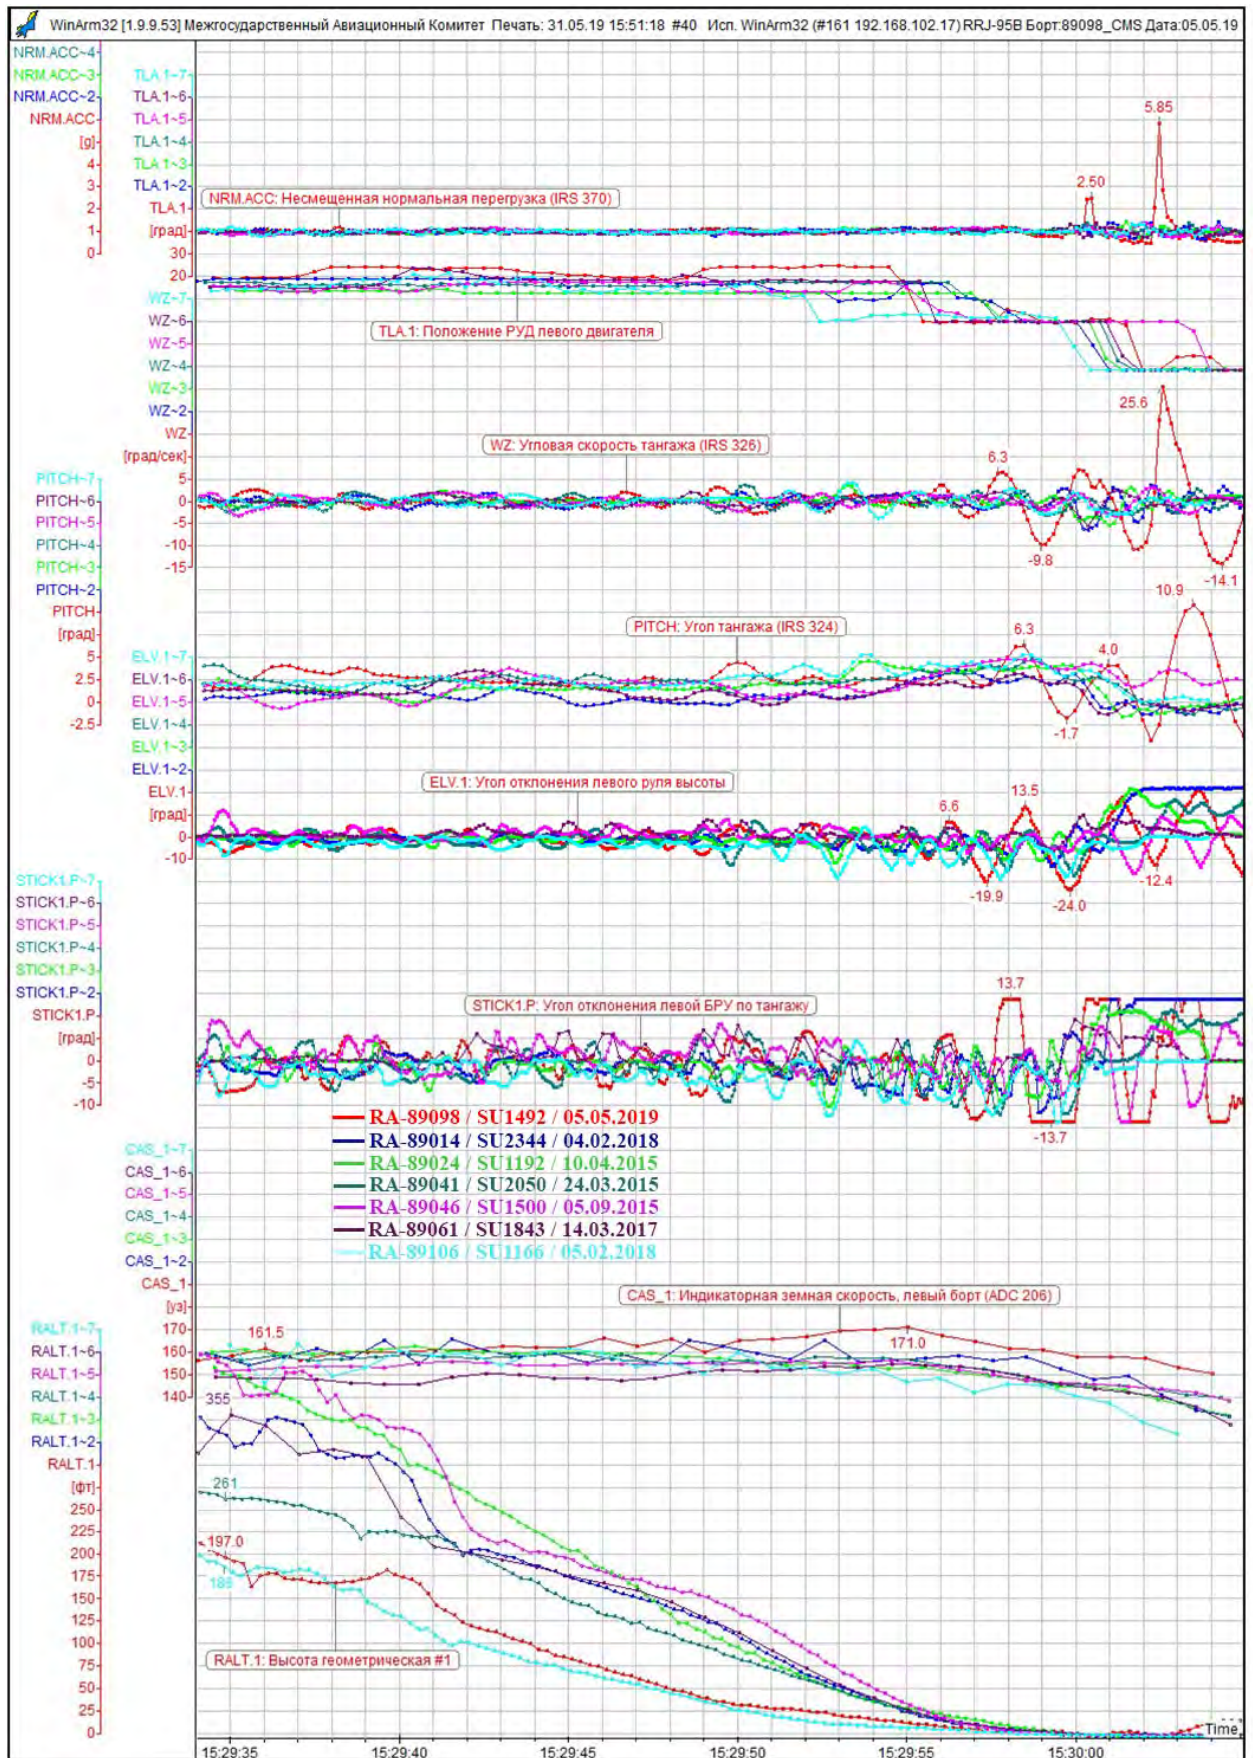
Fig. 43. Approach comparative analysis performed in DIRECT MODE

Similar "sweeping" movements were observed during landing performed in «DIRECT MODE» by other crews of the airline (Fig. 43). Reasons of these peculiarities are being analyzed.
