FINAL REPORT

**ACCIDENT
INVOLVING ATR 72 AIRCRAFT
REGISTRATION MARKS TS-LBB
ditching off the coast of Capo Gallo (Palermo - Sicily)
August 6th, 2005**

AGENZIA NAZIONALE
PER LA SICUREZZA DEL VOLO

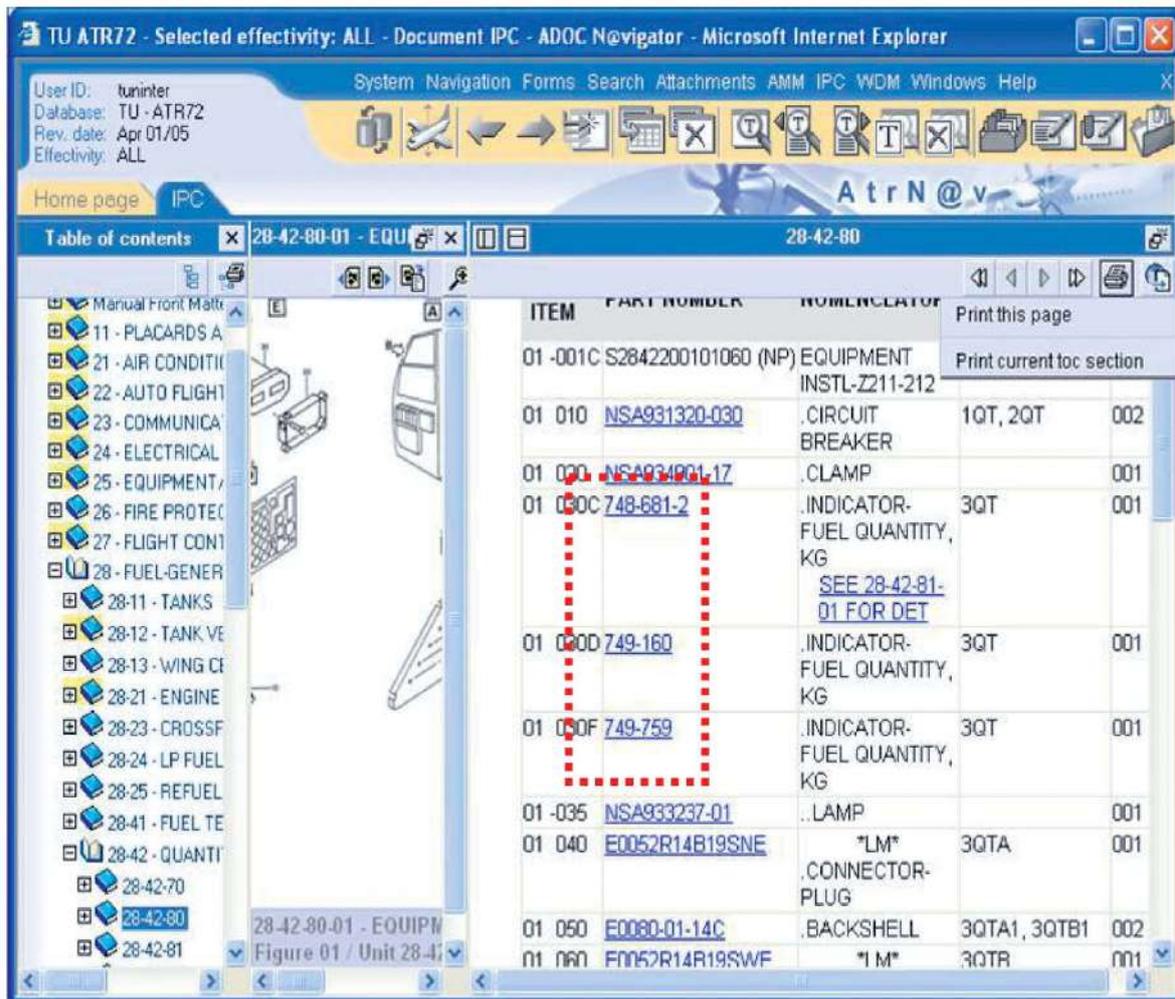
Figure 4: IPC video screen.

He therefore checked using a video terminal the electronic Illustrated Parts Catalogue (IPC - which is the only reference document for the operators), supplied by the aircraft manufacturer, and identified three Part Numbers (P/N) corresponding to the FQI to be replaced, all suitable to be fitted on ATR 72 aircraft:

- 748-681-2;
- 749-160;
- 749-759.

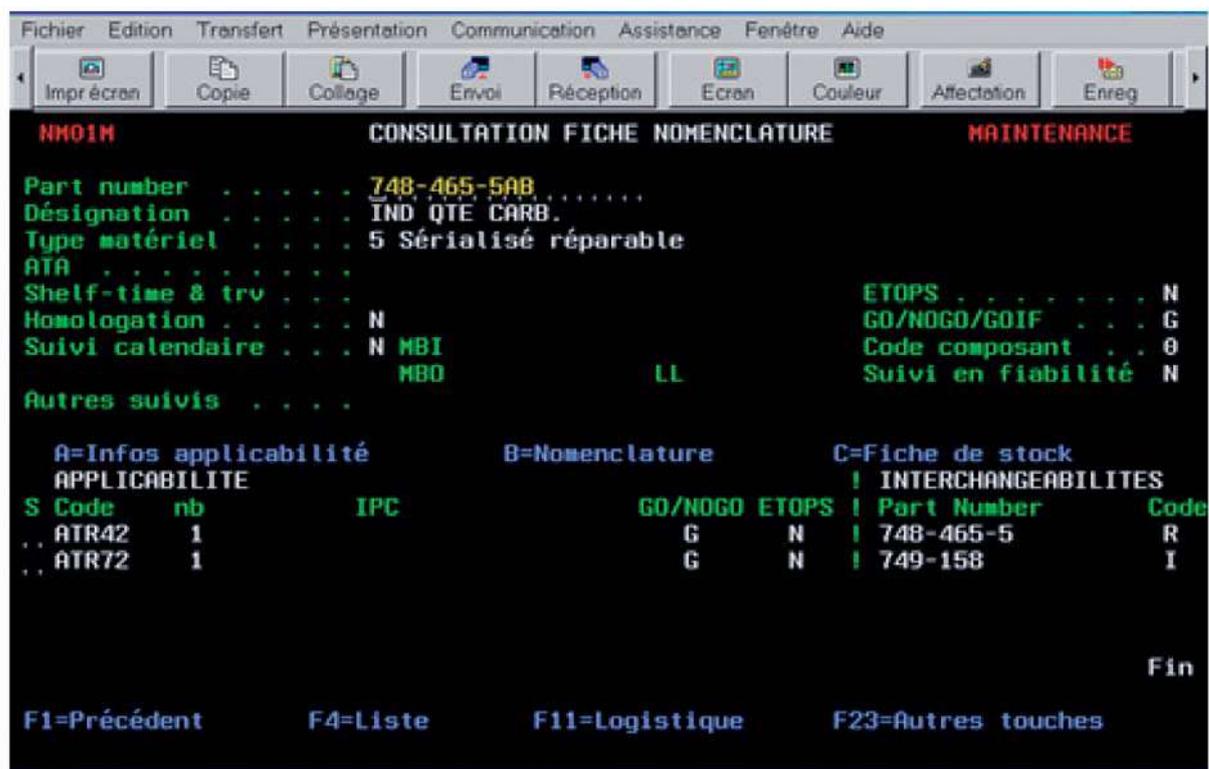
Figure 5: Screen information provided by ®AMASIS.

As this result was rather strange, considering that at least the FQIs already installed on the aircraft of the carrier should have shown on the information system, the technician tried to look for FQIs recorded with a P/N different from the one listed in the IPC; the technician started a new database search entering only the first three digits of the P/N, followed by a dash ("748-"), then scrolling through the list looking for any FQI suitable for installation on ATR 72 aircraft. With this method and following the search procedure of the ®AMASIS system, the technician was able to find the part called "IND QTE CARB", identified with P/N 748-465-5AB, which the system showed as suitable to both ATR 42 and ATR 72 aircraft, and also interchangeable with FQI P/N 749-158.

In the section “APPLICABILITÉ” (bottom left of figure 5), the “Code” field indicates in fact the type or the family of aircraft on which the part can be installed, the “nb” field shows the quantity needed on each aircraft and the IPC code in the ®AMASIS video should give the chapter, page, section and figure of the IPC where the part is listed. In the section “INTERCHANGEABILITÉS”, at the bottom right of figure 5 are listed the P/N of other interchangeable parts, while the field “Code” shows any restrictions (“I” means full interchangeability, “R” means interchangeable but with restrictions imposed by the manufacturer).

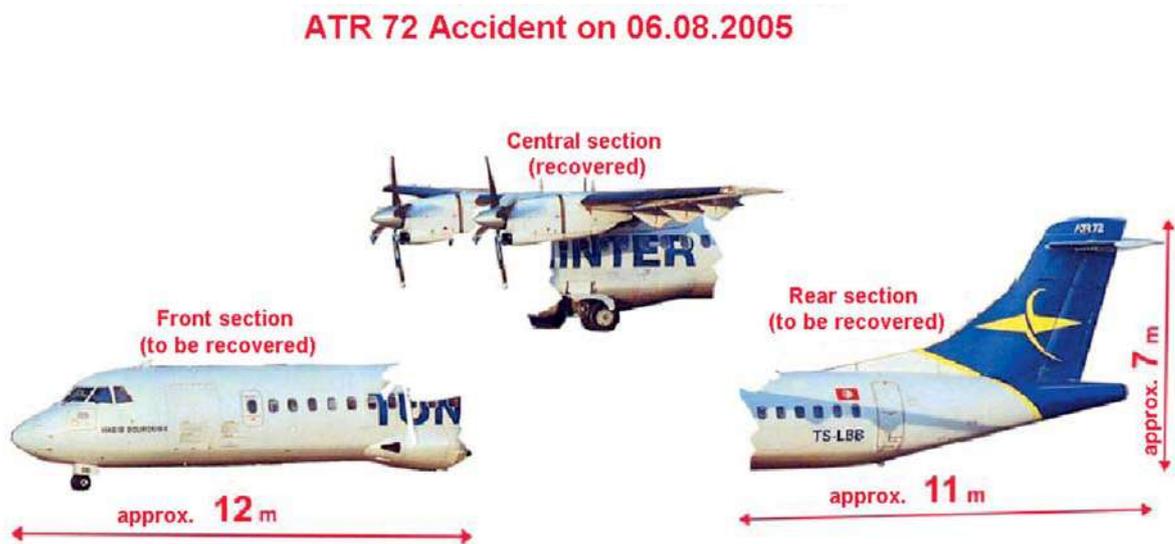
- LH and RH wings with nacelles and engines and part of the central fuselage;
- The rear, including the vertical and horizontal stabilizers and part of the fuselage;
- Front and central section of the fuselage, also including the cockpit.

The illustration in figure 6 shows the three parts of the aircraft discussed above, with indication of the parts which were recovered later on, as they had sunk shortly after the ditching. Such reconstruction of the wreckage was made immediately after the event, on the basis of the available information, and proved useful for carrying out the subsequent wreckage recovery operations.

Figure 6: Illustration showing the three sections the aircraft broke into, following impact with the sea surface (ANSV reconstruction). The indication “to be recovered” refers to the date of August 6th, 2005. These parts were later recovered.

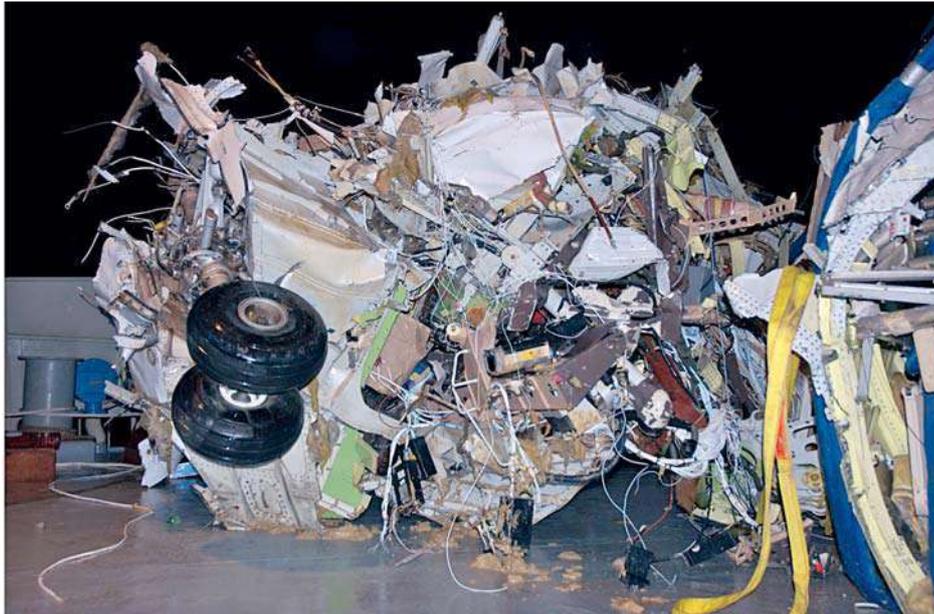
As far as the front section is concerned (cockpit and the front fuselage), this was completely crushed, as can be seen in photo 2, which relates to the recovery of the wreckage, carried out during the last week of August 2005.

Photo 2: Cockpit soon after recovery from the seabed.

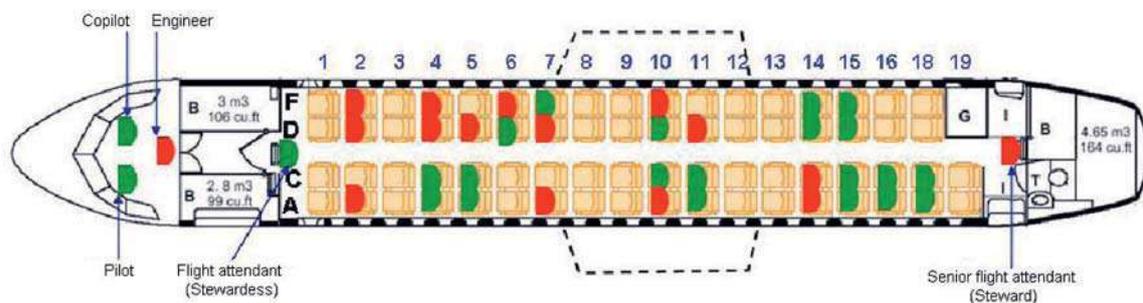
Figure 7: ATR 72, TS-LBB seat occupation on the aircraft before ditching.

With reference to Figure 7, the red boxes indicate the occupants who suffered fatal injuries, while the green boxes indicate the position of the survivors on the aircraft. The following paragraph 1.15.3. provides a description of the type of injuries suffered by the passengers, linking their position on the aircraft to the deformations which occurred to the aircraft following ditching.

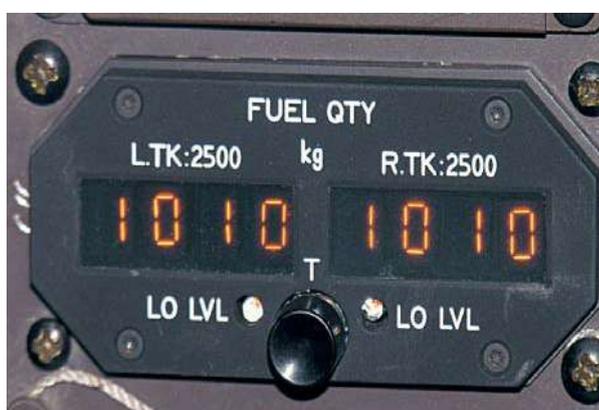
Photo 8: FQI ATR 72.

Difference between FQIs, when not installed on the aircraft, is also determined the P/N on data plate on top of it which is different between ATR 72 and ATR 42 type FQIs .

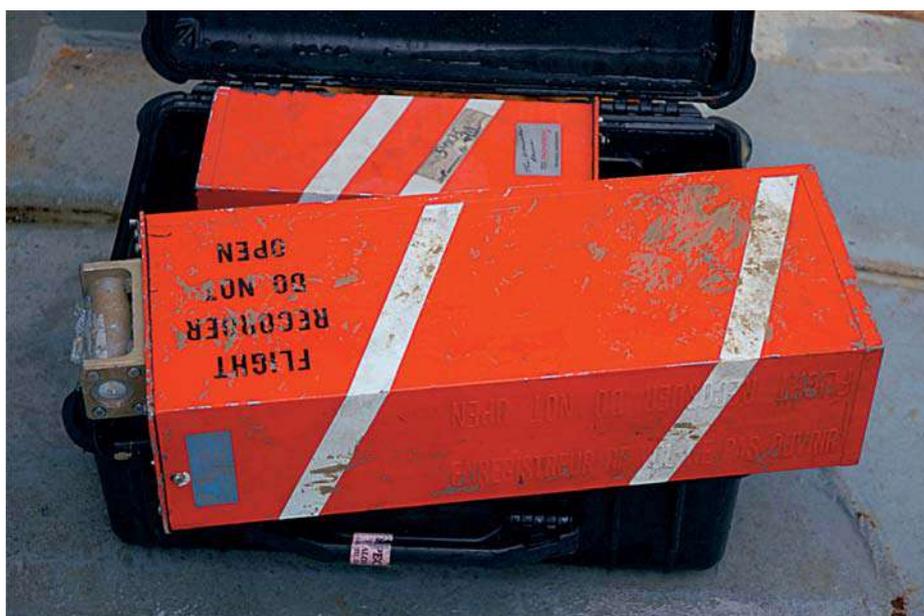
The CVR was removed from its housing, at the back of the fuselage on the right-hand, immediately after recovery of the wreckage, on August 28th, 2005.

However, the FDR was located on the bed of the sea, away from the fuselage, and was recovered on August 30th, 2005.

Photo 16: The recovered FDR (foreground) and CVR.

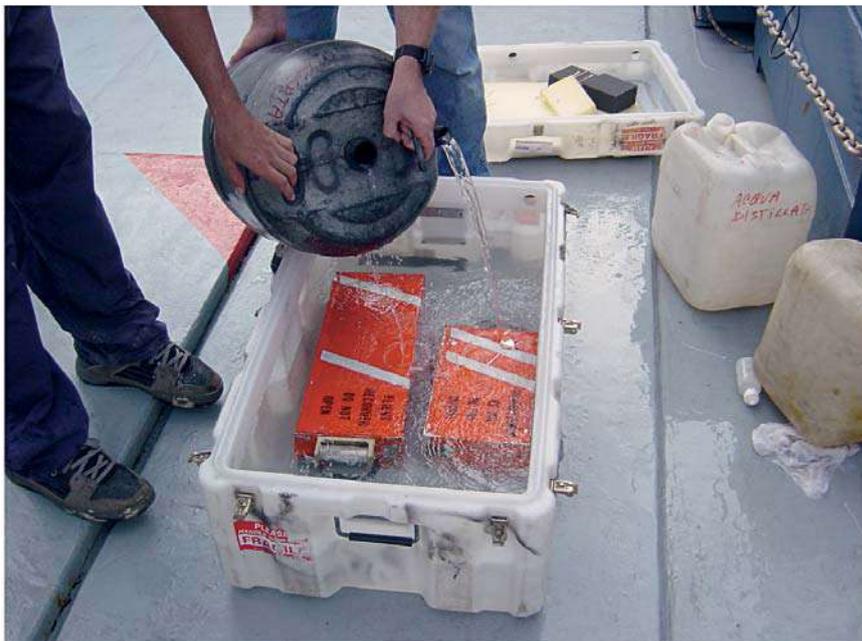
The two recorders were washed immediately using fresh water and then placed in distilled water, where they were kept until opened, on September 10th, 2005, at the ANSV laboratories.

Photo 17: Preservation of the FDR and CVR in distilled water.

Both units were in reasonable general condition, without evidence of impact or fire damage.

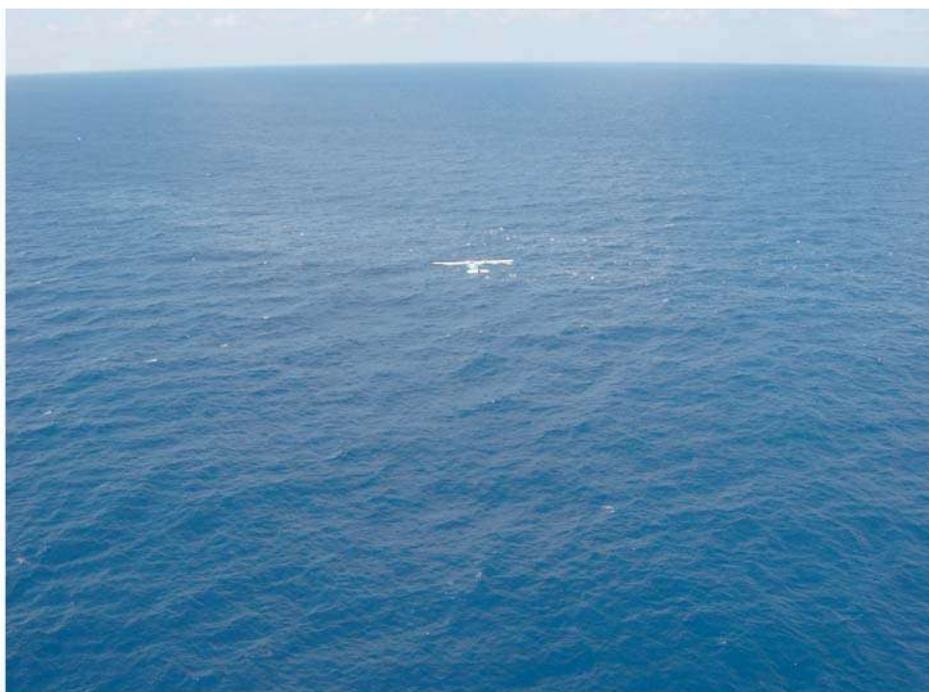
This was also confirmed by the B737 aircraft flight captain, who flew over the area where the event took place, giving Palermo control tower the position of the wreckage. Photo 19, taken by the first helicopter arriving on the scene, clearly shows the rear of the aircraft on the sea surface, together with the LH and RH wings. The nose of the wreckage is oriented at 040°/050°.

Photo 19: View of the wreckage upon arrival of the first rescue helicopter.

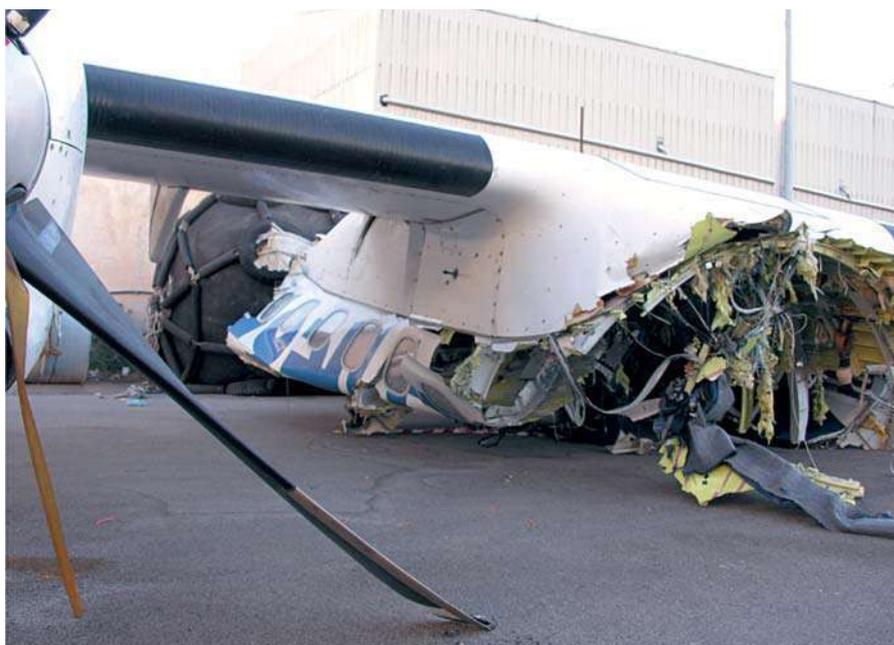
- Both the inner and outer dripsticks (magnetic graduated rod used to check the quantity of fuel inside the wing fuel tanks) appeared in good condition.
- Gravity refuelling point in good conditions: no corrosion and filter in good condition.
- Panel opening area for access to the Feeder Tank: no contamination detected, presence of water and fuel (or at least of two fluids with different densities) inside the tank. No visible damage to the internal pipes.
- Presence of water inside the wing fuel tank possibly penetrated from the NACA air vent (underside of the wing) during the period in the water after ditching.

Photo 20: Part of the central fuselage with LH and RH wings.

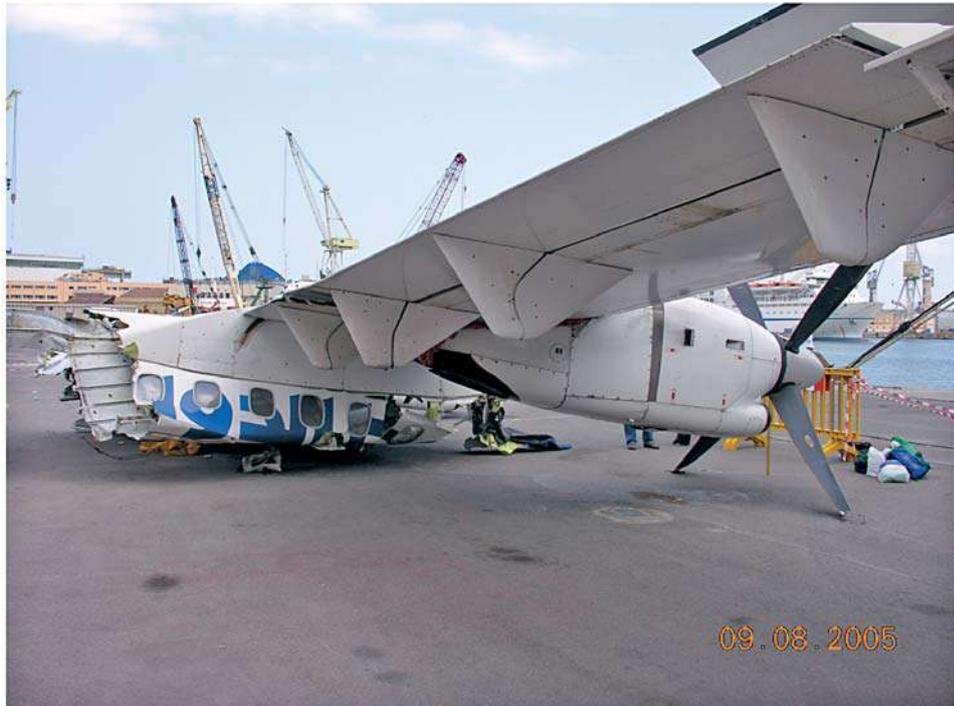
Photo 22: Part of the central fuselage with LH and RH wings at the Port of Palermo.

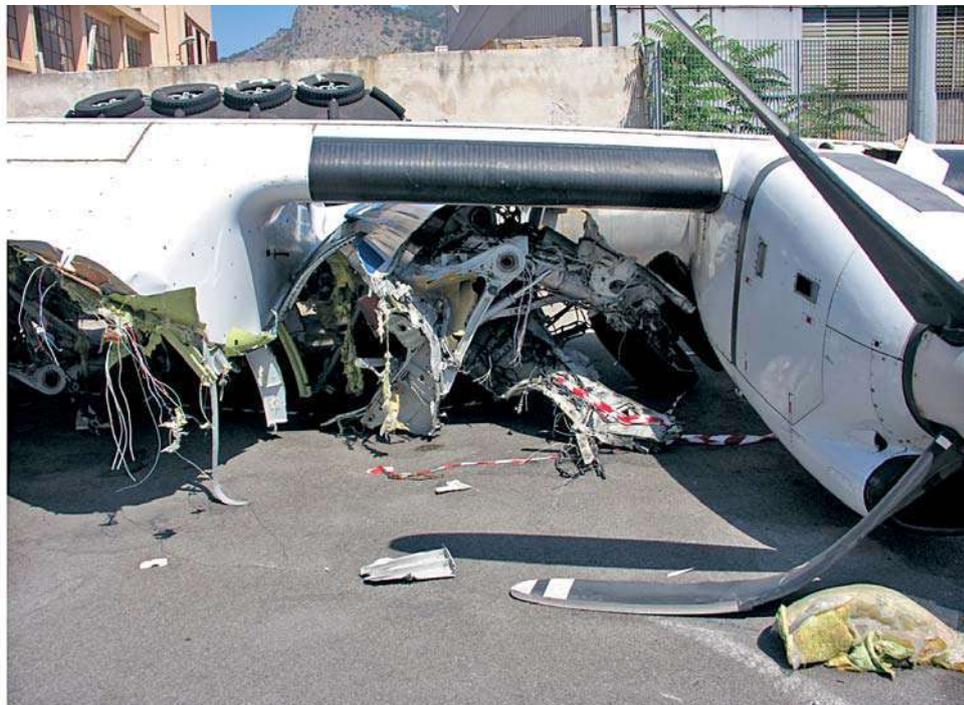
Photo 23: Part of the central fuselage with LH and RH wings at the Port of Palermo, the central section.

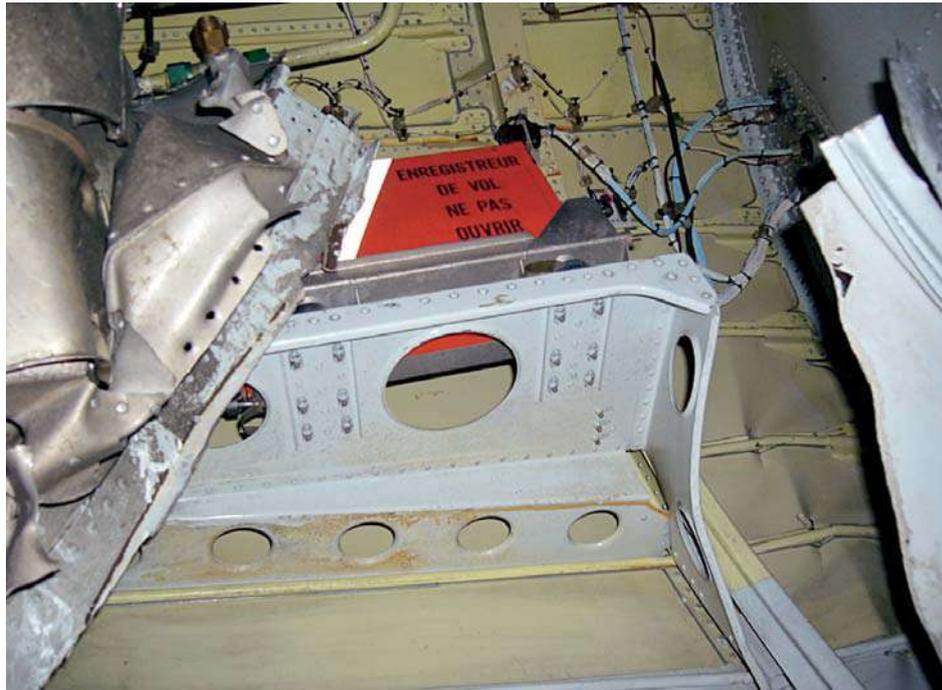
Considerable structural damage was found on the inside. The pressure bulkhead between the cabin pressurized zone and the tail had a large diagonal gash (see photo 34 and 61). The tail assemblies did not show any significant deformation. The CVR was removed from its housing. It was removed, immediately washed with fresh water and then placed in a container full of distilled water. The supports of the FDR housing appeared damaged and the device itself was missing (photo 61).

Photo 26: CVR in its housing inside the aircraft.

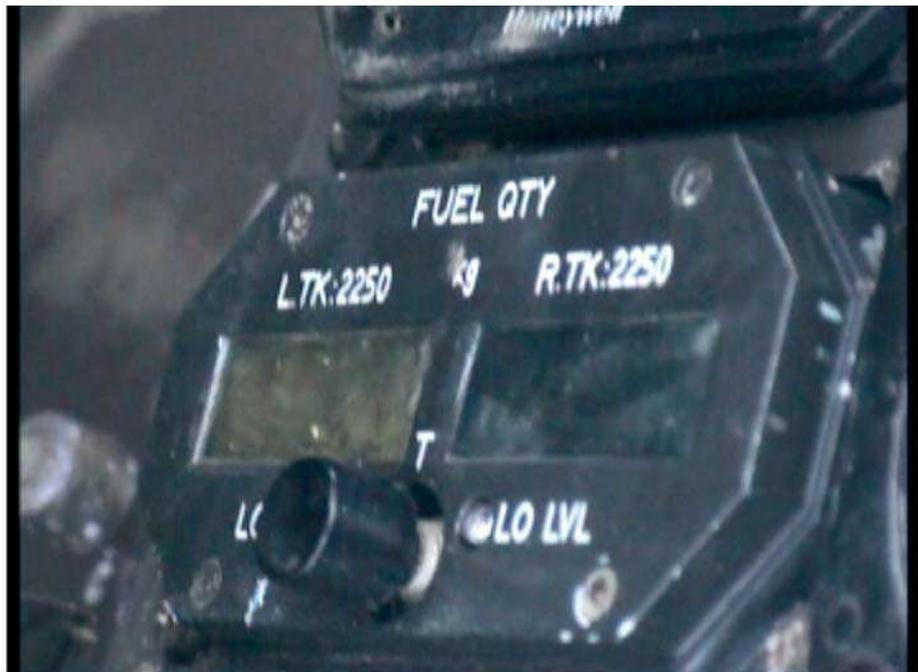
The Fuel Quantity Indicator was still in its housing inside the cockpit. Photo 29 shows the front part of the instrument with the writing 2250 kg, which indicates the maximum fuel capacity of each wing fuel tank. In effect the indication of 2250 kg relates to indicators used by the ATR 42 models. Subsequent checks did in fact confirm that the FQI installed was a model intended for ATR 42 aircraft.

Photo 29: The FQI installed on the TS-LBB - video still taken immediately after recovery.

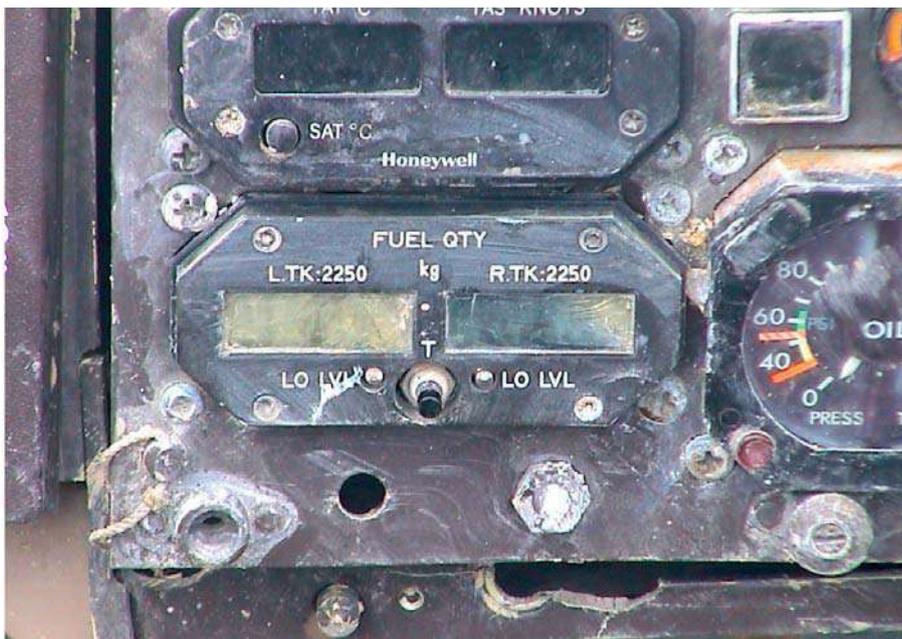
Photo 30: FQI front panel recovered from the wreckage. Note the inscription “2250” corresponding to an ATR 42 type FQI.

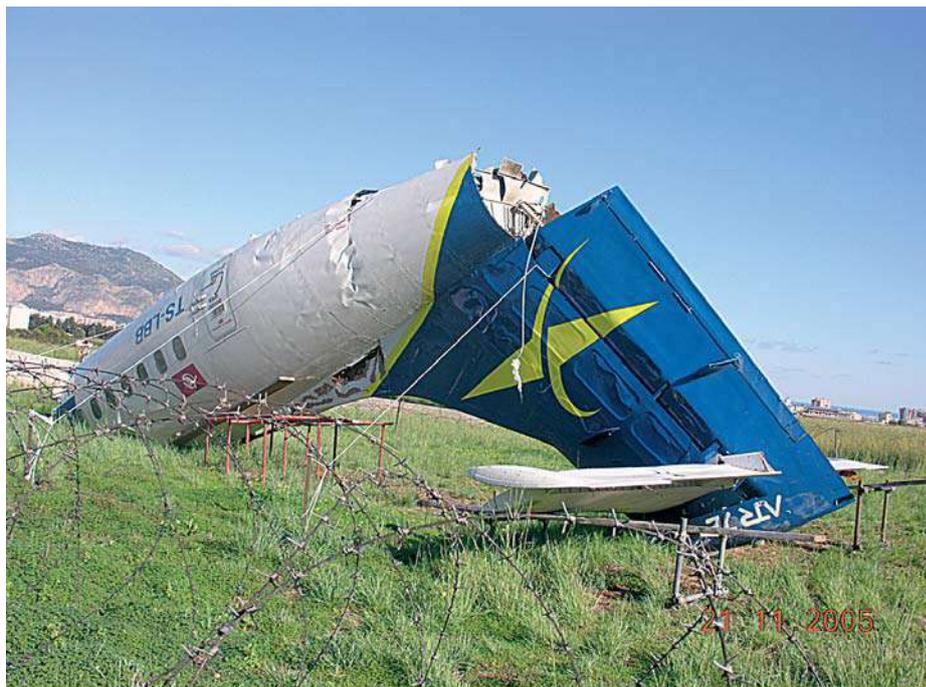
The rear of this section showed a great amount of damage and deformation, resulting in the breaking of the pressure bulkhead between the pressurised and the non pressurised zone. This indicates that the impact of the aircraft against the sea surface was very strong. The rear had in fact completely collapsed, while the seating area was virtually intact.

Photo 33: Rear of the wreckage at Bocca di Falco airport, right-hand view.

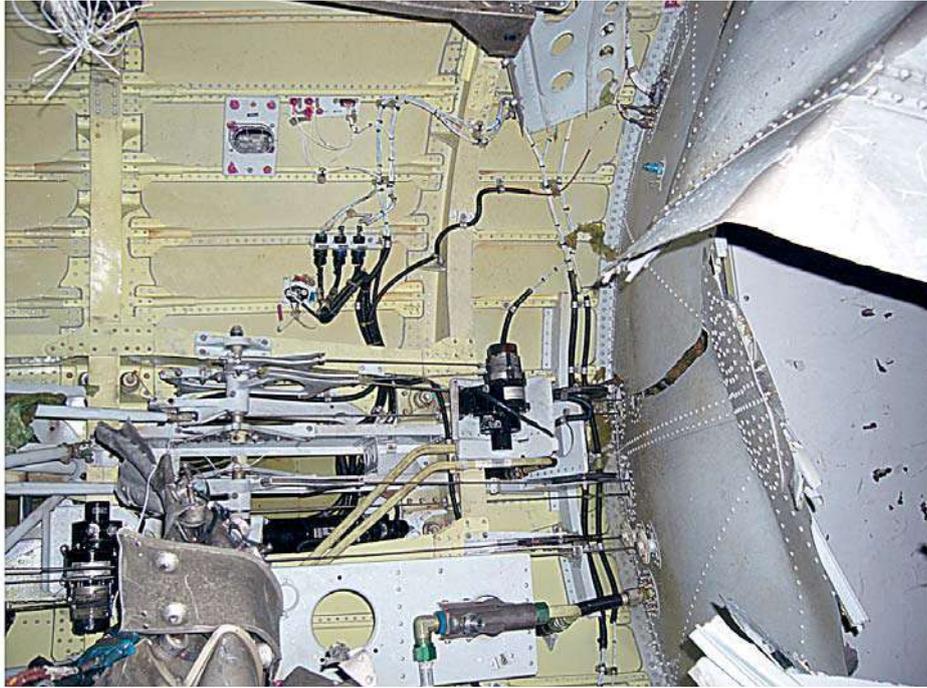
Photo 34: Rear of the aircraft, inside view. Note the deformation of the pressure bulkhead.

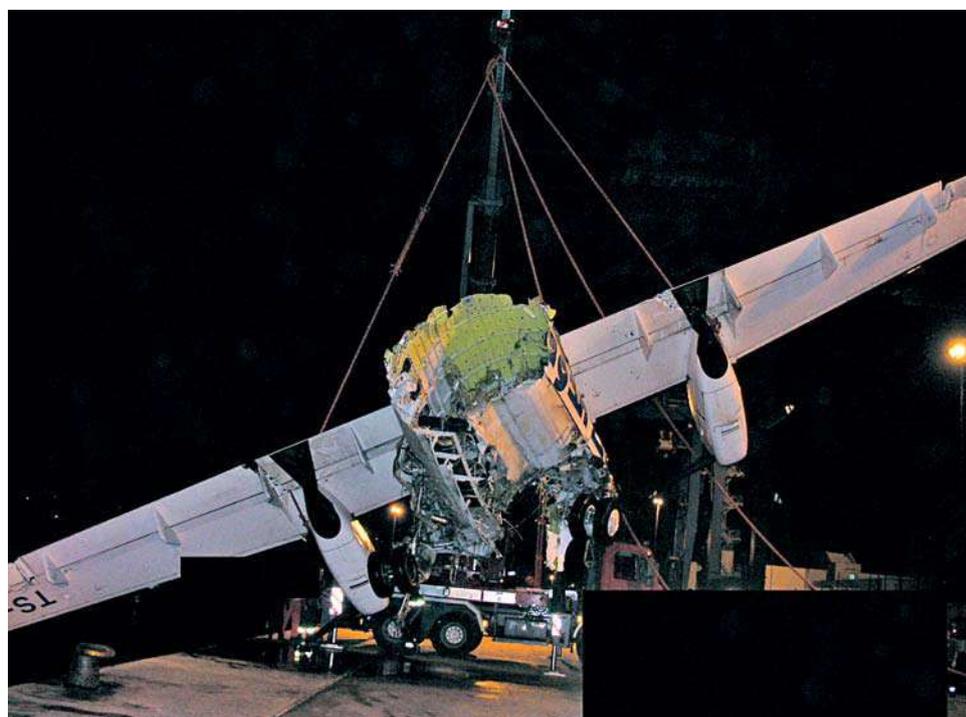
Also this section shows no evidence of breaks due to fatigue and/or any corrosion. All sections show breaks typical of overload.

Photo 36: Central section of the wreckage, with LH and RH wings, during recovery.

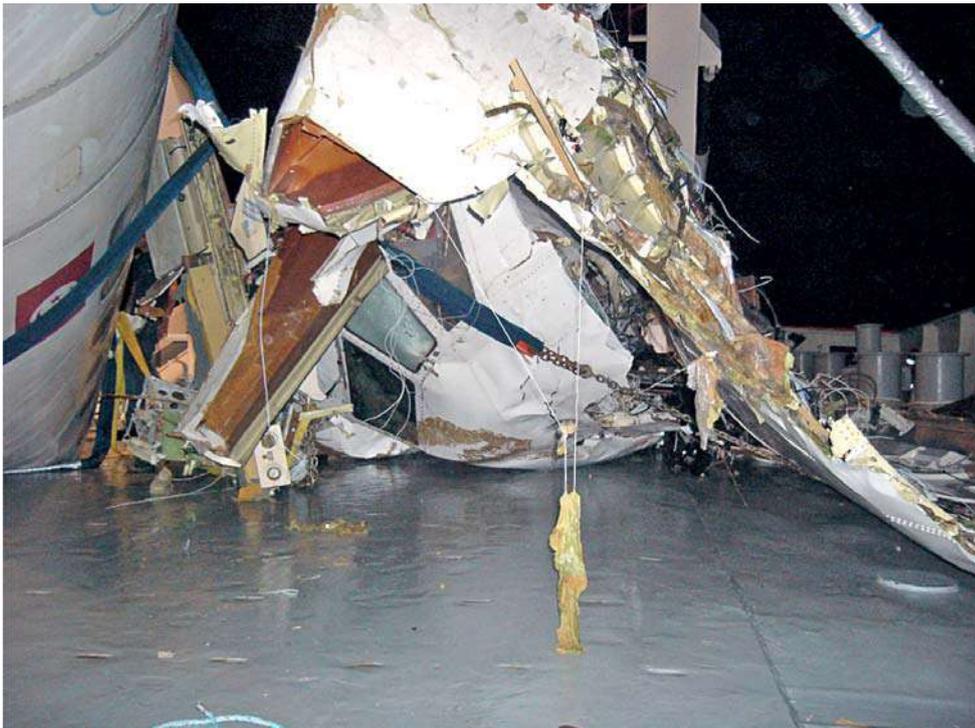
Photo 37: Part of the cockpit immediately after recovery.

Of the three occupants that were in the cockpit at the moment of ditching (the two pilots and the engineer), the pilots suffered injuries that were in fact not as serious as one would have expected considering the condition in which the cockpit was found, after being recovered from the sea bed (see photos 37 and 38). It is therefore highly possible that most of the deformation found on the front part of the aircraft might have been caused by the impact with the sea bed, as well as the subsequent impact of the tail section against the cockpit itself.

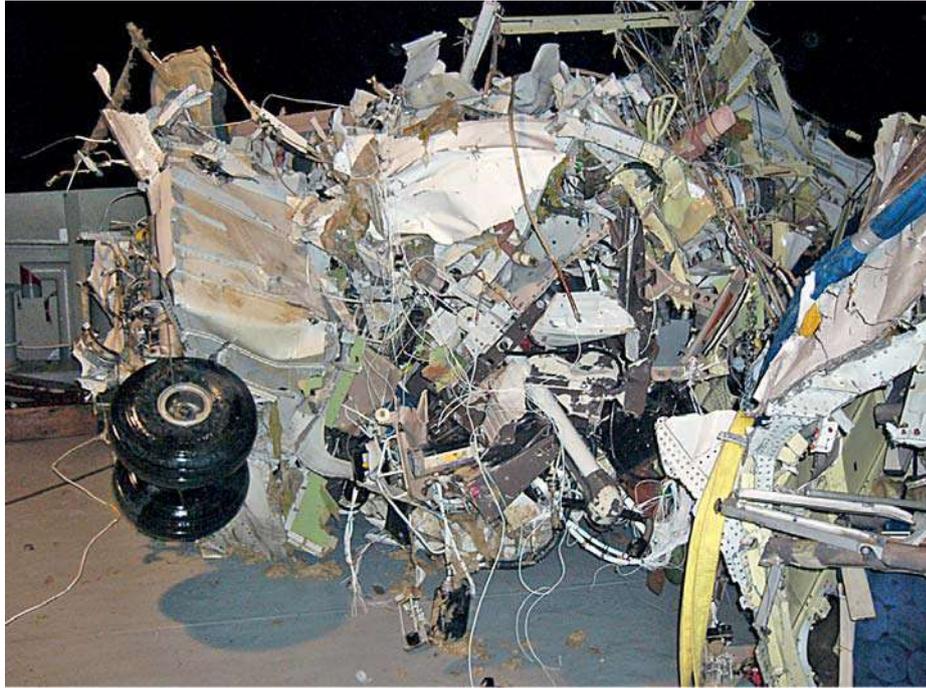
The internal structure of the right-hand of the aircraft showed an extensive amount of damage. The seats and the floor were no longer attached.

Photo 38: Part of the front section of the fuselage immediately after recovery.

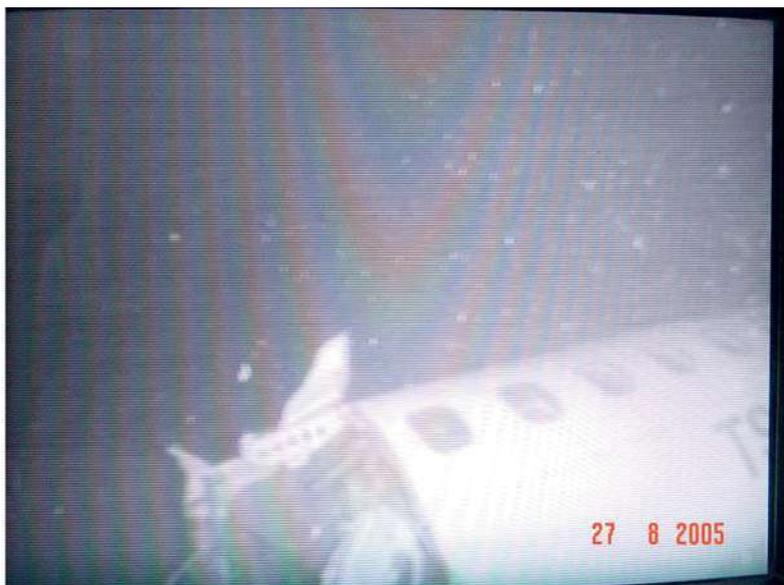
05.08: contact and visual inspection of some parts of the wreckage, particularly the tail assembly. The geographical coordinates were in accordance with those established by the Navy during the previous days. In order to check for any human remains, the inside was inspected. This operation was performed with difficulty (the roof of the cabin had collapsed). The results were negative.

Photo 53: The tail section at the bottom of the sea (approximate depth 1450 metres).

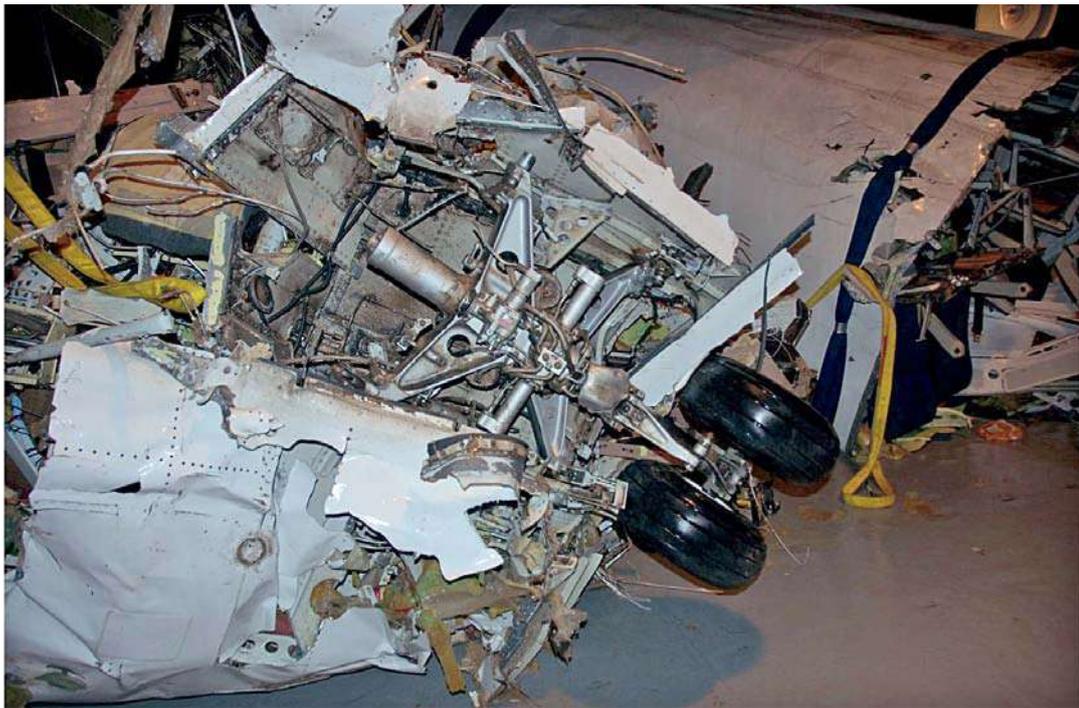
06.37: The front part of the fuselage, including the cockpit, was located. Its front section appeared crushed.

Photo 59: Front of the fuselage, nose landing gear.

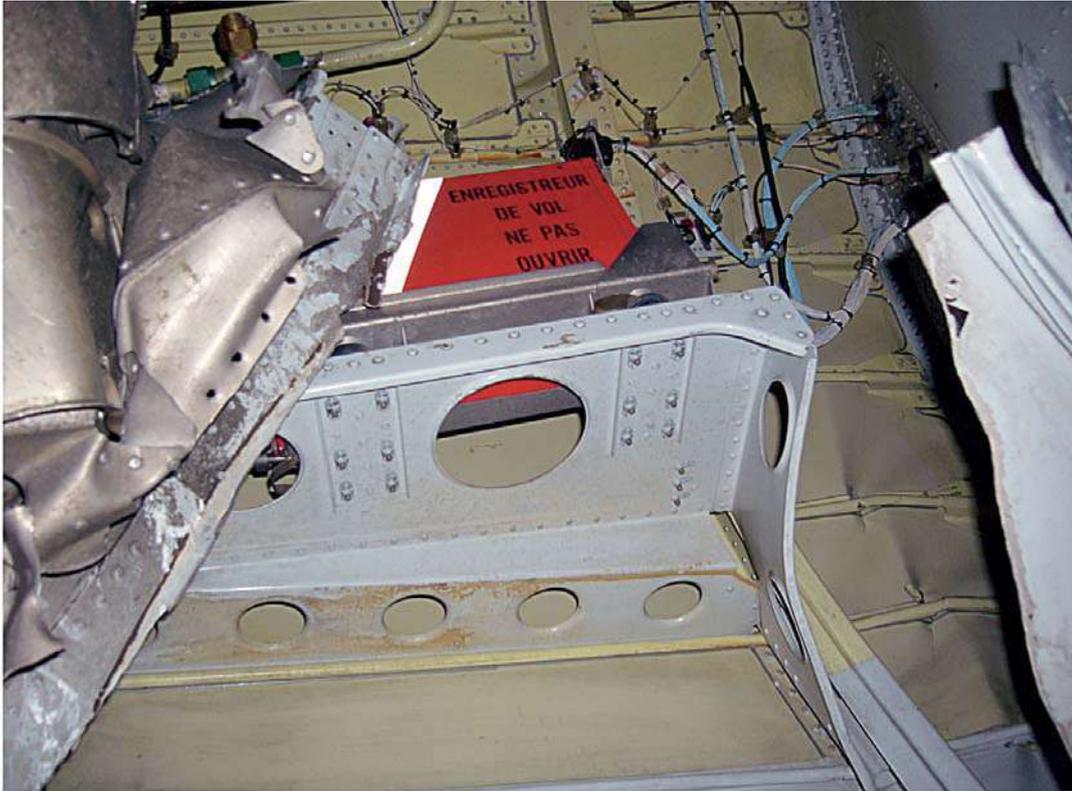
22.00: the recovery of the tail section was completed. This was positioned on the deck of the ship. The rear section was immediately inspected from ANSV personnel, looking for the flight recorders. The CVR was in its position, but the FDR was missing. The FDR housing showed

Photo 62: CVR in its housing.

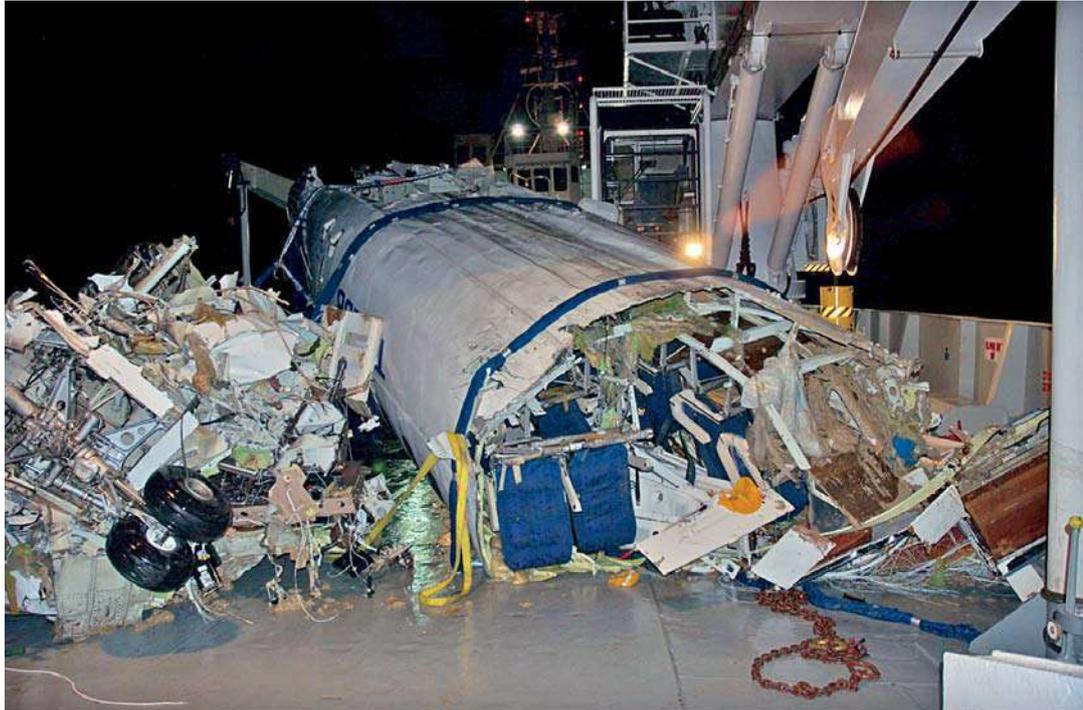
Once the tail section was positioned on the ship's deck, with lifting gear still attached, the recovery personnel realised that a large part of the fuselage remains were still attached to the tail. In fact, the remaining part of the aircraft, including the front of the fuselage and the cockpit, was still attached to it. This meant that approximately 70 to 80% of the wreckage had now been recovered.

Photo 63: Tail section on the ship's deck with front part of the fuselage

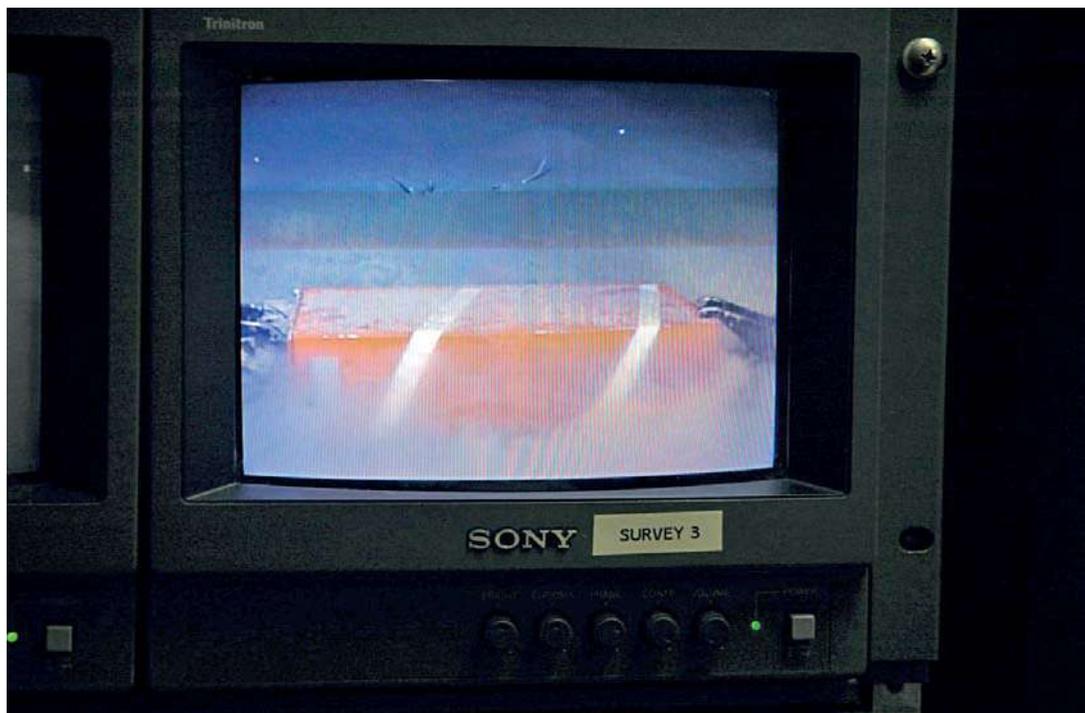
01.40: The research operations on the seabed continue and the FDR is sighted at geographical coordinates 38° 23.42 N - 013° 27.15 E. It appeared in good condition and was brought back to the surface using the ROV mechanical arms.

Photo 64: Recovery of the FDR by the ROV.

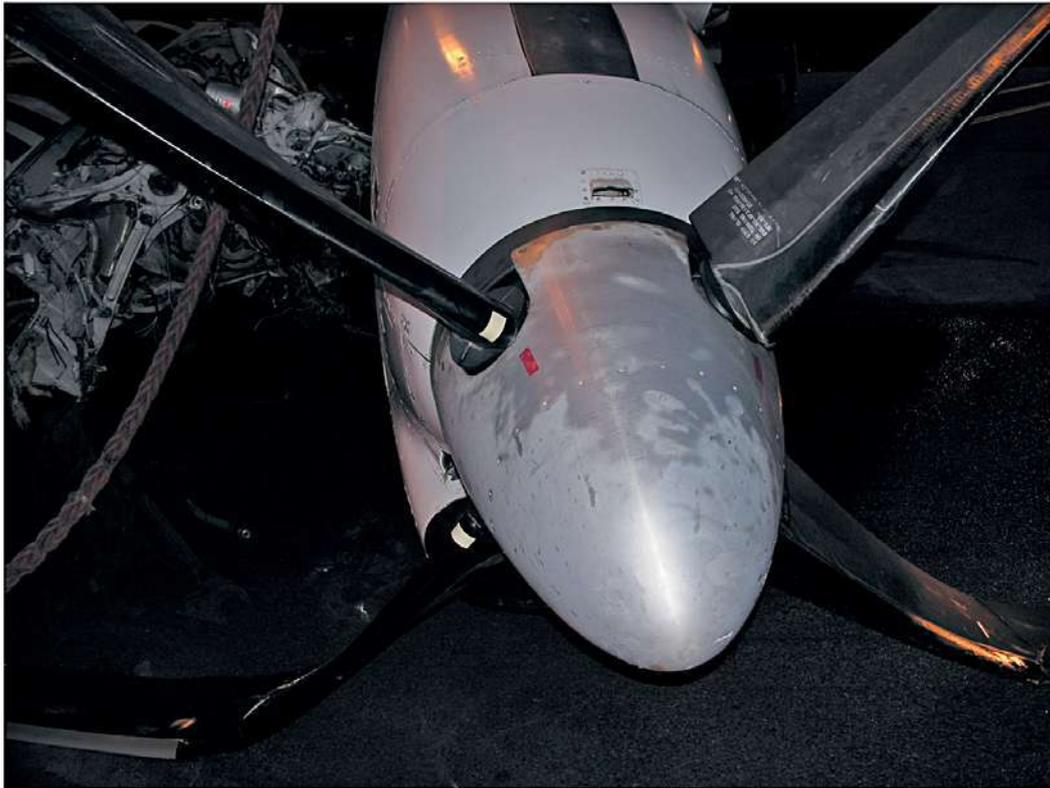
Photo 70: Note the feather position of the right engine propeller.

- The substantial integrity of the propeller blades, which were only damaged during the recovery operations and placement on the wharf of Palermo harbor (bending);
- Pitch of the blades in the fully feathered position (the position of minimum drag to forward motion);
- No evidence of fuel or lubricants leaks;
- No evidence of damage to the feed lines.

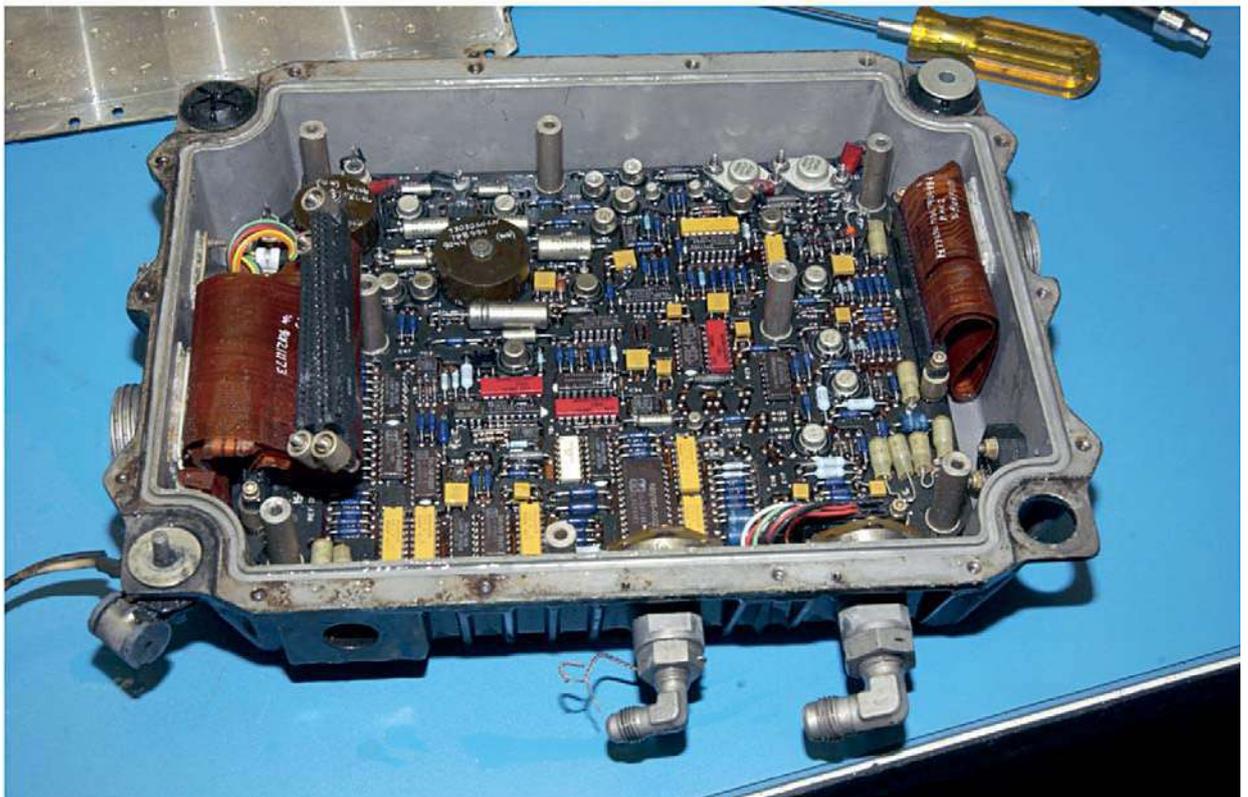
The information recovery operation gave positive results. This was also due to the good condition of the devices. The data recovered are in the form of a list of failure codes that have occurred from the date of the last reset, but they are not associated to a time parameter that could indicate when exactly they happened.

From the analysis of these data, it is possible to safely confirm that the engines did not suffer any notable failures, such as high turbine temperatures, compressor stall and/or malfunctioning of the internal components, which may have caused a spontaneous engine shutdown.

Photo 75: EEC internal circuits.

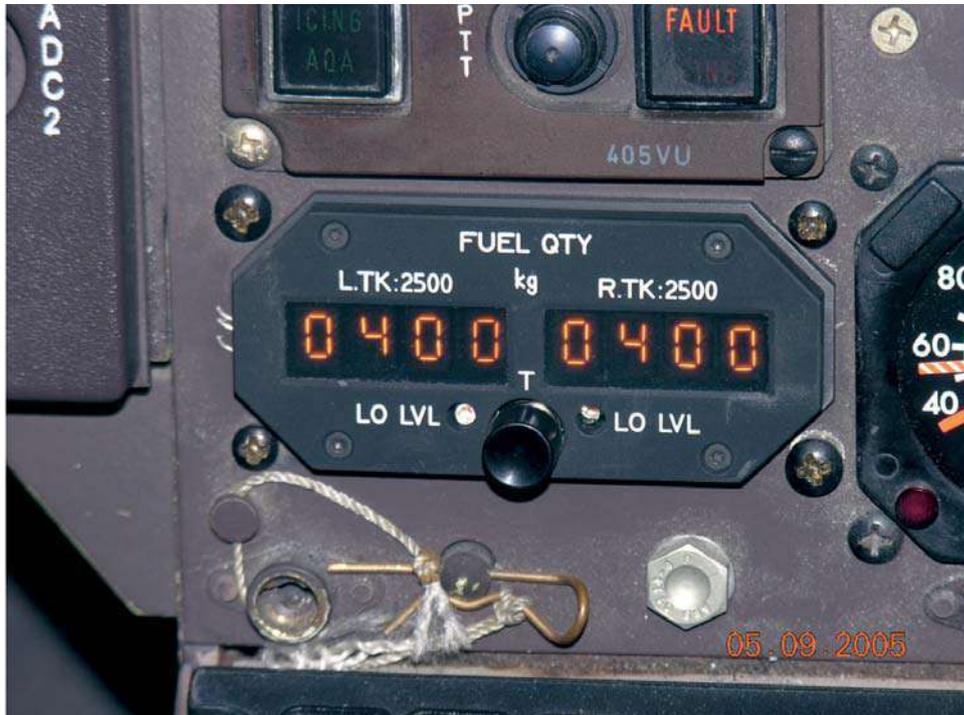
Photo 76: Indication given by ATR 72 FQI fitted on an ATR 72 with 400+400 kg of fuel in each tank.

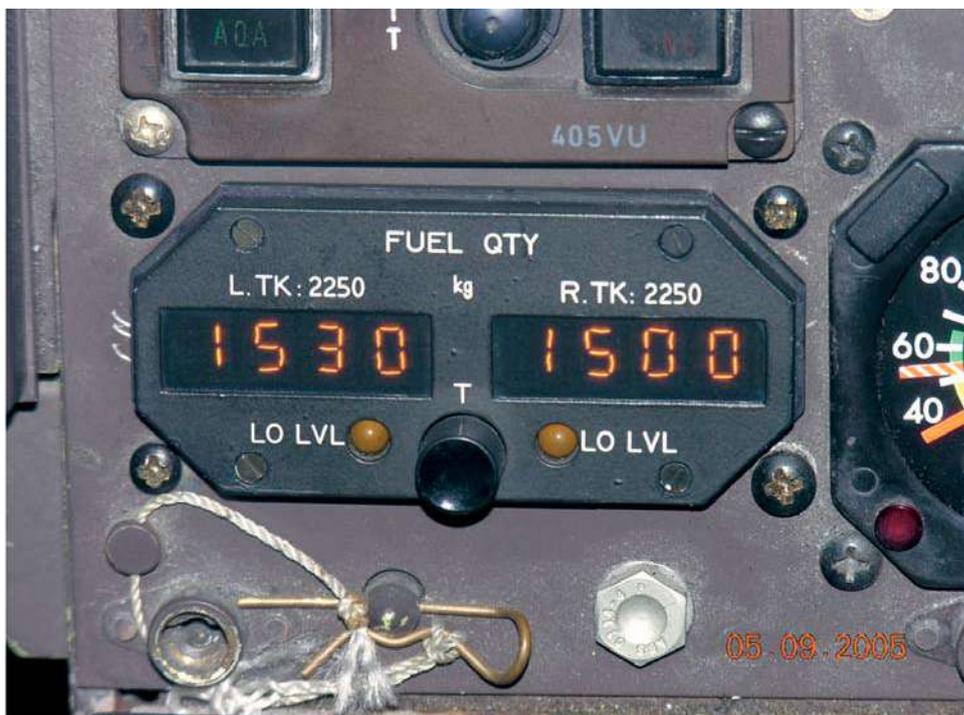
Photo 77: Indication given by an ATR 42 FQI fitted on an ATR 72 with 400+400 kg of fuel in each tank.

From the analysis of the results, it is therefore possible to state that the quantity indicated by an ATR 42 type FQI installed on an ATR 72 aircraft is higher than the quantity actually present in the fuel tanks and that it follows a linear variation curve, which is shown in the graph itself. In particular, by extrapolating the data based on the value of 0 kg, the indication of an ATR42 type FQI is equal to approximately 1800 kg. This is the quantity given by the TS-LBB crew to the air
