FINAL REPORT

**ACCIDENT
INVOLVING ATR 72 AIRCRAFT
REGISTRATION MARKS TS-LBB
ditching off the coast of Capo Gallo (Palermo - Sicily)
August 6th, 2005**

AGENZIA NAZIONALE
PER LA SICUREZZA DEL VOLO

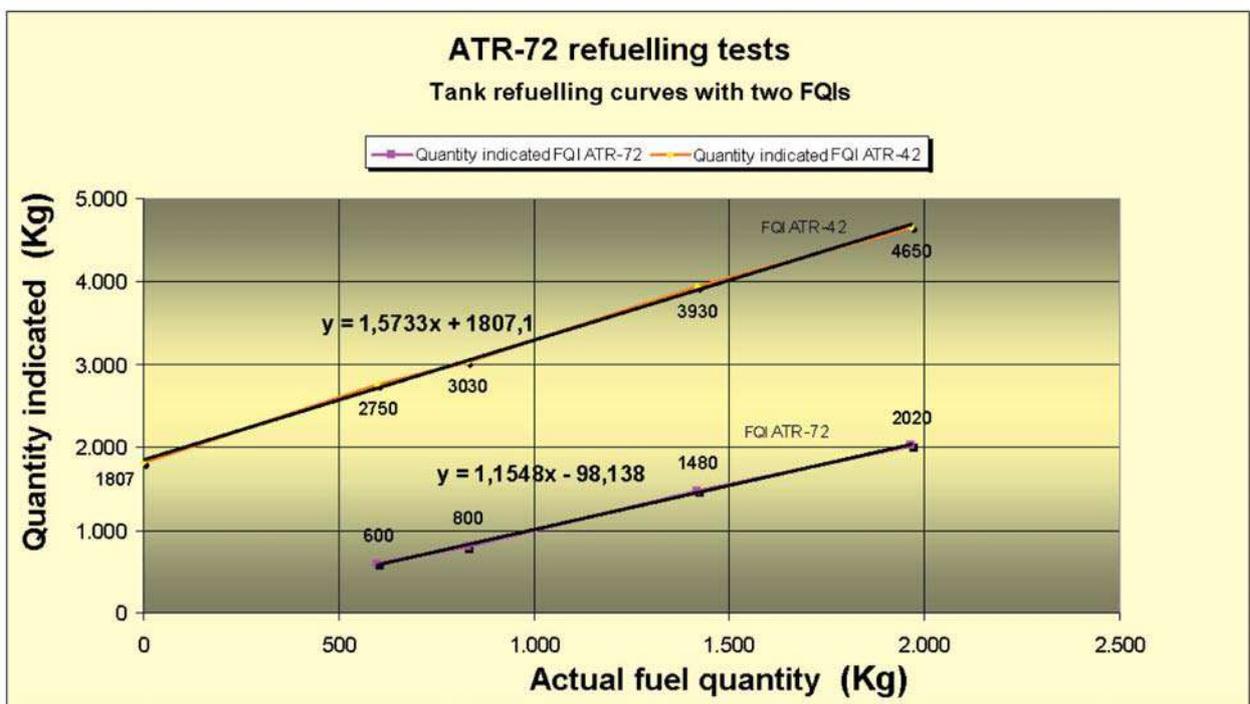
Figure 22: Tank refuelling experimental curves using two FQIs.

From the analysis of the results, it is therefore possible to state that the quantity indicated by an ATR 42 type FQI installed on an ATR 72 aircraft is higher than the quantity actually present in the fuel tanks and that it follows a linear variation curve, which is shown in the graph itself. In particular, by extrapolating the data based on the value of 0 kg, the indication of an ATR42 type FQI is equal to approximately 1800 kg. This is the quantity given by the TS-LBB crew to the air

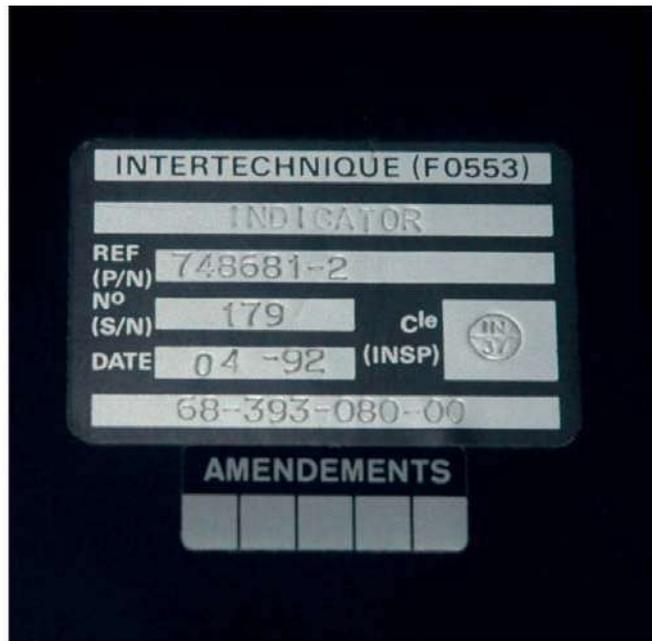
The same search was then performed by inserting P/N 748681-2, therefore omitting the dash between the first and second group of numbers. This is the P/N as printed (see photo 80) on FQI S/N 179, removed from the aircraft TS-LBB for replacement. In this case, the video monitor responded with the information relating to P/N 748681-2, called INDICATOR.

Photo 80: FQI S/N 179 nameplate (Data Plate).

- The ®AMASIS system also recognises dashes between alphanumeric groups as significant characters.
- The P/N number stamped by the manufacturer Intertechnique on the S/N 179 FQI, is different from the one listed in the IPC for the ATR 72 aircraft, with the dash after the digits 748 being missing. P/N 748681-2 is also listed on the document called "Authorised release certificate – Airworthiness approval tag" (subsequently replaced by JAA FORM ONE, now EASA FORM ONE); the P/N of ATR's IPC reflects the Intertechnique certification P/N as determined by Intertechnique itself.

On the contrary, the plate attached to instrument P/N 748681-2 S/N 179 (see Photo 80), which was removed from TS-LBB, has no hyphen after the first three figures.

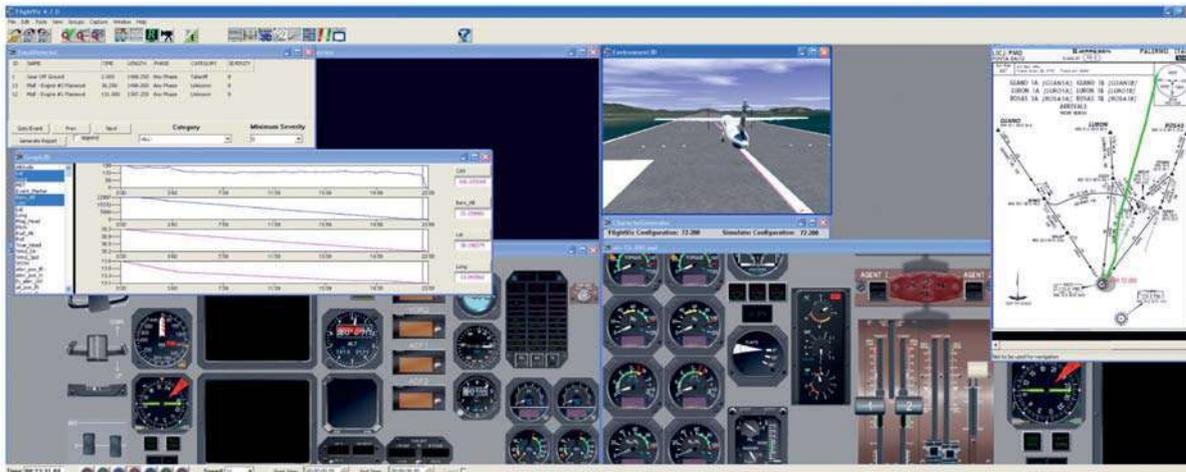
Figure 23: Reproduction of flight made, Simulation 1, final part.

From the figures regarding the speed profile shown in Tables 10 and 11 above, it will be noted that said profile is more linear in Simulation 1 than in Simulation 2, despite the fact that in neither case the speed was always constant or equal to the VmHB (optimum speed – optimum gliding speed) selected for the “fictitious” mass of 19.000 kg.

The crew that conducted Simulation 1 also reported during the debriefing that, although they had been able to land on runway 20, the decision to continue the approach when at 1000 ft, about 3 NM away from the TVOR/DME “PRS”, was not typical in operational terms. Pilots are not normally trained to land without flaps and without engines, so they had not been sure they could make a safe landing. In real conditions, without the certainty of being able to make a safe landing, they would very probably have opted to bring the aircraft down into the sea, where there is a better chance of limiting damage to aircraft and passengers than when making a forced landing on irregular ground, even in the awareness of having fuel on board, which may undoubtedly constitute a hazard factor in terms of passenger safety.

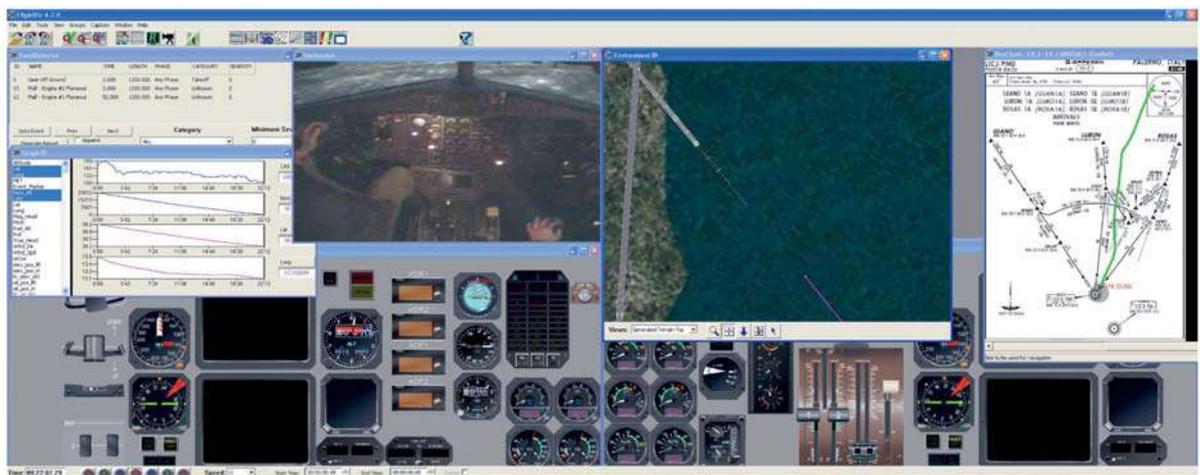
Figure 24: Reproduction of flight made, Simulation 2, final part.

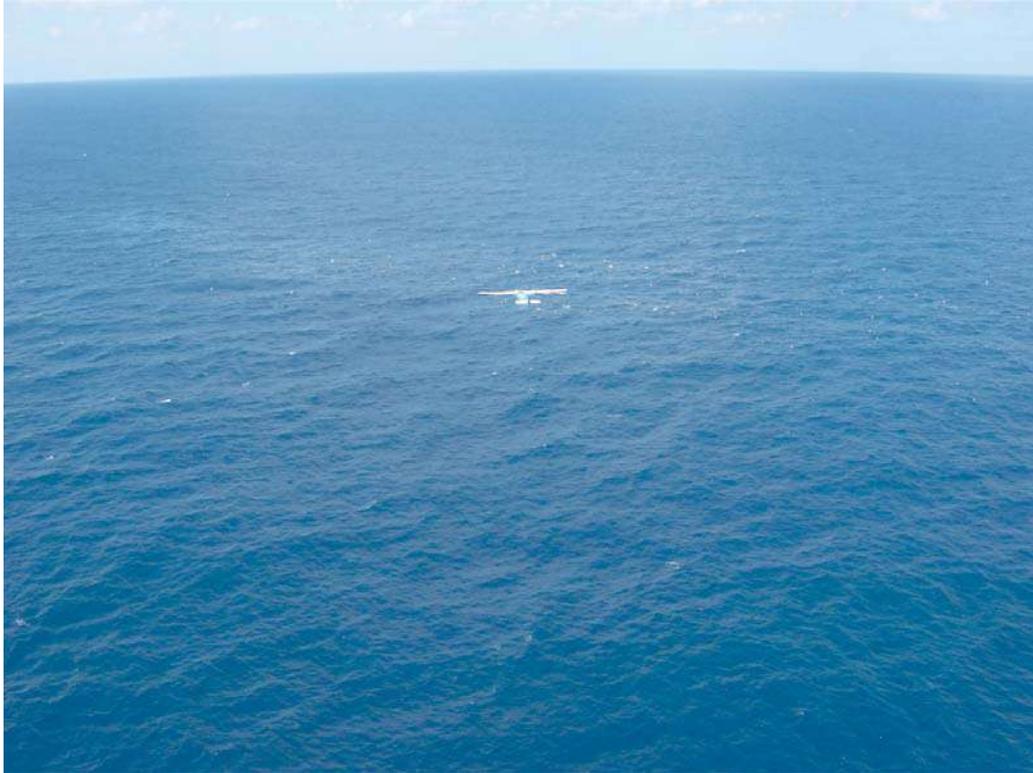
As far as the ditching of TS-LBB is concerned, it must be emphasised that the swell conditions and the wind direction were not easy for the crew to establish.

Photo 82, taken about 40-45 minutes after the aircraft ditched from the rescue helicopter that was the first to arrive on the scene, shows that the conditions at sea did not make it possible to distinguish the swell direction for certain at low altitude (approximately 500-1000 ft).

Photo 82: The TS-LBB wreckage shortly after ditching.

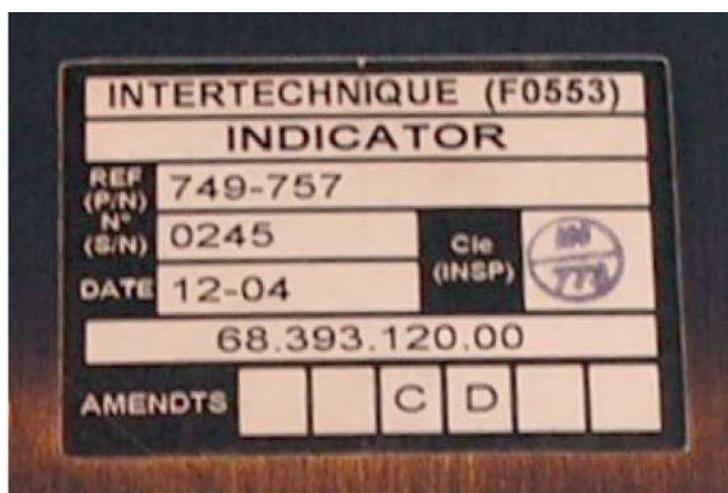
Photo 83: FQI Identification Plate.

It is pointed out that only in the latest CMM, 28-42-83, is the hyphen dropped after the first three figures of the Part Number (P/N); however, during a visit to FQI's manufacturer premises and from the observation of some FQI's produced in December 2004 (photo 83) and April 2005 (photo 84), it has been noted that the identification plates attached to the instruments continue to feature it.

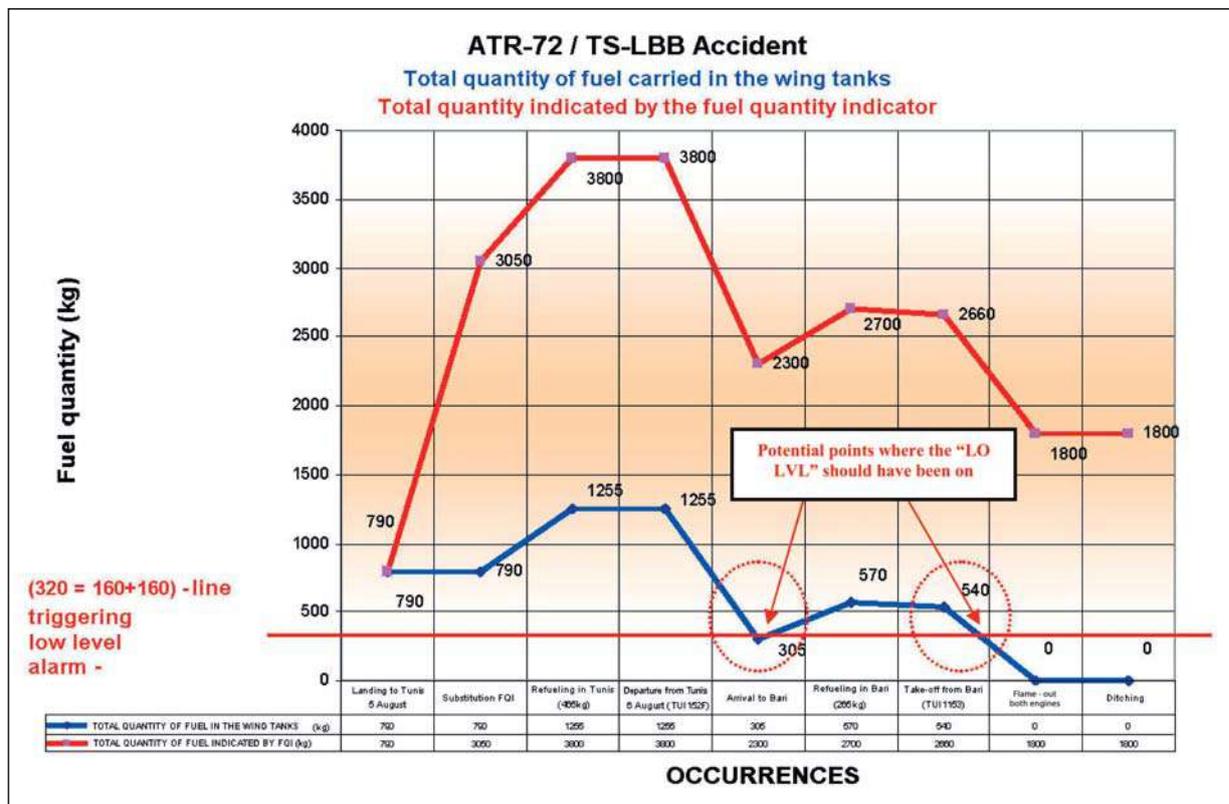
²³ With an ATR 42 type Fuel Quantity Indicator installed on board an ATR 72, the fuel quantity indicated obeys the following law of variation, determined experimentally: $Y = 1,572 X + 1807,8$ (in which X is the quantity of fuel actually carried on board). For example, with 600 kg fuel actually on board, the quantity indicated by the ATR 42 type FQI will be about 2750 kg.

The graph shown in Figure 27 gives the quantity of fuel actually on board (blue line) and the quantity indicated by the FQI (red line) for each stretch flown by TS-LBB.

Figure 27: Quantity of fuel indicated (red line) and actually on board (blue line). Note: a margin of error of approximately $\pm 2-3\%$ should be considered for the figures stated.

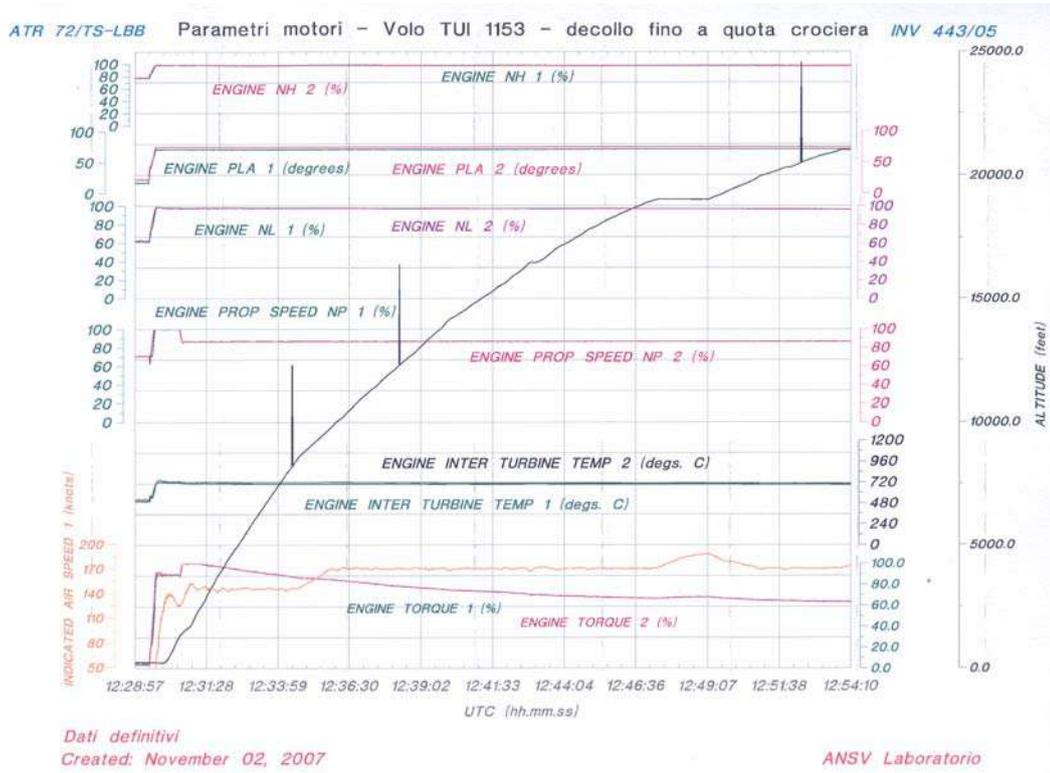
It will be noted from the graphs shown in Figure 28 that the engine parameters were normal and within the prescribed limits in the takeoff and climb to initial cruising altitude phase. The flight thus went off normally, without any aspect of particular note, from takeoff from Bari airport until the first engine flame out (right engine). The data extracted from the FDR regarding the working of the two engines suggest nothing out of the ordinary throughout the whole of the phase preceding the RH engine shut down.

The temperature, engine speed and fuel flow readings were, in fact, within normal values, as

illustrated in the graphs in Figure 28. Fuel consumption was normal and settled at a rate of about 10 kg/min in the cruising phase (graphs in Figure 29).

Figure 28: Pertinent engine parameters from takeoff to initial cruising altitude.

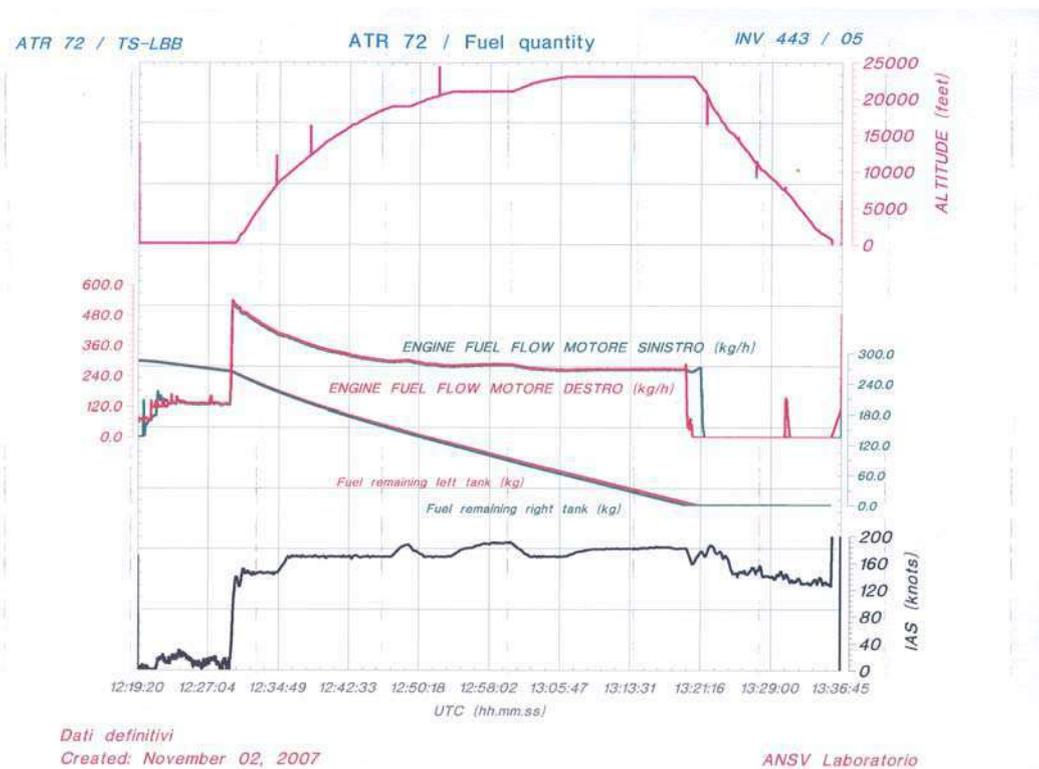
Figure 29: Fuel quantity and consumption status. “Fuel remaining” parameter is determined from the fuel flow data and it is not directly recorded by the FDR

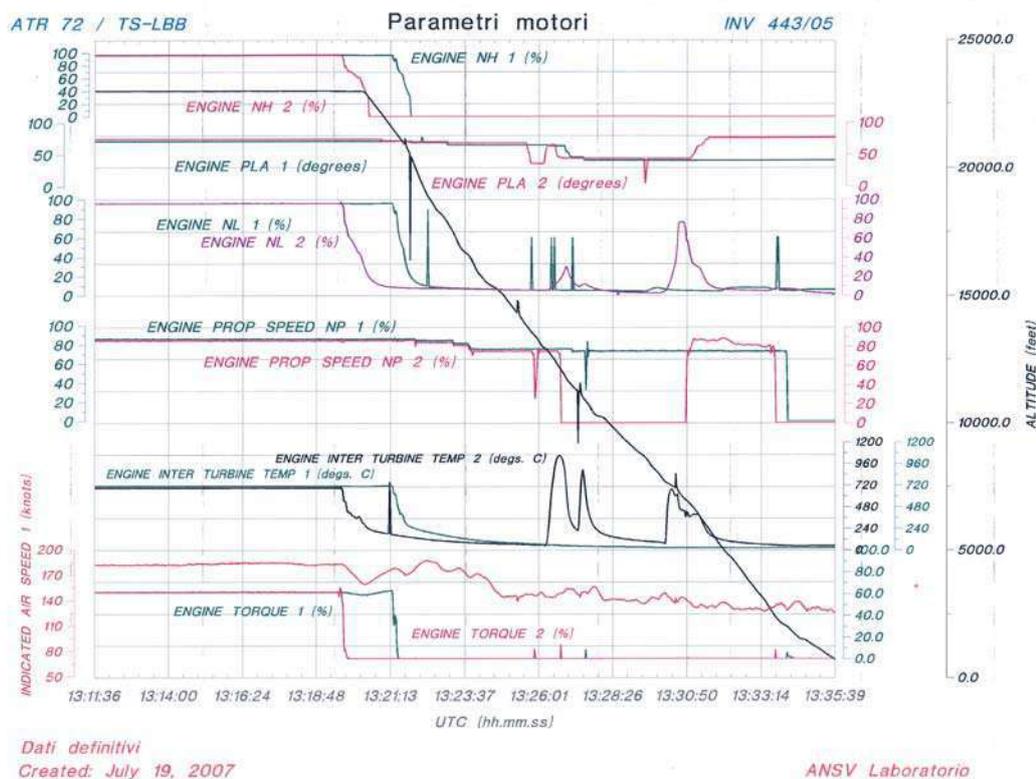
An analysis of the cockpit conversations that emerge from the CVR, plus the FDR data regarding aircraft altitude and speed parameters and the information supplied by the flight crew, have made it possible to reconstruct the action taken by the crew at the time when the first failures occurred. Figure 30 illustrates the main engine operation parameters; it may be seen that both engines shut down in linear fashion, without increases in internal temperature or an abrupt increase/decrease in speed in either engine.

Figure 30: Pertinent engine parameters.

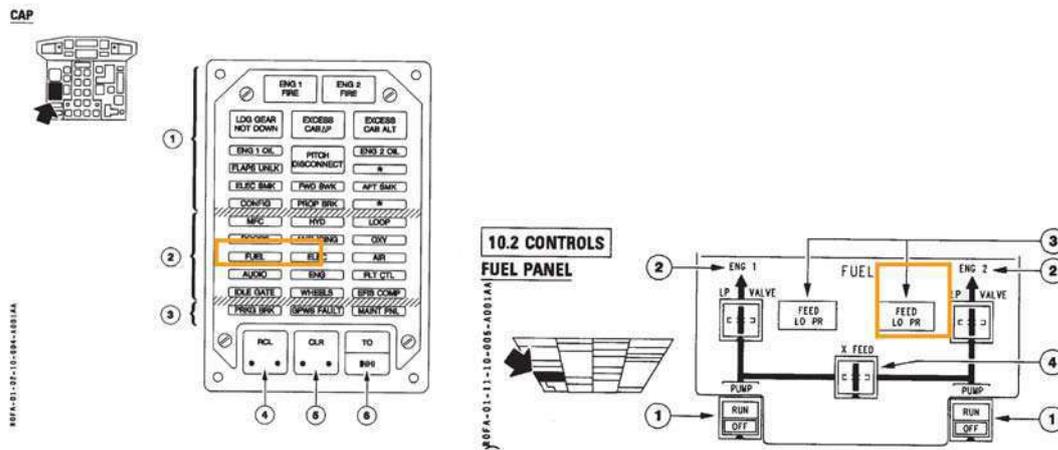
The first indications of malfunctioning to reach the cockpit were the amber “FEED LO PR” and “FUEL” lights illuminating on, respectively, the fuel panel and the Crew Alerting Panel (CAP), accompanied by the associated single chime.

Figure 31: CAP and Fuel Panel.

The “FUEL” warning light on the CAP lighting up alerts the crew to an abnormal situation requiring corrective action, and the “FEED LO PR” warning light illuminates whenever the pressure of the fuel flow into the engine concerned falls below 350 mbar (5 psi). This is a sign of a possible fuel pump failure, a suspected fuel leak in the fuel ducts, or shortage of fuel. In the case in point, it was a sign of shortage of fuel.

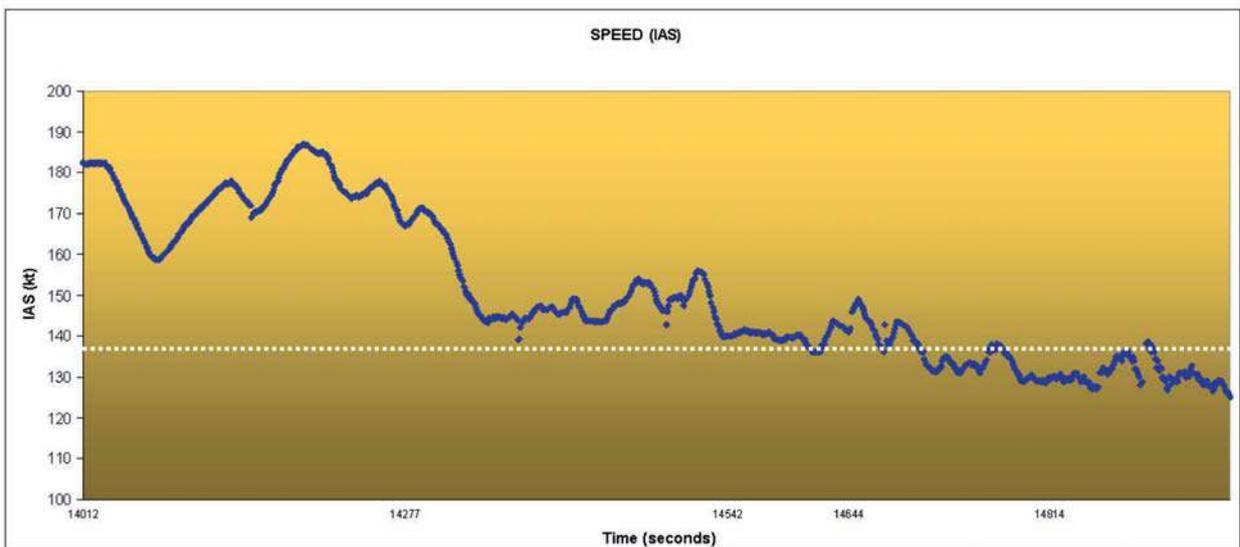
Prior to attempting re-ignition, the aforementioned procedure (“BOTH ENGINES FLAME OUT”) prescribes achieving and maintaining what is known as drift-down speed (V_{mHB} , optimum descent speed). This speed is given in the OPS DATA section in the QRH; with an aircraft mass of 17.000 kg, as in the case in point, said speed is about 129 knots with flaps 0°, and 137 knots for an aircraft mass of 19.000 kg (dotted line in figure 32). At the time of the second failure, the aircraft was flying at a speed of about 180 kts, and the flight crew in any case maintained speeds considerably higher than those prescribed by the procedure down to an altitude of about 6000 ft. As will be seen, moreover, from the speed graph shown in Figure 32, which covers the final phase of the flight after both engines had shut down, the speed varied considerably over time. However, as was also confirmed by the tests performed on the flight simulator, it is no easy matter for a flight crew to succeed in maintaining a constant speed profile throughout an emergency similar to the one that involved TS-LBB. This is primarily so because of the difficulty of using the emergency instruments provided with a reduced electrical supply (airspeed indicator, stand-by horizon, altitude and vertical speed indicator) and the practical problems encountered in handling and operationally manage the flight.

Figure 32: Indicated Air Speed (IAS) final phase recorded by FDR.

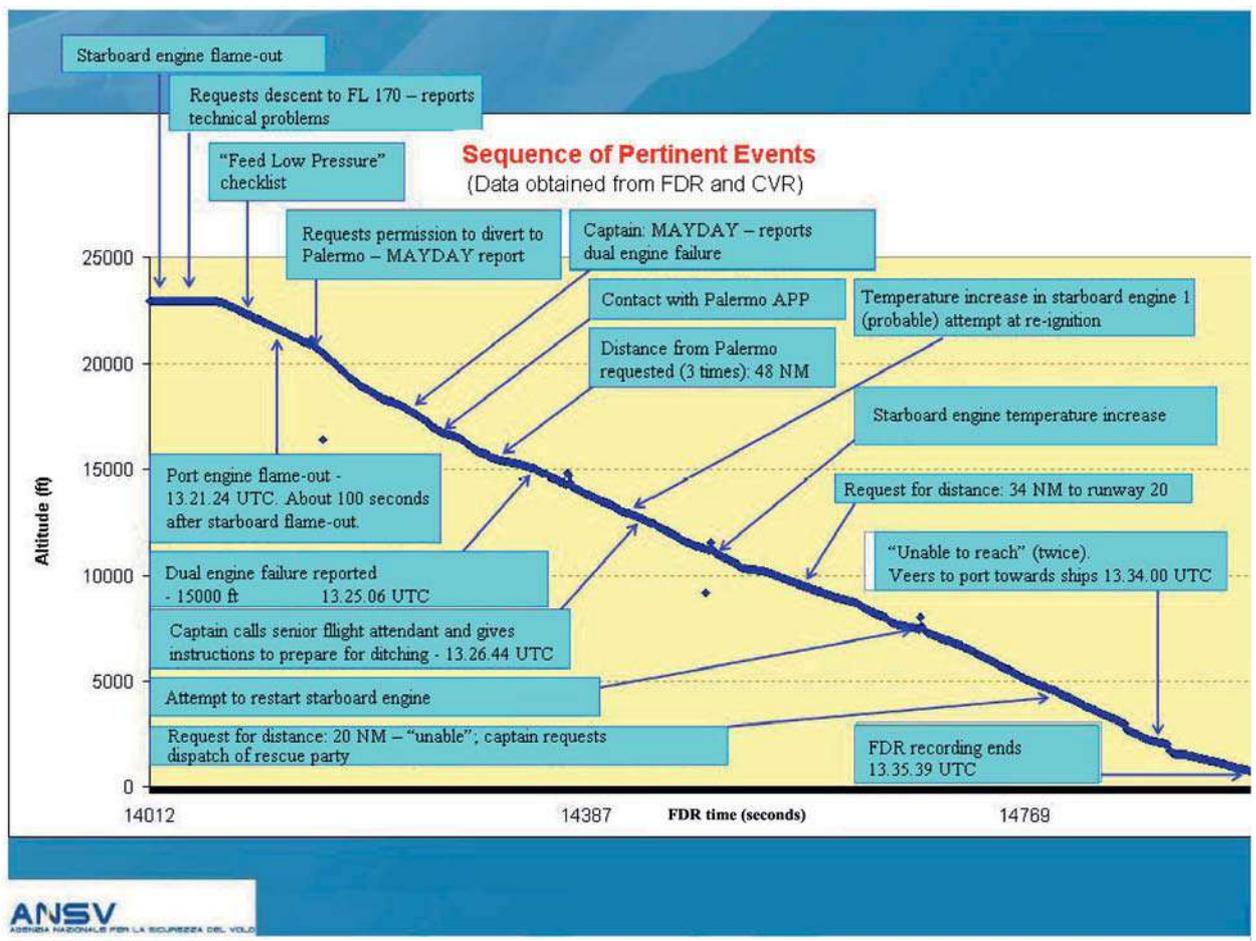
Whereas Figure 33 shows the same sequence in diagram form, taking aircraft altitude as the base parameter.

Figure 33: Sequence of pertinent events.

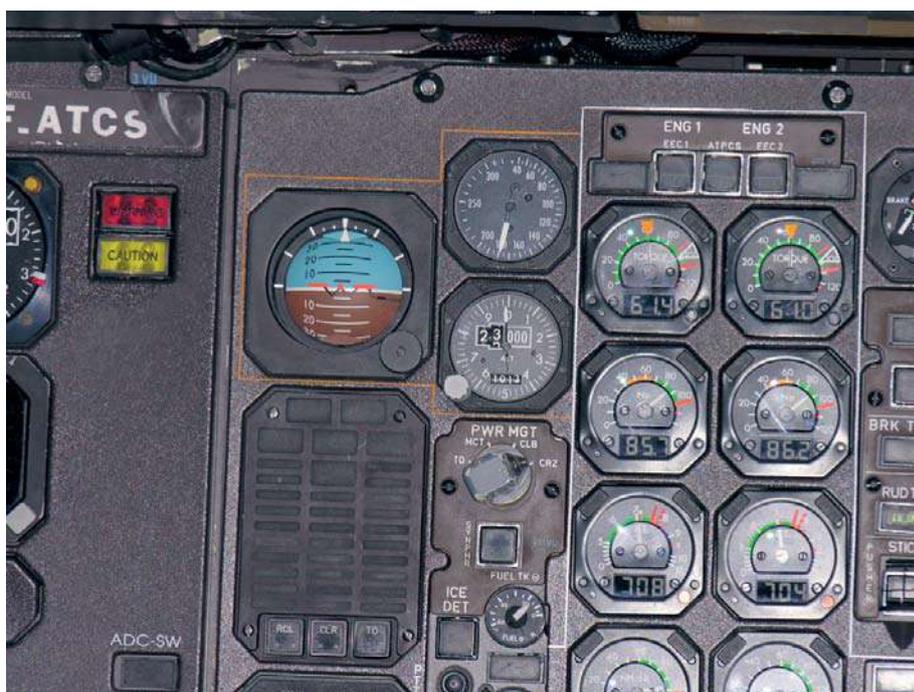
After identifying the first failure and starting to apply the relevant check list, the crew detected a loss of thrust in the RH engine followed, shortly after, by the other (LH) engine failure. This emergency situation was not handled correctly, as the checks prescribed in the applicable “BOTH ENGINES FLAME OUT” check list were not performed. However, the particular operating conditions in which the crew found itself must be borne in mind: without information in the cockpit on the distance from Palermo (with the second engine out of action, the DME values are not available), with reduced flight instruments, with a misleading fuel quantity reading, dual engine failure and the prospect of ditching. With dual engine failure, and hence with the electrical generators inoperative, flight instrument availability is limited and the crew has only the stand-by instruments to rely on for the purposes of handling the aircraft.

Photo 85: Detail of stand-by instruments.

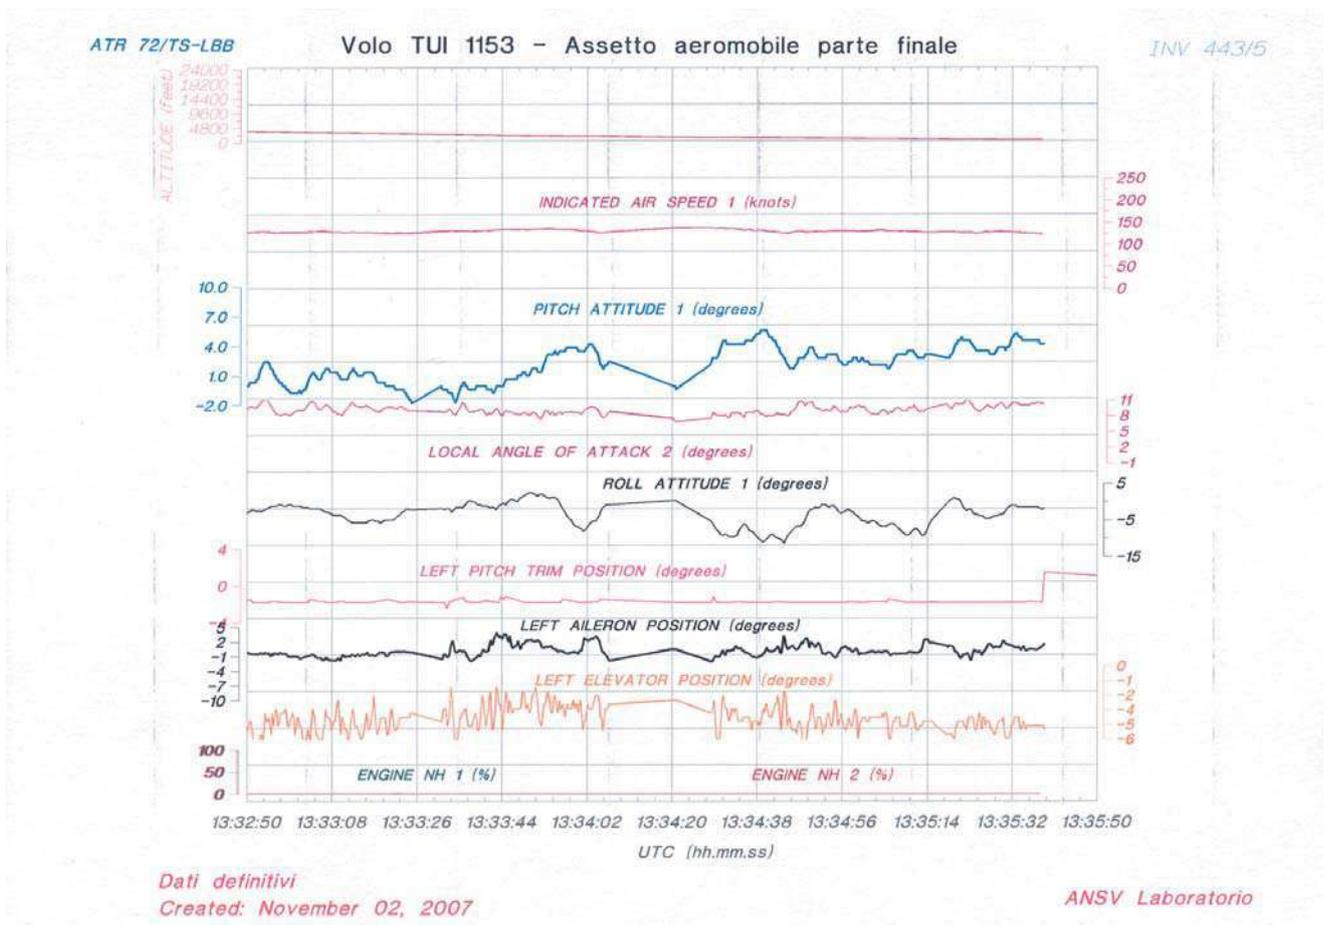
The FDR stopped recording with the aircraft at an altitude of 728 ft and Indicated Air Speed of 125 kts. From analysis of relevant data recorded during the previous minute, it has been determined that the aircraft had a descent rate of approximately 700 to 800 ft/min. Therefore in the hypothesis, highly probable, that the pilot maintained the same descent rate until impact, it can be reasonably assumed that approximately one minute has elapsed between FDR recording interruption and the impact with the sea surface. Such hypothesis is verifiable with the comparative analysis of FDR and CVR end of recording timing, with ATC timing (see paragraph 1.11.4.). Regarding the evaluation of parameters needed for determining the dynamics during the final part and that regarding the ditching, it has been necessary to use the results from wreck analysis, CVR data and available witness statements.

Figure 36: Relevant parameters during final phase.

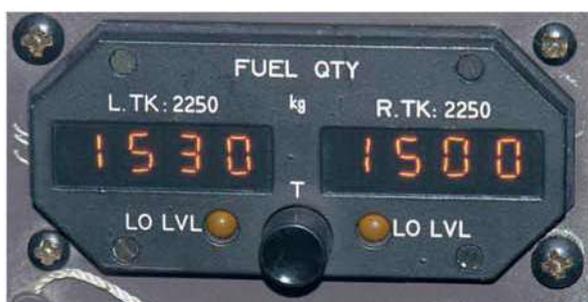
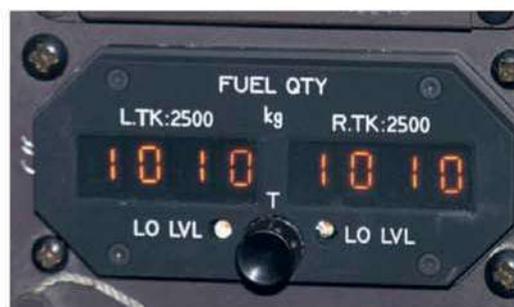
The wing tanks of the ATR-72 and ATR-42 differ in terms of maximum fuel capacity and shape, as well as number of the probes; as a consequence FQIs for the ATR-72 and for the ATR-42 utilize different algorithms to process the input capacitance signals coming from the tank probes and therefore they are not interchangeable (see manufacturer curves in Annex).

Nevertheless the FQIs for the ATR-72 and ATR-42 have the same dimensions and installation interface; this means that an FQI for the ATR-42 could erroneously be installed on a ATR-72 model and viceversa. The only visible difference between the two FQIs is the indication in small white digits of the maximum fuel quantity per tank, which is “2500” for the ATR-72 and “2250” for the ATR-42.

Fuel Quantity Indicator ATR-42

Fuel Quantity Indicator ATR -72

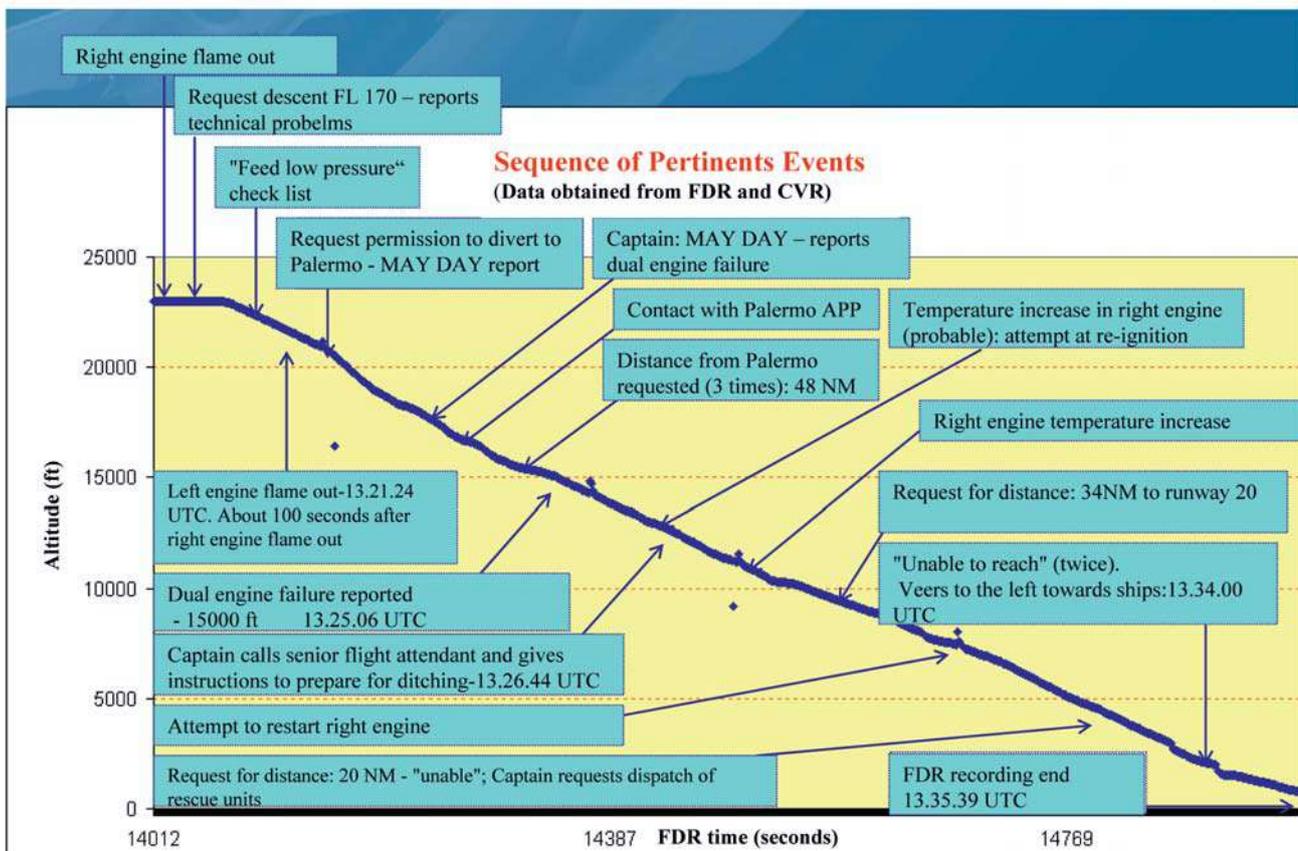
ATR 72 / TS-LBB Ditching - 6 august 2005
Flight TUI 1153 - Sequence Events of interest

N.	Event	FDR Time (seconds)	UTC time (hh.mm.ss from FDR)	Altitude (ft)	Airspeed (kts)	Note	Distance from Palermo TVOR/DME
1	Right engine shut down	14030	13.19.43	22.940	182	Radio contact with Roma control (Roma ACC)	
2	Request descent to FL 170	14058	13.20.10	22.940	166	TUI 1153 declares technical problems	
3	"Feed low pressure" check list reading	14091	13.20.44	22.410	165		
4	Left engine shut down	14131	13.21.24	21.340	178	100 seconds since right engine shut-down	
5	Request diversion to Palermo	14142	13.21.35	21.060	175		
6	MAYDAY	14159	13.21.51	20.550	171		
7	MAYDAY again	14220	13.22.53	18.140	178	Captain: "We lose both engines" - 14230	
8	Radio contact with Palermo approach (APP)	14255	13.23.28	16.960	177		
9	TUI 1153 confirms MAYDAY conditions	14281	13.23.54	16.290	168	Request latest wind conditions in Palermo

N.	Event	FDR Time (seconds)	UTC time (hh.mm.ss from FDR)	Altitude (ft)	Airspeed (kts)	Note	Distance from Palermo TVOR/DME
31	TUI 1153 reports that they are not able to reach the runway and asks for the rescue service	14802	13.32.35	4.260	130		
32	TUI 1153: "Unable to reach" (2 times) and inform Palermo that he is going towards two "boats"	14887		2.040	134		
33	FDR ending	14988	13.35.39	728	125		
34	Sound ("cricket"). Most probably the stall warning sound	15035					
35	Impact with the sea - CVR ending	15045	13.36.36			Radial 053 from Palermo TVOR/DME	22 NM
