*Accident
which occurred
on 30 January 2000
in the sea near Abidjan Airport
to the Airbus 310-304
registered 5Y-BEN
operated by Kenya Airways*

REPORT

This report presents the conclusions of the Commission of Inquiry on the circumstances and causes of the accident that occurred on 30 January 2000 in the sea near Abidjan airport to the Airbus 310-304 registered 5Y-BEN operated by KENYA AIRWAYS, which was undertaking the Abidjan - Lagos -Nairobi flight KQ 431.

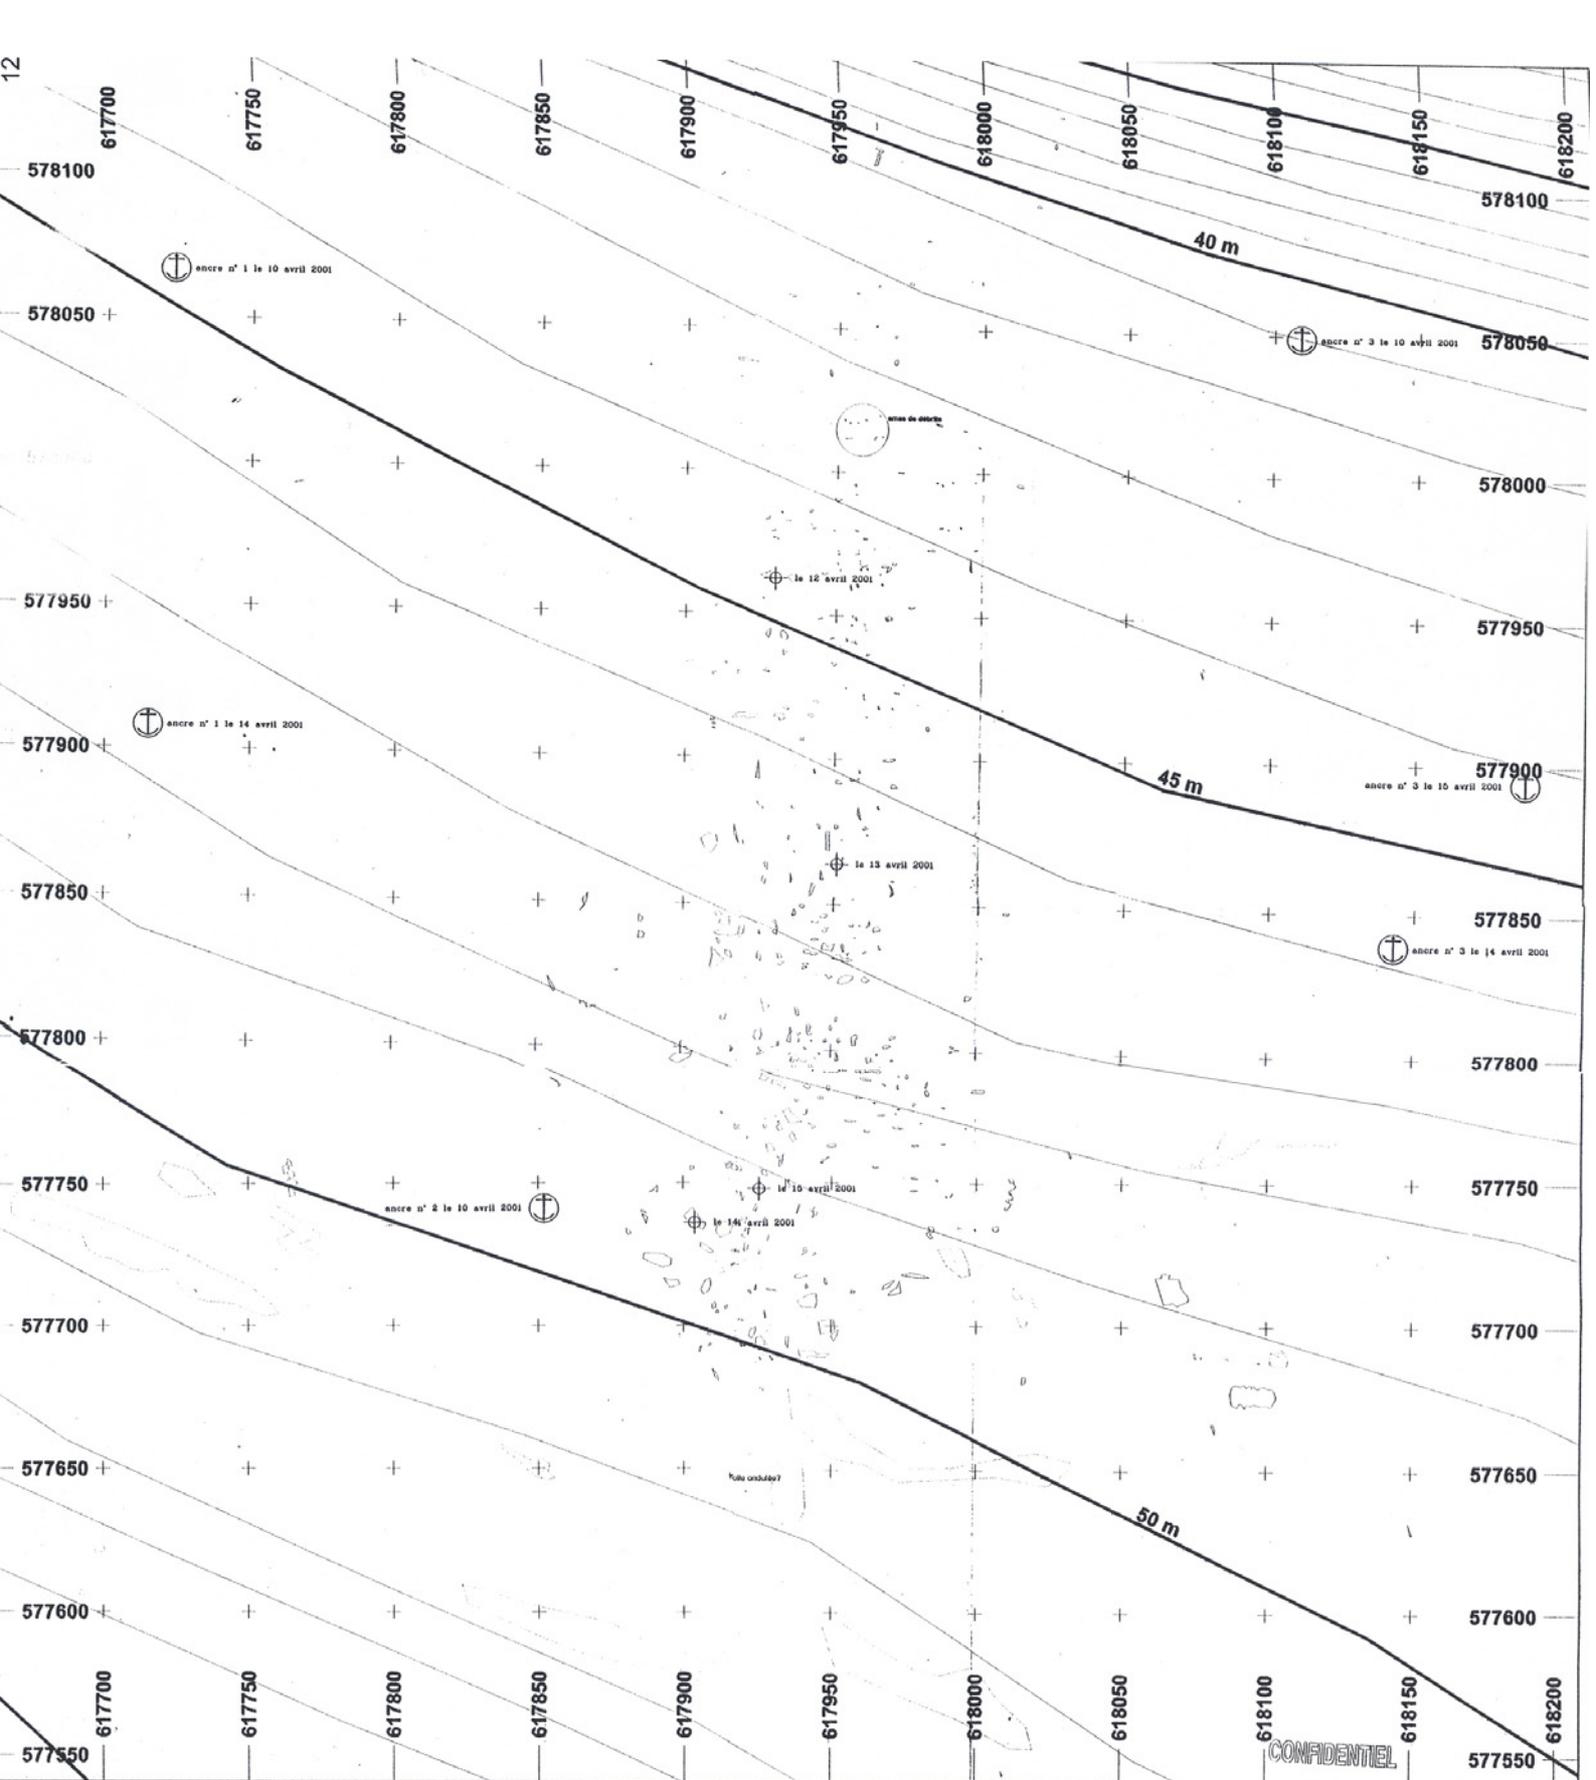
CARTOGRAPHIE DU PLAN DE REPARTITION DES DEBRIS

- Position de l'arrière du SEA RELIANCE
- Positions des ancres
- Contour des débris
- Contour des reliefs

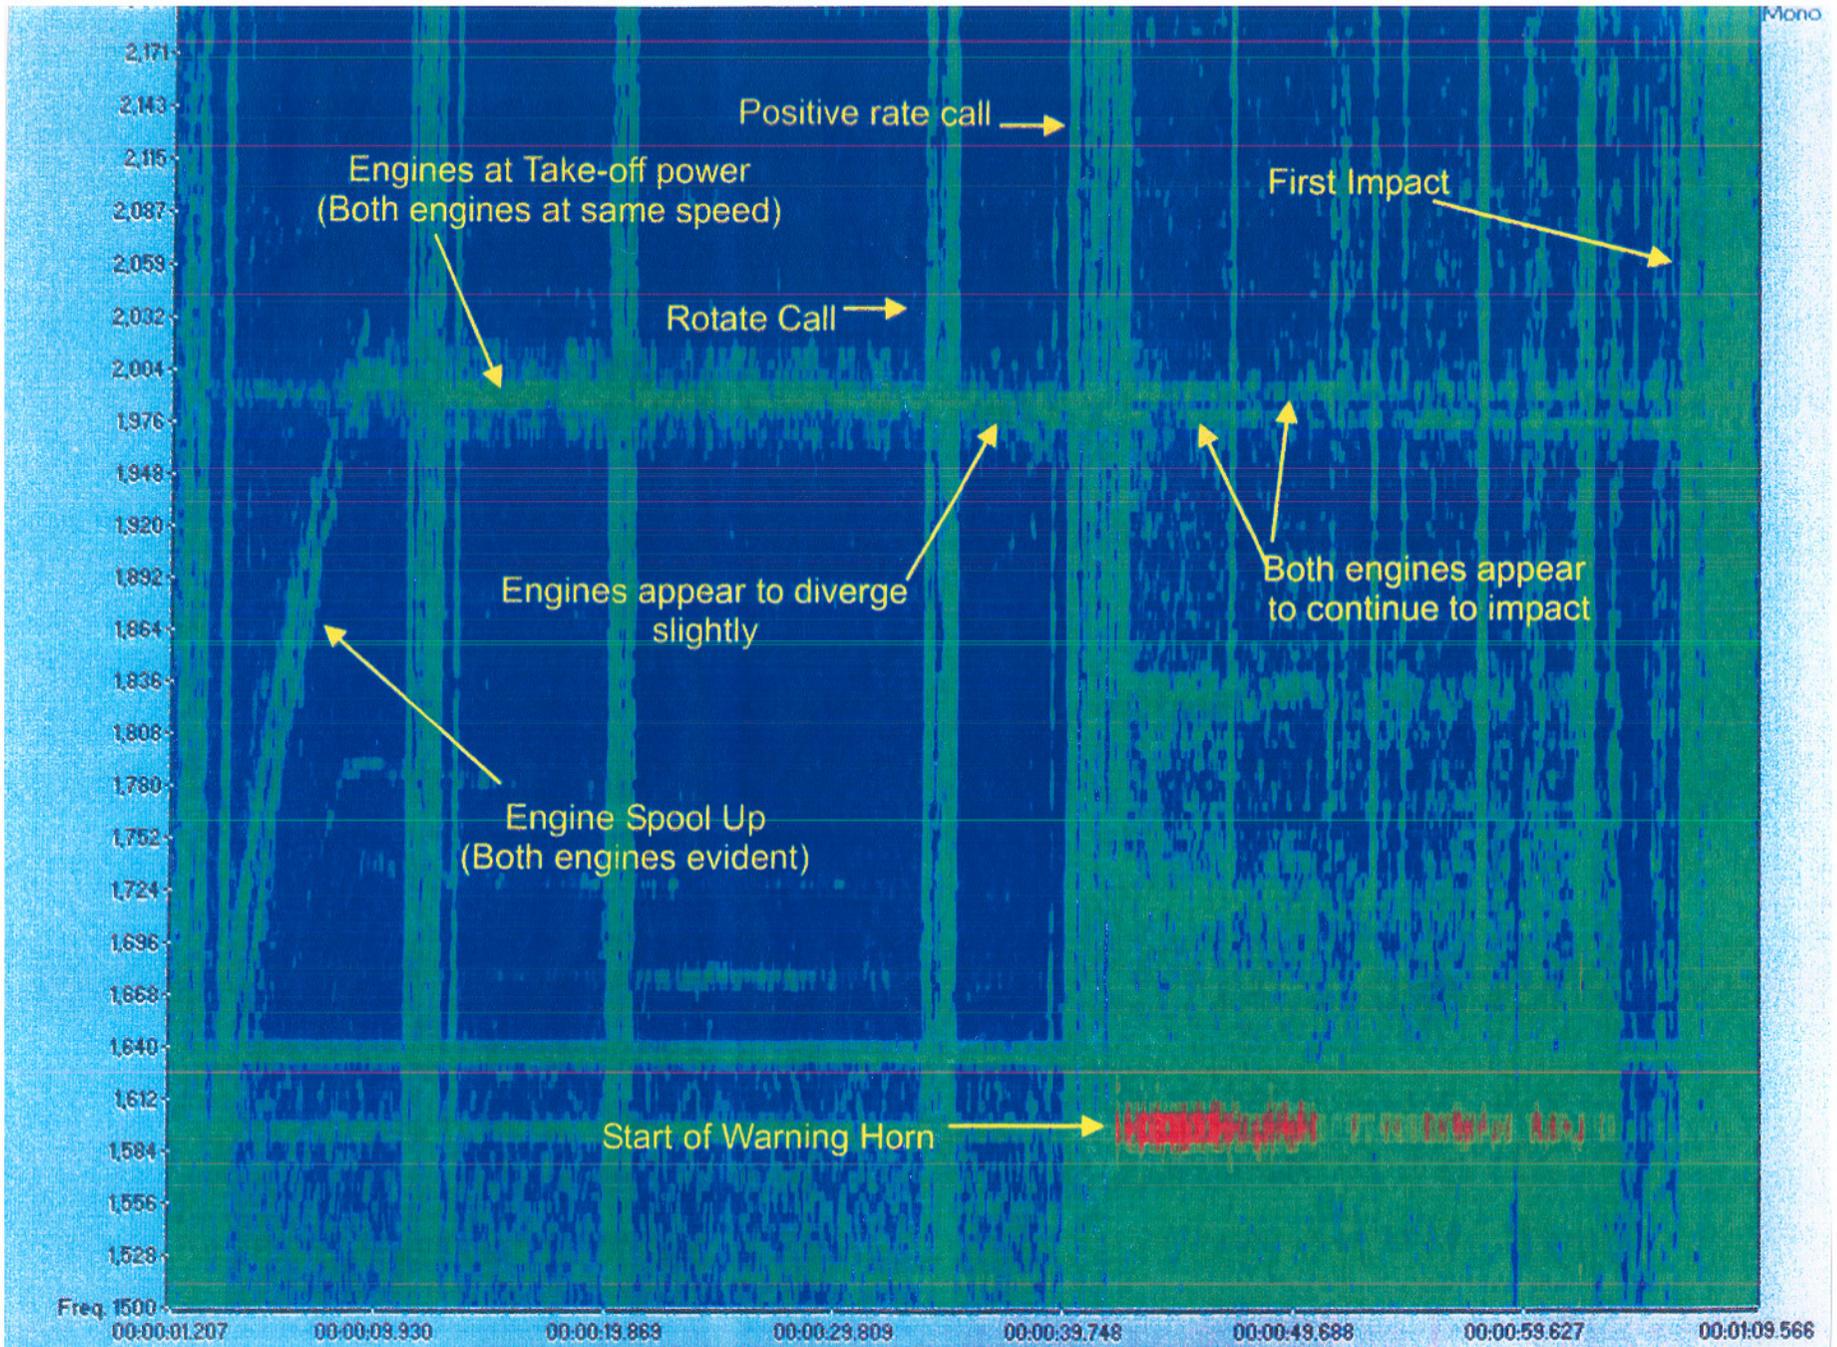
Figure 11: Engine Sonagram
Kenya A310

A spectral analysis of the CAM channel for the accident take-off showed the spool-up of both engines to thrust levels which were consistent with take-off thrust (Appendix C, Figure 11). The engine signatures indicated that both engines were matched at the take-off thrust setting during the initial portion of the take-off roll. A slight divergence in thrust was noted after rotation, however, both engines appeared to continue at high thrust levels up to the time of impact. The signature of the stall warning horn, at approximately 1,600 hz, can be seen at the bottom right corner of the figure.

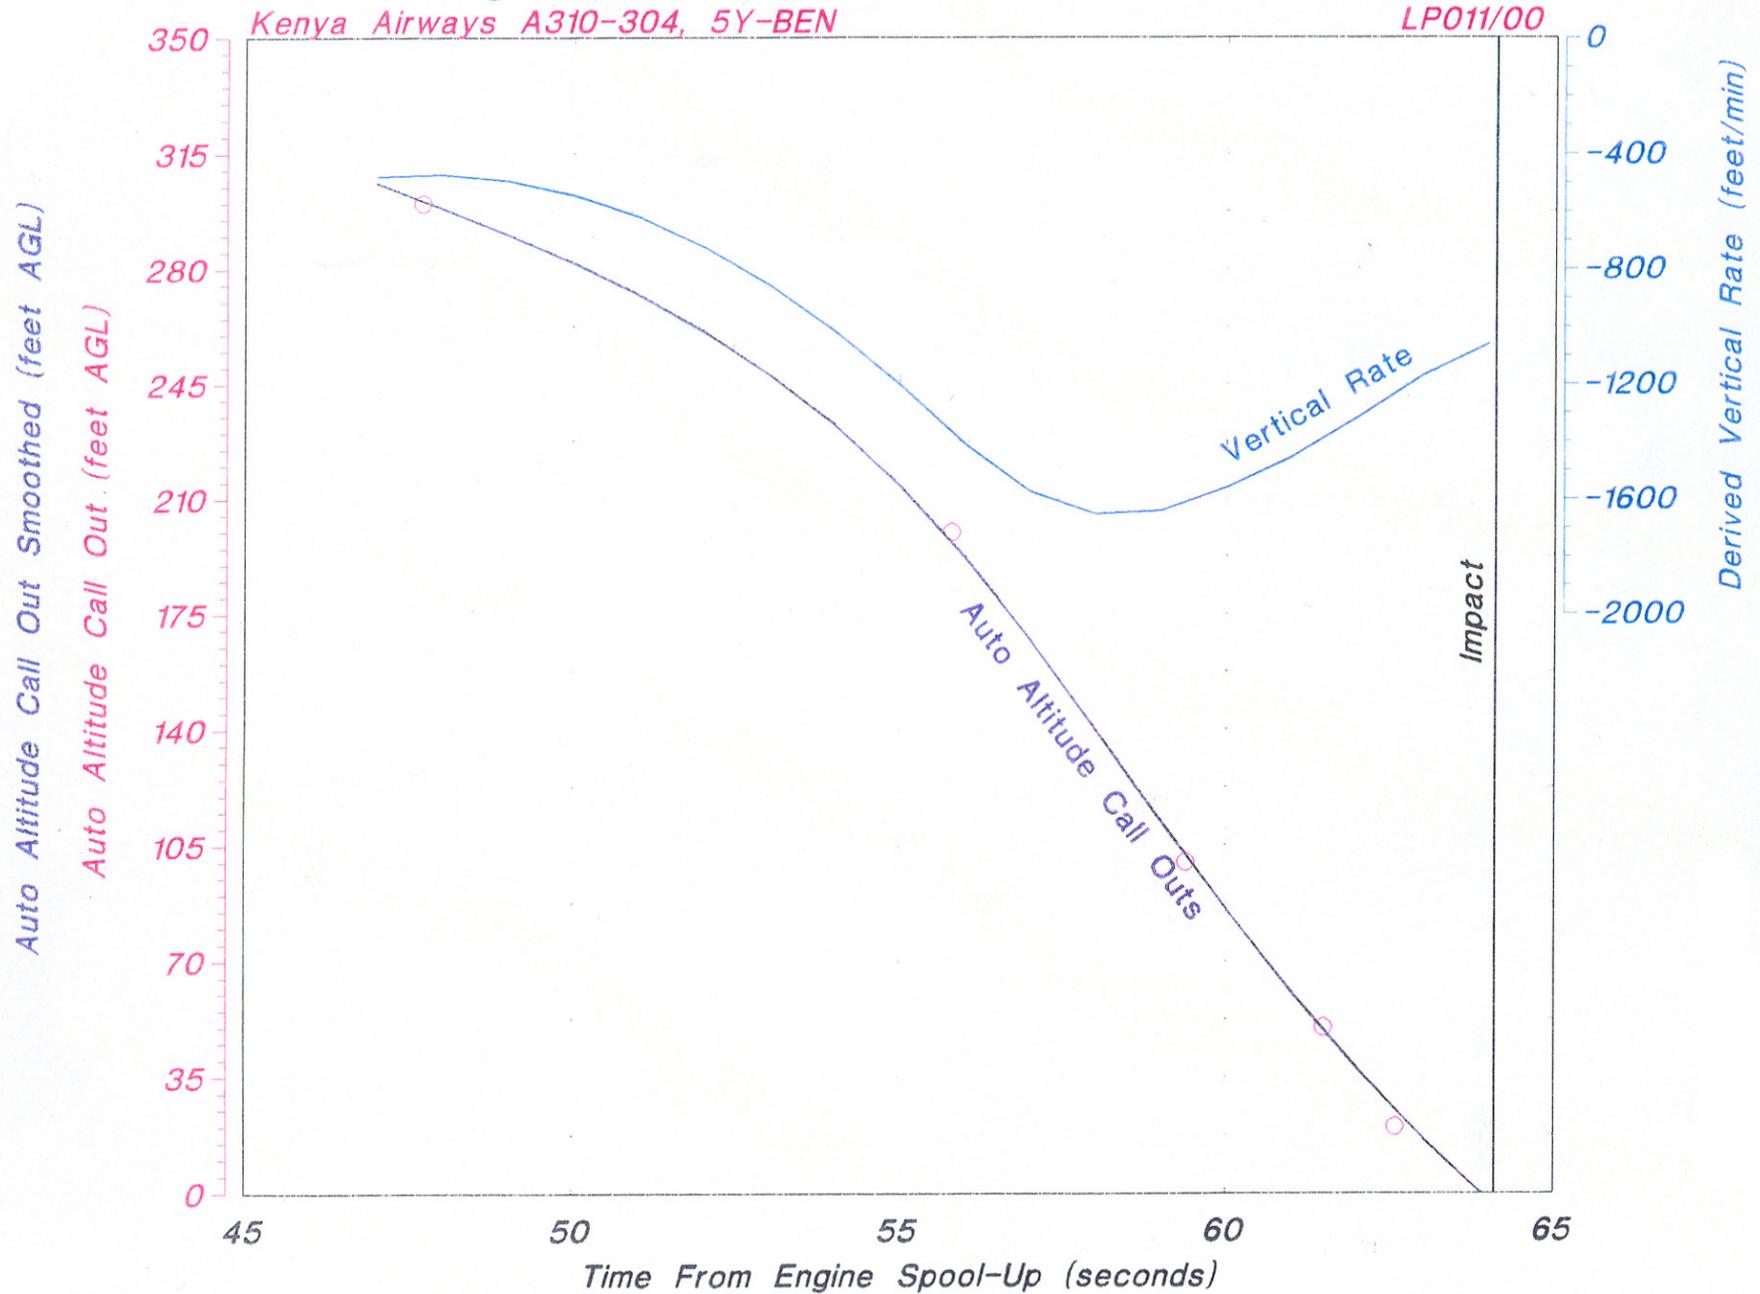
Figure 12: Auto Altitude Call Outs

The auto altitude call outs recorded during the final 16 seconds of the take-off were plotted as a function of time from the start of engine spool-up (Appendix C, Figure 12). A mathematical smoothing algorithm was applied to the data, which was then differentiated to provide an indication of the vertical rate of climb. The CVR recording indicated that there was a change from a positive to a negative rate of climb at some point following the stall warning activation. The derived vertical rate suggests that the rate of descent exceeded 1,000 feet/min, and that a recovery was possibly initiated, as suggested by an apparent reduction in the rate of descent, during the final 10 seconds of the flight.
