Report

Accident on **27 November 2008**
off the coast of Canet-Plage (66)
to the **Airbus A320-232**
registered **D-AXLA**
operated by **XL Airways Germany**

BEA

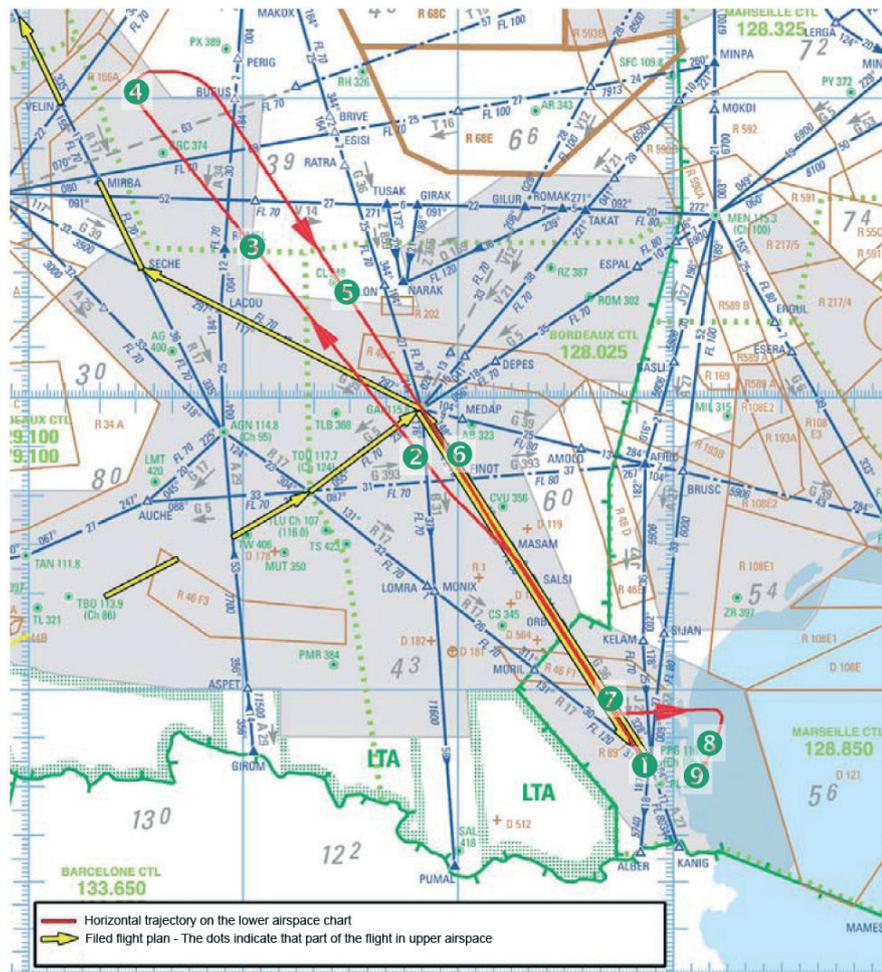
The recordings stopped at 15 h 46 min 06.8. The last recorded values were a pitch of 14 degrees nose down, a bank angle of 15 degrees to the right, a speed of 263 kt and an altitude of 340 ft.

Between the time the stall warning sounded for the first time and the moment the recordings stopped, sixty-two seconds had passed.

- ① 14 h 44
Takeoff from Perpignan aerodrome
- ② 14 h 52
The controller told the crew that they could not perform a “360”
- ③ Between 15 h 04 et 15 h 06
Blockage of angle of attack sensors 1 and 2
- ④ 15 h 12
Turn back
- ⑤ 15 h 22
Arrival at FL 390
- ⑥ 15 h 26
Beginning of descent
- ⑦ 15 h 34 min 34 s
Co-pilot: “(...) we’ll appreciate a radar vector the approach”
- ⑧ 15 h 43 min 41 s
Thrust levers on IDLE
Beginning of the check on the low speed angle of attack protections
- ⑨ 15 h 45 min 05 s
Stall warning

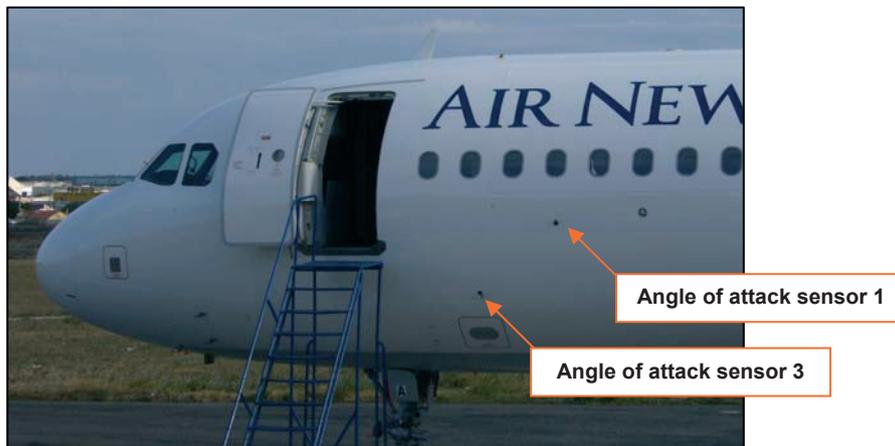
1.6.6.3 Description and position on A320

Two of the three angle of attack sensors are installed symmetrically, one behind the forward left passenger door (sensor 1) and the other to the right of the fuselage, above the forward cargo door (sensor 2). The third (sensor 3) is located on the left side, in front of and below sensor 1.

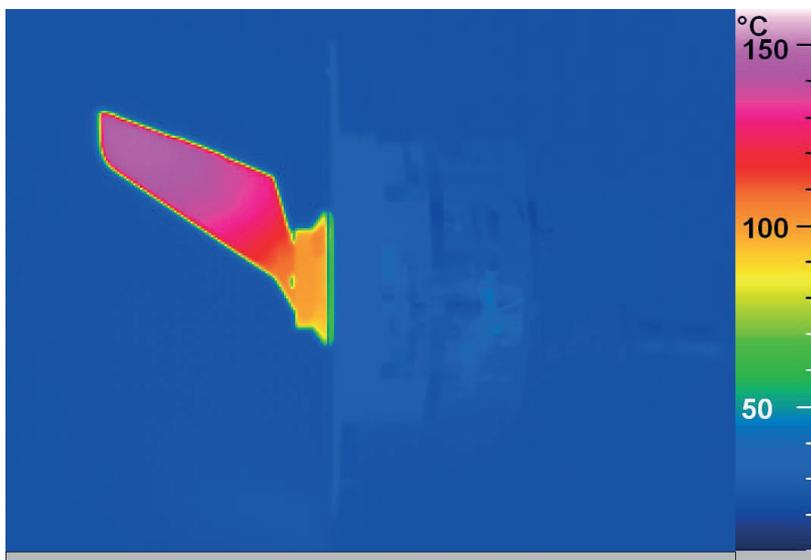
1.16.1.5 Temperature measurements

The thermal image below, taken with an infra-red camera, shows the distribution of temperatures of a new angle of attack sensor whose heating system and resolvers have been powered for five minutes in ambient conditions.

This thermal image does not show the temperature inside the sensor housing.

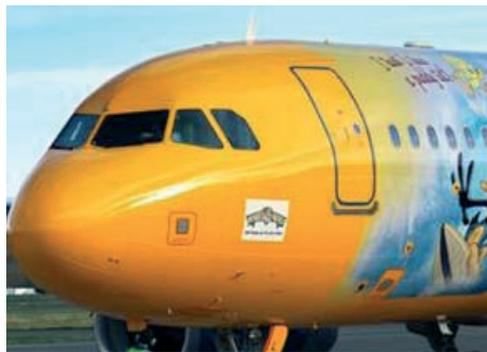
- ❑ The mounting flange of angle of attack sensor 1, which remained attached to the sensor and to the fragment of the panel, showed the presence of the application of a yellow paint underneath the white paint. This yellow paint, which corresponds to one of the aeroplane's previous liveries, was also visible under the white paint of a section of the fuselage framing this mounting flange.

ZK-OJL (the previous registration of D-AXLA) in the Freedom Air Limited livery
(source: Air New Zealand)

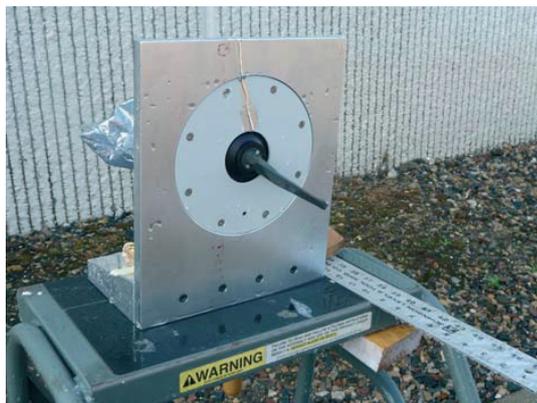
The angle of attack sensor was mounted on to a panel reproducing an aeroplane fuselage panel. It was exposed to jet of water at 270 kPa⁽²¹⁾ at a distance of 30 cm from all directions within a cone at ± 45 degrees centred on the perpendicular axis to the sensor face, for five minutes. Without being dismantled, the device was placed in an environmental chamber simulating the temperature (- 54 °C) and altitude pressure conditions prevailing at FL 350 in standard atmosphere (test B corresponding to paragraph 6.3 of the protocol). The angle of attack sensor heating system was not powered during the temperature and pressure conditions set-up in the environmental chamber.

Simulation of the aeroplane installation

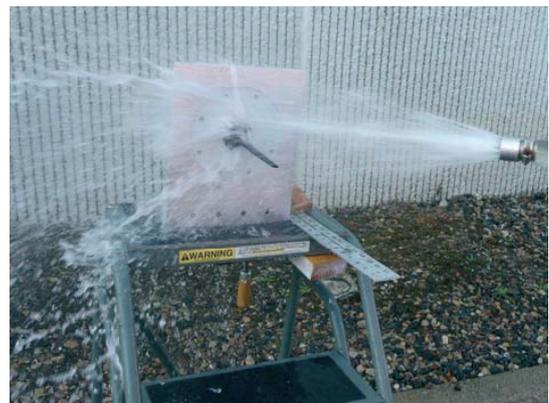
Exposure to a jet of pressurised water

- ❑ Exposing the sensor to a jet of pressurised water can lead to water being introduced into the sensor body as well as to blocking of the turning parts by icing, at the time of exposure to negative temperatures without heating;
- ❑ A small amount of water in the bearings was also enough to block the turning unit in these conditions.

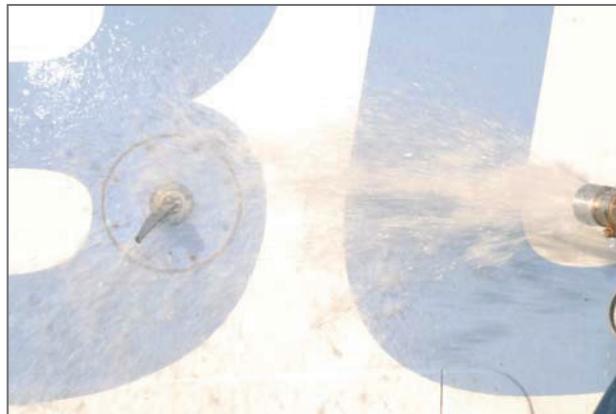
Sensor 2 was exposed to a water jet, without protection, in conditions similar to the test carried out at Goodrich (see 1.16.1.9.1). The jet was applied, with a hosing tool (not recommended by Airbus for cleaning procedures) which was used during the tests carried out at Goodrich, with a to and fro movement on and around the sensor, staying within a cone of ± 45 degrees centred on the perpendicular axis to the sensor face.

The temperature at take-off was about $+ 8$ °C. Climbing through FL 300, about 23 minutes after take-off, sensor 2 was blocked at $+ 1$ ° value while sensors 1 and 3 indicated values consistent with the flight phase. The SAT was $- 51$ °C, the TAT was $- 26$ °C and the temperature recorded by the temperature sensor located close to the sensor 1 upper bearing was $- 15$ °C. Sensor 2 started to unblock gradually 51 minutes later. The SAT was $+ 2$ °C, the TAT $+ 4.75$ °C and the temperature close to the upper bearing was $+ 4.5$ °C. The angular position delivered by angle of attack sensor 2 became nominal 1 min 32 s later while the SAT was $+ 1.75$ °C, the TAT $+ 9,5$ °C and the temperature close to the upper bearing was $+ 5.5$ °C. Appendix 9 presents the evolution of specific flight parameters, including temperatures inside the casing.

Dismantling of sensor 2 casing confirmed the presence inside of a small amount of water. The difference between the volumes of water found inside the casing during the tests at Goodrich and at the end of this flight could be explained by the different application of the water jet on the angle of attack sensors. During the tests performed at Goodrich, the water jet was aimed more or less permanently at the angle of attack sensor while, in the context of the in-flight tests, it was applied with a to and fro movement and around the sensor.

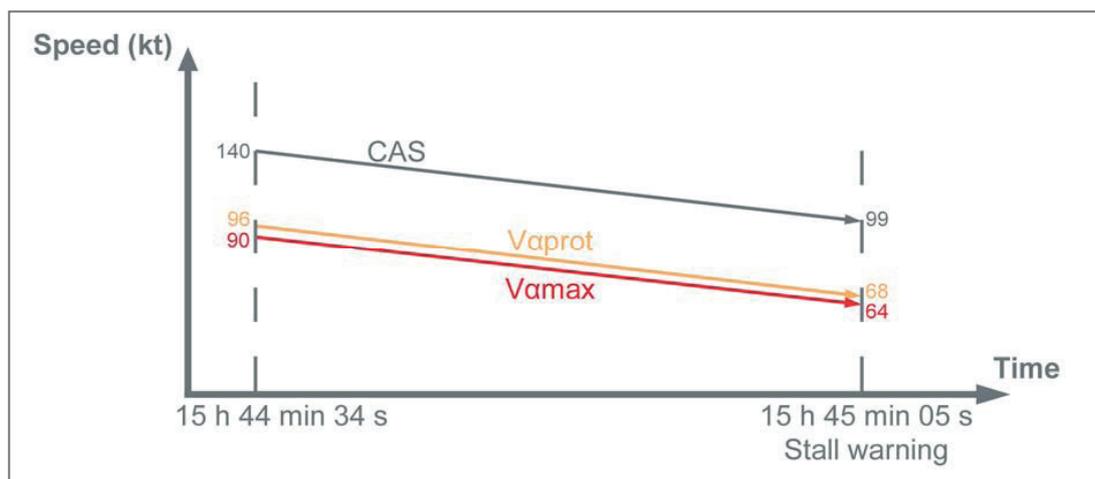
- ❑ Calculate the limit speeds presented to the crew during the accident flight. Once the angle of attack values stopped evolving, the limit speeds presented to the crew were proportional to the air speed. Thus, when the air speed dropped, the limit speeds also dropped by the same proportion. By way of comparison, the limit speeds where angle of attack values would not have been blocked were also recalculated (normal operation). These calculations facilitated the reconstitution of the speed band in normal operation and for the event flight.

Evolution of limit speeds during the accident flight (for information only)
(in normal operation and in the accident flight conditions, Vamax = 107 kt and VLS = 123 kt)

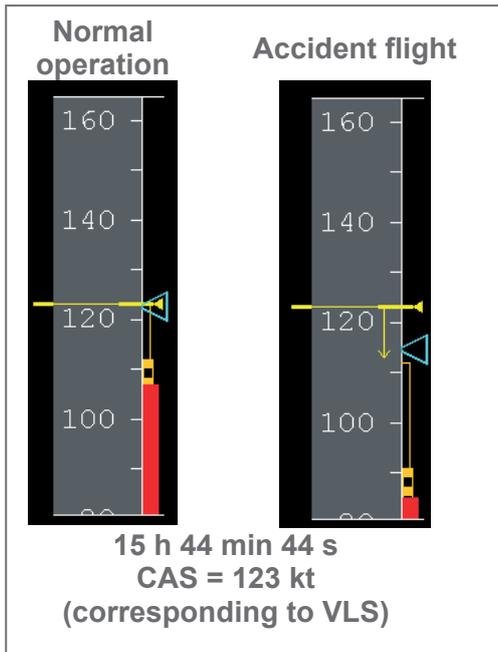
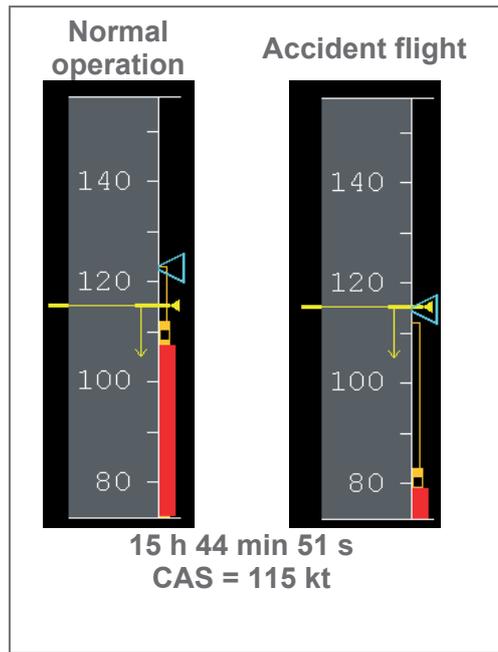
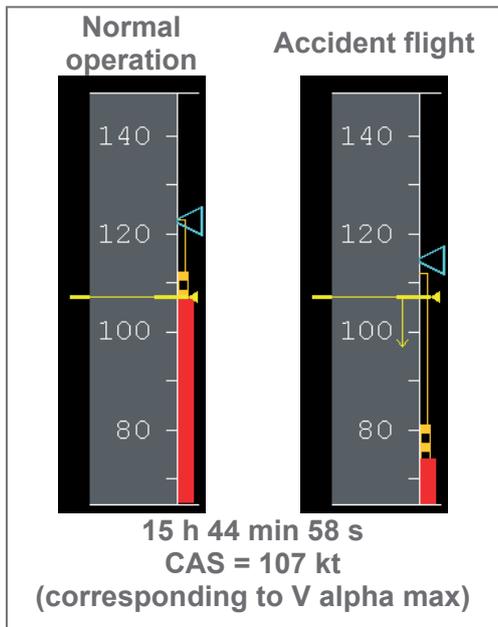
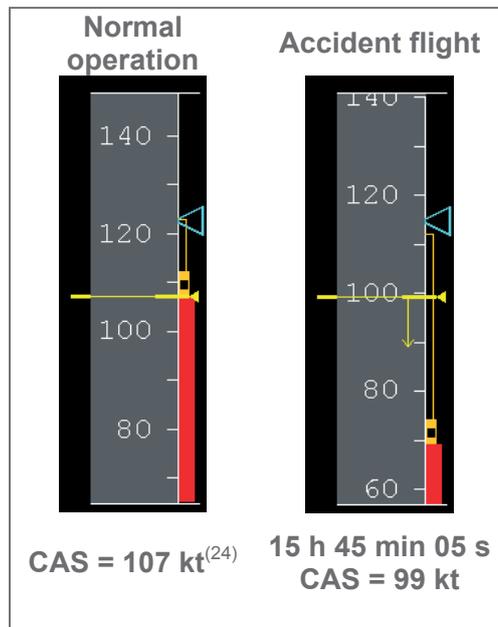
Auto-trim

From 15 h 44 min 30 the automatic trim function displaced the stabiliser as far as the electric nose-up thrust stop (- 11 degrees). The stall warning sounded at 15 h 45 min 05. The nose down commands applied by the Captain on the sidestick brought the elevators, due to the load factor, to the neutral position, without however pushing them to the stops⁽²⁵⁾. Consequently, the trimmable stabilizer did not move even though the flight control law was *normal*.

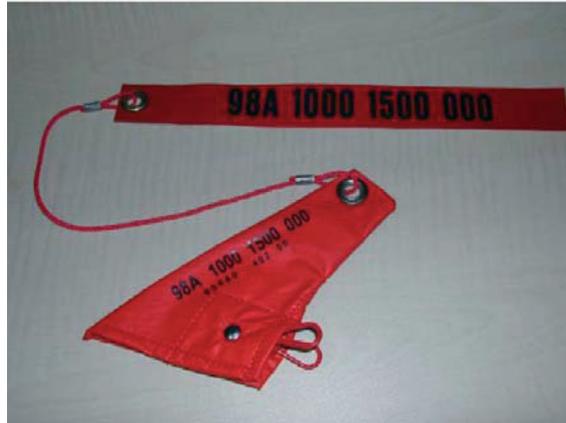
Example of protective equipment

The angle of attack sensor protections are not totally impermeable. The cleaning procedure specifies however that adhesive tape must be placed wherever cleaning products could penetrate.

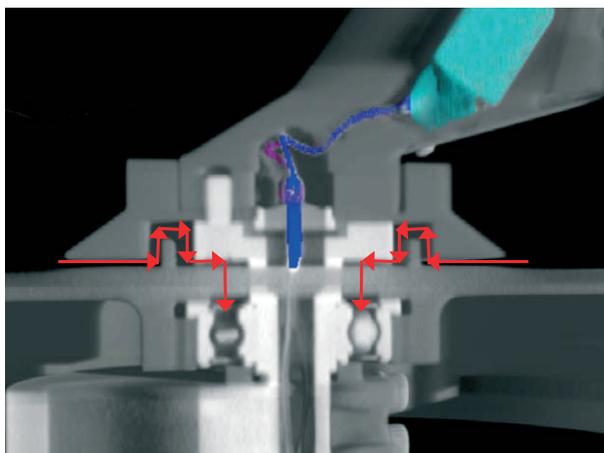
The angle of attack sensors were not protected when the aeroplane was rinsed with fresh water and some water certainly penetrated inside at least two of the three angle of attack sensors (AOA sensors 1 and 2). This water remained inside the sensors for the three days that the aeroplane remained outside of EAS Industries premises before the accident flight. The temperatures encountered during the climb caused this water to freeze and the AOA sensors to block. The seals of the angle of attack sensors bore no traces of damage previous to the impact with the surface of the sea. They thus did not contribute to allowing water to penetrate inside the angle of attack sensors.

Taking into account the results of the bench and in-flight tests (see 1.16.1.9), it is likely that a small quantity of water having penetrated inside of upper bearing (according to the route indicated in the diagram below), following specific washing conditions, was enough to cause, when frozen, the blockage of this bearing and thus of the AOA sensor.

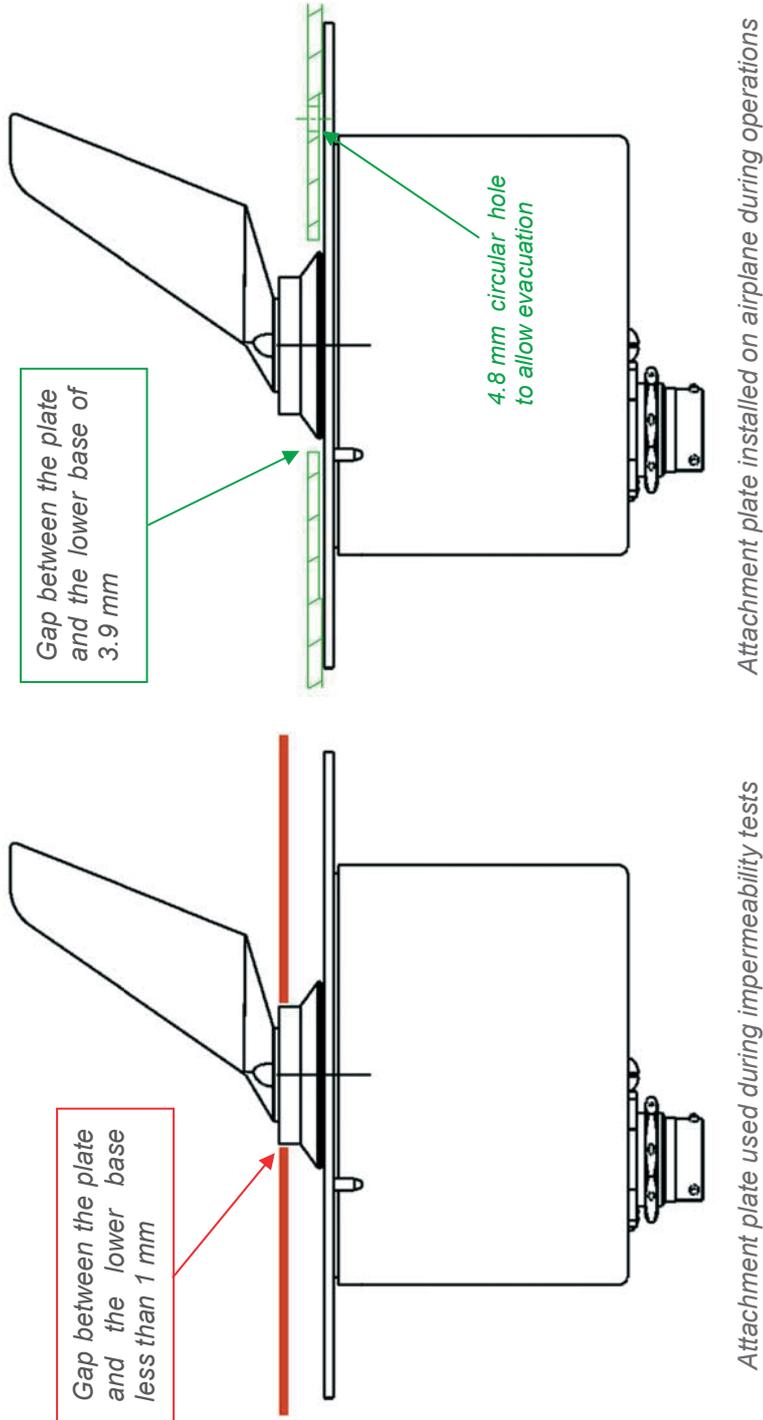
Differences between the attachment plates used during the impermeability tests and in operation

To ensure compliance with the regulatory requirements, the minimum levels of performance applicable to each item of equipment, in all of the specified operating conditions, are defined in the technical standard order for the equipment, if it exists (in the case of AOA sensors, TSO C54 issued by the FAA or ETSO C54 issued by EASA). The AOA sensors installed on aeroplanes in the A320 family comply with these technical standard orders, meet the specifications set by Airbus and are approved to be installed on these aeroplanes. However, during the investigation, it was noted that for the impermeability tests, undertaken by the equipment suppliers to demonstrate compliance with the minimum levels of performance defined by the technical standard orders, the installation conditions for the AOA sensors were different from those on the aeroplane.

Even if this difference between the installation of the AOA sensors during the impermeability tests and in operation did not contribute to the accident, it nevertheless constitutes a safety loophole and this is why the BEA recommends:

- **That EASA, in liaison with the other regulatory authorities, ensures that, in order to certify the adequacy of an item of equipment in relation to the regulatory requirements as well as to the specifications defined by a manufacturer, the equipment installation conditions during tests performed by equipment manufacturers are representative of those on the aeroplane.**

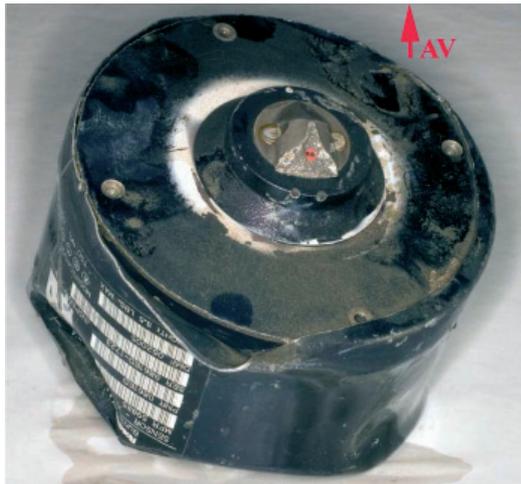
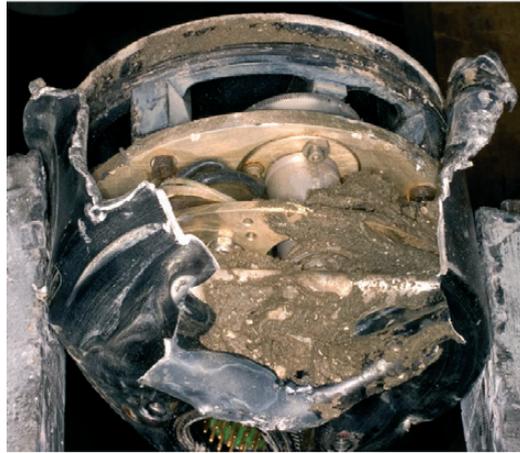
General view of the sensor

A deposit of white paint covered the upper face of the body, making a ring of about 5 mm wide, around the base of the broken vane and locally going over onto the bottom of the base.

The water escaping from the housing was filtered. No significant items, except fine sand were recovered from this water.

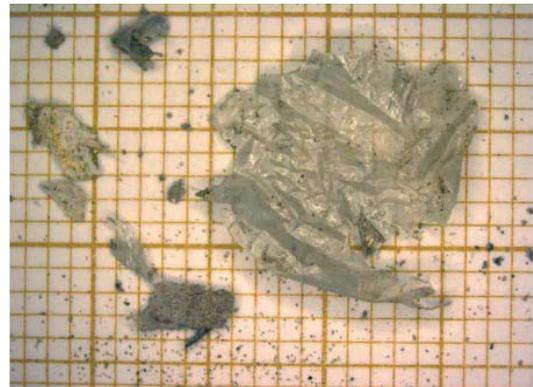
View of the film

Flexible film in the sensor recess, under the base of the vane

This film was about 10 mm square and around 0.01 mm thick. It was flexible and light, slightly crumpled, with a few clear parallel folds. Other smaller particles of the same type were recovered from the same zone. All of these particles were of polyester (terephthalate type).

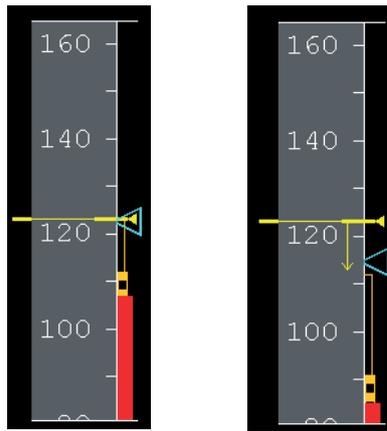
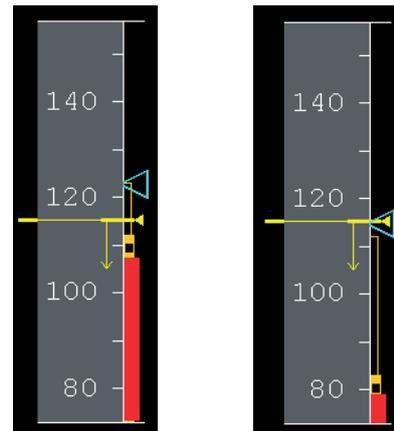
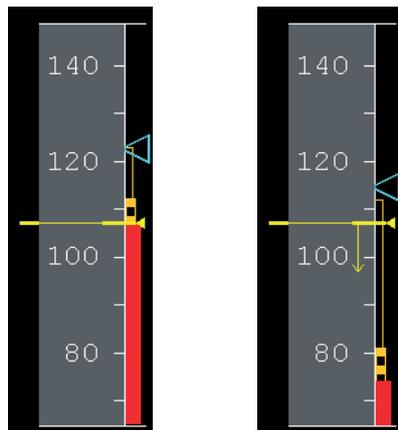
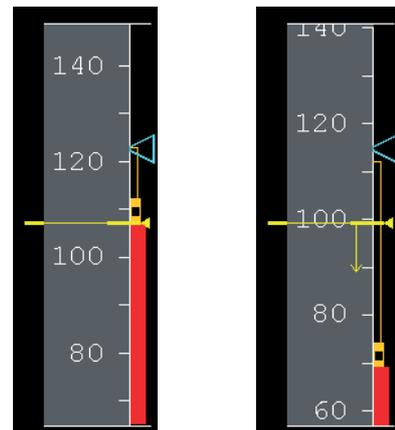
15 h 44 min 44 s
CAS = 123 kt
(corresponding to VLS)

15 h 44 min 51 s
CAS = 115 kt

15 h 44 min 58 s
CAS = 107 kt
(corresponding to V alpha max)

CAS = 107 kt⁽¹⁾ 15 h 45 min 05 s
CAS = 99 kt

⁽¹⁾With normal functioning of the high angle of attack protection, the speed cannot go below V_{amax}
