# BEA

# INVESTIGATION REPORT

## **Accident to the AIRBUS - AS350 - B registered F-GIBM**

on 07 March 2021  
at Touques (Calvados)

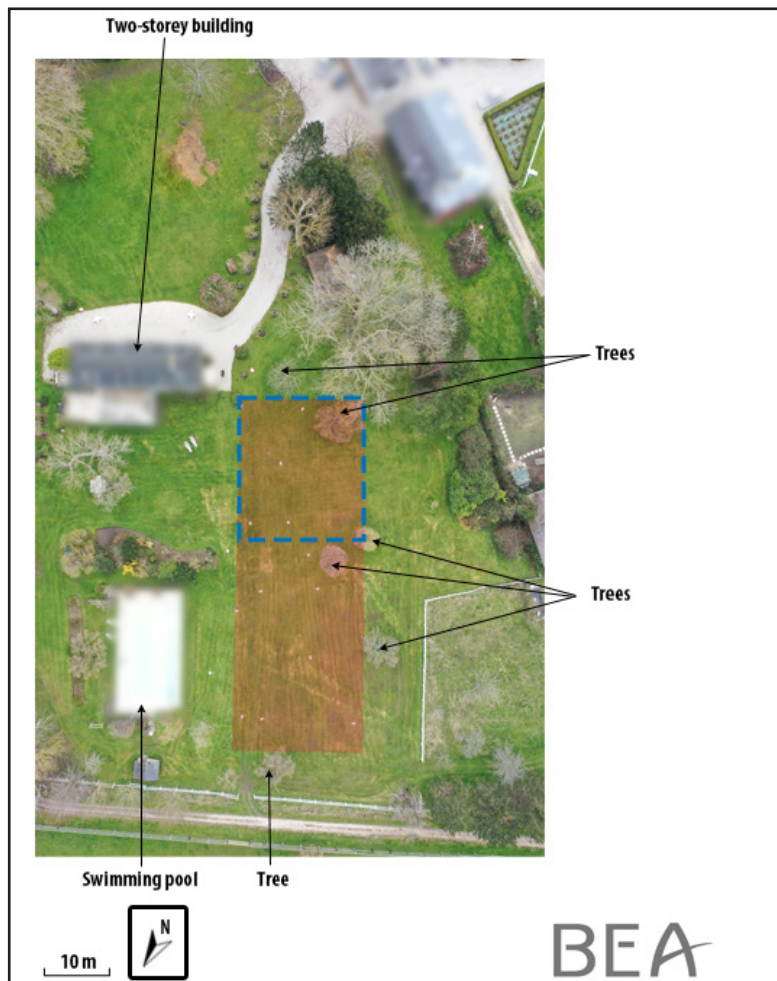
Figure 3: Detailed view of HLS

The HLS had two distinguishable areas: one, the furthest forward with respect to the approach path (see Figure 3, shown by blue dashes) measured around 20 m by 18 m, the second, the furthest back measured 30 m by 18 m. The ground of the lowest part of the terrain and the furthest from the building was spongy, making landing the helicopter and the boarding/disembarkation of passengers complex.

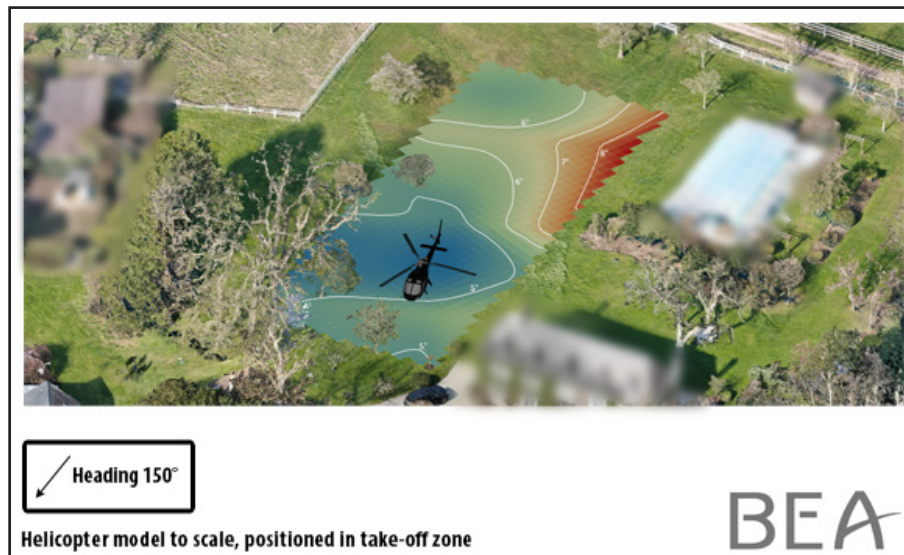
Figure 4: Accident site with areas of gradient

The HLS had variations in slope illustrated in [Figure 4](#). These restricted the landing areas as specified in the aircraft flight manual.

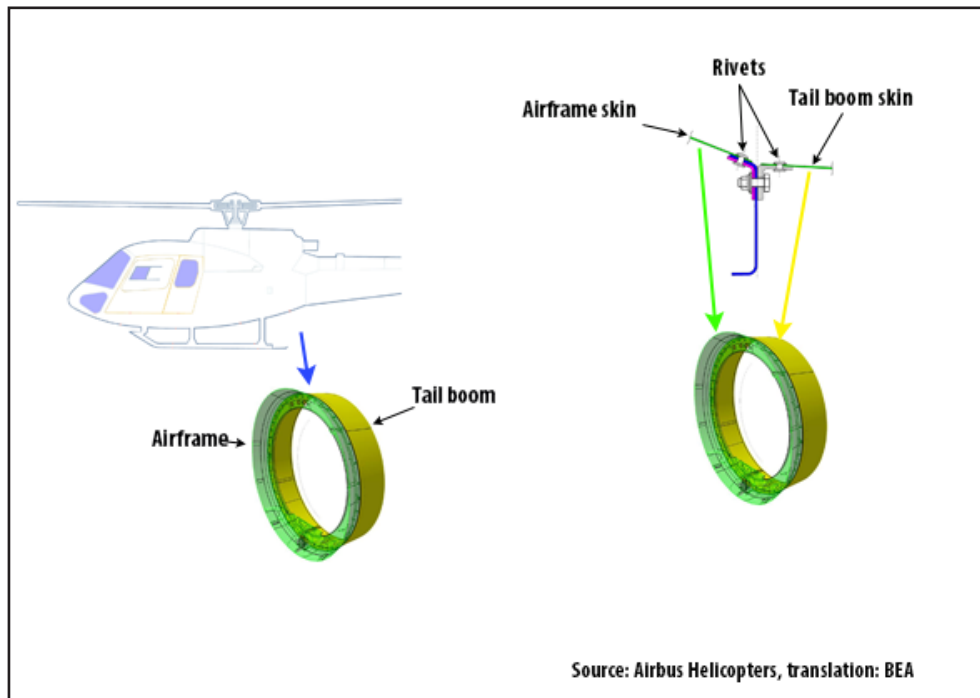
Figure 13: Diagram of junction between airframe and tail boom

- ☐ The rear part of the airframe has a frame associated with an angle over 360° facing aft.
- ☐ The tail boom also has a frame in immediate proximity with this junction area. The tail boom skin is positioned over the outer surface of the angle on the airframe side. The junction is then secured by means of 99 rivets.

The tail boom separated from the main part of the helicopter in line with this riveted junction. Ninety percent of these rivets were found to have sheared (see [paragraph 1.12.2](#)).

The overtorque led to loads, in line with the riveted junction, greater than the ultimate shear strength of the most loaded rivet. When one of the rivets sheared, it overloaded the neighbouring rivets which failed in turn, until the remaining section of the tail boom skin bent.

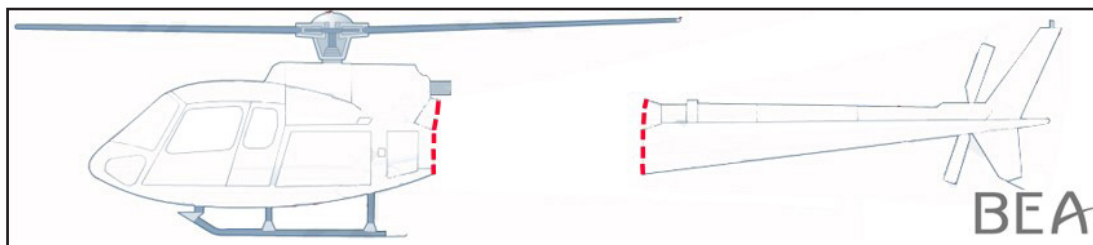
Figure 21: Airframe/tail boom junction diagram

The diagram below illustrates the area where it was observed that the tail boom separated from the airframe.

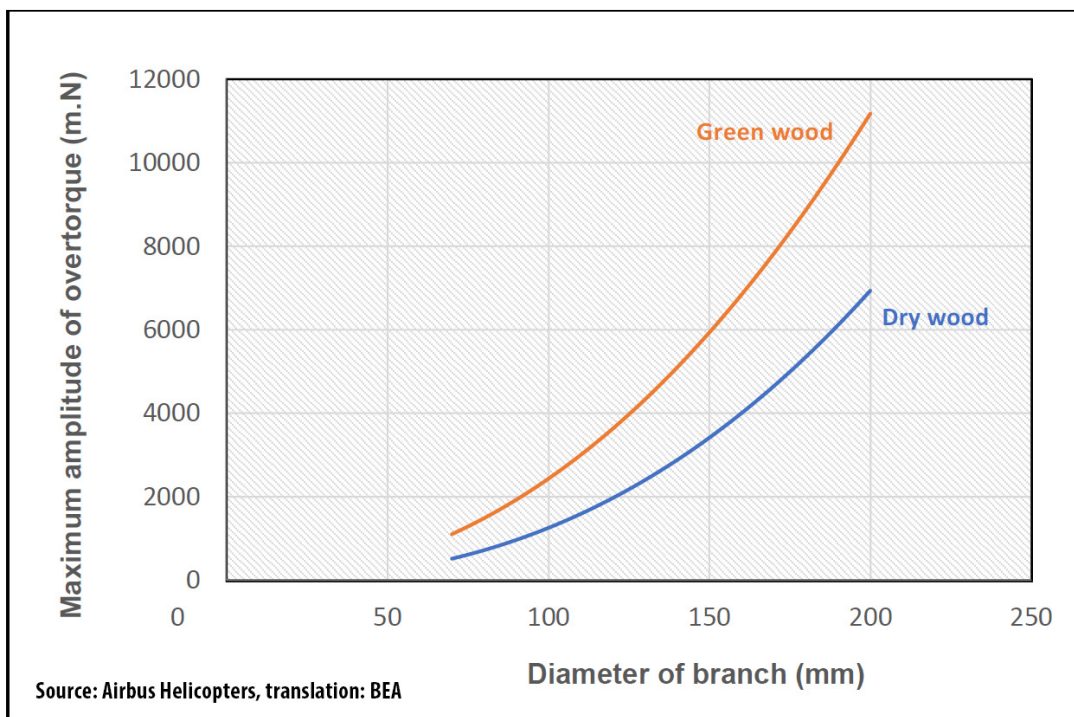
Figure 22: Representation of overtorque as a function of diameter of branch inserted in main rotor

Data for each wood “*calibre*”, dry or green, was acquired by means of the tests, indicating the maximum amplitude of the overtorque as a function of the diameter of the branch inserted.

The following graph shows the results obtained. On this graph, for each wood calibre, dry or green, these points are situated on a curve represented by a mathematical law.

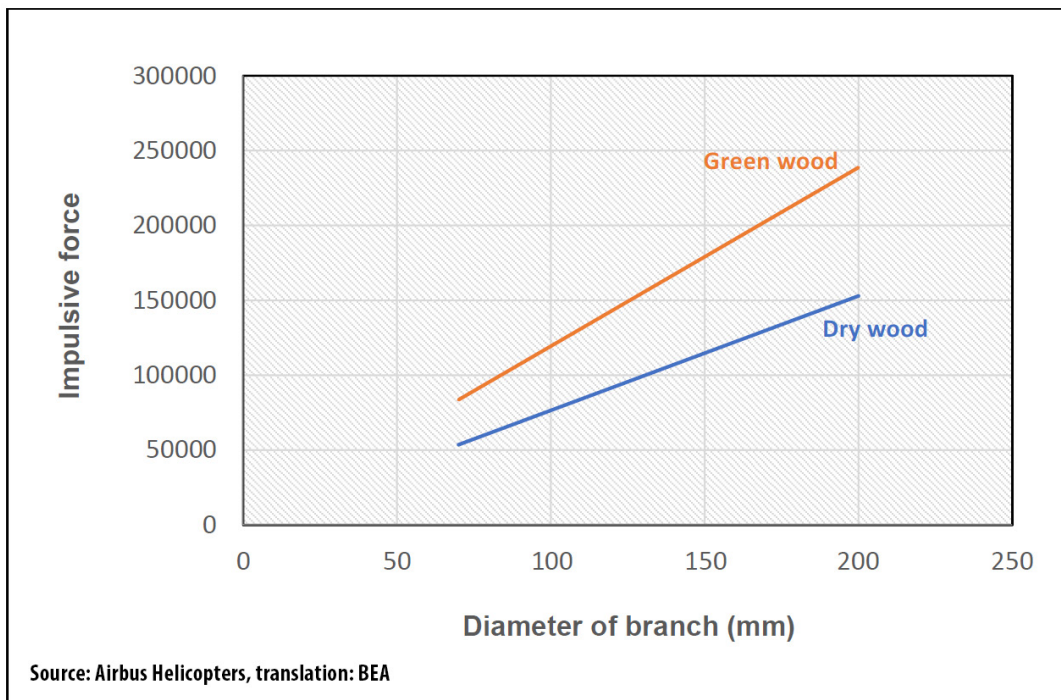
Figure 23: Representation of impulsive force as a function of diameter of branch inserted in main rotor

This impulsive force represented a branch striking a blade. It was represented in the form of a periodic sinusoidal signal. The period of the signal corresponded to the time to cut the branch, the amplitude of the signal decreasing with time.

This model established a linear law between the impulsive force and the diameter of the branch inserted in the main rotor as illustrated in the graph below.

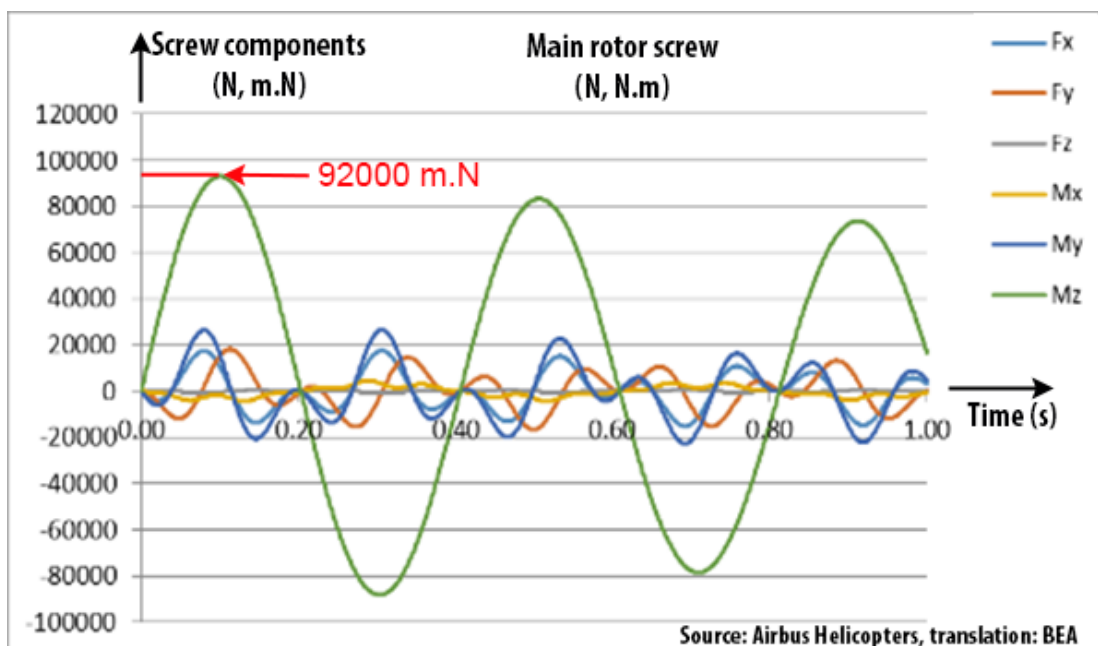
Figure 25: Representation of forces and moments in rotor head

The branch diameter taken for each interaction was 14 cm.

If these hypotheses are taken and the model adapted to the main rotor of the AS350 B, the torque on the rotor axis, i.e.  $\vec{M}_z$ , had a maximum amplitude of 92,000 m.N.

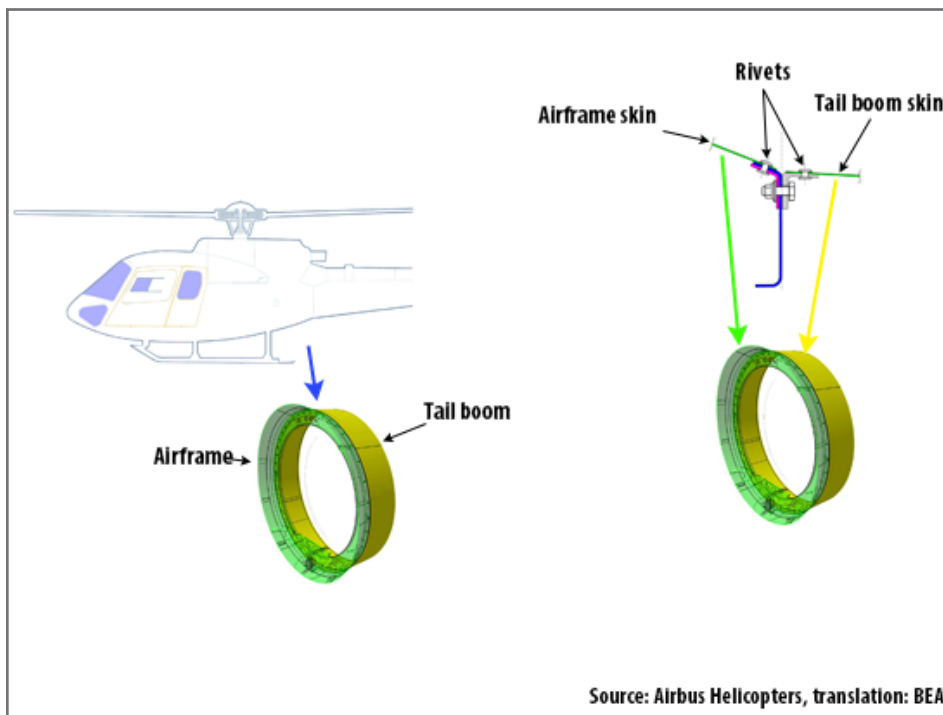
Figure 26: Diagram of junction between airframe and tail boom

- ❑ The rear part of the airframe has a frame associated with an angle over  $360^\circ$  directed aftwards.
- ❑ The tail boom also has a frame in immediate proximity with this junction area. The tail boom skin is positioned over the outer surface of the angle on the airframe side. The junction is then secured by means of 99 rivets.

The graph below shows the shear strength envelope of the most loaded rivet ensuring the mechanical junction between the airframe and the tail boom. In this figure, the envelope is represented in terms of moments generated (on the  $\vec{y}$  and  $\vec{z}$  axes) in line with this junction.

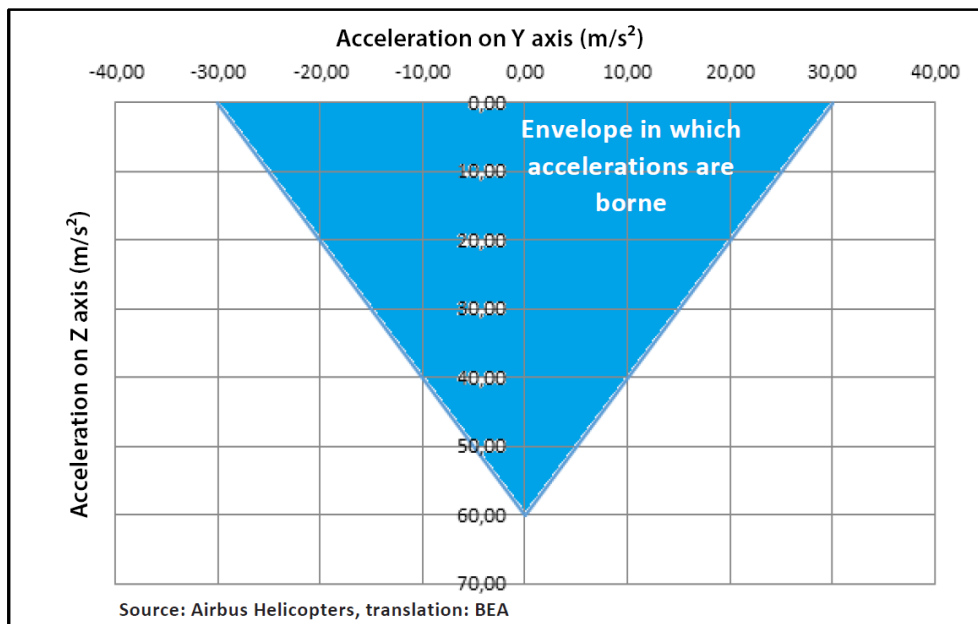
Figure 29: Representation of envelope in which accelerations are borne by seats equipping F-GIBM

The illustration below shows the seat worthiness envelope to vertical accelerations (on the Z axis oriented upwards) and lateral accelerations (on the Y axis) for the type of seat which equipped F-GIBM, in accordance with the certification file of the aircraft equipped with this type of seat.
