*Accident
on 25 July 2000
at "La Patte d'Oie"
in Gonesse (95),
to the Concorde,
registered F-BTSC,
operated by Air France*

Preliminary report
translation
f-sc000725pa

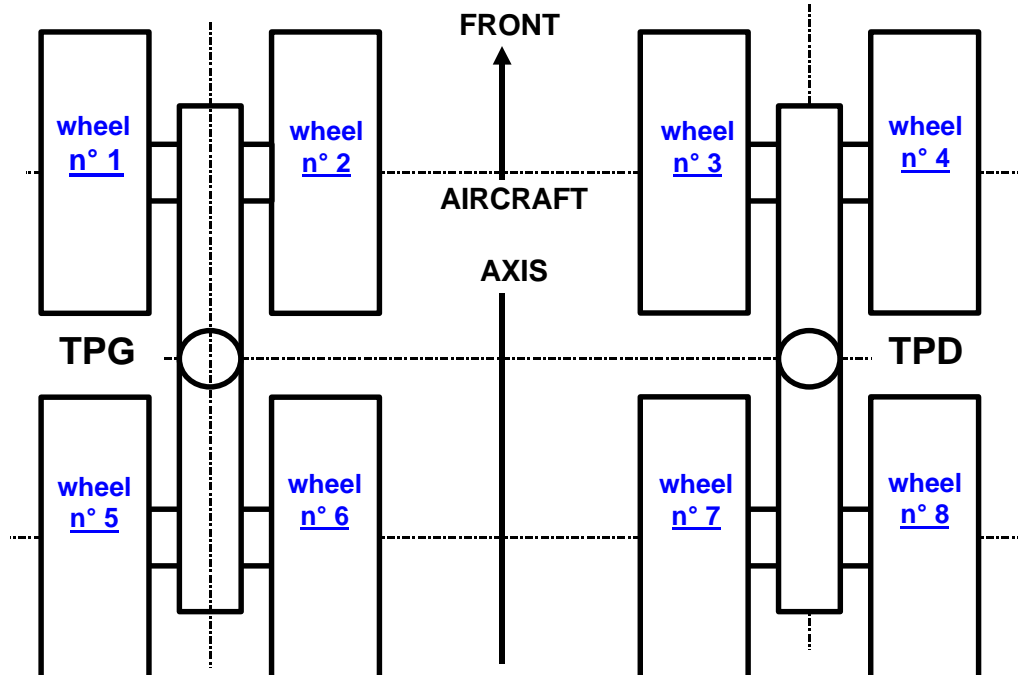
Figure 3 (from above)

On the day of the accident, the main landing gear wheels and tyres on F-BTSC were installed as follows:

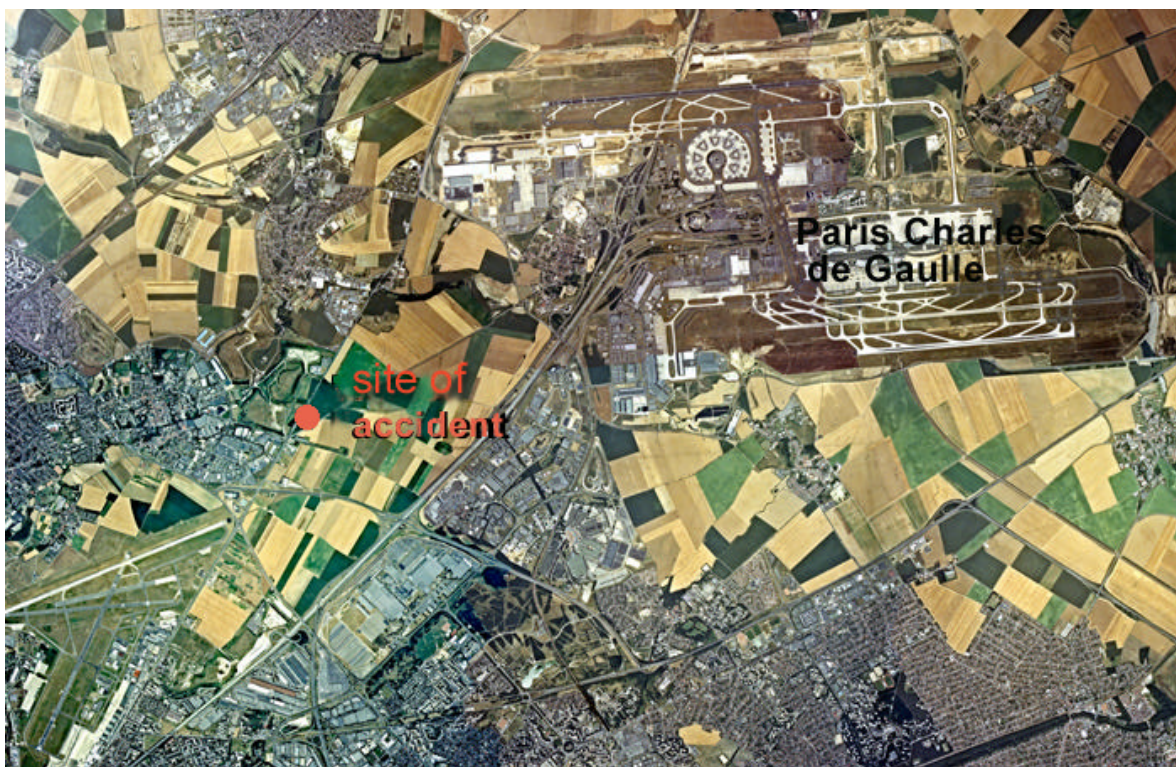
The crash occurred south-west of Paris Charles de Gaulle airport at about 9 500 m from the threshold of runway 26R in a level area. The altitude of the area is 400 feet. The wreckage was at the intersection of the N17 and the D902 roads.

Aerial photo of the accident area

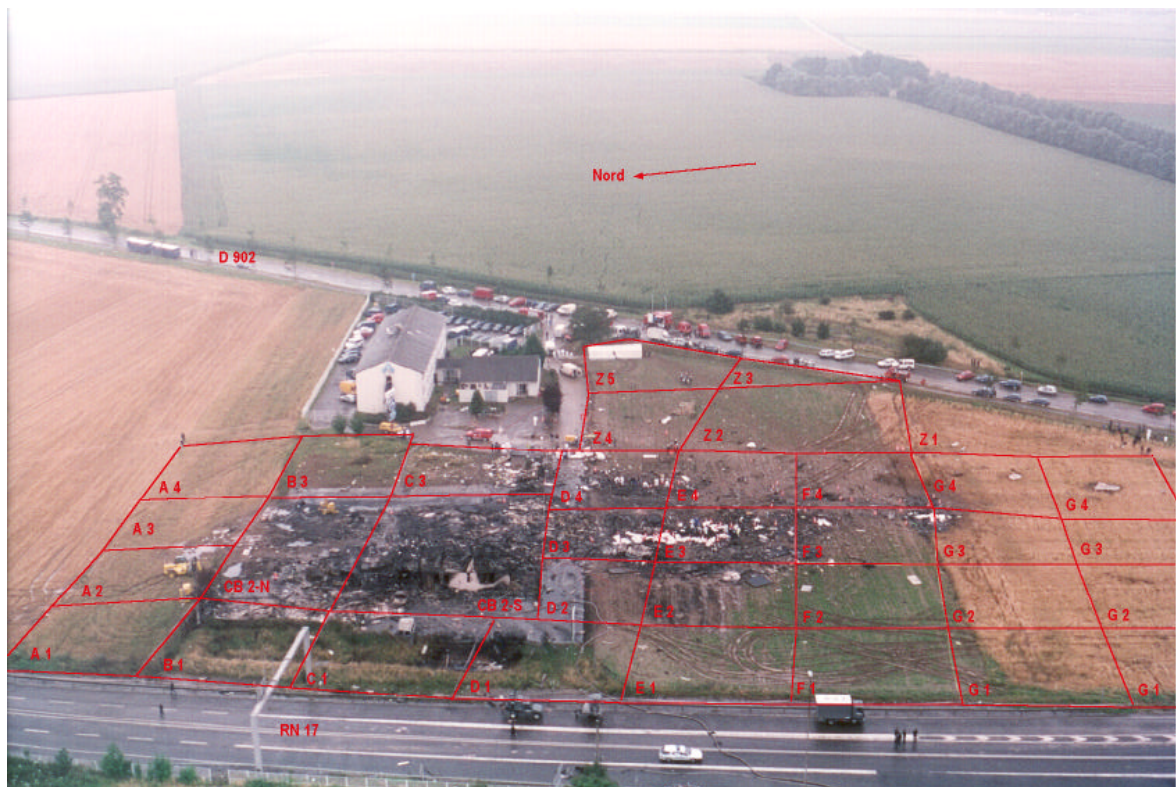
The crash site was divided into a grid. The various areas were referenced to this grid.

Aerial view showing grid

Examination of the site showed that the aircraft had struck the ground on heading 120° left, with little horizontal speed. After the impact, it broke and spread generally to the south, with the aircraft upright.
