## CHAPTER 9

# INTERNATIONAL CONVENTIONS, LEGISLATION, REGULATIONS AND CO-OPERATION

# BOW DOOR FAILURES AND INCIDENTS

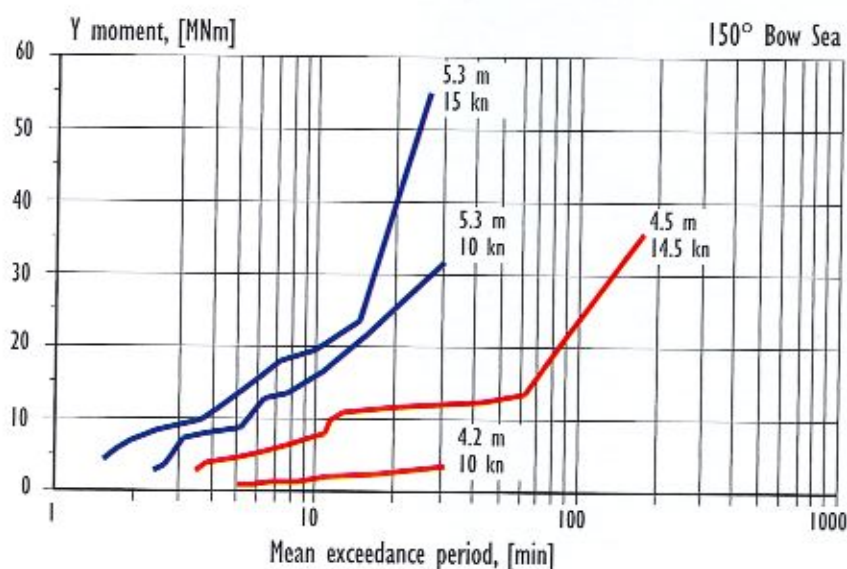
The most critical wave-induced load component, the opening moment around the deck hinges, the Y moment, measured in the different tests is plotted in Figures 12.1–12.2 on the basis of mean exceedance period. The vertical force, the Z force, is shown in a similar way in Figures 12.7–12.8. Mean exceedance period means here the average time between individual load peaks equal to or higher than the corresponding value. The graphs were produced by taking the total full-scale time of each test series and dividing it by the number of load peaks exceeding a certain level as given by the Weibull plot in SSPA Report 7524.

The longitudinal and vertical force peaks always appeared in phase and with approximately the same magnitude. Only a few of these load peaks, however, resulted in a positive opening moment about the hinge axis that would have been large enough to exceed the closing moment from the static weight of the visor, and only two opening moments were above 20 MNm. Most of the load cycles caused closing moments with peak levels up to about 5 MNm.

Figure 12.1 Measured wave-induced vertical opening moment on the visor in bow sea.

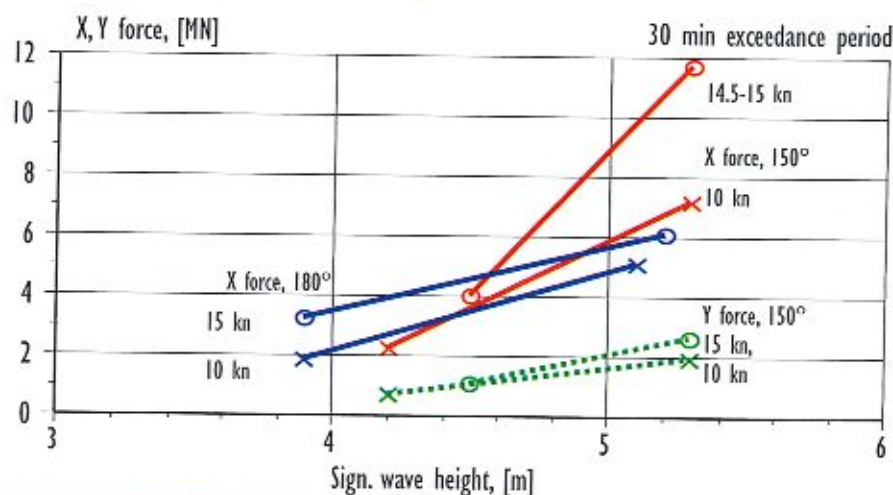
The wave forces show an approximately linear relation to the speed in bow sea for both wave heights studied. A decrease of speed from 15 kn to 10 kn thus reduces the forces by about one third. In head sea, at higher wave heights, the speed influence seems to diminish.

Figure 12.4 Longitudinal and transverse wave force on the visor: Model test results in head and bow sea at 10 and 15 kn speeds.

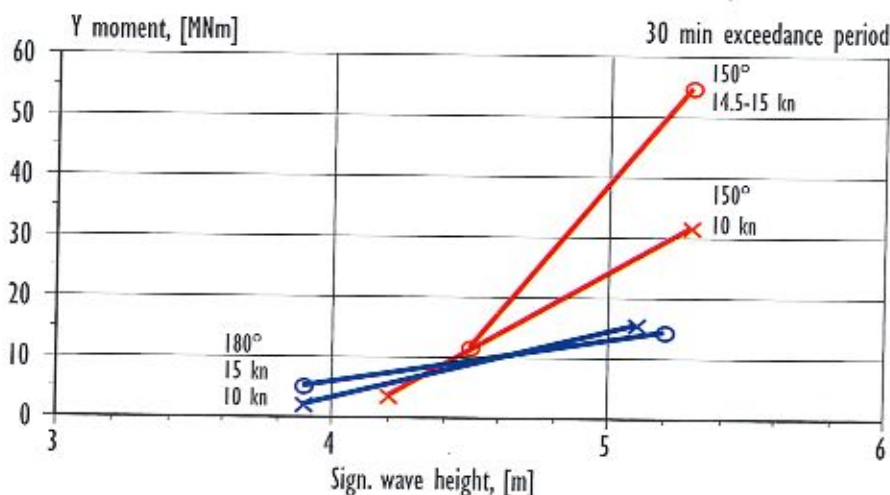
Figure 12.6 Wave-induced opening moment about visor deck hinge axis. Model test results in head and bow sea at 10 and 15 kn speeds.

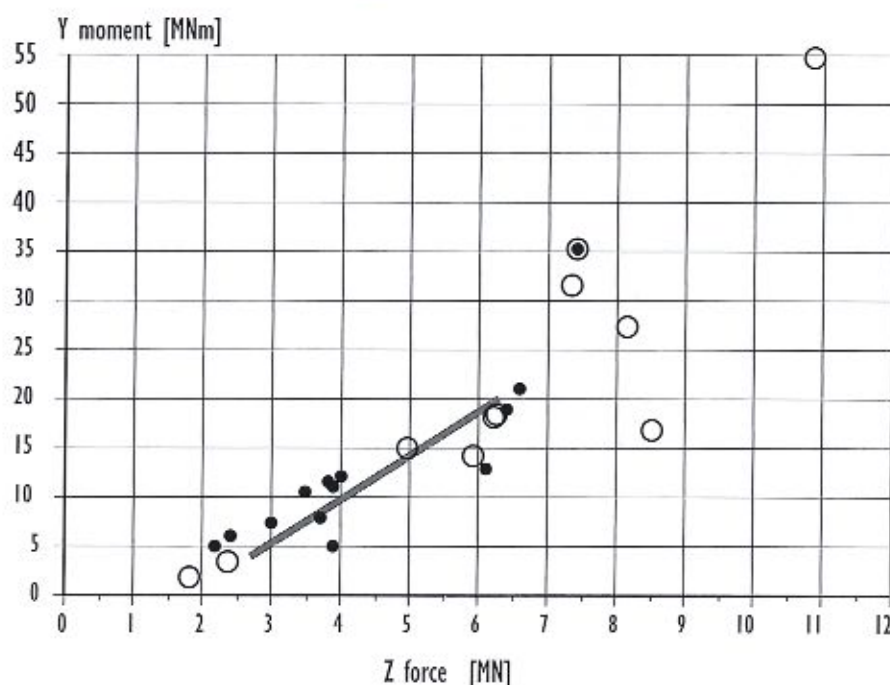
tests had rather high crests compared to their troughs, this estimate may be on the high side. On the other hand, the uncertainty in sea state is, according to the meteorological institutes, about 0.5 m in significant wave height. Were this uncertainty also accounted for, the maximum values in the given range would increase significantly.

**Figure 12.10 Correlation between vertical forces and opening moments from model tests. Rings show the single highest measured value in the different series, black dots show the 13 highest values in the test with bow sea and  $H_s=4.5$  m. The line shows the estimated range of maximum loads for the accident condition.**

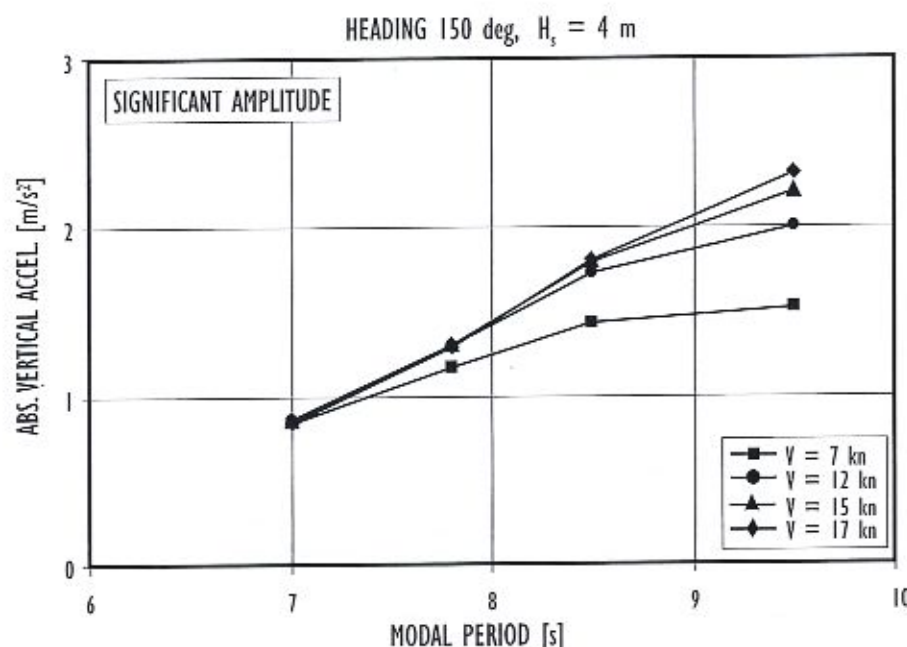
Figure 12.11 Vertical acceleration at the station of the bridge in bow sea with  $H_s = 4$  m.

Just before the accident the significant amplitude of vertical acceleration at the bow visor was 2–2.5 m/s² and the largest amplitudes may have been about 0.4g. This acceleration level is roughly half of the level at which cargo vessels change heading or slow down to decrease the accelerations, and about two thirds of the corresponding level for ro-ro cargo vessels.

A reduction in speed from 15 knots to 7 knots would have decreased the significant vertical acceleration from about 1.5 m/s² to 1.3 m/s² in the fore part of the passenger compartment, or at the station of the bridge (Figure 12.11). By changing the heading to waves, the acceleration level would have started significantly decreasing in stern-quartering waves. Considerably higher vertical accelerations than these predicted for the ESTONIA have been measured on board passenger vessels in severe storms in many sea areas including the Baltic.

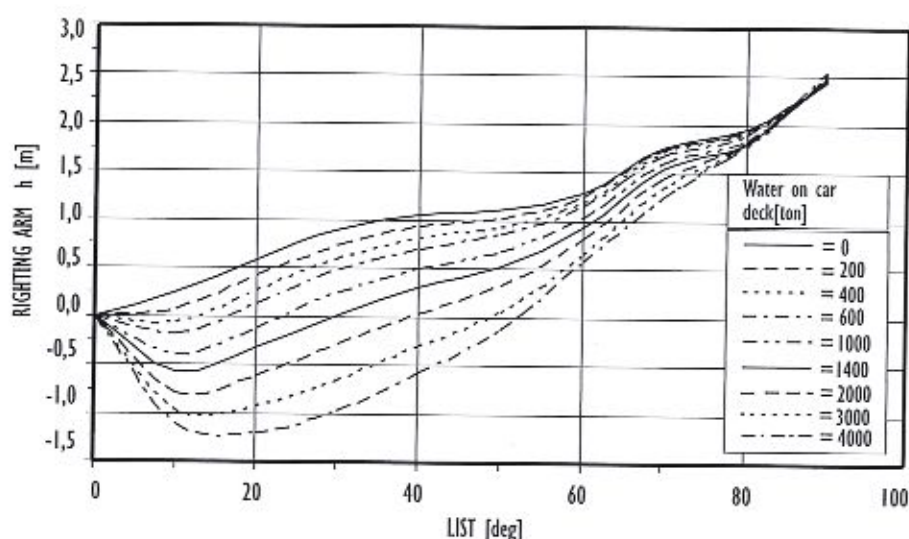
shows static stability curves for increasing amounts of water on the car deck, from 0 to 4,000 t. These curves apply when ship side is intact. The analysis shows that 400 t of water on the car deck will give a static list angle of just over 10° and 1,000 t just over 20° (Figure 12.13). The additional heel from a sharp turn at 15 knots would be about 3°.

and above the car deck, the residual stability with water on the car deck would not have been significantly changed at large heel angles (Figure 12.12). The capsize could only have been completed through water entering other areas of the vessel.

Figure 12.12 ESTONIA's static stability curves for different amounts of water on the car deck, ship side assumed intact.

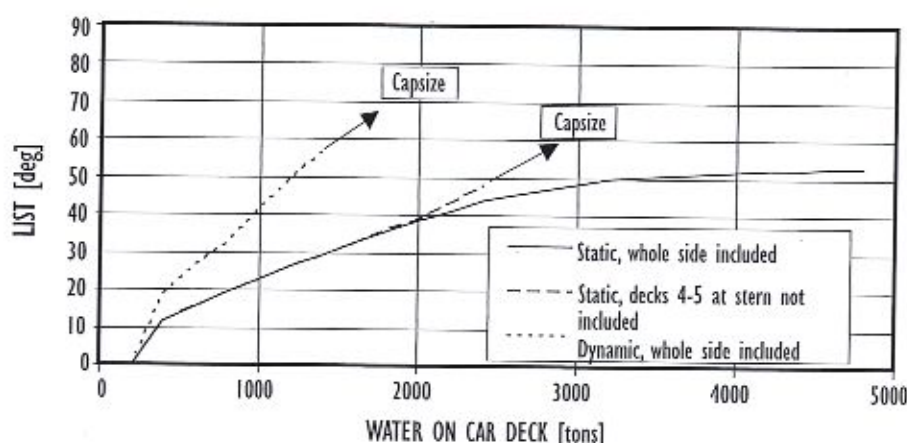
Figure 12.13 ESTONIA's list against the amount of water on the car deck.

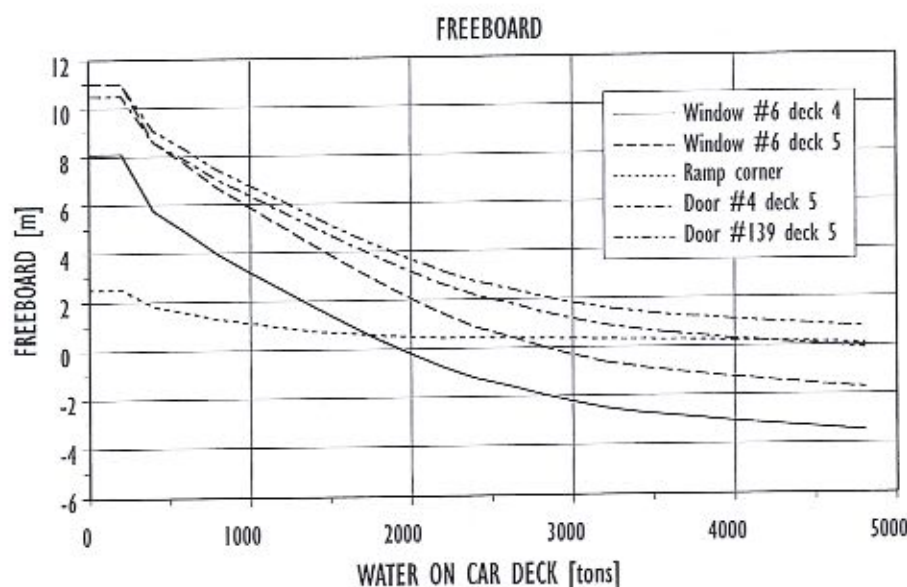
According to the hydrostatic calculations, a continuously increasing amount of water on the car deck would make the aft windows of deck 4 the first possible flooding point to other areas (Figure 12.14). Soon thereafter the windows and the aft entrance doors of deck 5 would

Figure 12.14 Freeboard to first possible flooding points plotted against amount of water on car deck. The openings are aft side windows on decks 4 and 5 at frame #6, bow ramp starboard corner, aft door on deck 5 and fore door on deck 5.

also be submerged. A little less than 2,000 t of water on the car deck would be sufficient to bring the first flooding points down to the mean water surface. In this condition the list would be about 35°. The lowest corner of the ramp opening would here be still a little above the mean water surface.

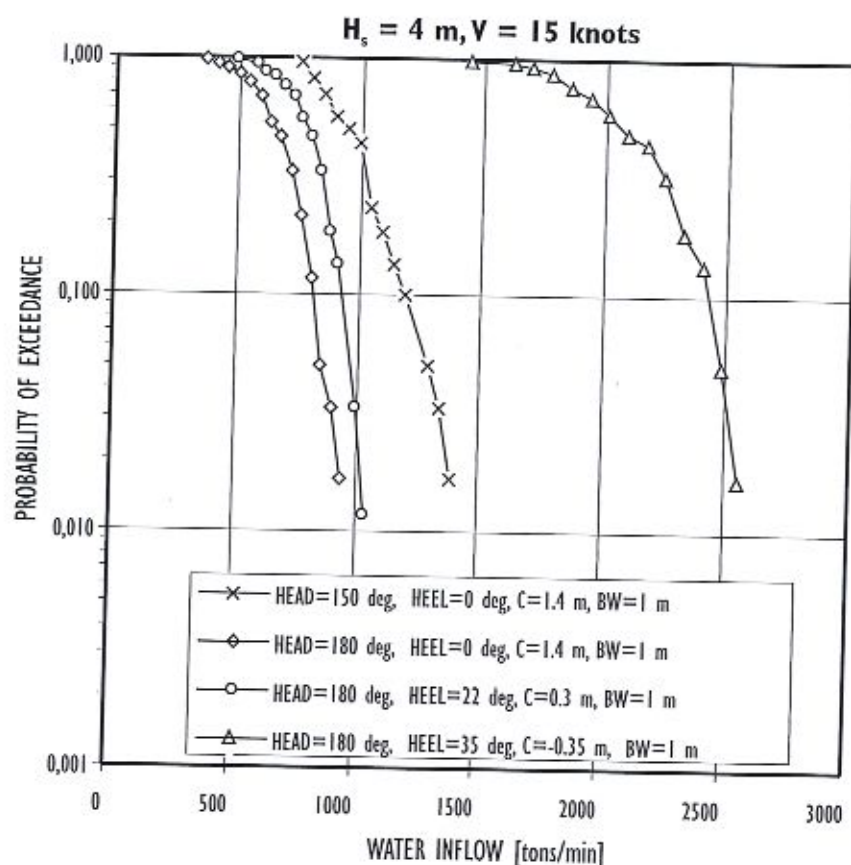
Figure 12.15 Probability of exceedance for different amounts of water inflow to car deck through bow ramp opening in bow and head seas at 15 knots speed with list angle as a parameter.  $C$  = Freeboard to the starboard corner of ramp,  $BW$  = bow wave height.

studies produced some differences regarding the motion characteristics and the results diverged with respect to heel angles; however, the inflow rate is generally 2–3 times larger than the initial upright condition when 1,800 t has entered the car deck and the heel is around 35°.

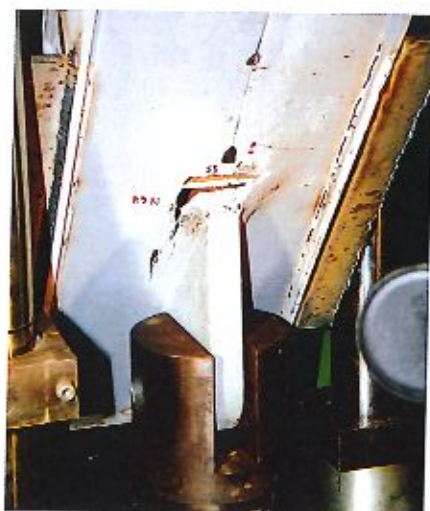
Four full-scale mock-up tests were made with various degrees of rigidity in the plate membrane and stiffener plates onto which the lock lug had been welded (Figure 12.21). In the relevant test cases the failures were very similar to the authentic failures, i.e. tearing of the aft plating. Membrane and stiffener stiffness had a significant effect on the strength of the lug attachment model. The test which was deemed to be most representative gave a failure load of the lug attachment of about 1.8 MN. Tensile tests of authentic plates were made. A welding defect was noted on the authentic port side installation of the horizontal stringer (Figures 12.22 and 12.23). This defect was estimated to reduce the strength to 1.2 MN,

Figure 12.21 Full-scale mock-up test of the side locking lug structure.

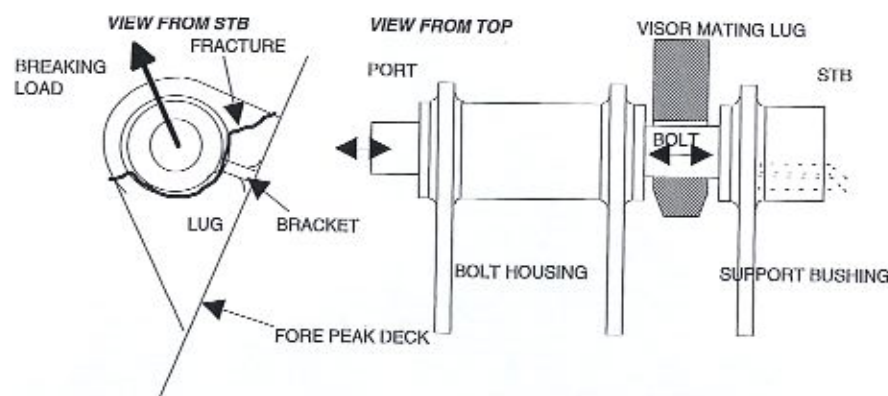
The load-carrying capability of the bottom lock assembly (Figure 15.2) to failure has been estimated using calculations detailed in the Supplement. Only two lugs, symmetrically located one on each side of the visor lug, effectively contributed in carrying load applied in the longitudinal direction via the visor lug. This failure pattern is also supported by the result of tests carried out in Hamburg and referred to below.

Figure 15.2 Bottom locking device.

to a tensile load of up to 1.5 MN (Supplement).

The Commission has learnt that the bottom locking device assembly was manufactured by the yard as a shop sub-assembly that was subsequently welded to the forepeak deck. No detailed drawing with welding data was issued specifically for this subassembly as welding data was generally contained in yard standard tables. The Commission has not found information on any modifications or repairs of the bottom lock. The paint test (see 12.7 and the Supplement) and statements by people involved in maintaining the lock indicate that it is original or dates back to a very early period of the vessel.
