## Port State Control Training on MV ESTONIA

### 1. Objective

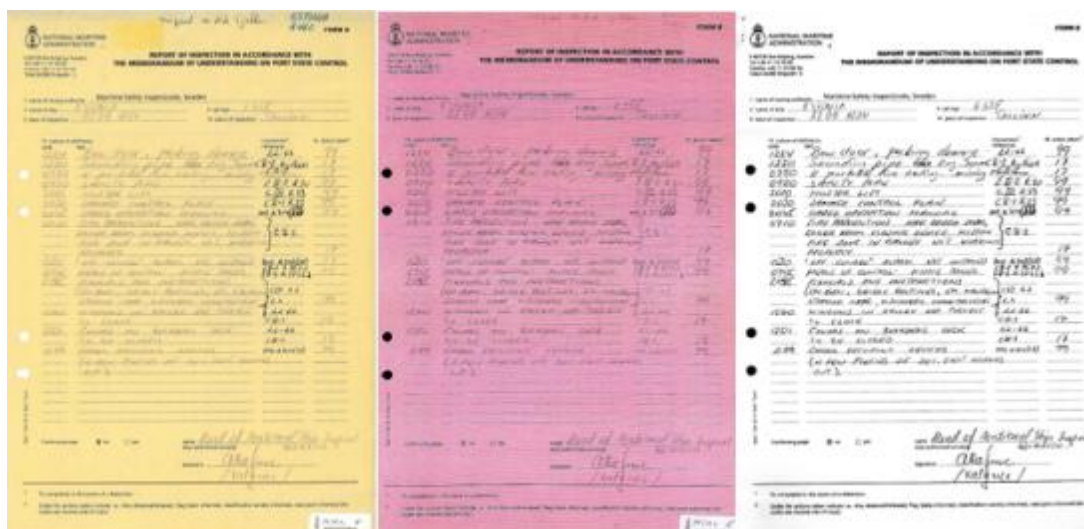
Image A. Miniatures of Figures 1, 2 and 3. A larger representation of the figures is shown in Section 4.4.5.

The only remaining original sheet from the training is the yellow sheet (Image A and Figure 1). The original is kept in the Swedish National Archives and has been examined in situ. The yellow and pink sheets were connected until they were sent to SKL for forensic examination in 2000<sup>14</sup>. The original pink sheet (Image A and Figure 2) is missing after it was examined by SKL.

The yellow and pink sheets are identical, except from the marking made by SKL in the bottom right corner (the serial numbers differ).

A copy, made in black and white, is kept in the Swedish prosecutor's archive in Stockholm (Image A and Figure 3). In situ examination confirms that it is a photocopy of the yellow sheet,<sup>15</sup> which is confirmed by a splotch from the yellow sheet, appearing as well on the photocopy as on the pink copy. That the notes and markings, compared to the yellow original sheet, are missing indicates that the photocopy was made before the yellow and pink originals were handed in to JAIC in November 1994.

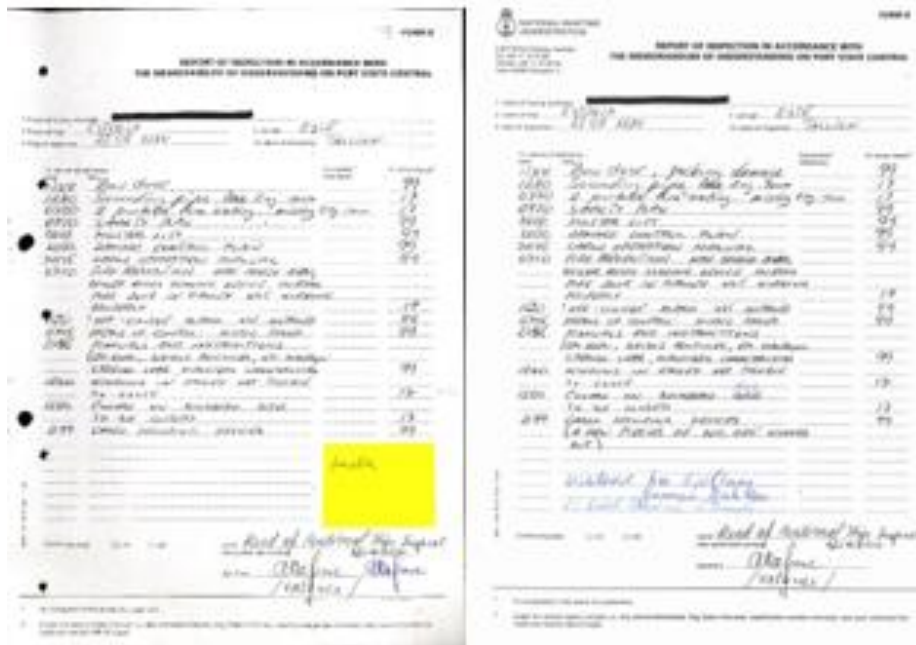
Image B. Miniatures of Figures 4 and 5. A larger representation of the figures are shown in Section 4.4.5.

from the documents in Figures 1, 2 or 4.<sup>16</sup> The documents in Figures 3 and 5 were apparently not available for examination. SKL had at this time access to the original yellow and pink sheets (Figures 1 and 2), but not the photocopy of Figure 4 with the genuine second signature, nor the original to the fax-transmission of Figure 6A.

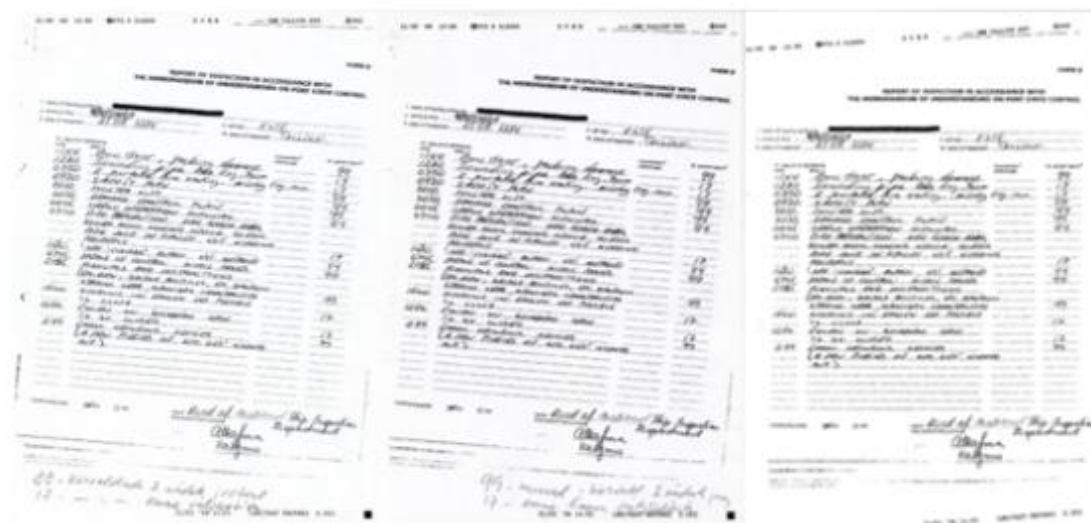
Image C. Miniatures of Figures 6A, 6B and 6C. A larger representation of the figures are shown in Section 4.4.5.

In addition, the JAIC supplement 223 contains a depiction of a fax-transmission of the copy of the white sheet which is a result of copying and editorial changes. However, the original for this depiction has not been found. Instead, two photocopies made during the editorial process are displayed in Image C and in Figures 6A and 6B, respectively. Image C also includes the depiction from JAIC Supplement 223 (Figure 6C).

All these copies lack information in column three. Also, the name of the issuing authority (“Maritime Safety Inspectorate, Sweden”) in line 1 is crossed out in an identical way (see section 4.4.4). These findings strongly indicate that these three documents are all photocopies originating from the original top, white sheet. There are, however, a number of discrepancies.

The examination result was that the document in Figure 6C was determined not to be a direct reproduction from documents in Figures 1, 2, or 4. It was also found that any other conclusions could not be made without other originals.

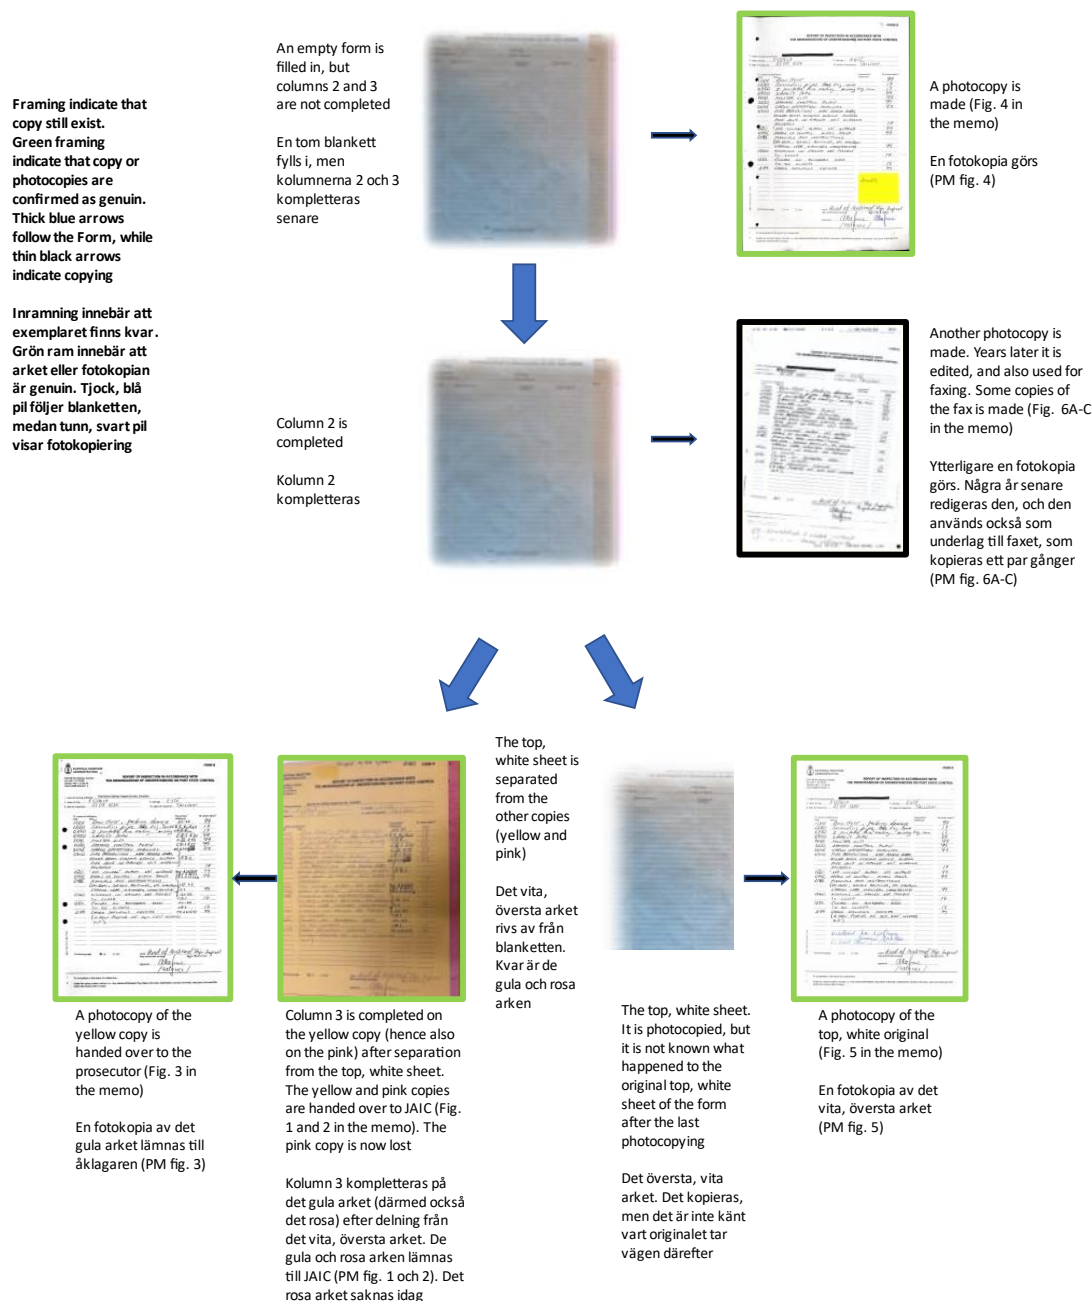
Figure 7. Chart showing the evolvement of the different copies of the protocol. Figure 3 has a splotch which is the same as in Figures 1 and 2. The cross-out of line 1 is identical in Figures 4, 5 and 6A-C, which means that they originate from the very same original, i.e., the top, white original sheet (or possibly a copy of it).

- Figures 1, 2 and 3 have a similar splotch on the same spot on them.
- The cross-out of line 1 on Figures 4, 5 and 6A-C is identical, thus they all originate from the very same original (the top, white sheet).
