Safety Investigation Report of the Sinking of the Fishing Trawler, 501 Oryong

Date of Casualty: 2014.12.01

Date of Publication: 2016.03.11

**Special Investigation Team,
Korea Maritime Safety Tribunal**

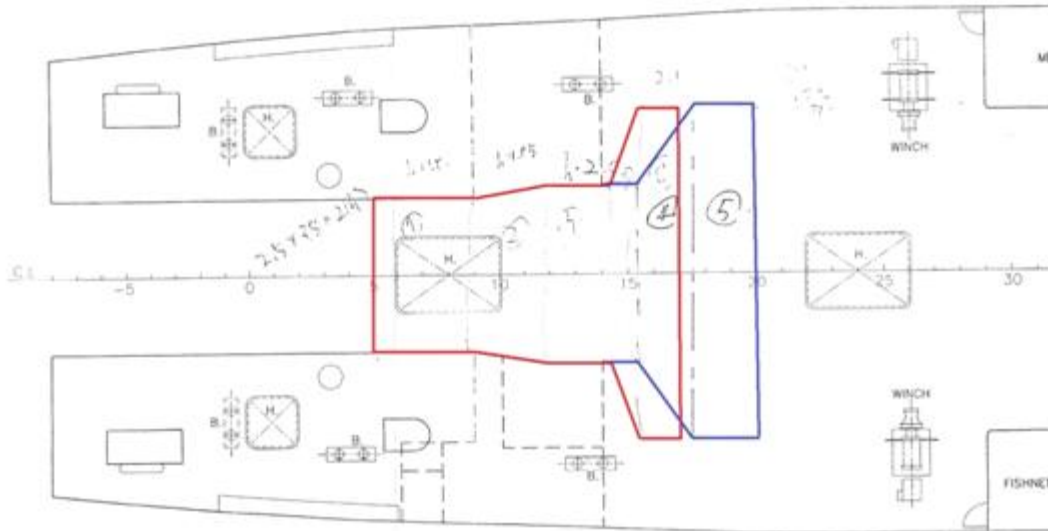
[Image 3] Expansion of fish bunker (blue line)

2.3.4 The main modifications made to the vessel at Gamcheon Port are as follows. First, in order to process a large amount of pollack caught in the North Pacific Ocean at once, the fish bunker where the fish are temporarily stored was expanded by 2m to the fore.

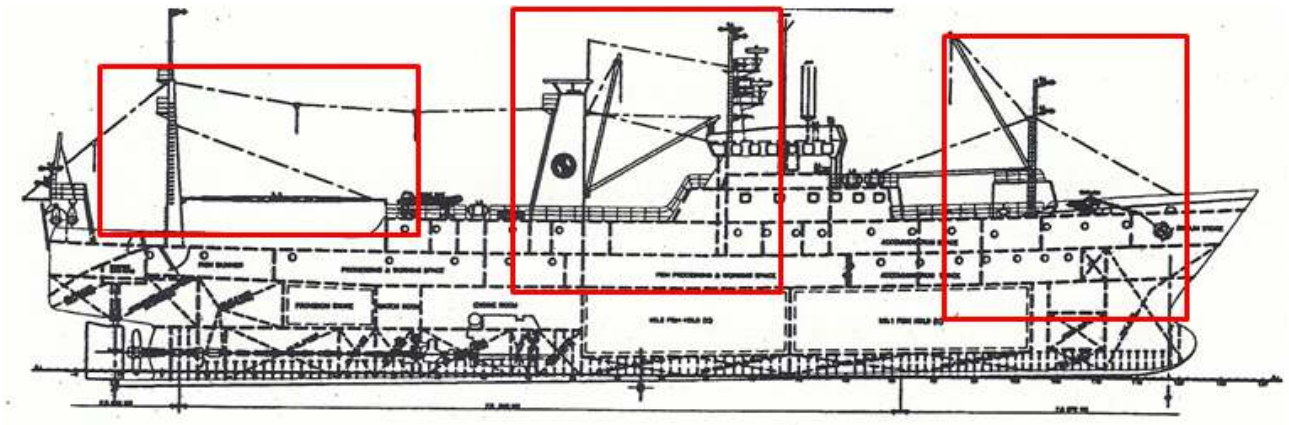
[Image 4] New installation of derricks (the two boxes from the right)

2.3.6 Third, two derricks, used for unloading, were each installed on top of fish holds number one and two. As the previous operation was mainly along the coast, it was possible to unload the catch using unloading equipment on land. However, in the case of pollack fishing in the North Pacific Ocean, the vessel needs to be equipped with an unloading device because the catch has to be transferred to a carrier.

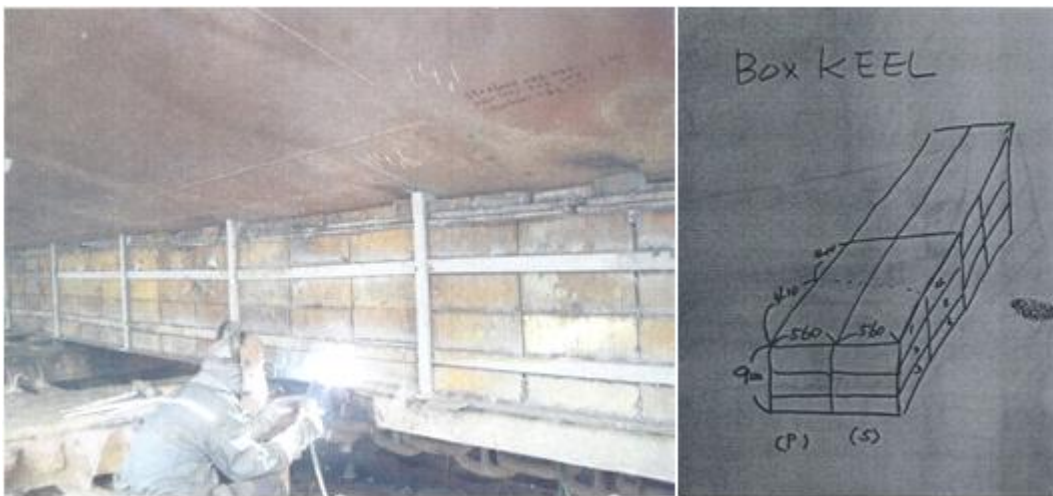
[Image 6] Installation of box keel at the bottom of the ship

- 2.3.9 In addition, as the classification society changed from BV to RS, an incline test was conducted prior to the departure from Gamcheon Port in March 2011. As a result, it was instructed not to operate with a full fuel tank in tanks number 9, 10, 11, and 12 in order to improve the stability of the vessel. It was then informed to complement its stability by installing a box keel of 175 tons by August 2011.

- 2.3.10 Therefore, from June 3, 2011 to June 28, 2011, the vessel was lifted to Gangnam Shipyard at Gamcheon Port for regular repair. The ballast (about 17 tons) in a small box keel form was removed and 260 ballasts of box keel (height of 0.3m, width of 0.41m, length of 0.56m, weight of 0.54 tons) were manufactured and installed at the bottom of the ship.
- 2.3.11 After installing the box keel, the light load displacement weight increased by 157.6 tons, from 2,329.54 tons to 2,487.14 tons, but the

balance point was lowered, thereby negating the conditions imposed on the use of fuel tank mentioned in 2.3.9.

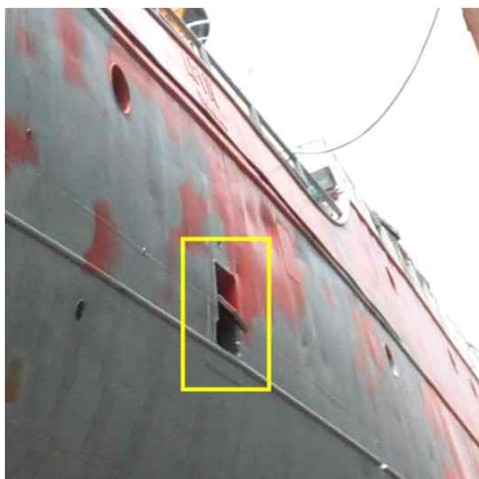
[Image 8] Installation status of sewage discharge outlet of a vessel of same model (right side)

3.1.4.1 A sewage discharge outlet (0.6m wide and 0.7m high) has been installed on the floor of the processing room (6.8m high) between portside frame numbers 17 to 19, as can be seen on Image 7 and Image 8, to discharge waste produced from processing fish in the processing room.

※ For 501 Oryong, it is installed in the same location but on the left side

3.1.4.3 After the vessel departed from Gamcheon Port in Busan in July 2014, the shutter of the sewage discharge outlet fell off in mid-September of the same year during operation at the fishing ground, but it was left neglected until the day of the casualty without any repair.

4.2.5.1 The vessel continued to engage in fishing operations without repairing the shutter of the sewage discharge outlet at port side which became detached mid-September of the same year. Therefore, on December 1st, the day of the casualty, it is appropriate to review the vessel stability based on an inflow angle that is in line with the base line of 6.4m from the upper surface of the sewage discharge outlet (Image 7: refer to the installation status of sewage discharge outlet)

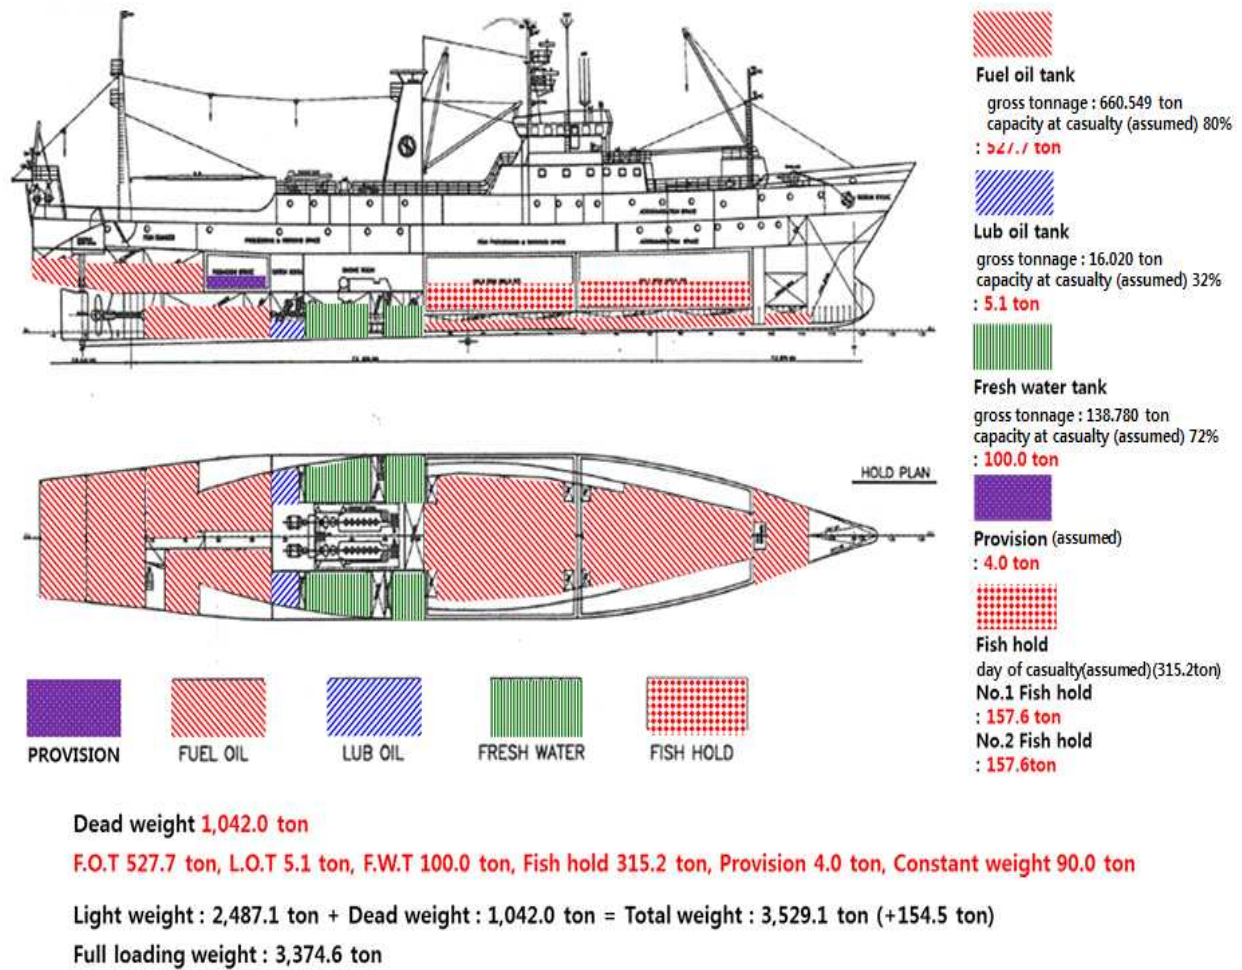
[Image 29] Distribution of deadweight at the time of casualty (fish, fuel etc.)

4.3.3.2 Image 29 shows the total load capacity and weight distribution at the time of the casualty, and due to the remaining catch of 315 tons, fuel of 527 tons and lubricating oil of 5.1 tons, it is presumed that the vessel had loaded about 131 tons over its maximum capacity compared to the full load displacement.

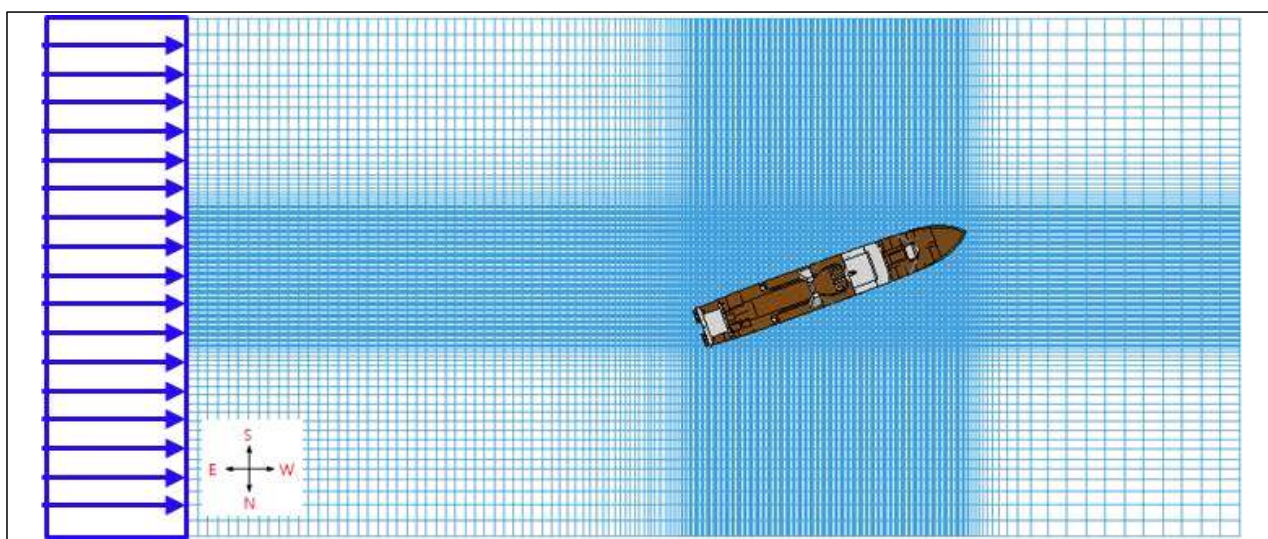
[Image 34] Direction of waves in Case 1-1

4.3.4.1 In Case 1-1 (starboard incline of 10° after getting underway), in addition to the 80 tons of seawater that was poured into the fish bunker along with the catch of fish, about 170 tons of seawater entered the ship, flooding the floor of the fish processing room. Without a fully closed hatch cover, the vessel had set its course towards the west while receiving waves from port stern at 20° , as shown in Image 34.

4.3.4.2 At the time, a part of the starboard stern had sunk underwater and waves were swelling over the stern deck. The sewage discharge outlet at stern port was located relatively higher than the water level as the hull had been tilted starboard, but there was still some inflow of seawater as the port stern periodically sank underwater as waves rolled onto the hull at a sharp angle.

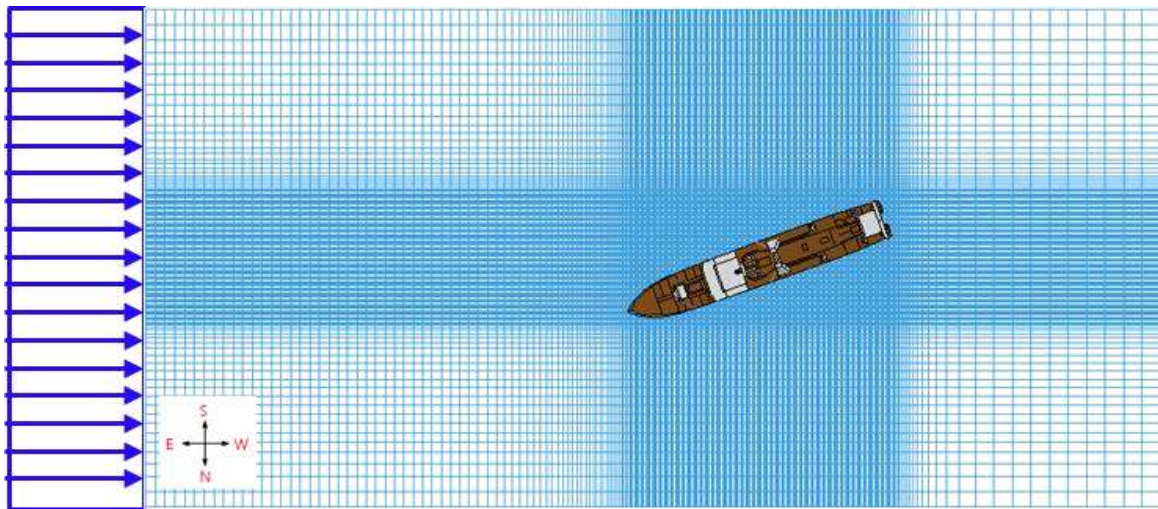
[Image 35] Direction of waves in Case 1-0

4.3.4.3 In Case 1-0 (presuming a different situation to that of Case 1-1, receiving waves with starboard bow at a 20° angle), it is presumed that a significant amount of seawater has entered the fish bunker while releasing the catch of fish. In addition, it is presumed that the vessel had set sail with no hull incline after changing its course without a fully closed hatch cover, while receiving waves with starboard bow at an a 20° angle. There was no increase in the inflow of seawater except the 80 tons that were poured into the fish bunker along with the catch of fish.

4.3.4.5 From the results of the simulation, it could be confirmed that if the vessel had turned its position so that the bow faced the waves before pouring the catch of fish through the open hatch cover of the fish bunker, as in case 1-0, the casualty would not have taken place, as waves would not have swelled over the upper deck.

4.3.4.6 Furthermore, even if water had continued to flow in through the hatch cover after it set sail, the vessel could have been turned so the bow faces the waves, which would have prevented waves from swelling over the upper deck. Then, after closing the hatch cover properly with sufficient time, the ship could have continued to get underway by resetting the course. In this case, the casualty would not have taken place.

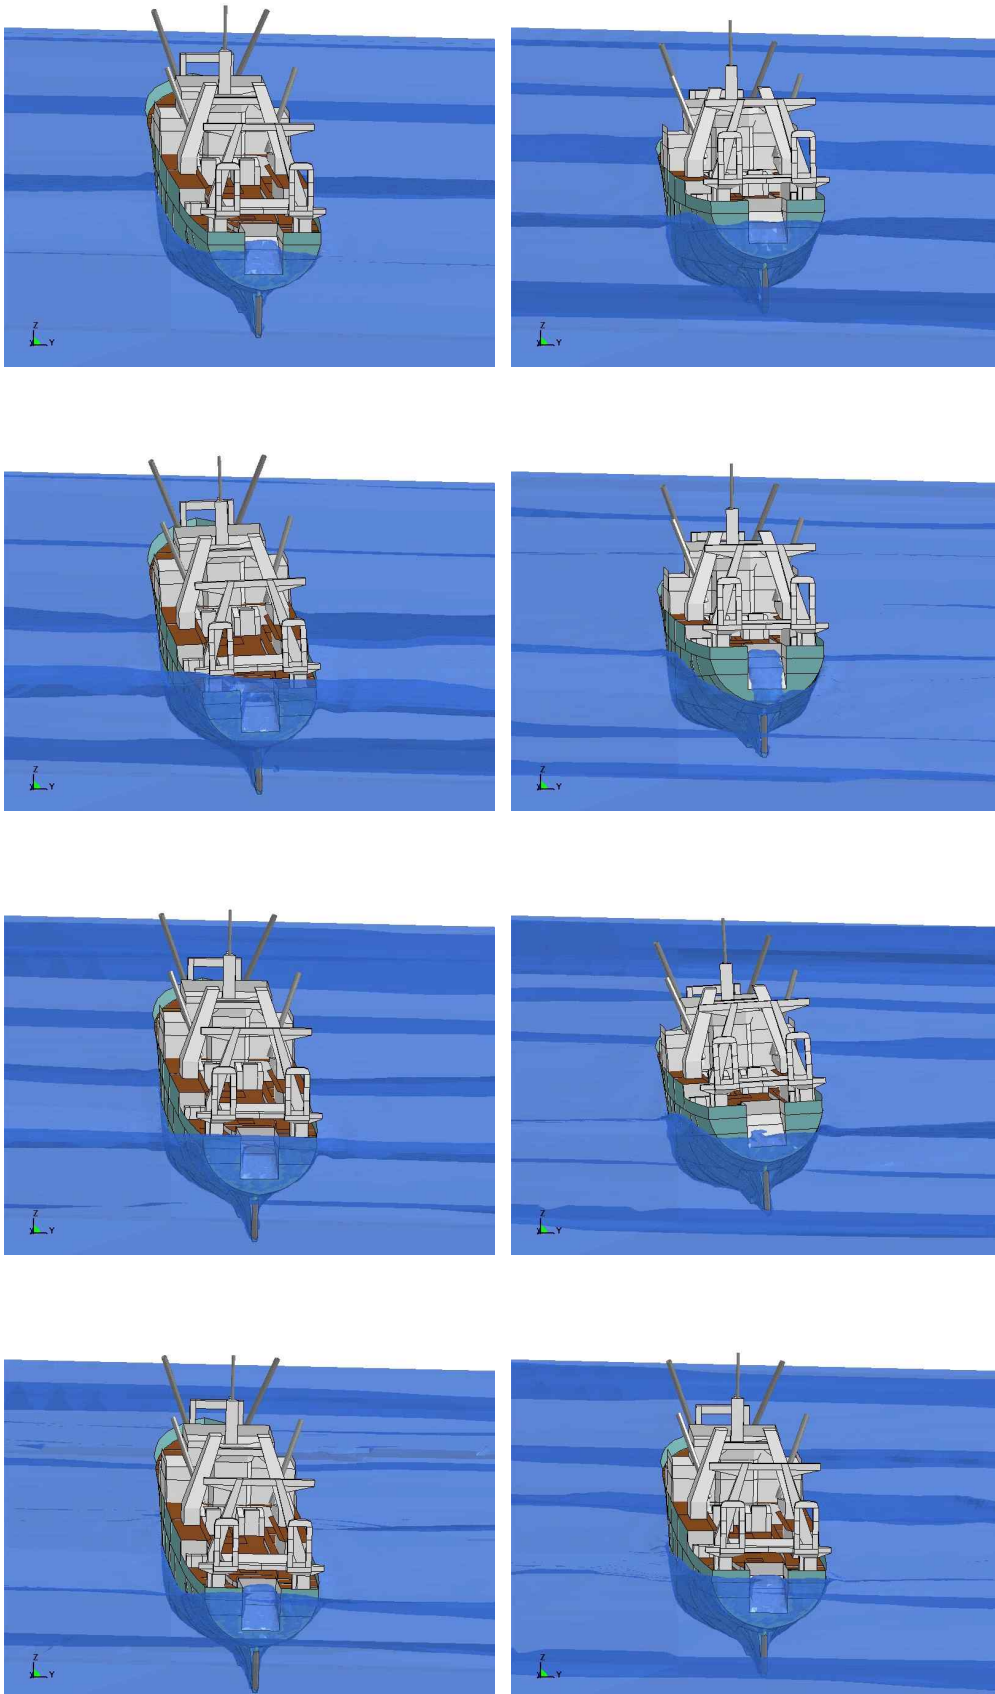
[Image 35-1] Movement in Case 1-0
(waves, starboard bow 0°) observed at stern

4.3.4.4 According to the simulation result of Case 1-0, despite the small angles of pitching and rolling, waves did not swell over the upper deck and no additional seawater flowed through the hatch cover or the sewage discharge outlet. The results are as shown in Image 35-1.

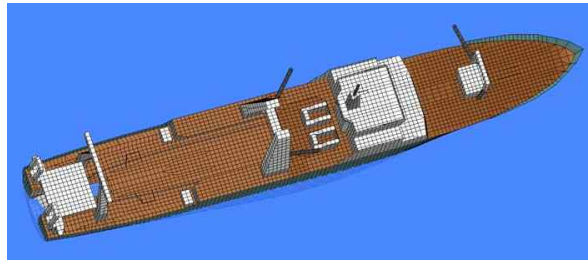
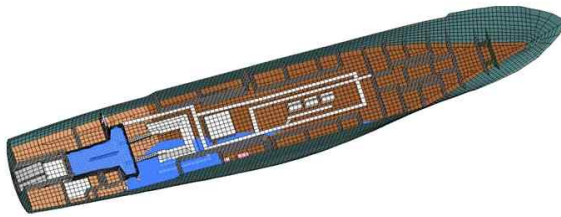
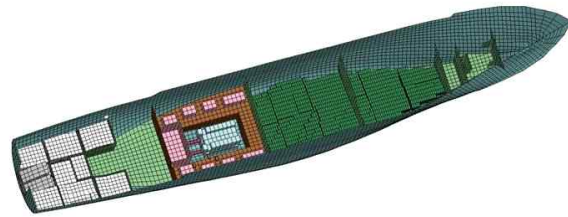
[Image 36] Status of seawater inflow in Case 1-2

4.3.4.7 In Case 1-2 (starboard incline by 20° due to transverse waves at port), waves are crashing into port stern at 20° and 290 tons of seawater have flowed in through the hatch cover and the sewage discharge outlet. This has caused the hull to tilt to starboard by 20° as the water starts to flood the fish processing room and the steering room.

4.3.4.8 The continuous inflow of seawater and the large incline towards starboard caused part of the starboard stern to sink from due to the pitching and rolling of the vessel. As a large amount of water flowed into the steering room, 70% of the steering room gets flooded and the rudder stops at hard port.

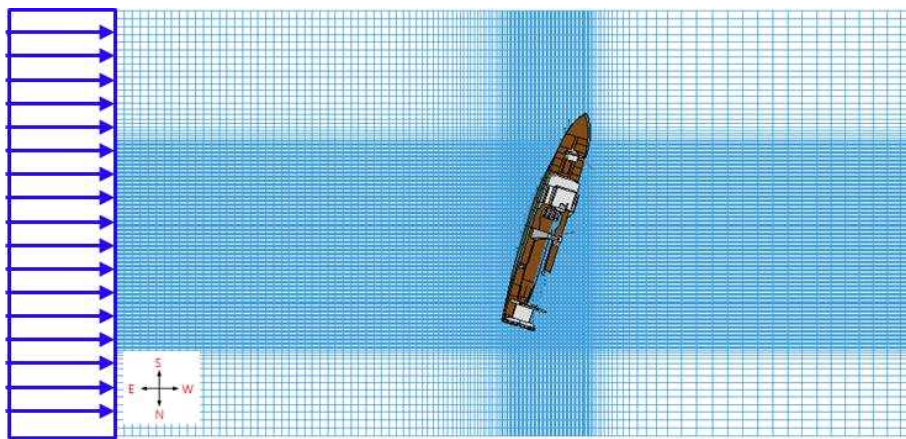
[Image 37] Direction of waves in Case 1-3

4.3.4.9 In Case 1-3 (rudder out of control, starboard incline by $25-30^{\circ}$), the in operable status of the rudder in Case 1-2 continued and as the hull was hit by waves from the stern port side at a 72.5° angle, the hull tilted significantly starboard and the slope increased to $25-30^{\circ}$.

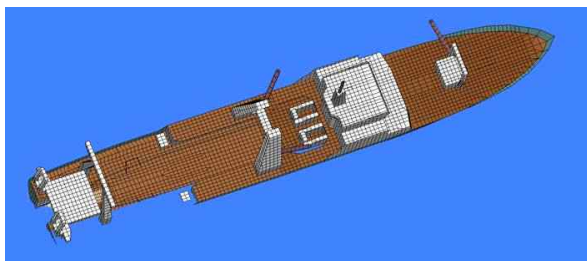
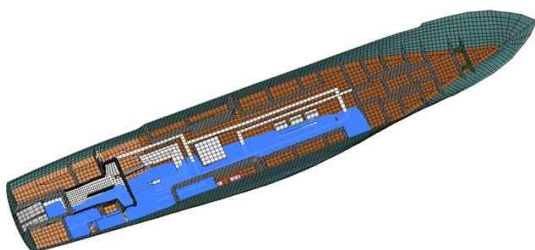
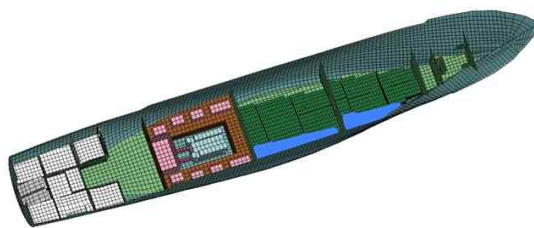
[Image 37-1] Status of Seawater Inflow in Case 1-3

4.3.4.10 With the hull tilted 25° to starboard, waves rolled into the port stern at an angle of 72.5° , which caused seawater amounting to 471 tons to continue flowing in through the hatch cover and the sewage discharge outlet. The seawater flowed into fish holds 1 and 2 and filled up the lower part (6% of the entire area) of the fish hold.

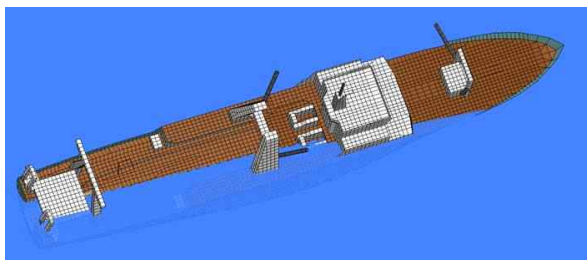
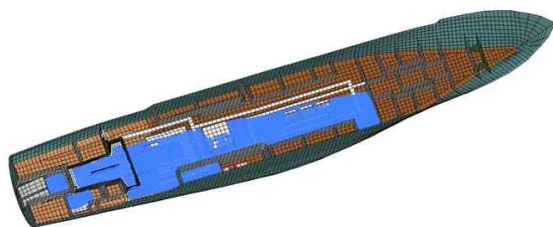
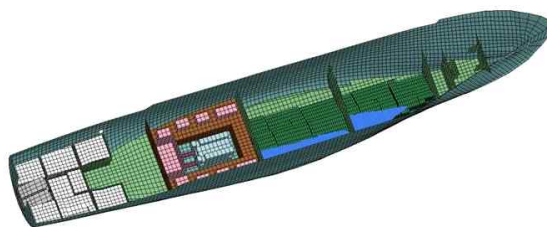
[Image 38] Status of seawater inflow in Case 1-4

4.3.4.11 Case 1-4 (stopped at starboard incline of 35°) is a continuation of Case 1-3, where the stern port is being hit by waves at an angle of 72.5° and the hull is tilted starboard by 35° . Although the seawater inflow amounts to 588 tons, the use of 2 pumps on board prevented the hull from further tilting starboard.

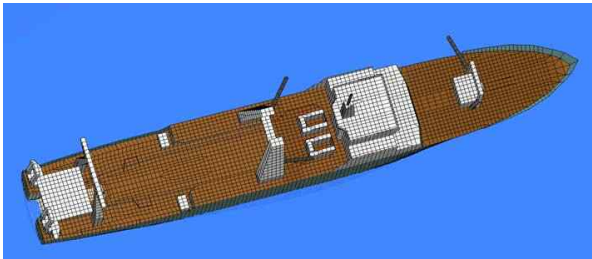
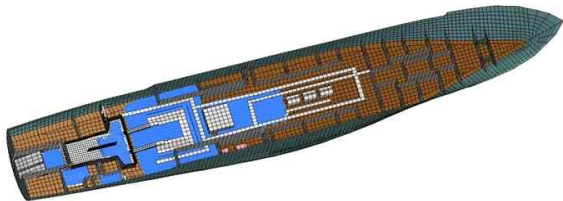
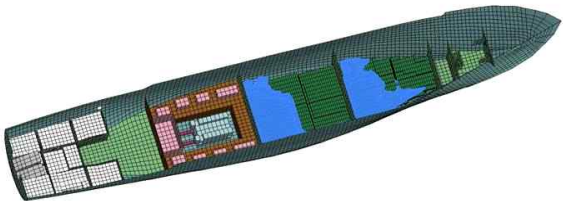
[Image 39] Status of seawater inflow in Case 2-0

4.3.4.12 In Case 2-0 (temporary equilibrium in transverse waves at port due to transfer of load to port side), about 30 tons of fish in the fish hold and about 48 tons of fuel have been transferred from starboard to port when the hull inclined to starboard greatly from Case 1-4.

4.3.4.13 By continuing to pump out water while transferring fish and fuel load, the crew managed to discharge a significant amount of seawater in the fish processing room. The amount of water decreased to about 225 tons, and the vessel maintained its equilibrium temporarily while the port stern faced waves at a 72.5° angle. Then, as the amount of water increased to 273 tons due to a continuous inflow through the sewage discharge outlet at port side, the vessel began to tilt to starboard by about 5° .

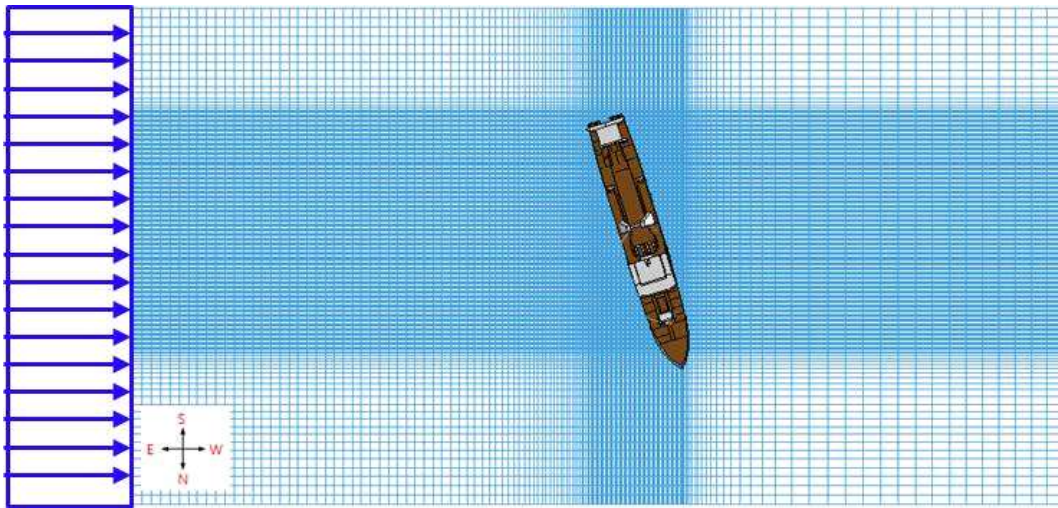
[Image 40] Direction of waves in Case 2-1

4.3.4.14 In Case 2-1 (port incline of 10° in transverse waves at starboard after transferring weight to port side), the vessel temporarily maintained its equilibrium but when water continued to flow in through the sewage discharge outlet at port due to waves hitting the port side, the boat was turned so that the starboard faces the waves in an attempt to reduce the amount of inflow into the vessel by using the engine only as the rudder was stopped. As in Image 40, when the vessel receives winds at starboard stern from an angle of 72.5° , the vessel tilts to port by 10° and the inflow of seawater amounts to 358 tons. ³⁷⁾

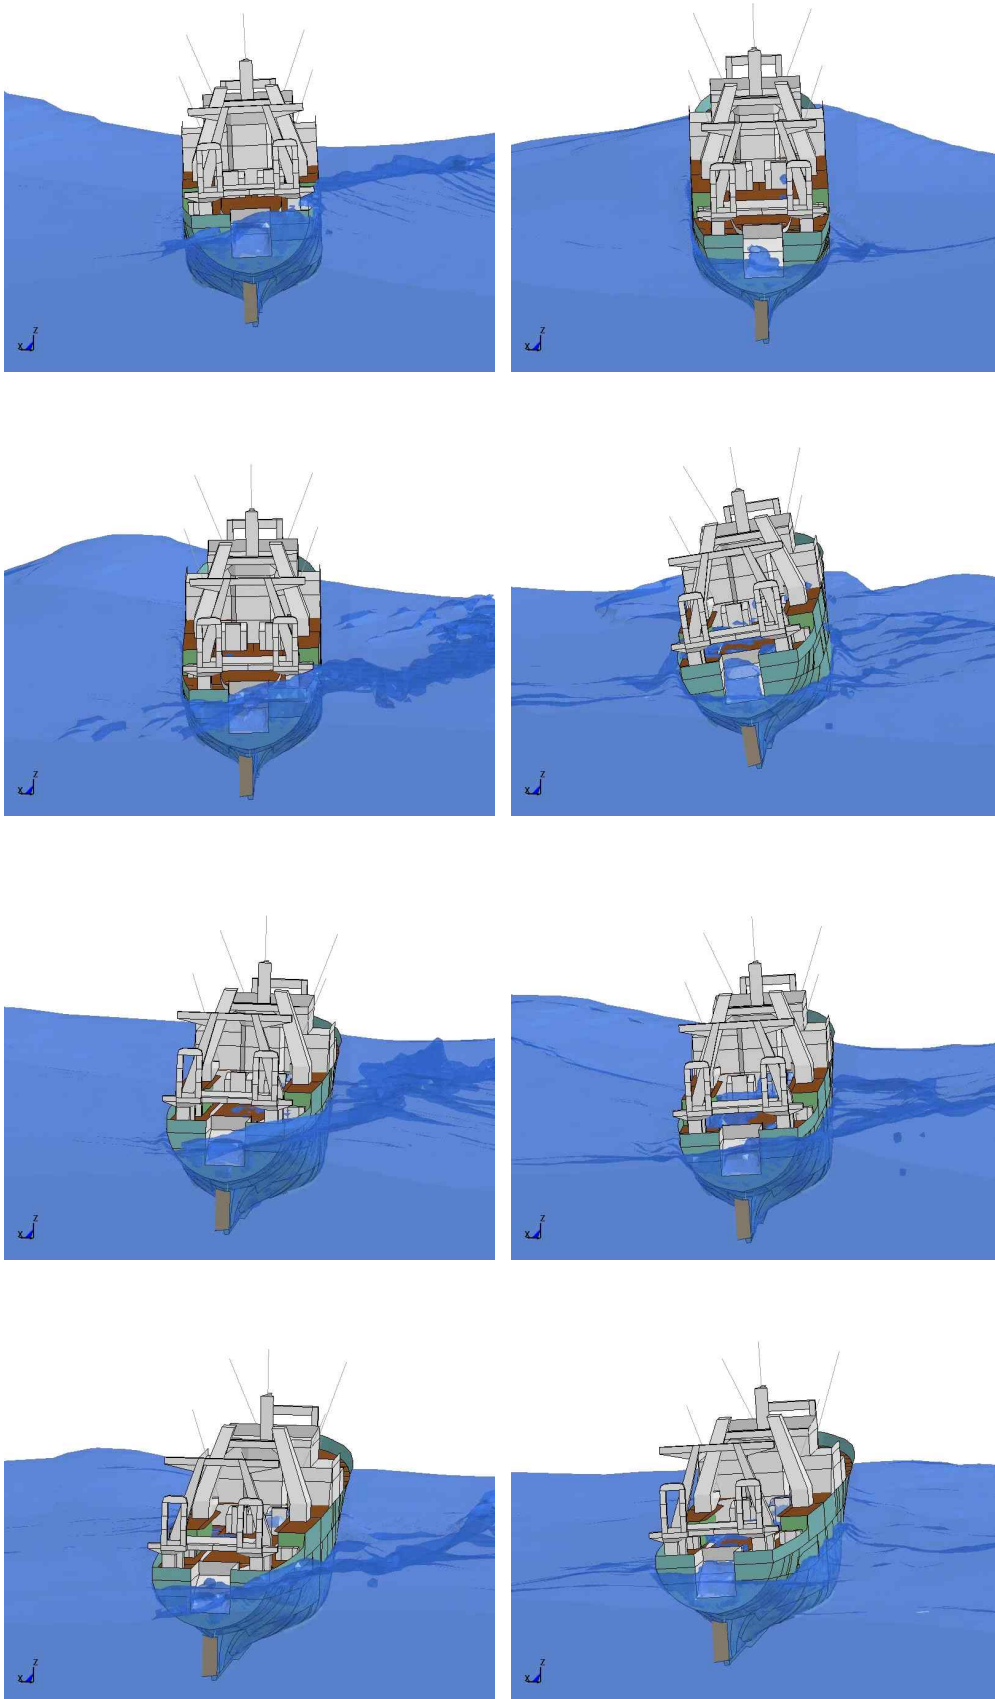
[Image 40-2] Movement in Case 2-1 observed at stern

the port. But as the situation worsened, the vessel was turned once more to making the waves hit the starboard side.

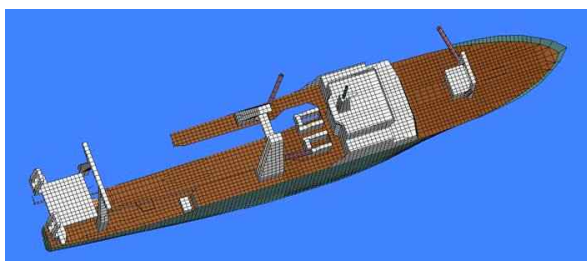
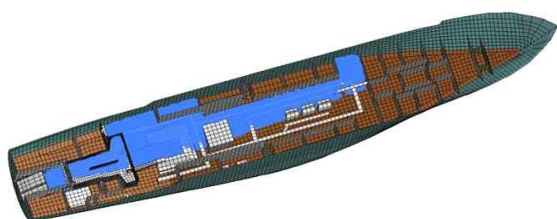
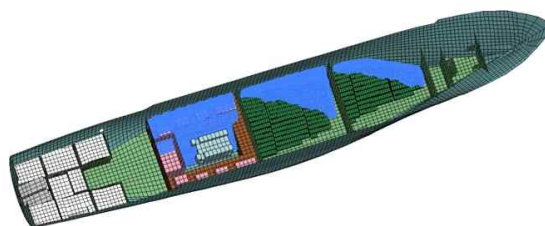
[Image 41] Status of seawater inflow in Case 2-2

4.3.4.15 In case 2-2 (continuous inflow of seawater, stern sinking, port incline of 30-35°), a large amount of water continuously flowed into the vessel, with waves rolling into starboard at an angle of 72.5°, and caused the hull to tilt steeply towards port by 30-35°.

4.3.4.16 In particular, as the port stern periodically sank underwater, the inflow of seawater through the sewage discharge outlet at port greatly increased, and the port inflow angle became larger. The amount of water on board reached 723 tons and water seeped into the engine room as well.

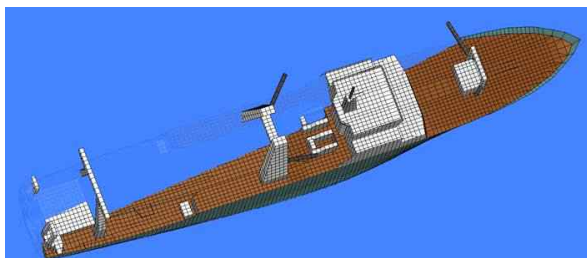
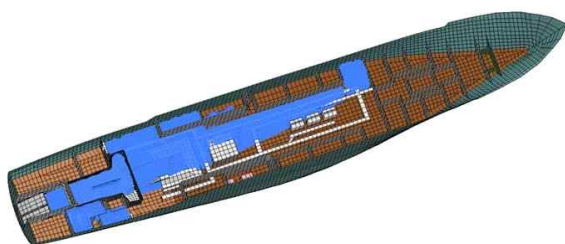
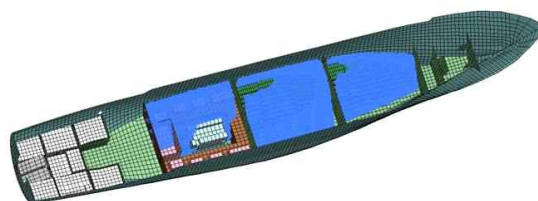
[Image 42] Status of seawater inflow in Case 2-3

4.3.4.17 In Case 2-3 (stern sinking accelerates, port incline of $45\text{--}50^\circ$), waves continue to strike the starboard side at an angle of 72.5° . As the inflow of seawater increases, the hull steeply tilts to port by more than 45° . With water flowing into the engine room and the fish hold, the stern of the vessel continues to sink.

4.3.4.18 At the time, as a result of the increase in inflow of seawater in the engine room, about 67% of the engine room was flooded and the engine stopped. The overall inflow of seawater amounted to 1,056 tons.

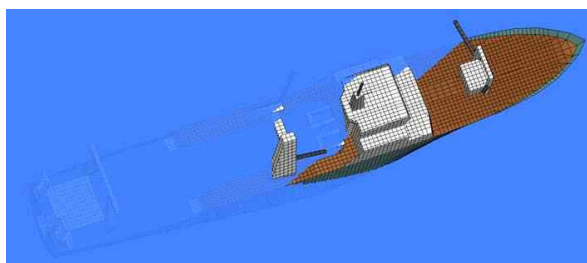
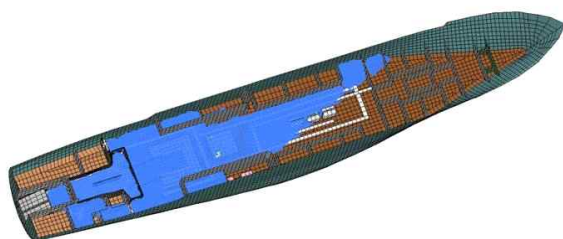
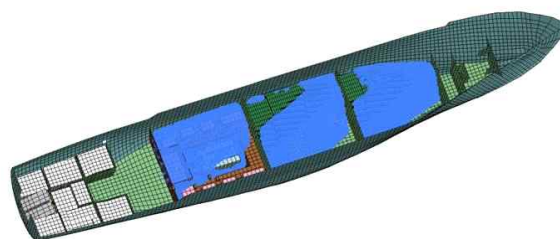
[Image 43] Status of seawater inflow in Case 2-4

4.3.4.19 In Case 2-4 (sinking from stern, port incline greater than 65°), with waves continuing to roll into the starboard side at an angle of 72.5° , it was verified that water was flowing in through various openings of the vessel. As the vessel tilted to port by more than 65° , it lost buoyancy. The vessel steadily sank from stern, and the amount of inflow into the vessel amounted to 1,540 tons.

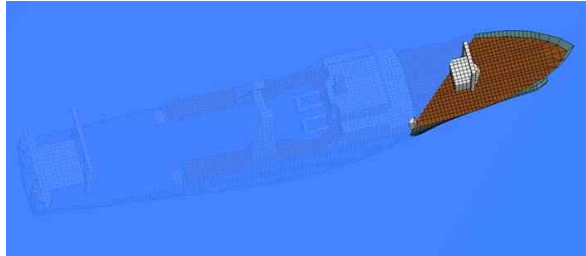
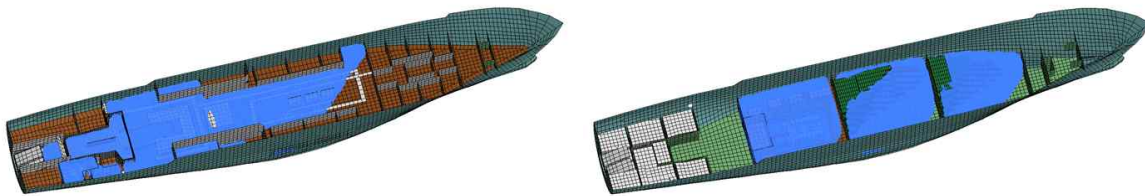
[Image 44] Status of seawater inflow in Case 2-5

4.3.4.20 In Case 2-5 (complete sinking, port incline of more than 80°), with waves continuing to crash into the starboard at an angle of 72.5° , the continuous inflow of seawater increased the transverse slope towards port by more than 80° , and the sinking accelerated. The

amount of seawater in the vessel reached 1,910 tons.
