## FINAL RUNWAY EXCURSION INCIDENT REPORT 24 June 2025

Runway Excursion Divi Divi Air

Divi Divi Air, Air Operator Certificate No. 10  
De Havilland/Viking DHC-6-300 TWIN OTTER  
PJ-DVG, MSN 347  
Flight DVR 269 from Aruba (TNCA) to Curaçao (TNCC)

**Final Incident Report  
CURCW/22/555-4**

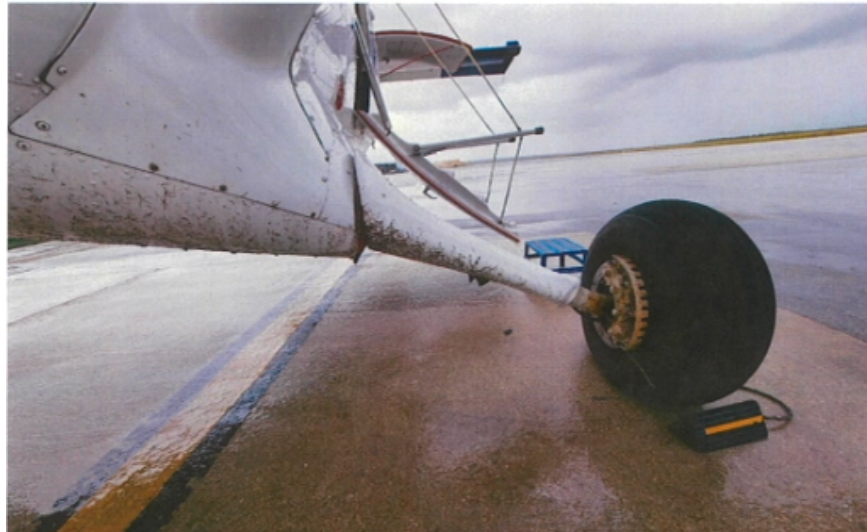
Tire Tracks

- 2.8 The movement to the right occurred in such a way that the aircraft finally stopped off the runway. Once the nose wheel got more out of line of the aircraft displacement, the possible drag caused by nose wheel skidding, further contributed to the displacement to the right. As directional control was being lost, a lateral runway excursion was inevitable. The aircraft ended up 90 meters to the right of the centerline or +/-60 meters from the runway edge.
