- ### 報告内容
- 背景
  - 近年の歴史的建造物被害
  - カトマンズの地震危険度
  - 歴史的建造物を対象とした建物調査
    - トモグラフィによる建物調査
    - 微動計による建物の振動調査
  - レンガ壁の要素試験
  - 実験・計測を基にした構造物のモデル化と解析
  - 狭隘地区構造物群の脆弱度評価への適用

- ### 背景
- ◆ 立命館大学グローバルCOEプログラム (2008-2012) 『歴史都市を守る「文化遺産防災学」推進拠点』
    - ・ネパール・カトマンズプロジェクト
      - 歴史的建造物の耐震性評価
      - 狭隘地区の脆弱度評価
 (この研究は、立命館大学・谷口仁士教授、土岐健三教授、大窪健之教授、板谷直子准教授、京都大学・古川愛子准教授、トリバン大学・マスキー教授、ハリ講師と共同で行われたものです。)
  - ◆ カトマンズにおける他の地震防災関連調査
    - ・ JICA: 2002年「カトマンズ盆地地震防災対策計画調査」  
(カトマンズ盆地の地震防災計画の立案、地震防災のためのデータベースと地震被害想定を作成)
    - ・ WB: 2011年 Nepal Hazard Risk Assessment (ネパール全土)
    - ・ UNDP: 2012年 Multi Hazard Survey (カトマンズ)
    - ・ JICA: 2014年ネパール国カトマンズ盆地における地震災害リスクアセスメントプロジェクト詳細計画調査
    - ・ 愛媛大学: 2006年よりカトマンズにサテライトオフィス

*Investigation of Historic Building (1)*  
*(Elastic Wave Tomography)*

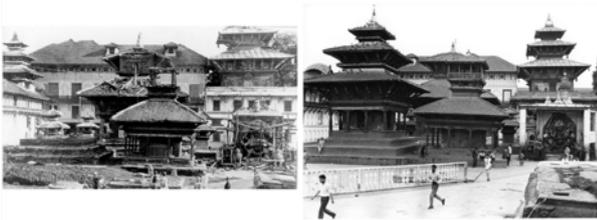
**Kathmandu Durbar Square**

during 1934 earthquake (left) and contemporary state (right)

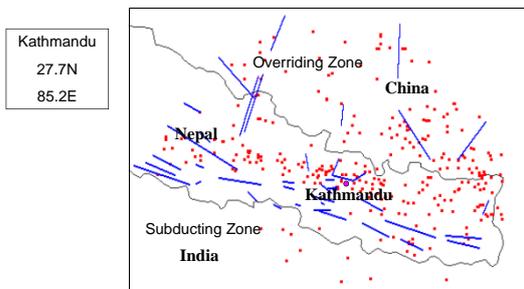
**Seismic Activities**

(by H.R. Parajuli., J.Kiyono, et.al [2008])

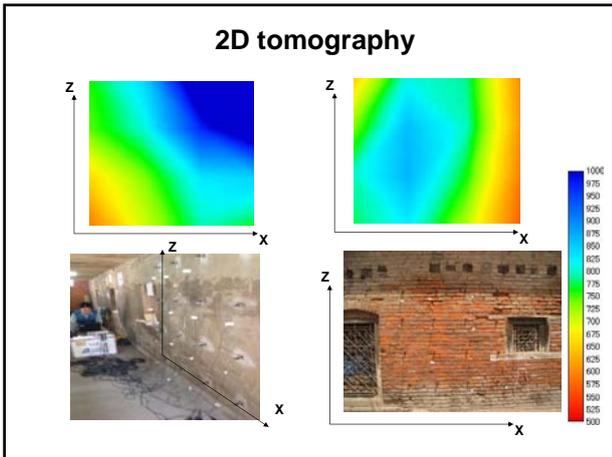
- ### Results
- P-wave velocity of Intact brick
    - about 2,500m/sec
  - Apparent P-wave velocity of wall :
    - $30,000/x$  (x: thickness of wall[cm])
  - Average P-wave velocity of masonry wall:
    - 500m/sec~1000m/sec
  - Brick quality is very poor because of the aging and underground water absorption

- ### まとめ
- ✓ ネパールの歴史的建造物群は過去の地震でも大きな被害を経験してきた。そしてその都度、また元の材料を使って再建されてきた。
  - ✓ ハザード解析より、50年40%、10%、5%の震度階級は、それぞれ震度4、震度5弱～5強、震度5強～6弱程度に対応する。
  - ✓ 経年劣化や地下水の吸収等によって組積造建物のレンガの質が落ち、弾性波トモグラフィーの結果より、本来の波速の1/3～1/5程度にまで減少している。
  - ✓ 2階建て歴史的組積造の卓越振動数は、短辺方向で並進・ねじれそれぞれ4.3Hzと5.8Hzであった。
  - ✓ 歴史的建造物に使用されているレンガとレンガ壁の要素試験により、密度やヤング率、圧縮強度やせん断強度の値を得た。
  - ✓ 弾性波トモグラフィーや要素試験で得られた値を利用して、歴史的建造物の解析モデルを作成し、微動観測による振動特性で妥当性を検証した。
  - ✓ 数値解析により、耐震補強法の評価を行うとともに、歴史的建造物群の脆弱性評価を行った。震度5弱程度で歴史的建造物群は大被害を受ける。
  - ✓ 近傍にすべりの大きな領域、地盤の弱い盆地構造、耐震補強を行う余裕なし、建て増しや古く耐震性のない組積造建物群、1934から80年経過・・・

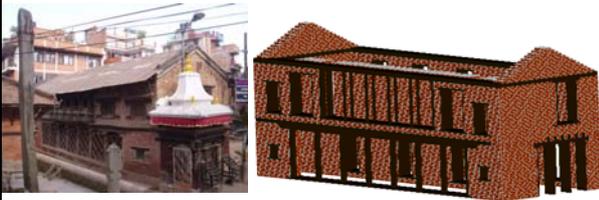
**Modeling with Refined DEM**

- Total number of elements 63,978  
Rectangular parallelepiped
- Size of bricks 10cm × 10cm × 20cm
