## No. 8

Middle East Airlines Co., Viscount 754, OD-ADE, and Turkish Air Force, C-47, CBK 28, were involved in a mid-air collision over Ankara, Turkey, on 1 February 1963. Report, dated 30 April 1963, released by the Department of Civil Aviation, Ministry of Communications, Turkey.

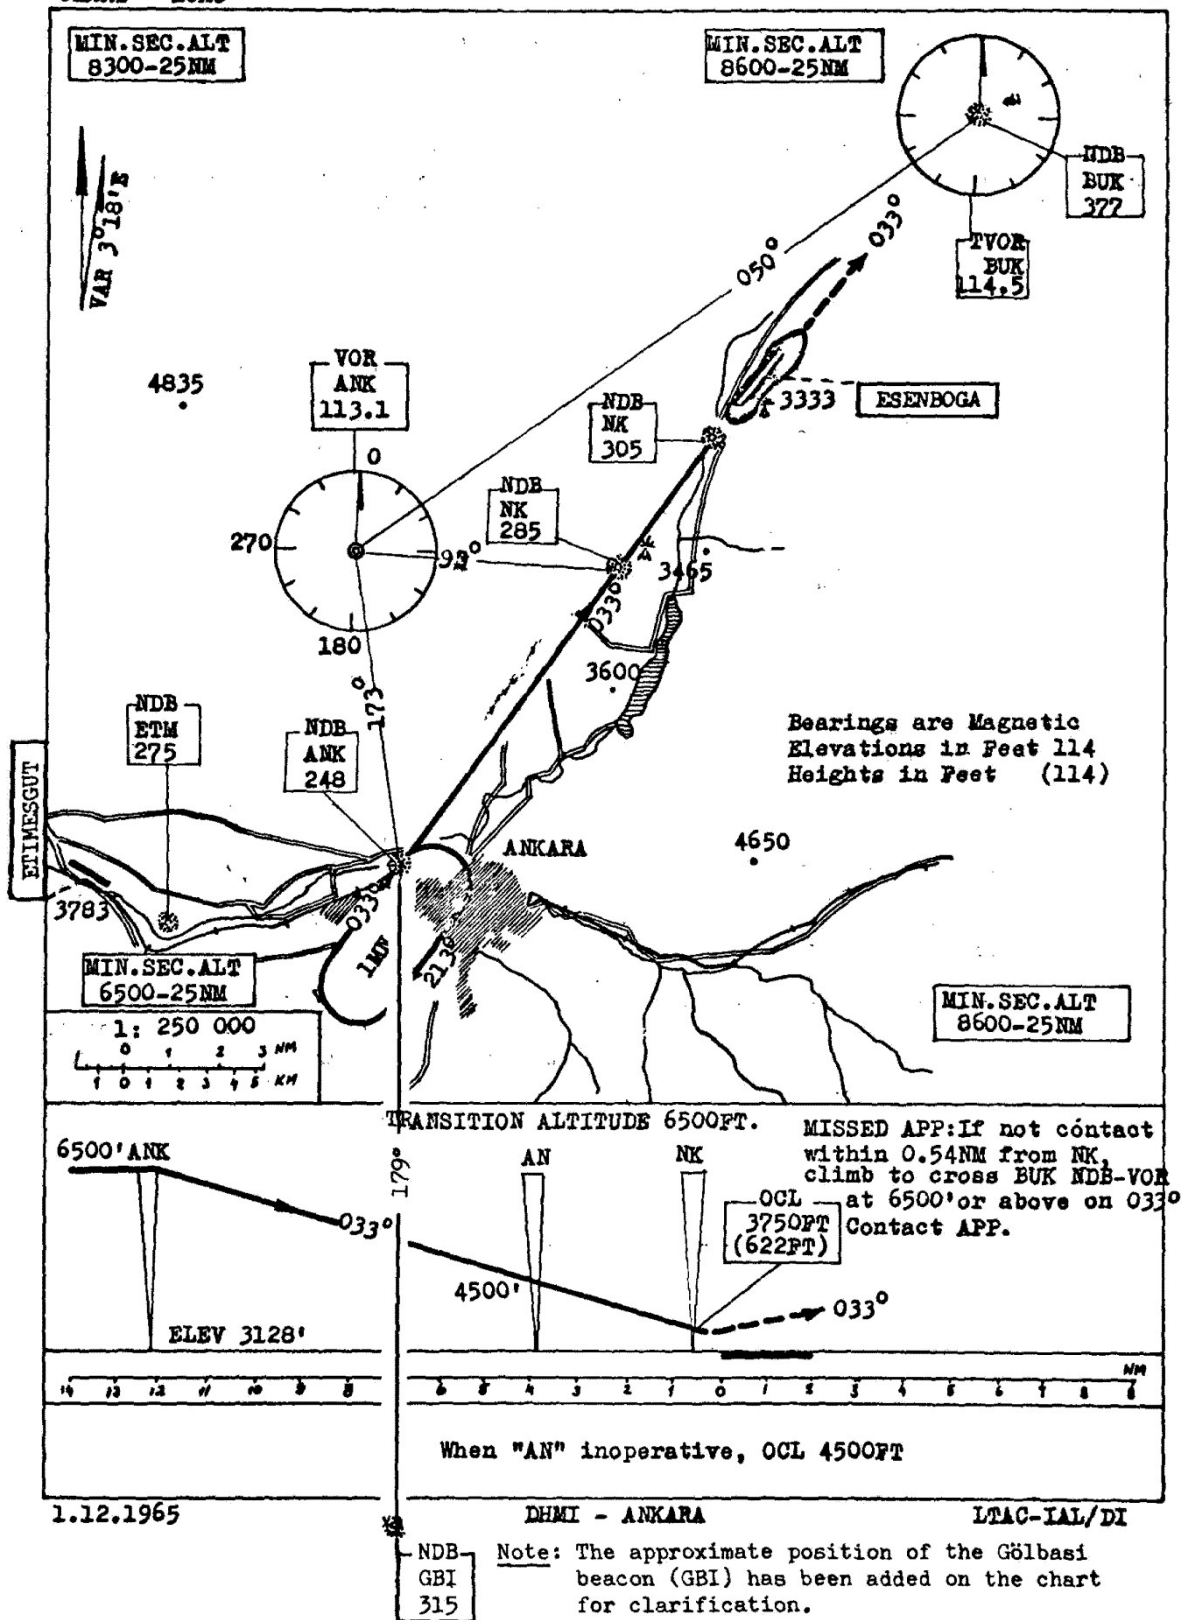
FIGURE 1

ELEV 3128 FT

ESENBOĞA TWR 118.1-121.5-3023.5 ANKARA/ESENBOĞA  
ESENBOĞA APP 117.9-119.1-121.5 TURKEY **NDB 2**
