AIRCRAFT ACCIDENT REPORT

NORTHEAST AIRLINES, INC.
FAIRCHILD HILLER FH-227C, N380NE
NEAR HANOVER, NEW HAMPSHIRE
OCTOBER 25, 1968

NATIONAL TRANSPORTATION SAFETY BOARD
Bureau of Aviation Safety
Washington, O. C. 20591

Report Number: NTSB-AAR-70-7

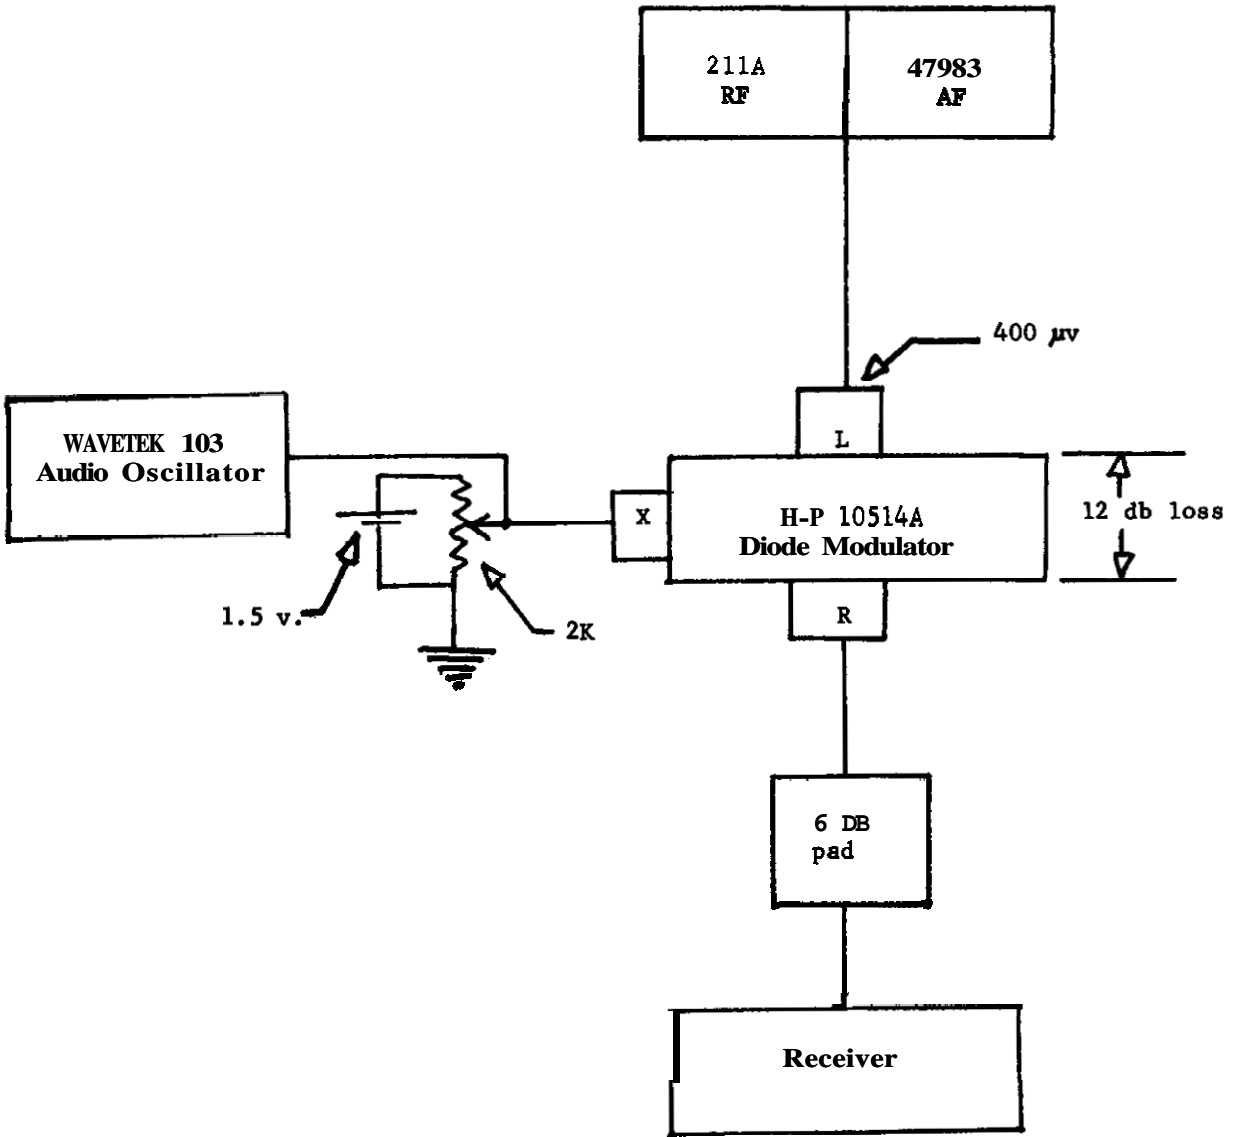
Figure 1

- (1) Set up test equipment as shown in Figure 1.
- (2) Insert a standard VOR signal, and set 211A attenuator to 400 pv output.
- (3) Adjust battery bias to obtain 12 db loss through H-P 10514A mixer. 0.75 m.a. current was necessary in FAA testing.
- (4) Using VTVM, measure the level of the 30 Hz variable AM modulation in the 30 Hz channel of the VOR receiver (primary of output transformer).
- (5) Turn off 30 Hz variable AM modulation from VOR audio source.
- (6) Set audio oscillator output to 1/3 of the value measured in Step (4) to obtain 10 percent modulation. Restore 30 Hz AM,

A VOR receiver is not susceptible to reflection interference of the kind described in para. 2.a. *if*, using this test procedure, the bearing error is found to be not more than ± 2 degrees in the manual channel and not more than ± 5 degrees in the automatic channel.
