# AIRCRAFT ACCIDENT REPORT

HUGHES AIR WEST DC-9, N9345  
AND U.S. MARINE CORPS F-4B, 151458  
NEAR DUARTE, CALIFORNIA  
JUNE 6, 1971

NATIONAL TRANSPORTATION SAFETY BOARD  
Washington, D. C. 20591  
REPORT NUMBER: WTSB-AAR-72-26

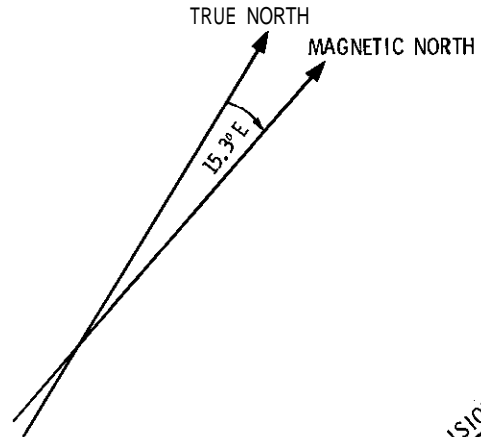
# COMPUTED RANGES, BEARINGS, AND CLOSURE

PRIOR TO EVASIVE MANEUVER	
DC-9-31	F-4B
39° MAG	145° MAG
400K TAS	420K TAS
(FLT. RECORDER)	(RIO TESTIMONY)

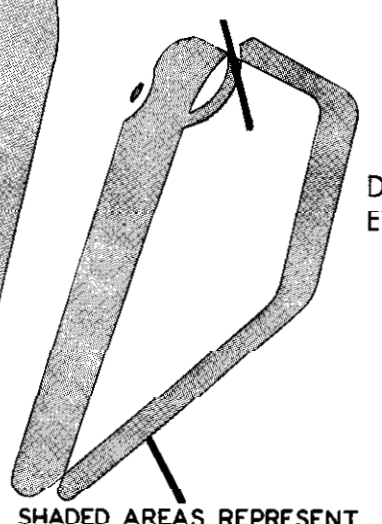
DC-9 VISIBILITY FROM CAPTAIN'S DESIGN EYE REFERENCE POINT

CLEAR AREAS REPR  
BINOCULAR VISIOI

SHADED AREAS REPRESENT  
MONOCULAR VISION ONLY
