INVESTIGATION NO. 2813
THE ATLANTIC COAST LINE RAILROAD COMPANY
REPORT IN RE ACCIDENT
AT STOCKTON, GA., ON
AUGUST 4, 1944

Accident at Stockton, Ga., on August 4, 1944, caused by
a broken rail, as a result of the presence of
transverse fissures.

Inv-2813
 Atlantic Coast Line Railroad
 Stockton, Ga.
 August 4, 1944

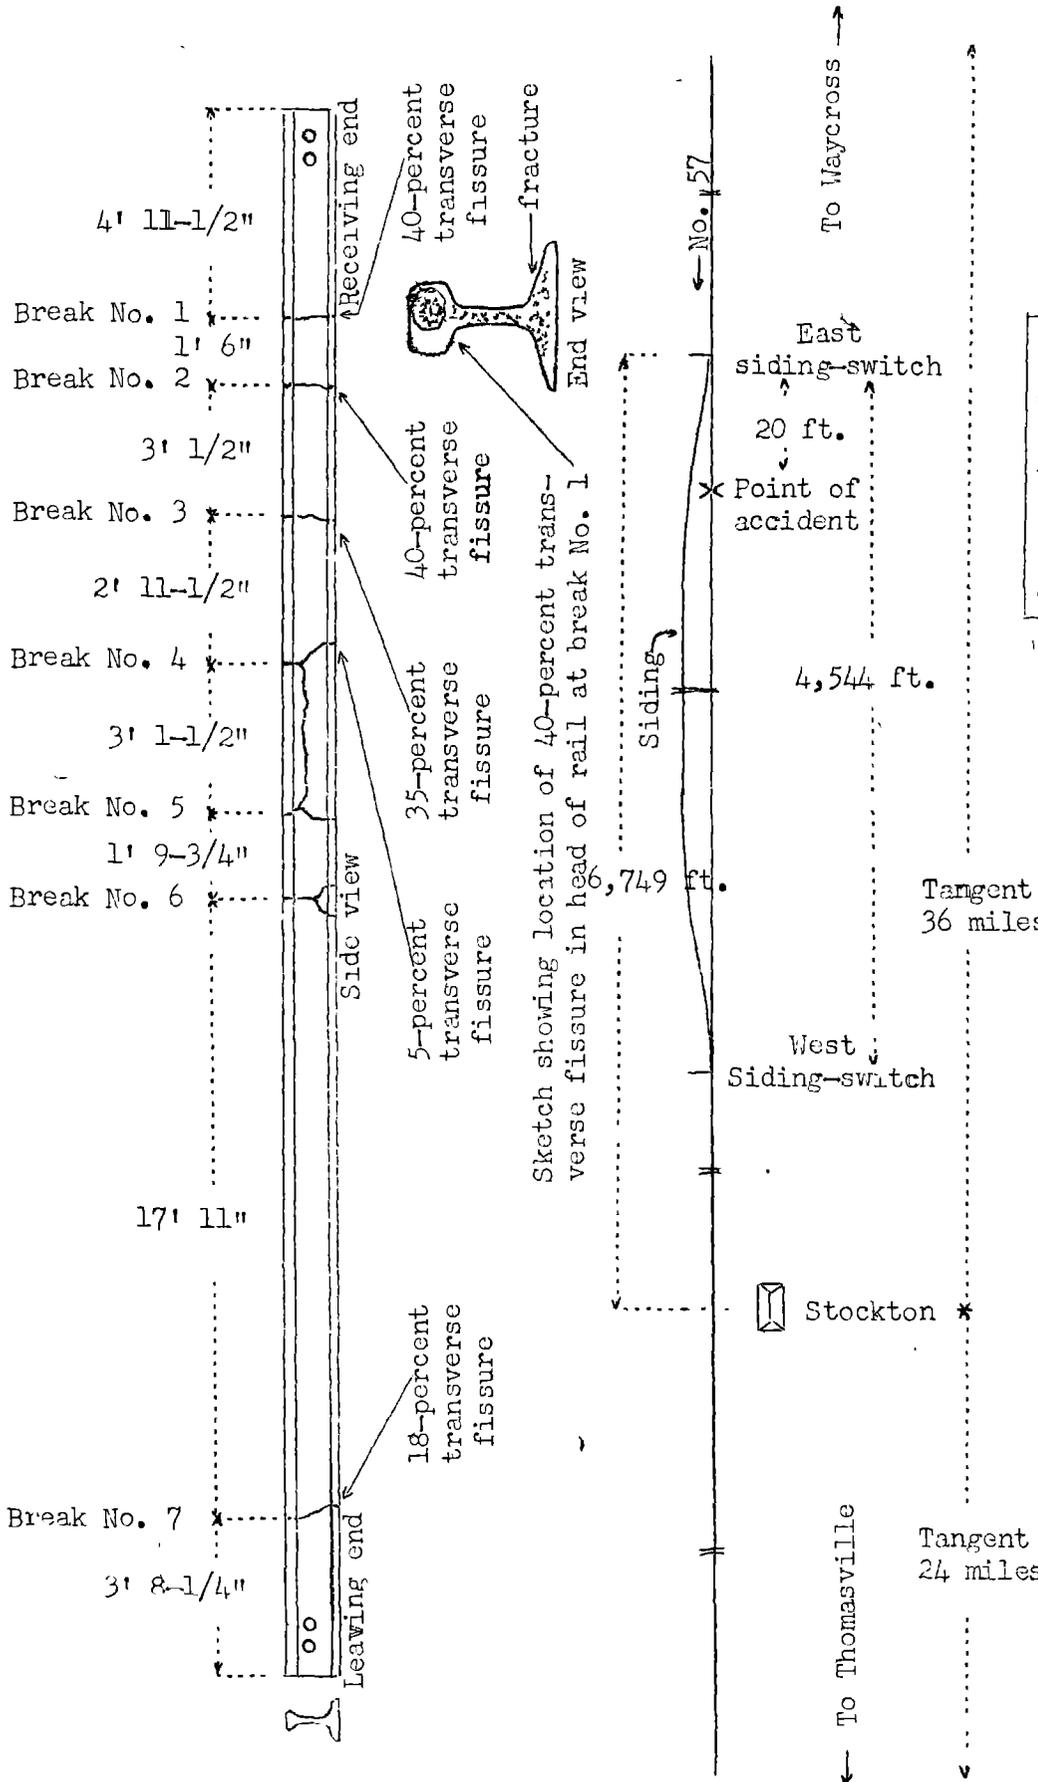
o	Waycross, Ga.	34.2 mi.
o	Dupont	8.3 mi.
X	Stockton	(Point of accident)
		61.5 mi.
o	Thomasville, Ga.

Location of Accident and Method of Operation

This accident occurred on that part of the Waycross District extending westward from Waycross to Thomasville, Ga., 104 miles. This was a single-track line over which trains were operated by timetable and train orders. There was no block system in use. At Stockton, 42.5 miles west of Waycross, a siding 4,544 feet long paralleled the main track on the north. The east switch of the siding was 6,749 feet east of the station. The accident occurred on the main track 20 feet west of the east siding-switch. The main track was tangent throughout a distance of 36 miles east of Stockton and 24 miles westward. At the point of accident the grade was practically level.
