Material Studies in a High Energy Spark Gap

Abstract—The chemical interactions and physical processes occurring in a high energy spark gap with different combinations of gases, electrodes, and insulators were studied. The electrodes studied were graphite and a tungsten-copper composite; the insulators were Lexan and Blue Nylon; and the gases were N_2 and SF_6 . The gas composition was monitored with a mass spectrometer. Spectroscopic techniques were used to observe the arc channel. The electrode surfaces were studied with several surface analysis techniques, including scanning electron microscopy, electron spectroscopy for chemical analysis, Auger electron spectroscopy, and X-ray fluorescence. The breakdown voltage distribution was examined for different material combinations. The plasma chemistry processes involving the gas, electrode, and insulator materials were found to affect the voltage self-breakdown distribution. The detailed surface analysis gave information about the nature of the chemical processes. The presence of Blue Nylon seemed to have a more adverse effect than Lexan and graphite seemed to have a narrower voltage distribution than the tungsten-copper composite.

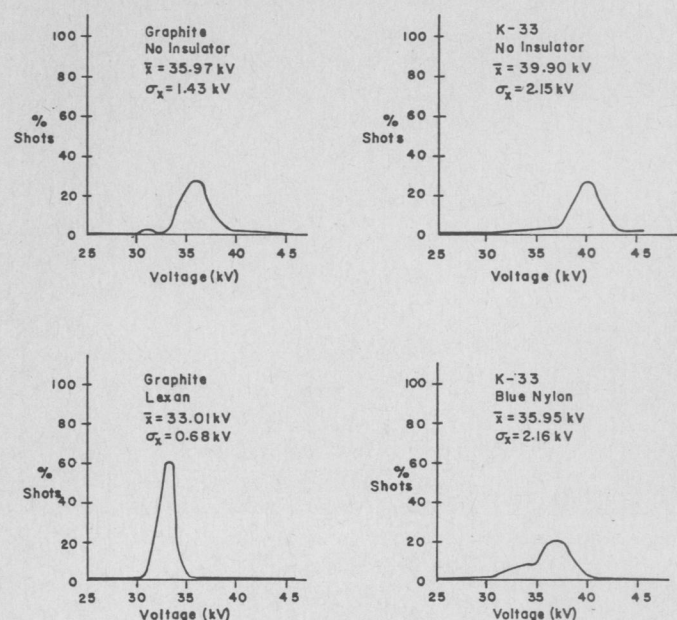
Fig. 13. Some voltage self-breakdown distribution functions after 10 000 discharges.

Fig. 13 shows some sample voltage self-breakdown distributions for the 500-shot sample window from 10 000–10 500 shots. The difference in \bar{x} is primarily due to slight variations in electrode separation from case-to-case. It can be seen that the introduction of a Blue Nylon insulator in the K-33- SF_6 system leads to a significant broadening of the distribution function on the low-voltage side. On the other hand, the introduction of Lexan in a graphite- N_2 system appears to improve the distribution function. The K-33 results are consistent with the observations of the silicon nodules observed on the K-33 surface when operated in SF_6 and exposed to a Blue Nylon insulator. These nodules may lead to local field enhancement and hence pre-fires. The apparent improvement in

graphite N₂ data when a Lexan insulator is inserted in the gap may be due to a thick organic coating that is observed on the electrode surface in this case. This coating may serve to smooth out field enhancement points.
