**AIRCRAFT ACCIDENT INVESTIGATION REPORT**

**THAI AIRWAYS INTERNATIONAL COMPANY LIMITED  
AIRBUS A310-204, HS-TIA**

**SURAT THANI AIRPORT  
THAILAND**

**11 DECEMBER 1998**

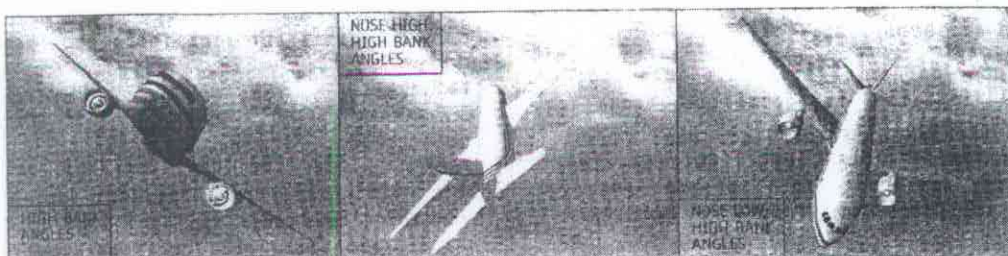
Any time the airplane is not in "zero-angle-of-bank" flight, lift created by the wings is not being fully applied against gravity, and more than 1 g will be required for level flight (figure 6). At bank angles greater than 67 degrees, level flight cannot be maintained within flight manual limits for a 2.5 g load factor (figure 7). In high bank angle increasing airspeed situations, the primary objective is to maneuver the lift of the airplane to directly oppose the force of gravity by rolling to wings level. Applying nose-up elevator at bank angles above 60 degrees causes no appreciable change in pitch attitude and may exceed normal structure load limits as well as the wing angle of attack for stall. The closer the lift vector is to vertical (wings level), the more effective the applied g is in recovering the airplane.
