Report No. 710/435

Metallurgical Examination of German Armor  
from a Pz. Kw. 131 Tank

March 15, 1943

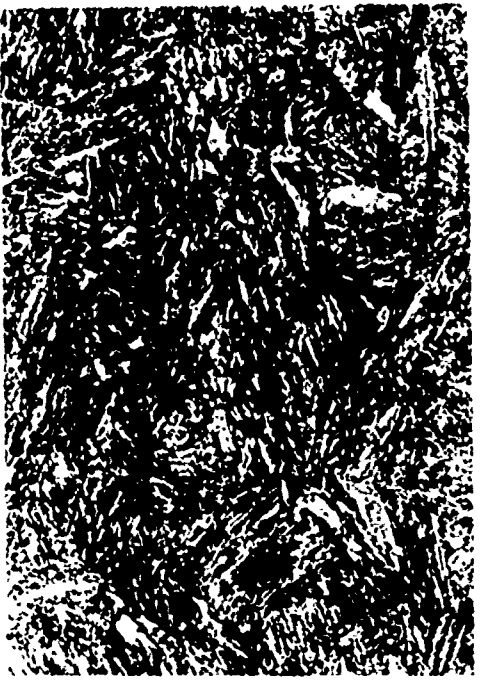
Microstructure of Plate (a)

X100 -A- Picral-Nital  
Banded Structure

X1000 -B- Picral-Nital  
Tempered Martensite

Plate a possessed an acicular tempered martensitic structure having a severe degree of banding. (Figures 6A and B)

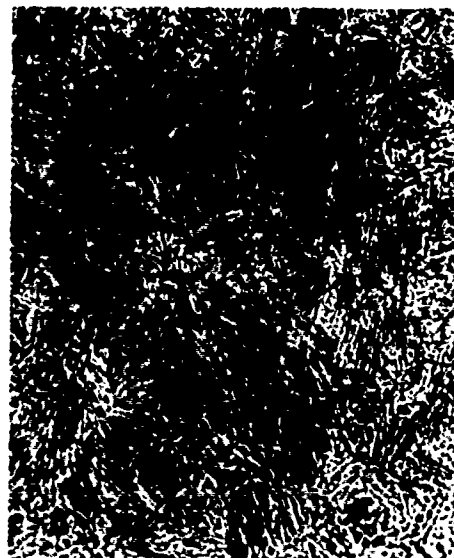
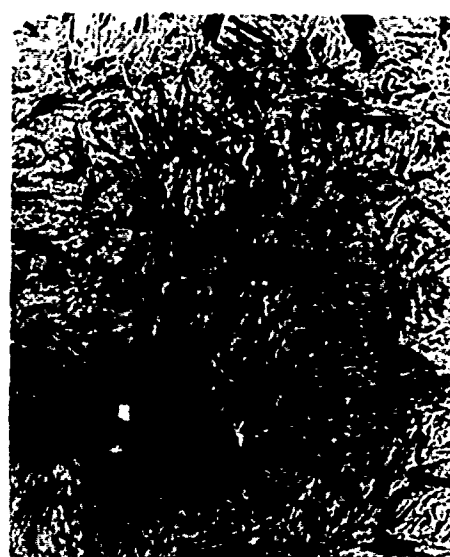
Microstructure of the Flange - Etched in Picral-Nital

X1000 -E-  
Low Carbon Martensite

X1000 -F-  
Carburized Case High Carbon Martensite

The flange is composed of a low carbon martensite in the core (Figure 7E) and a high carbon martensite in the case (Figure 7F).

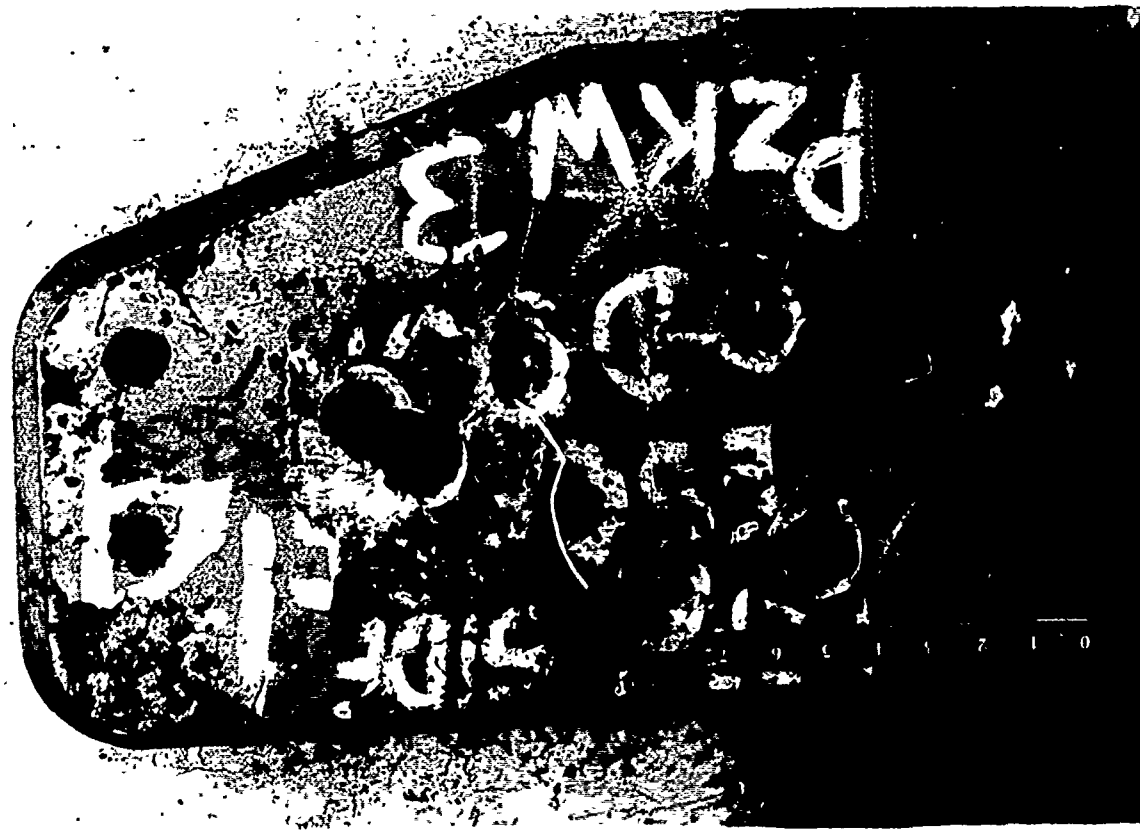
74655 12-4-42 AMERICAN PROVING GROUND ORDNANCE DEPT.  
armor Plate Escape Door, from left side of German Pz. Kw. III Tank, fired with 37 mm M51 A. P. C. at normal.
