NATIONAL
TRANSPORTATION
SAFETY
COMMITTEE

AIRCRAFT ACCIDENT REPORT

Garuda Indonesia Flight GA 880

Boeing B747-200 PK-GSD

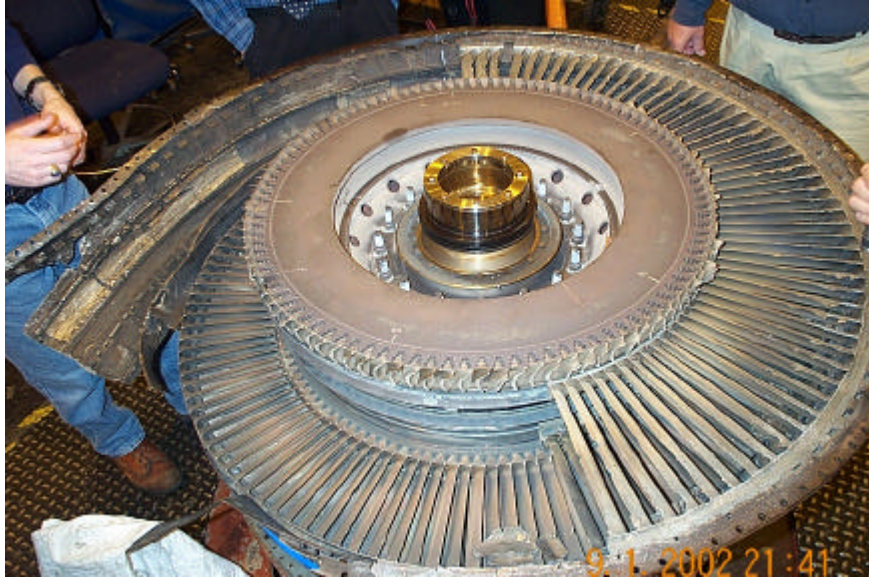
Figure B1. Engine #2 LPT Module (1) - 6th stage disc on top

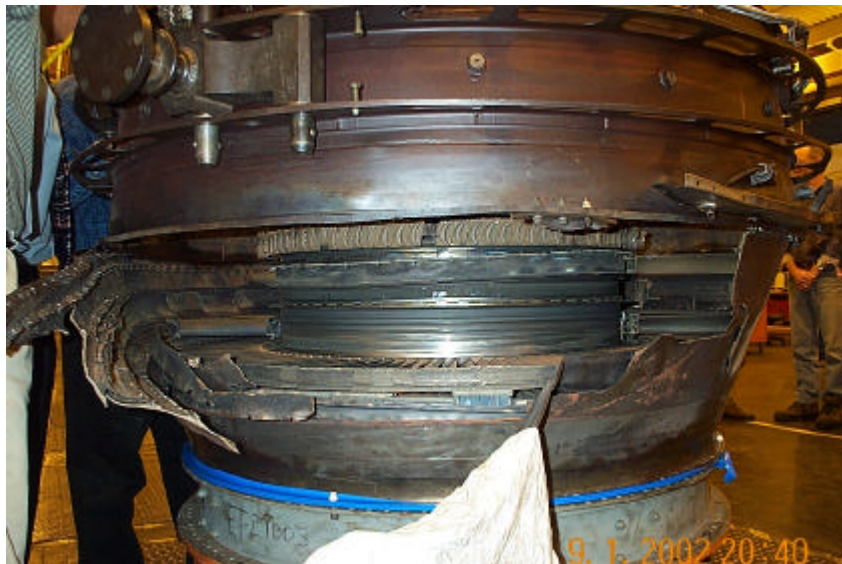
Figure B2. Engine #2 LPT Module (2)

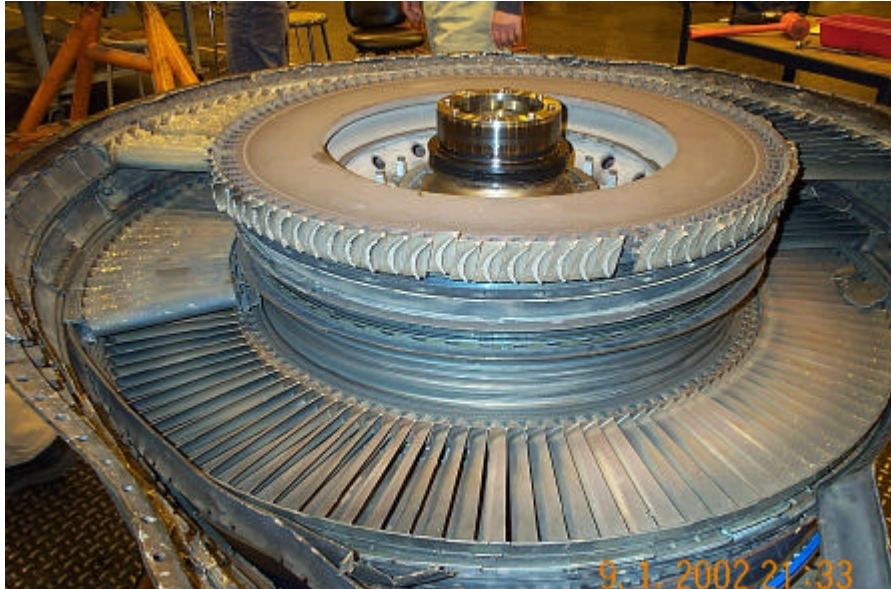
Figure B3. Engine #2 LPT Module

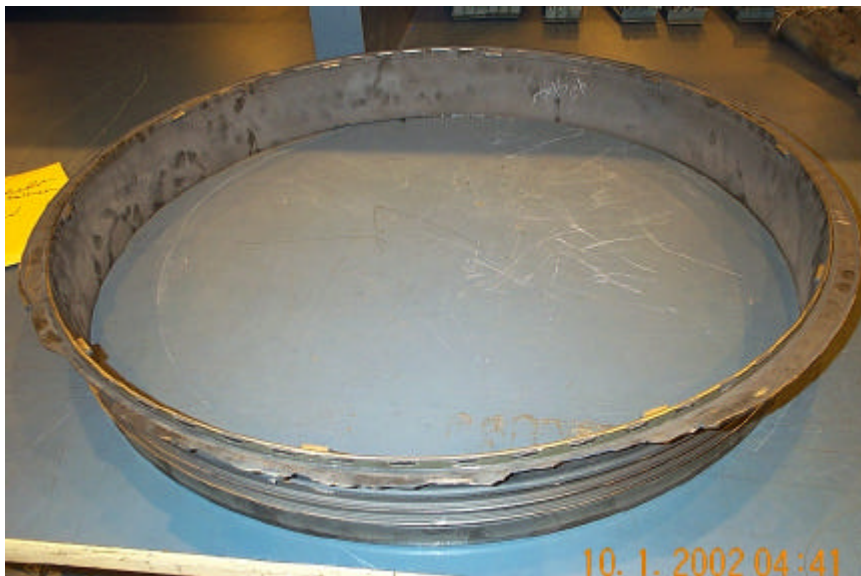
Figure B8. 5th stage inner airseal
